Part 1.4 Findings

FACTORS CONSIDERED BY THE PANEL

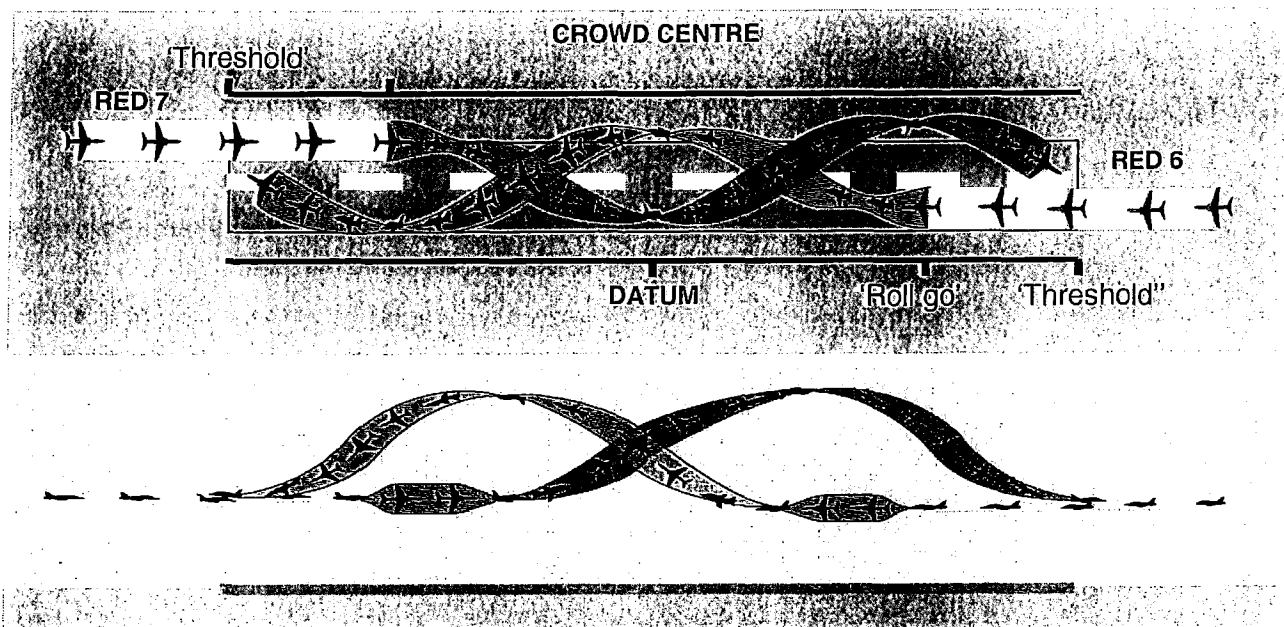
Fig 1 OBR Execution

a. **OBR Execution.** The OBR is flown by Red 6 and Red 7 in the second half of the display. It involves both aircraft descending towards their respective Cross Points. These are geographical features, 12000 ft apart, along the display line and not the point at which the aircraft cross in front of the crowd. Prior to reaching the Cross Points both aircraft turn towards each other and roll out on their predetermined line, whilst descending to 100 ft agl, 330 kts airbrake out (See Fig 1). Lines are chosen to guarantee a minimum of 100 ft lateral separation. The aircraft continue down their line until the first pilot reaches a second geographical point at which they call, 'Threshold'. The geographical features used for the 'Threshold' calls are 6000 ft apart and should be easily identifiable to the pilots. Providing the second pilot is visual with the first aircraft, on parameters and happy to commit to the manoeuvre, he will respond with a second 'Threshold' call. This call may not necessarily relate to his geographical feature. This is done to allow the pilots to commence the manoeuvre as expeditiously as possible. The second 'Threshold' call confirms that both pilots are happy to commence the next stage of the manoeuvre. The next action is initiated on a 'Roll go' call from Red 6. The timing of this call is judged purely on a visual picture based on Red 6's previous experience of flying the manoeuvre. On the 'R' of the roll, Red 6 changes smoke colour to blue and Red 7 to red. On the 'G' of go, both pilots drop their right wing and pull. On dropping the right wing, the pilots start a turn and should apply about 4g to allow the aircraft to cross flight-paths as they swap to the opposite line. This should only take a fraction of a second and almost immediately afterwards the turn is reversed to commence the barrel roll part of the manoeuvre. The two aircraft are then aiming to cross at the centre point of the crowd line, 'Datum'. The two individual aircraft flight paths are corrected in such a manner to allow this cross to happen approximately half way up the first stage of the barrel roll. Once the cross has happened each aircraft will continue their own barrel roll and fly away from each other.
