**SURVIVABILITY CONSIDERATIONS**

## **RESTRICTED – SERVICE INQUIRY**

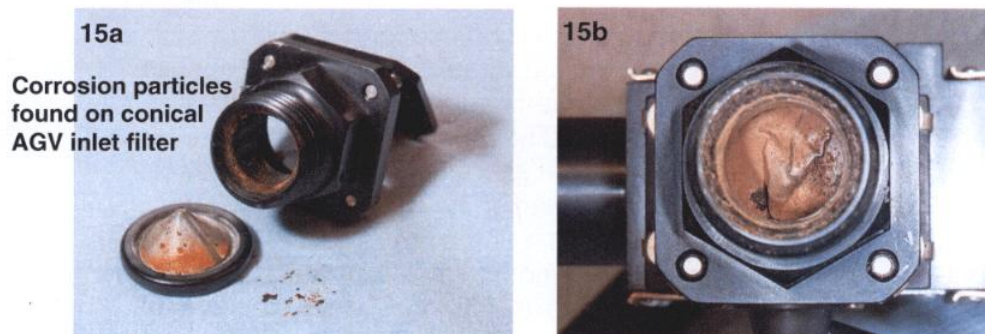
1.4.80. **Panel’s Assessment of the AGV Hazard.** The 2005 anti-G trouser occurrence had been captured on the Hawk T Mk1 SA’s risk register. The Panel assessed that the frequent anti-G system failures, which resulted in the same hazard of ‘anti-G trousers loss of functionality’, should have been captured on the SA’s risk register and highlighted to the Duty Holder chain for consideration. At the time of the accident there was no formal direction or guidance issued to the front line units operating the Hawk T Mk1 with regard to the engineering issue, operational risk or suggested mitigation.

1.4.81 During the final writing phase of this inquiry, an occurrence report was raised on 1 Mar 12 following an anti-G valve failure on a 4g run in and break to land; the anti-G system failed to inflate the pilot’s anti-G trousers. The occurrence report highlighted that no engineering fault report had been raised for this incident and the conical filter was found to have collapsed with evidence of corrosion present. This incident reinforces the requirement for proactive and diligent fault and occurrence reporting with the aim of preventing subsequent accidents or near misses. Figure 15b illustrates a separate case of a collapsed AGV inlet filter caused by corrosion on the inlet filter.

**Figure 15 – Examples of Hawk T Mk1 AGVs with corrosion on the inlet and conical inlet filter (15a) and a collapsed filter caused by corrosion particles collected on the inlet filter (15b).**
