PART 1.4 – ANALYSIS AND FINDINGS

1.4.1. **Background.** This was a fatal accident, during single seat operations in an aircraft which did not have an in-cockpit voice recorder or video. Additionally the shallow approach angle and high energy of the aircraft resulted in a multiple-impact accident sequence covering 46 000m² which was further complicated by the submersion of some evidence within the River Stour. The combination of these events complicated certain forensic aspects of the investigation, and in the absence of the pilot's testimony or any in-cockpit voice/video evidence, the Human Factor (HF) and medical investigations were reliant on a diagnosis by exclusion. Use of the 5M model, as detailed in the MAA Regulatory Publications (MRP), ensured a holistic approach was adopted throughout.¹ As relevant evidence emerged, the Panel systematically closed lines of inquiry, or opened others. The investigation highlighted a number of individual actions, local conditions, risk control measures and organisational influences that were factors in the accident. Any *post factum* inquiry may be at risk of hindsight bias. It is recognised that where a particular course of action is scruti

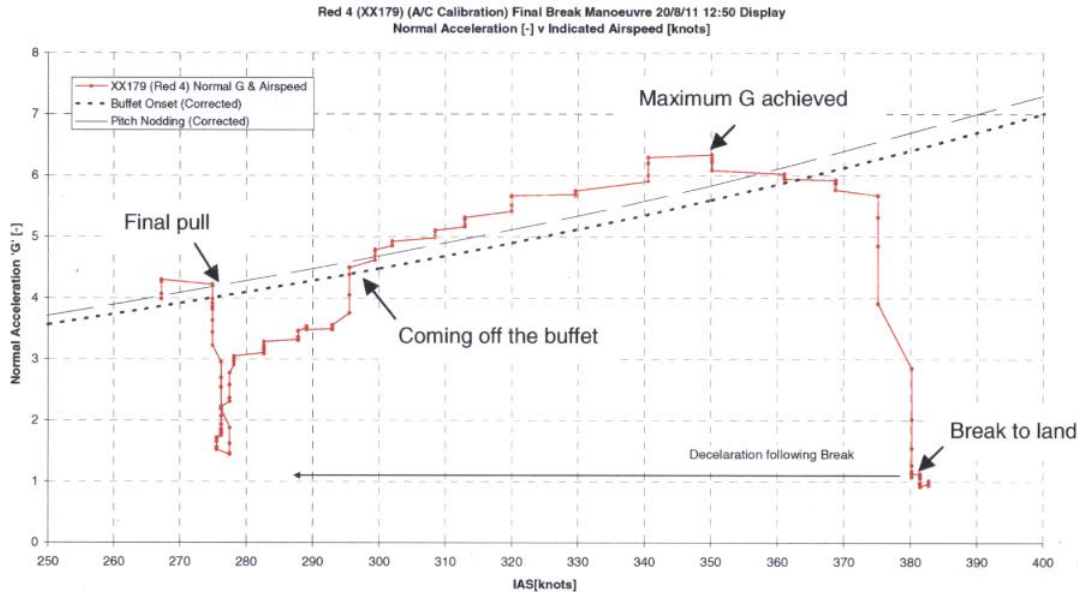
1.4.16. **Lift Boundaries.** The Hawk T Mk1 has a very clear lift buffet boundary which provides good warning of the stall. Hawk T Mk1 pilots use this boundary as an easily identifiable method of ensuring that the aircraft is flown to its maximum performance capability, while simultaneously increasing drag to reduce speed. An extended airbrake also increases airframe vibration, but the difference between airbrake buffet and lift buffet is unambiguous. In layman’s terms, flying in lift buffet is not dissimilar to driving a car over a cobbled surface; it is obvious when you do so. To assess the pilot’s level of situational awareness, the Panel analysed the ADR Gz trace against the Hawk T Mk1 theoretical lift boundaries as shown at Figure 1. Normal and typical breaks see the aircraft remaining in the buffet until the aircraft is downwind. The comparison with theoretical lift boundaries indicated that XX179 was flying in buffet from shortly after the break commenced until the speed reached 296 KIAS (approximately halfway around the turn). This equated to break +5.5 seconds and broadly coincided with the commencement of abnormalities in the control strategy.

**Figure 1 – Comparison of XX179 G trace with Theoretical Lift Boundaries
Normal Acceleration vs Indicated Airspeed [knots]**

- a. The likely trigger point in this accident occurred approximately 5 seconds after initiation of the Left/Right break, after which the pilot's control strategy became abnormal and the flight path became abnormal/atypical.
- b. Under normal circumstances, the pilot would have been aware that he was no longer flying in buffet approximately 5 seconds after the break commenced.
- c. The resultant flight profile was extremely unusual and, under normal circumstances, this would have been obvious to the pilot.

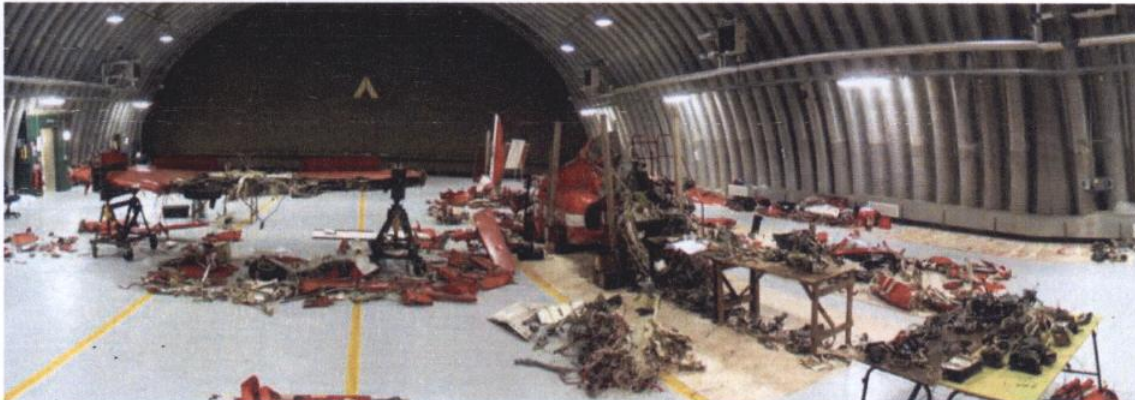
Figure 2 – XX179 lay out in MOD Boscombe Down as part of the engineering investigation.

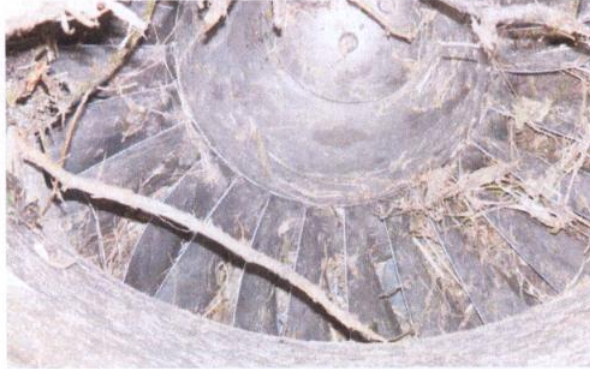
1.4.21. **Engine And Fuel Systems.** With the wreckage *in situ*, examination of the compressor blades indicated relatively minor damage, with the ingestion of mud and foliage being consistent with an engine that had been powered during the crash sequence; see Figure 3. The engine was recovered, still attached to the fuselage, and taken to MOD Boscombe Down where a design authority air safety investigator inspected the engine prior to its removal and transfer for a detailed strip and analysis. The detailed strip and analysis indicated evidence of bird ingestion, although ADR engine data suggested that this had not occurred airborne and the characteristics of the mechanical damage to the LP and HP compressor corroborated this assessment. Furthermore DNA analysis of bird remnants was consistent with a bird carcass found in the vicinity of the river bank. The cabin air supply system was intact, up to the engine to aircraft interface, with further mud ingestion corroborating the initial assessment that the engine was operating during the crash sequence. No evidence of cabin air contamination was found. Engine wear analysis was conducted using magnetic probe samples taken from the internal gearbox, HP and LP turbines, and the high speed and external gearbox. The wear analysis results were found to be normal. Figure 4, shows the extent of fuel contamination at the crash site which indicated that fuel remained in the aircraft at impact. Aviation fuel and engine oil samples were analysed, with each sample being consistent with its reference type. There was no evidence of adulteration of the samples with any other petroleum, oil, lubricant (POL) type

materials. Additionally, no significant degradation in the overall quality of the fluids was evident. In addition to the detailed engine examination, the ADR trace analysis revealed no engine anomalies. The Panel concluded that the engine and fuel system were **not a factor** in the accident.

Figure 3 – The forward face of the compressor as viewed through the left hand air intake.

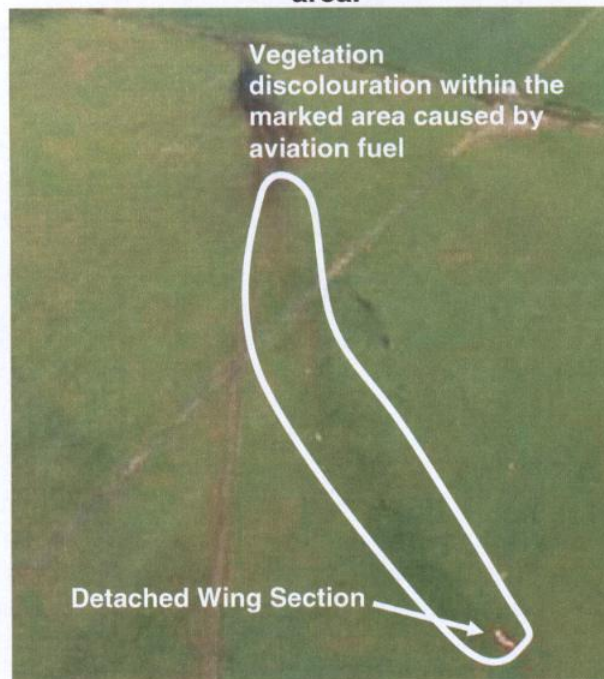
Figure 4 – Ground discolouration, caused by aviation fuel, shown within the marked area.

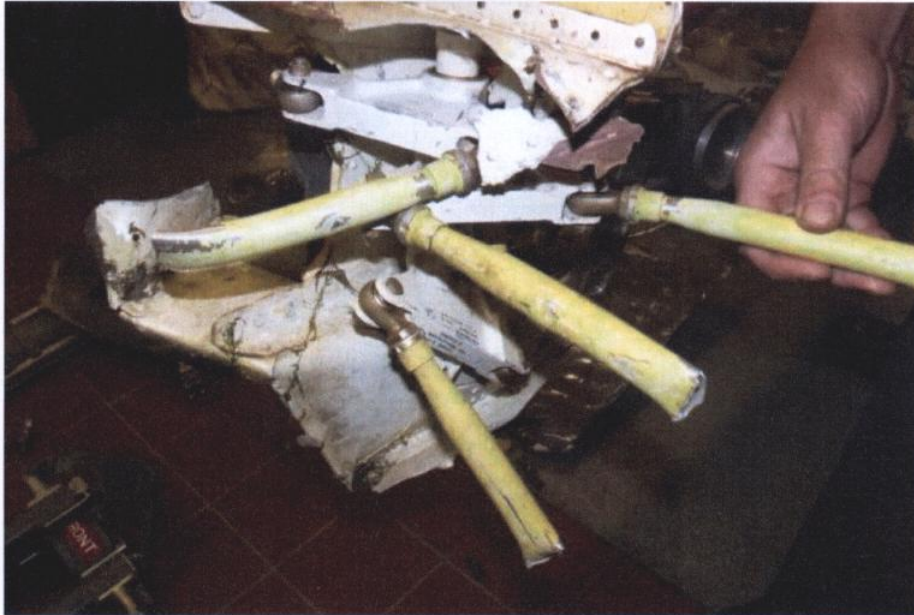
1.4.22 **Flying Controls.** The damage to XX179's control rods, powered flight control units (PFCUs) and control surfaces was inspected by several SMEs, who independently concluded that all failures were consistent with post-impact overload; an example of failure is shown at Figure 5. The PFCUs were also subject to functional testing and the results indicated that these units were all serviceable prior to impact. As part of the investigation it was noted that a servicing error had occurred following the incorrect placing of a washer on a PFCU connection; however, this had not affected functionality. This servicing error will be discussed in further detail at para 1.4.88. The SI Panel concluded that the integrity of the flying control system and control surfaces was **not a factor** in the accident.

Figure 5 – Typical example of XX179's damaged control rods post accident.

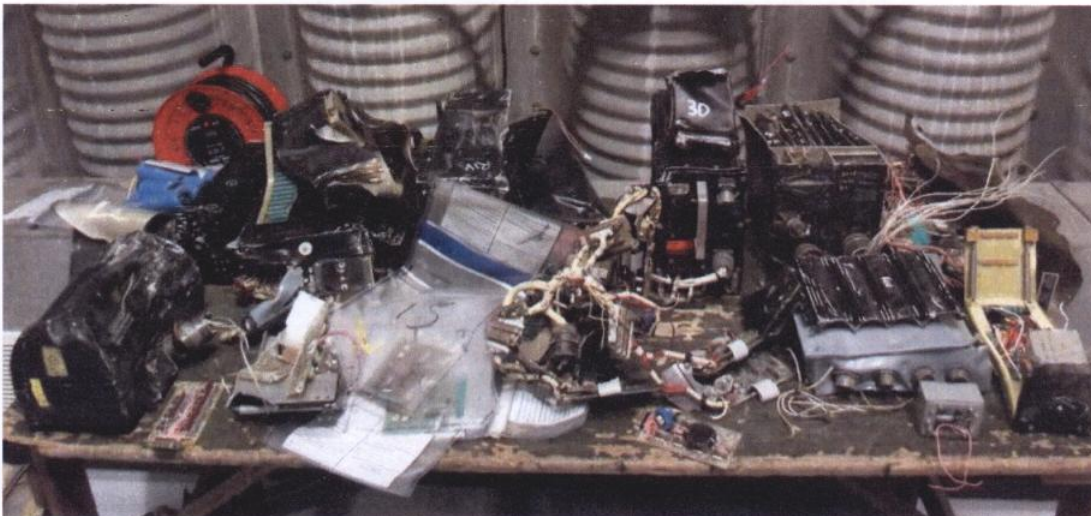
1.4.23. **Electrical Systems.** Due to significant damage, see Figure 6, it was not possible to conduct functional testing of the electrical systems. However, ADR analysis indicated there were no major unserviceabilities of the electrical systems during flight. Radio transmissions, DAU and ADR functionality, anti-collision lights and the aircraft nose light were observed to be operating correctly, which all indicated that power was being supplied to the essential services busbar up until the point of ground impact. The Panel concluded that, with no contradictory evidence, the aircraft electrical system was serviceable until impact, and was therefore **not a factor** in the accident.

Figure 6 – Damaged electrical components.

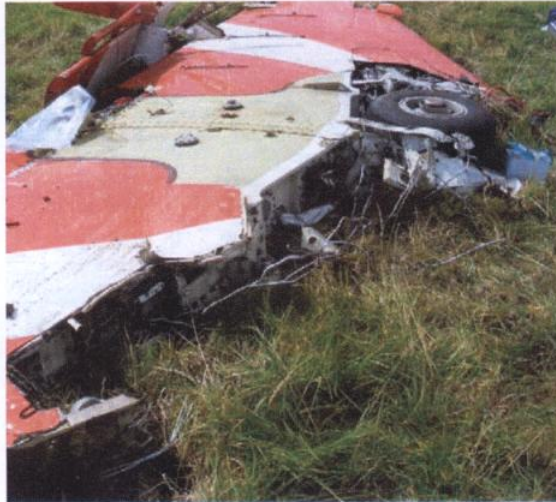
1.4.25. **Undercarriage.** XX179 was found with the nose wheel and left hand main wheel detached from the fuselage and wing structure. The right hand main wheel was found in the retracted position, as shown in Figure 7, with the lock engaged. The aircraft ADR indicated that the undercarriage was up and this was corroborated by eye witness accounts. It was concluded that the undercarriage was retracted at impact and was therefore **not a factor** in the accident.

Figure 7 – Underside of wing with right hand main wheel in the retracted position.

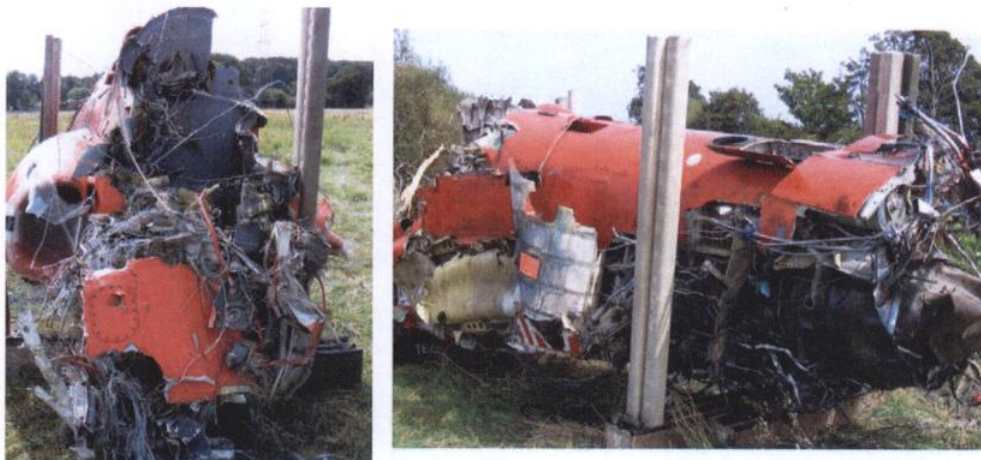
1.4.26. **Cockpit Instruments.** The river bank tree impact, discussed in para 1.3.10, resulted in significant damage to the front and rear cockpits, see Figures 8 and 9 below. The impact damage, coupled with the fact that the front cockpit instrument panel was submerged in the River Stour, resulted in an inability to conduct any functional testing for the majority of the instruments. The only instruments assessed as suitable for detailed forensic testing were the airbrake indicator, the standby attitude indicator and the main altimeter. The results of the forensic analysis were inconclusive due to the severe damage that had occurred. The Panel noted, from a review of the Air Safety Information Management System (ASIMS), that a trend of failures within the Attitude and Heading Reference Systems (AHRS) had affected the Hawk fleet. The implication of an insidious failure of the AHRS whilst the aircraft is being flown solo and under Instrument Meteorological Conditions (IMC) is potentially significant and could ultimately lead to inadvertent controlled flight into terrain. Considering the experience level of the pilot, the weather conditions and the fact that the break was a visually flown manoeuvre, the Panel concluded that it was unlikely that an AHRS failure would have led to an inadvertent controlled flight into terrain. Due to the nature of the visually flown manoeuvre, the Panel concluded that instrument failure was **not a factor** in this accident.

Figure 8 – General view of the front and left hand side of the fuselage structure.

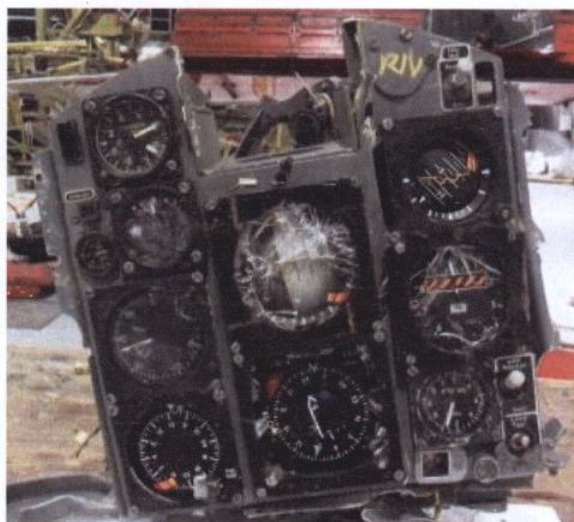
Figure 9 – Front cockpit centre instrument Panel.

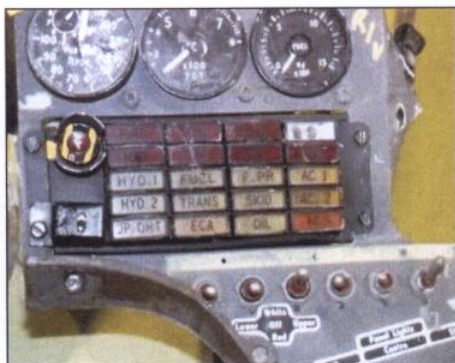
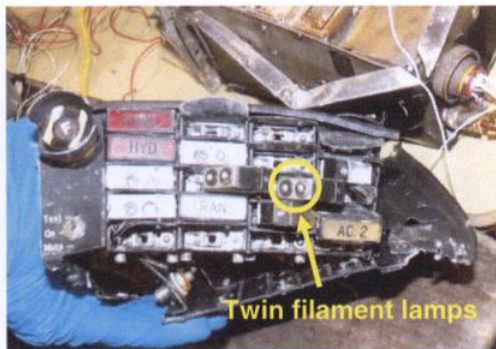
1.4.28. **Central Warning System.** The central warning system (CWS) provides the pilot with automated warning of system failures that require prompt action. The CWS comprises a Central Warning Panel (CWP) and 2 'attention-getter' lights in each cockpit which are powered from the essential services busbar. The CWP distinguishes between major and minor malfunctions using coloured, twin filament, warning lights; the former illuminating a Red caption which is backed by an audio warning and the latter illuminating an Amber caption with no audio. In both cases any CWP illumination will be visually backed by flashing attention-getters. An illumination of any Red captions will be recorded on the ADR. The front and rear cockpit CWPs, shown at Figure 10, were removed from the wreckage together with the only remaining 'attention-getter'. In some situations, filament failure characteristics can provide an indication of whether a lamp was illuminated at the point of impact so XX179's CWP lamps were sent for filament and glass analysis.

Figure 10 – Front (left picture) and rear (right picture) CWP.

Out of the 64 lamps examined, 16 of the lamps were found to be potentially illuminated at the time of impact. However, due to conflicting evidence between either twin lamps on the same caption or counterpart lamps on the other CWP, the analysis has shown the results to be inconclusive. In addition to the filament and glass analysis, and with the exception of the pre-flight test sequence, the ADR indicated that no Red CWP captions had been illuminated during the sortie. The significance of a possible Amber caption illuminating has been discussed at para 1.4.18.b. The Panel concluded that there was nothing in the CWP bulb analysis that contradicted the results of other engineering forensic investigation.

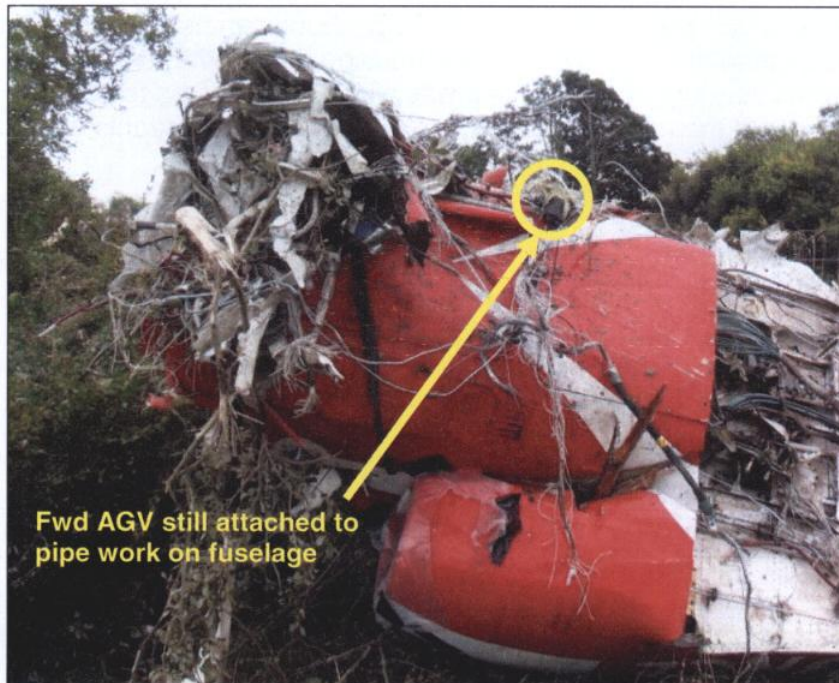
1.4.33. **Forward Anti-G Valve.** The front AGV ended up on the outside of the fuselage during the impact sequence and it was only the connecting pipe work that was holding it in the position as shown at Figure 11. The AGV had been subject to significant impact damage with the stop valve lever being ripped off whilst it was assessed to be in the mid-position. As with the rear cockpit, it was not possible to determine the lever's position at impact. However with both levers being found in abnormal positions the Panel concluded it was likely that they had been moved during the crash sequence. Corrosion product was identified within the inlet filter of the front AGV and some trace was also identified within the stop-valve. There was also evidence that the stop-valve and inner AGV had rubbed against each other during the service history of the component; however, there was no evidence to indicate that the rubbing caused the stop-valve to stick. Notwithstanding minor corrosion and indication of internal rubbing, testing of the forward cockpit AGV indicated that it was serviceable. Moreover, given the location of the AGV selection lever in the front cockpit, it was deemed highly unlikely that it could have been disturbed from the on position during flight. It was therefore considered likely that the AGV was fully functional prior to the ground impact and was **not a factor** in this accident.

Figure 11 – Fuselage wreckage with the front AGV still attached to the pipe work
