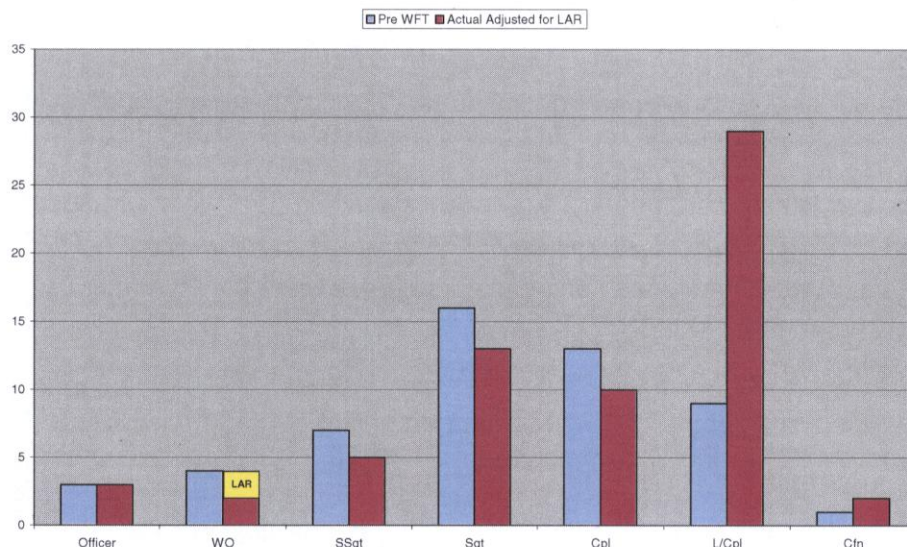
Fig 34 – 1 Regt AAC Wksp REME Manning Jul-Dec 11 (By Rank and Adjusted for LAR)

1.4.160 The Panel reviewed the Wksp's 8005 (Establishment) against the actual manning provided by Army Personnel Centre (APC) Glasgow and the Wksp's assessment of the manning between Jul and Dec. Even with adjustments made using Local Acting Rank (LAR), as directed by DEME(A) Chief Air Engineer, discrepancies were noted between the Pre-WFT establishment manning figure and the actual manning experienced at the Wksp.

1.4.161 The Wksp was undermanned due to the influences of both the wider REME Avn shortfall in manning versus liability and the transitory position as the Force moved towards the future Wildcat force structure, which had an increased reliance on In-Barracks Equipment Support (IBES). This was essentially contractor support at Forward which enabled uniformed personnel numbers to be reduced through a compensating reduction in REME Avn personnel. This meant that there had been a real-term reduction in REME Avn personnel for the Lynx Force ahead of Wildcat Introduction to Service.

1.4.162 While the Panel could find no evidence to suggest that under manning affected the outcome of this accident, it did conclude that the resultant symptoms observed had the potential to influence another accident. Under manning at 1 Regt AAC was therefore deemed to have been an **other factor (organisational influence)**.

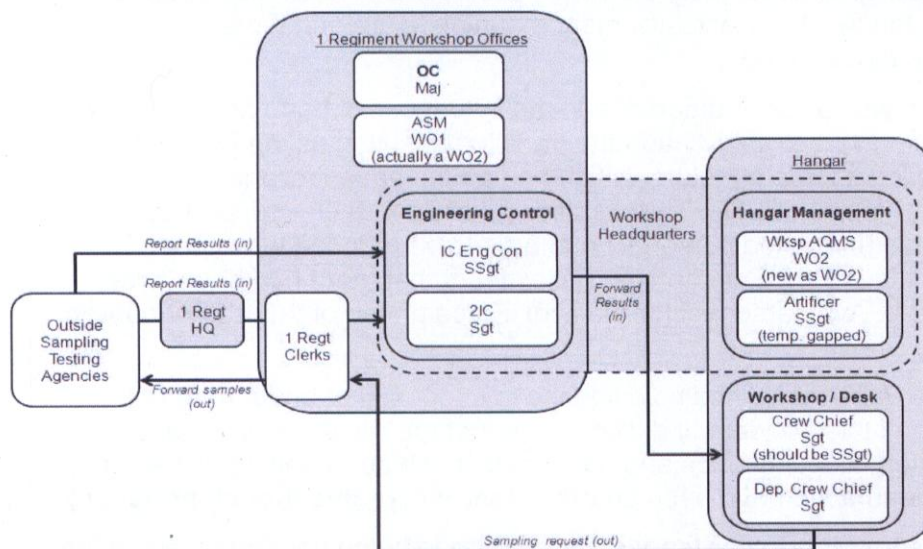
Fig 35 - 1 Regt AAC Wksp REME Supervisory Manning Organisation

1.4.166 The Panel found that the organisational requirements were not necessarily supported by sufficient resources in terms of on-base Wksp supervisors. Specifically, Wksp management were trying to maintain output but with manpower and experience limitations (**organisational influence**). This impacted on workload and management

effectiveness, which may have increased the probability of on-task distraction and/or knowledge, skill and other supervisory errors. Although this was not judged to have had a direct influence on this accident, the lack of suitably qualified and experienced personnel in some key positions was deemed to have been an **other factor**.

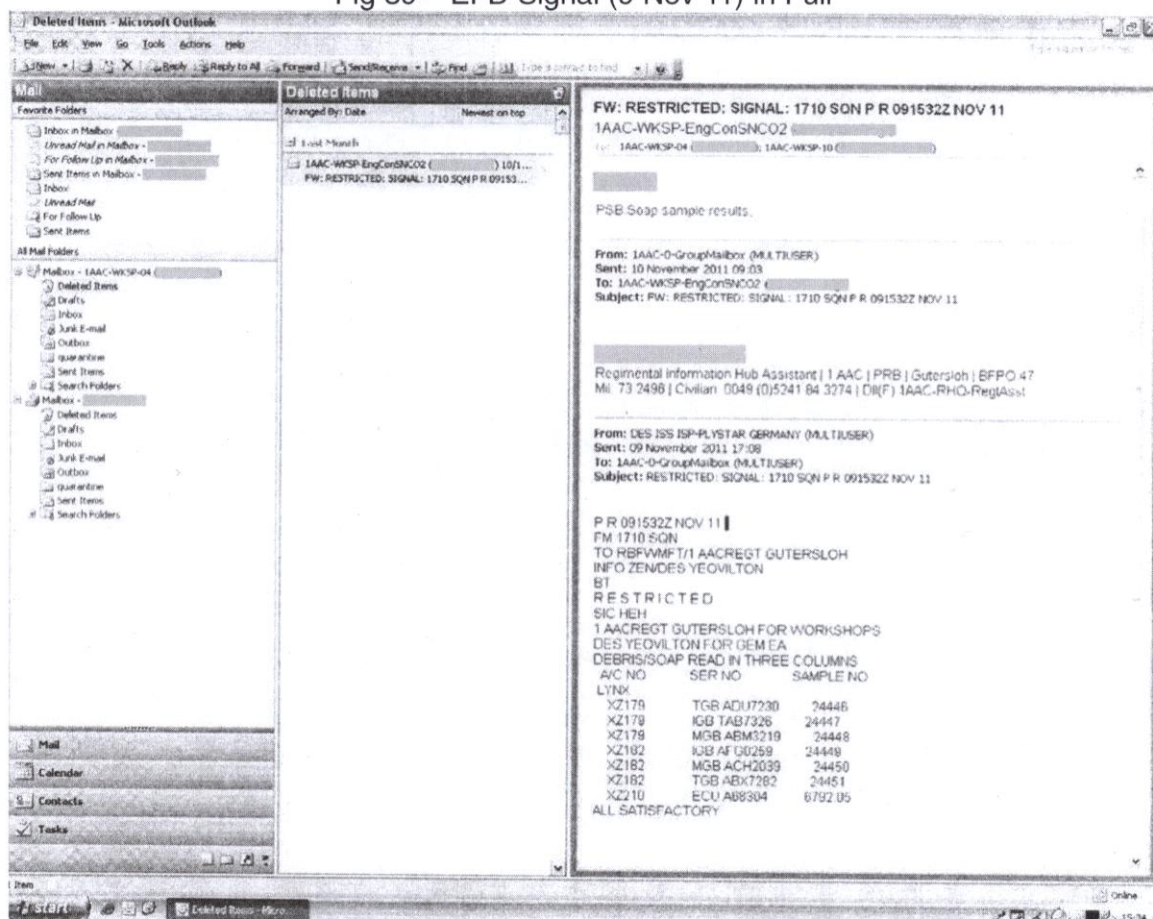
1.4.201 **Failure to Apply 1710 NAS (MIG) Advice to XZ210.** The Crew Chief only recalled receiving and reading the EFD Signal 6 (full text shown at Fig 39). He did not believe that it contained anything other than satisfactory results and therefore deleted the email without any further action or record being made. The 1710 NAS (MIG) signal was in a computer-generated standardised format for EFD samples, such that the first information listed related to a series of satisfactory results; notification of the unsatisfactory result and advice placing XZ210 on reduced sampling was listed at the bottom. When viewed in the MS Outlook reading pane on the Crew Chief's computer during the subsequent investigation, none of the information relating to reduced sampling for XZ210 was visible as shown in Fig 40.

Fig 40 – Crew Chief Screen Shot of EFD Signal 6 (9 Nov 11)
