PART 1.3 – NARRATIVE OF EVENTS

1.3.1 On 5 Jul 11, Puma HC Mk1 XW211 was due to fly a MAUM sortie departing at 0900; this sortie was delayed due to a change of crew. The amended crew were detailed to carry out a similar flight profile, having reverted to standard ac mass. The crew now consisted of 2 LCR pilots and a CR crewman. The sortie comprised basic navigation and GH.

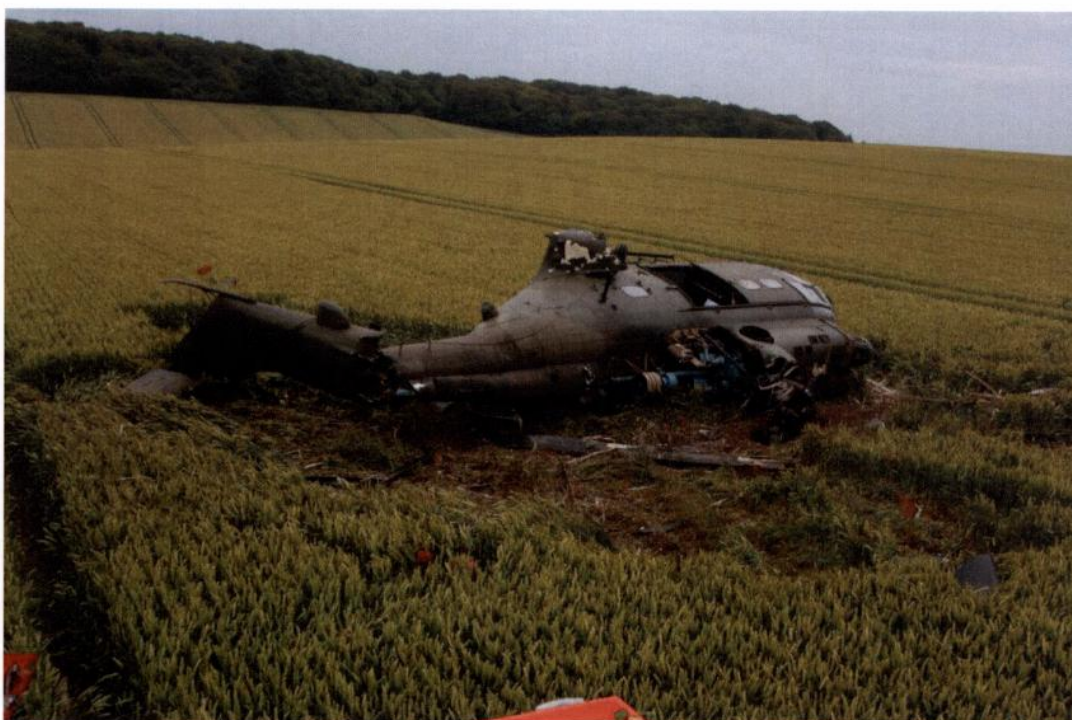
Figure 1 – XW211

1.3.3 XW211 landed at MW airfield for a planned refuel and a change of handling pilot/capt. During ac external checks, a discrepancy in the expected hydraulic fluid levels was found and in order to conduct fault diagnosis, the crew opened the MRGB cowling. Following telephone consultation with Puma Force engineering personnel, the ac departed MW to return to RAF Benson. Three minutes after take-off, the MRGB cowling departed the ac and impacted the MRBs and TRBs. The crew of XW211 carried out an emergency landing in a field to the SSE of Andover, resulting in Cat 5 damage (see Figure 1).

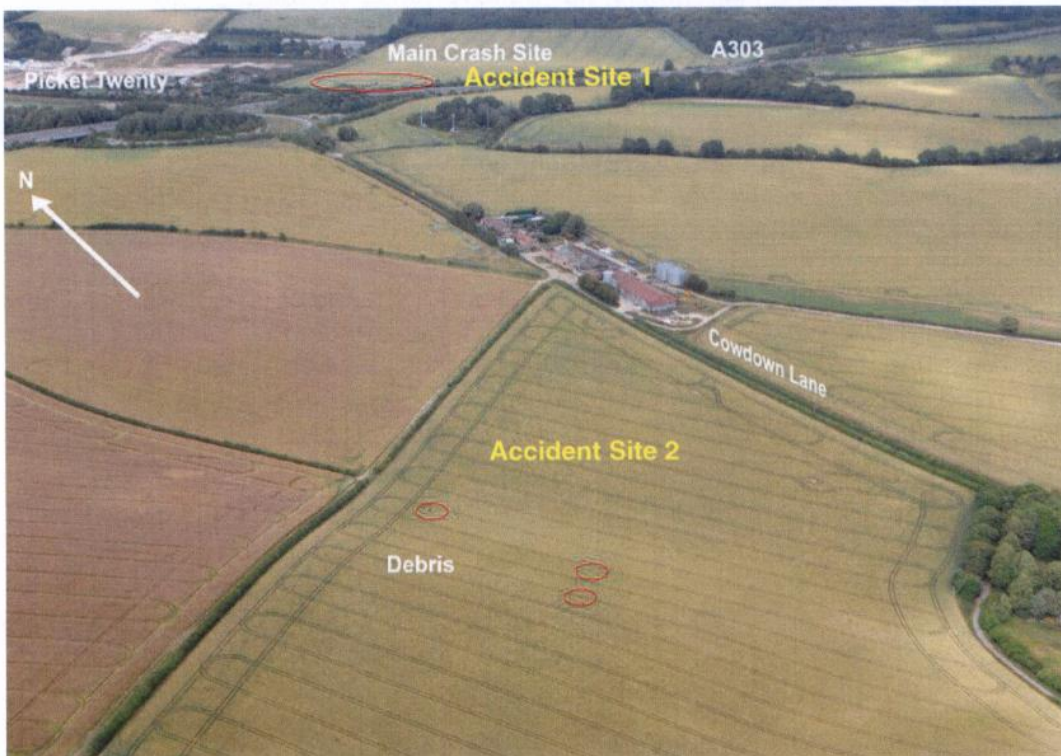
Figure 2 – XW211 Accident Sites

1.3.5 Ac debris was found at 2 sites as shown at Figure 2: the main crash site (Accident Site One); and an area 1.2 km to the SW of the main crash site (Accident Site 2) where parts from the MRGB cowling and MRBs were found.

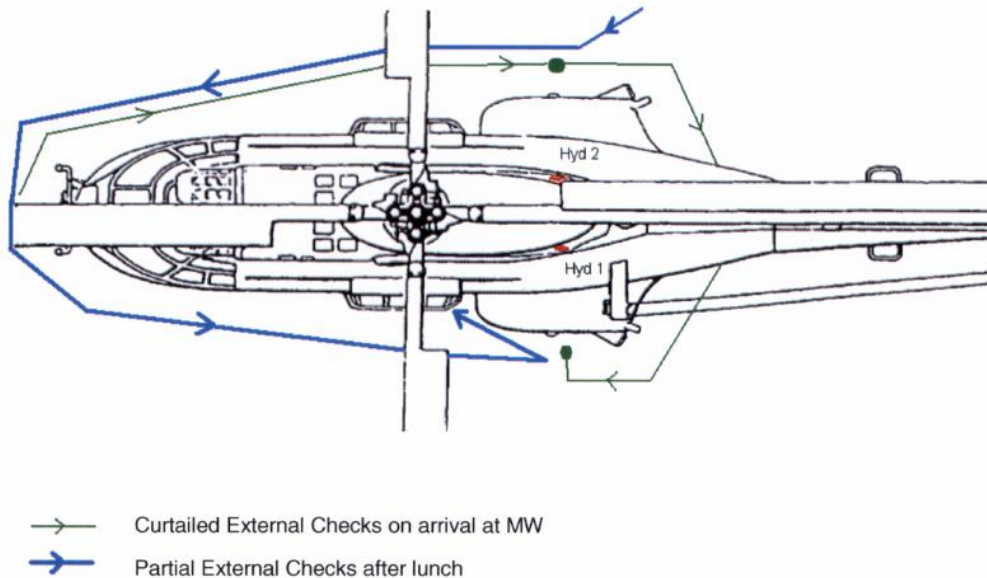
Figure 3 - Schematic of External Check Walk-Rounds at MW

1.3.17 XW211 departed RAF Benson at 0938 and arrived MW at 1138, whereupon the ac was refuelled. The change of ac capt was recorded on the MF705 (Puma), which was removed and taken to MW Tower for posting back to RAF Benson. As the oncoming capt, the HP commenced his external checks (as shown in green at Figure 3), which he curtailed when he found a discrepancy in the expected fluid levels between No 1 and No 2 hydraulic systems. The No 2 system indicated that the reservoir was filled to a level above the maximum limit (sight glass full), whilst the No 1 system indicated a fluid level within limits. This was reported by the HP to the DA via telephone.

1.3.22 The HP completed a partial external check of the ac moving anti-clockwise from the No 2 hydraulic reservoir to the No 1 hydraulic reservoir (shown in blue at Figure 3). At this point, he entered the Puma in preparation for the HTGR whilst the CM closed the MRGB cowling, watched by the NHP. The NHP then checked the security of the MRGB cowling.
