SAFETY ALERT

Subject: ROLLER-SHUTTER DOOR MECHANISM FAILURE

Number: 03/13

Date of issue:
26 February 2013
Reissued 27 March 2013

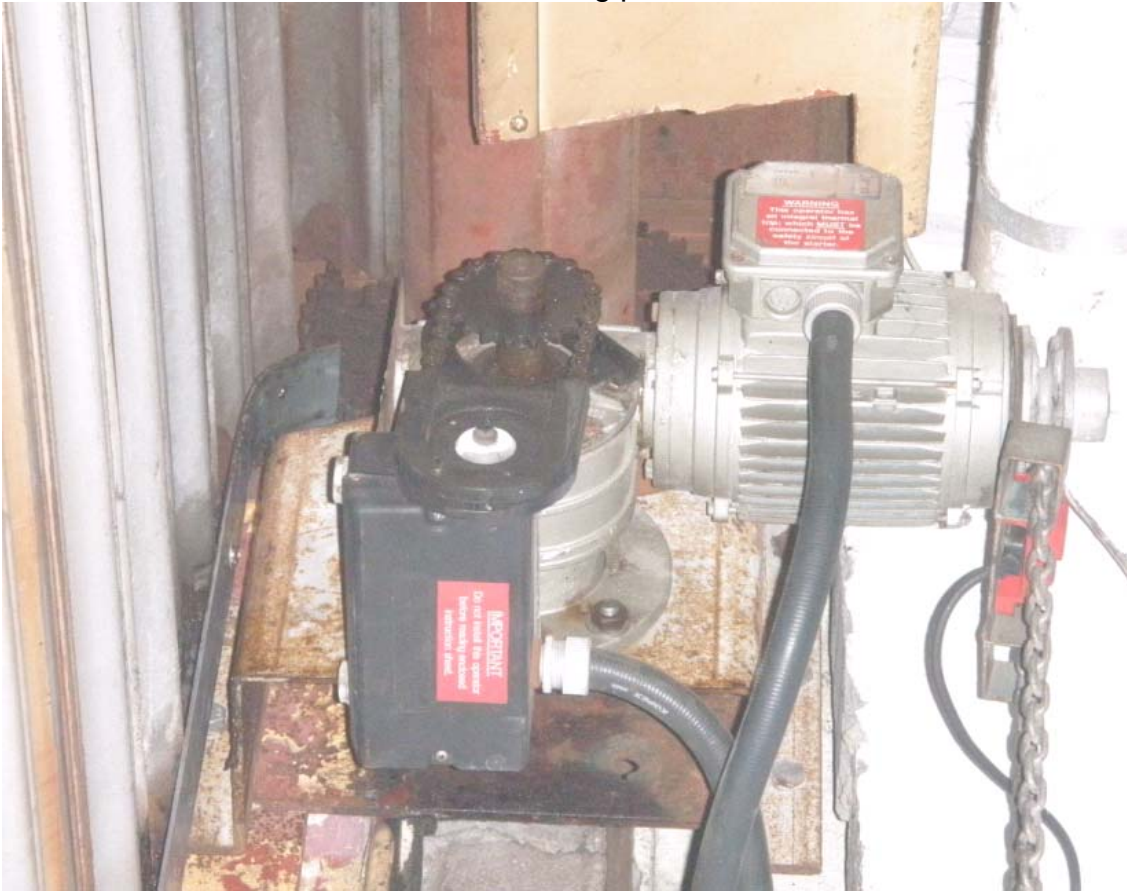
A roller-shutter door mechanism failed in an industrial portal type building, resulting in the failed gear wheel falling from the mechanism and narrowly missing an employee. The incident occurred whilst the door lifting mechanism was being operated via the control switch located below the motor and drive mechanism. Those nearby described a loud clunk-type sound followed by the mechanism ejecting a gearwheel that was still attached to its failed motion shaft (see Annex A below).

Rollershutter Door Mechanism – remaining parts:

- All roller-shutter doors operated by this mechanism are to be inspected for a tray beneath the mechanism that is able to contain any failed parts ejected from the mechanism. Those without trays are to be taken out of service until a tray is procured and fitted to the mechanism or equally effective controls are put in place.
- Similar aged doors should have their motive parts demounted, cleaned and be subject to a thorough examination by a competent person. A proportion of similar types should have motion shafts withdrawn and tested for similar flaws by non destructive testing.
- Newer doors of similar type should receive an in situ and thorough examination of shafts and gears specifically, with any concerns fed into reactive works.

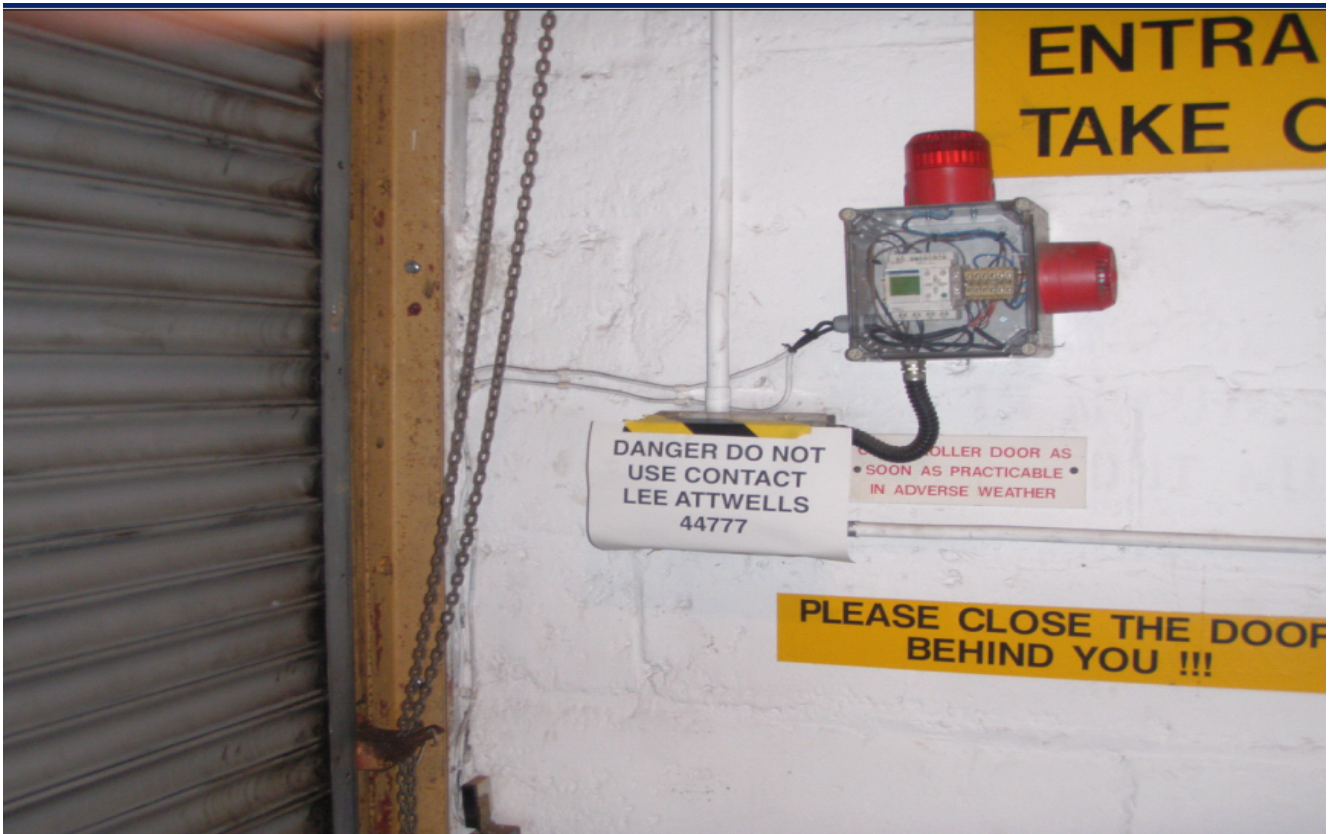
Door controls:

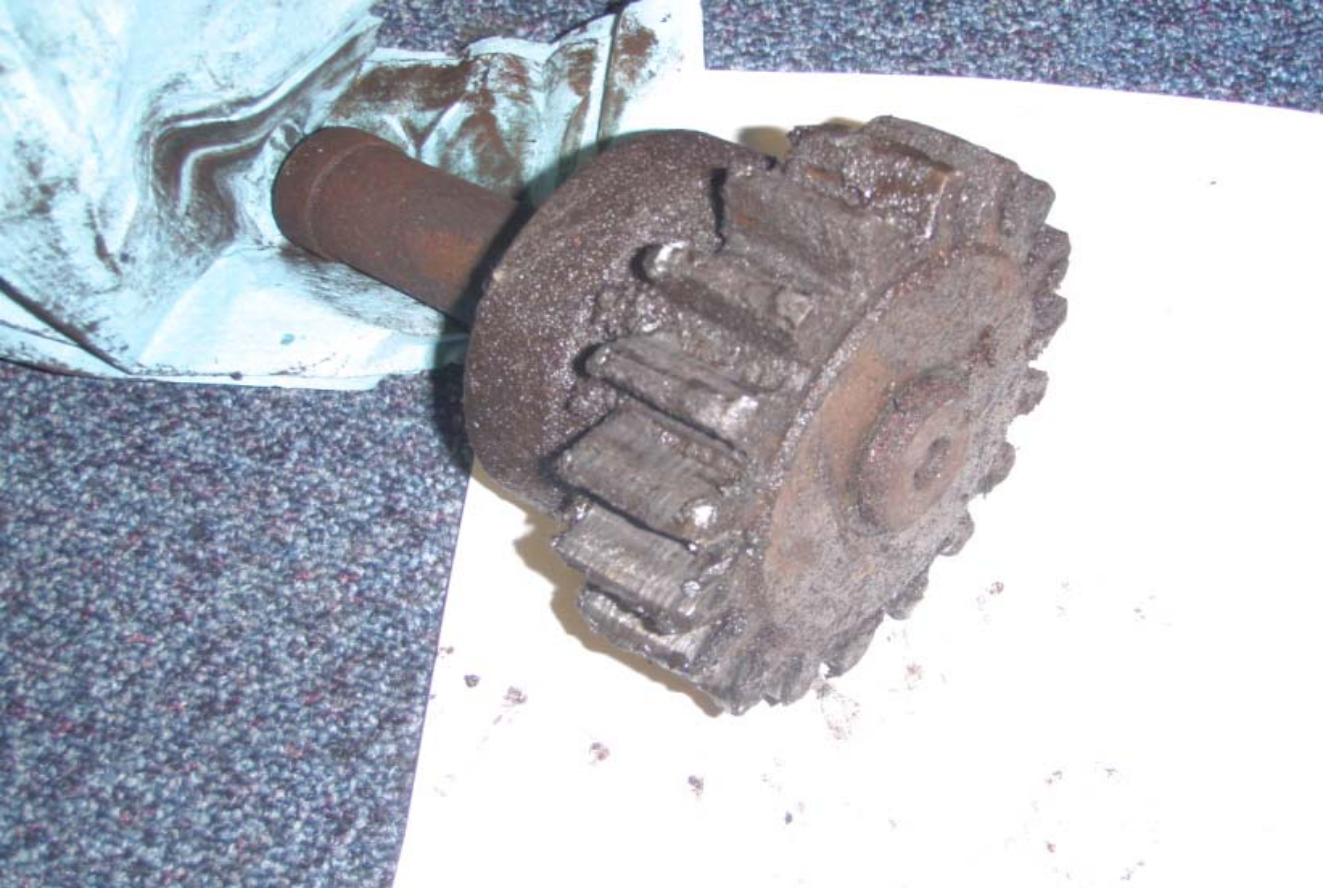
Gearwheel and Shaft:

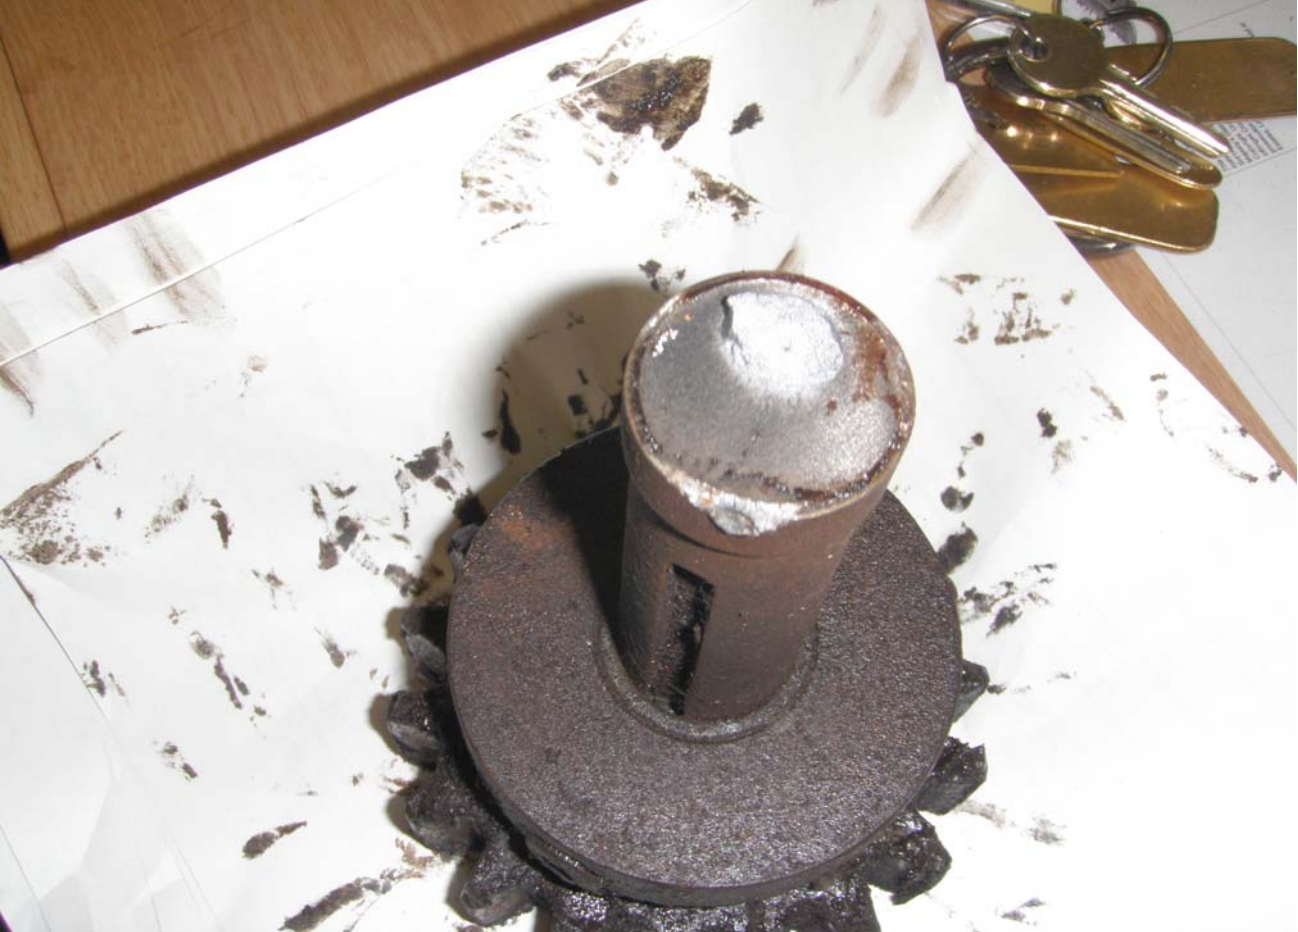
Gearwheel and shaft showing shear plane:
