SAFETY ALERT

Subject: Pipe Corrosion in Kitchen Floor Ducts and Voids

Number: 07/2013

Document Aim: To raise awareness of the corrosive effect of floor cleaning chemicals on pipework in the kitchen floor ducts.

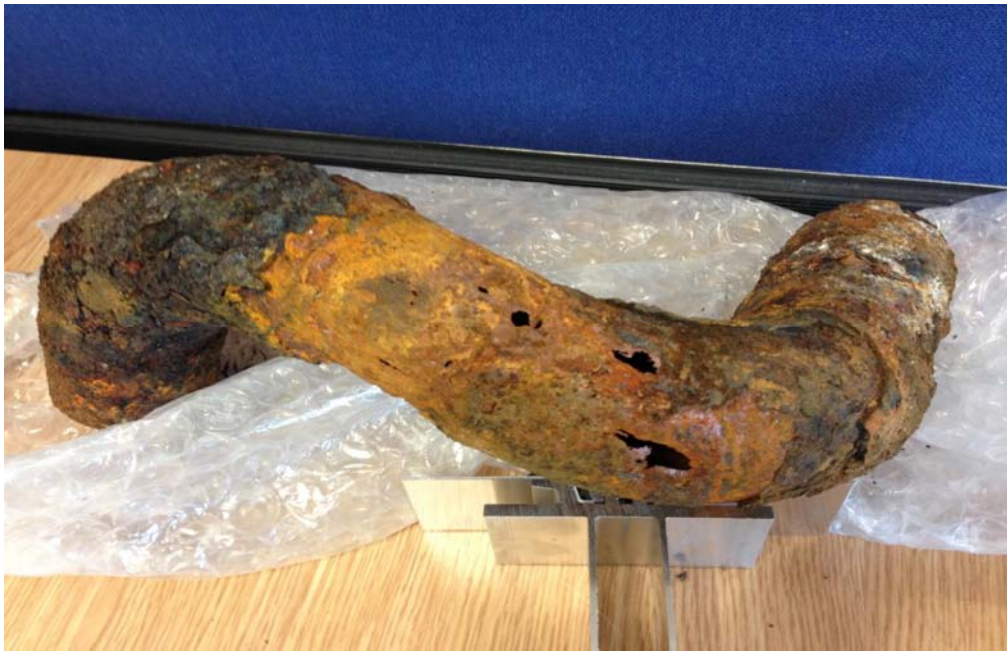
The pipe in question was (see Fig 1, 2 and 3 below) exposed by lifting the concrete covers to the void, through which the pipework was routed. The source of the leak was found to be through the walls of the pipe which can be clearly seen in Fig 1 below.

The corrosion was due to very aggressive corrosive action on the pipework as a direct result of chemicals and water used for cleaning processes of the kitchen floor passing through the void covers onto the pipework below.

All gas pipework which is routed through underground voids in the floors of Mess kitchen facilities should be inspected for their condition and any signs of corrosion.

All such situations should be monitored frequently and any damaged pipework removed and replaced.
