## **PART 1.3 – NARRATIVE OF EVENTS**

**Synopsis**

1.3.1. At 1105 hrs on 8 Jan 13, a Tucano T Mk1 ZF349, callsign LOP19, of Number 1 Flying Training School (1FTS) departed RAF Linton-on-Ouse with a crew of 2 on a routine Partial Test Flight (PTF). The Handling Pilot (HP) who occupied the front cockpit was an experienced Qualified Flying Instructor (QFI) and Unit Test Pilot (UTP); the Non-Handling Pilot (NHP), a Basic Fast Jet Training (BFJT) course student acting as a 'scribe'<sup>1</sup>, sat in the rear cockpit. The sortie was being flown following rectification work after an over-temperature of the Exhaust Gas Temperature (EGT) on the previous flight. The sortie profile followed that of the Tucano Flight Test Schedule (FTS), which included a check of engine performance and control in both Engine Electronic Control (EEC) Normal and EEC Manual modes. One element of the test was to confirm that, once the EEC was isolated in Manual mode, the engine response and power levels were satisfactory.

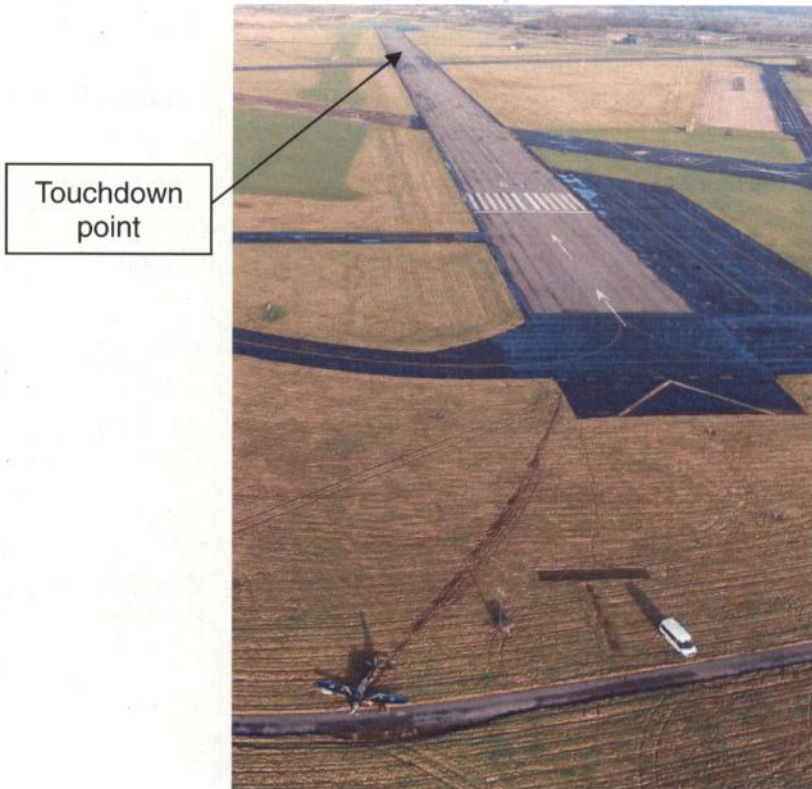
1.3.4. The NHP opened the canopy and observed white/grey wispy smoke coming from between the front and rear cockpits. The NHP conducted an emergency ground egress without inserting the ejection seat pin and exited onto the left wing to check that the HP was uninjured. The HP made 2 radio transmissions to Linton Tower stating that the crew were uninjured, selected the electrics off and exited the aircraft having made her seat safe. Both aircrew moved away from the aircraft to await the emergency services. No injuries resulted from the incident. Fig 1 shows the accident site.

Fig 1 – ZF349 Accident Site.

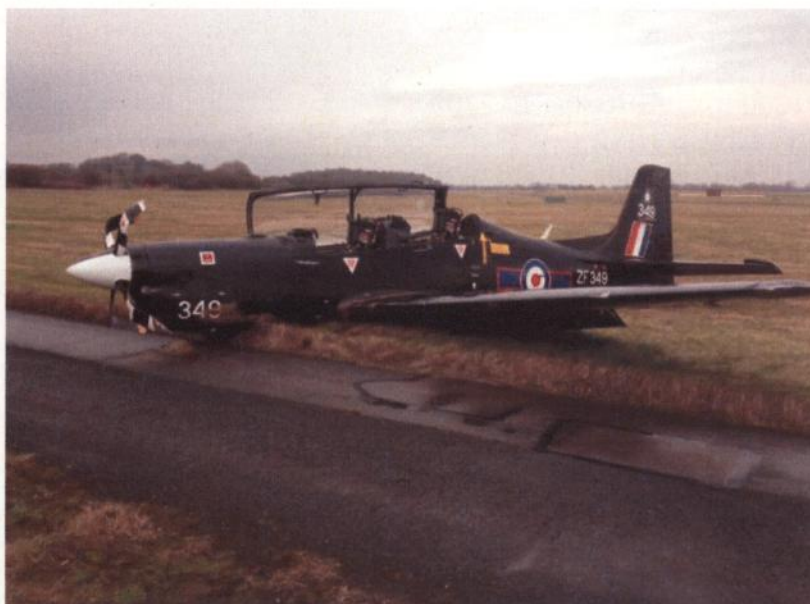
1.3.29. The aircraft's final resting position was approximately 30° off runway heading, Fig 2 shows the final position post egress. The aircraft sustained significant deformation and wear to the propellers (Fig 3) and exhaust eductors as it skidded down the runway and, as the aircraft travelled over the grass, the left-hand side main landing gear door and hydraulic pipe work was torn from the aircraft. The left-hand main landing gear door was found on the grass near to the overrun and the canopy was left open. The aircraft was assessed as Cat 4 (works).

Fig 2 – Aircraft After Egress.

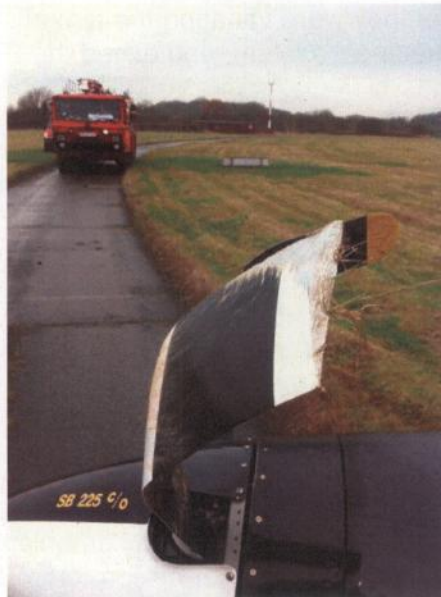
Fig 3 – Close-up of Damaged Propeller.

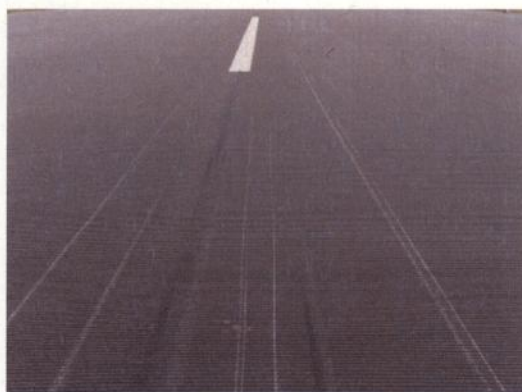
1.3.39. The accident took place within the airfield boundary of RAF Linton-on-Ouse and was contained therein. The MilAAIB conducted a sweep of the accident site the following morning which identified small items of debris on the grass near the edge of the runway adjacent to the touchdown point. Scratch marks from the engine eductors and propeller blades were visible along the runway centreline (see Fig 4) for the duration of the skid, as were some minor marks where the wings touched the ground. The change in surface from runway to grass resulted in the loss of a small length of hydraulic pipe and an actuator from the undercarriage system, as well as the left-hand main landing gear door. The MilAAIB's search yielded small fragments of aircraft skin and structure; no significant loss of material occurred.

Fig 4 – Scrape Marks on Runway.
