Post-incident reporting for reservoirs
Annual report 2012

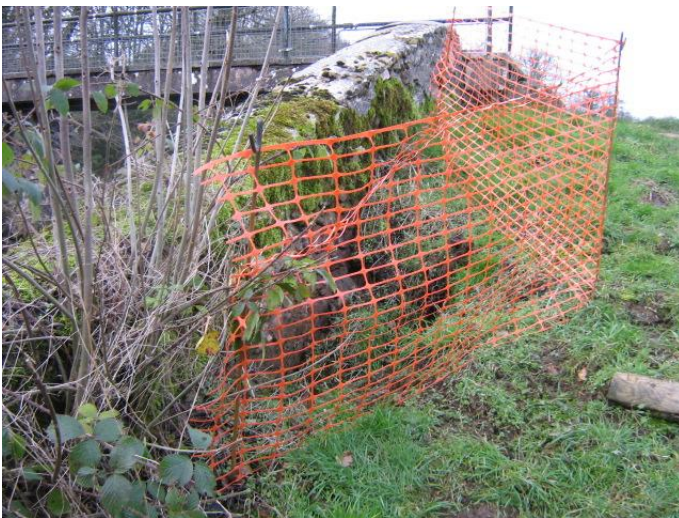
The undertaker found a depression on the downstream face of the dam next to the masonry side wall of the overflow spillway.

Figure 3.1 Sink hole beside the spillway wall (Photo courtesy of Wessex Water)

The internal erosion of the embankment fill material beside an overflow spillway channel wall may have started with water flowing through gaps within the masonry wall. This incident highlights that internal erosion beside spillways can happen when water leaks through walls that are not watertight. It is important to inspect walls beside spillways to make sure they are still watertight.

The reservoir was repaired by building a mass concrete plug to improve the seal between the masonry wall and the slurry trench cutoff. The repair worked and the reservoir has been returned to normal operation.

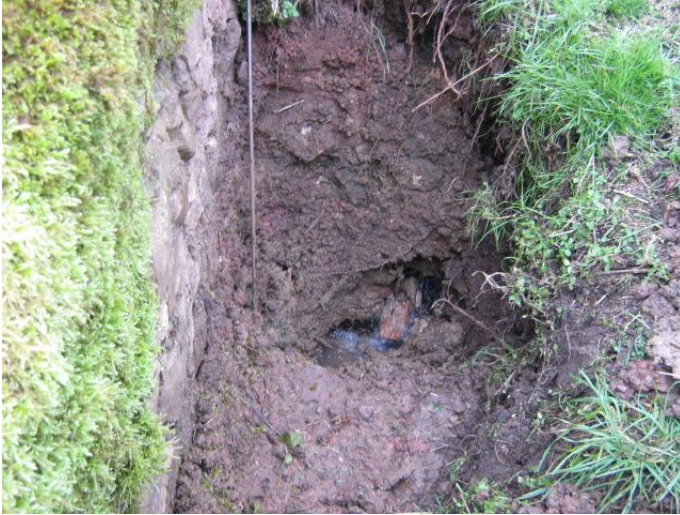
The reservoir water level was reduced by opening a scour pipe and using a mobile pump. Further, hand-dug, investigations found that water had been leaking through the masonry wall then passing along the outside of the spillway channel sidewall between the masonry and a slurry trench cutoff. The slurry trench had been installed to try to fix a previous leak. The undertaker found that the trench had been widened at the masonry wall interface, but this had not stopped the erosion.

Figure 3.2 Trial hole to investigate the source of the leak (Photo courtesy of Wessex Water)

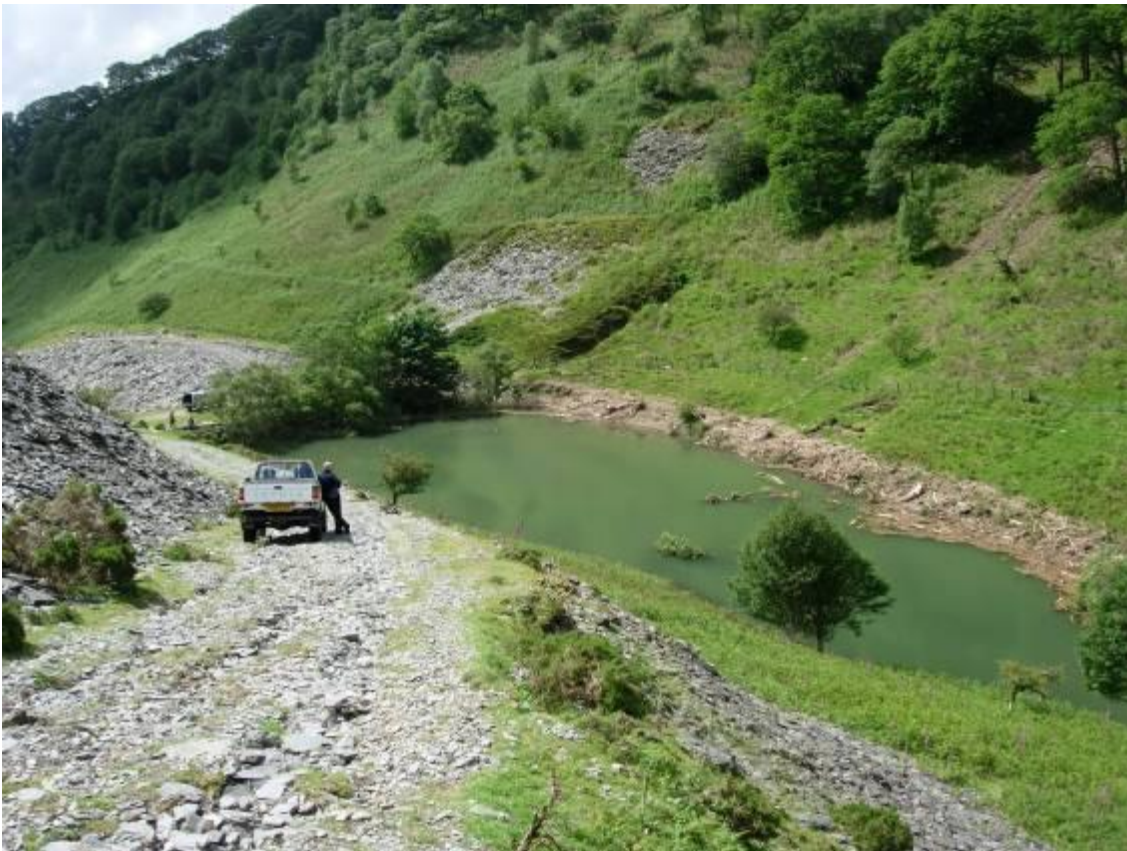
Figure 3.3 General view of the reservoir (Photo courtesy of Alan Warren)

A disused industrial reservoir formed by a rockfill dam had been left in the drained down condition but without any formal overflow spillway. Heavy rain within the small upland catchment area caused a landslide which entered the reservoir.

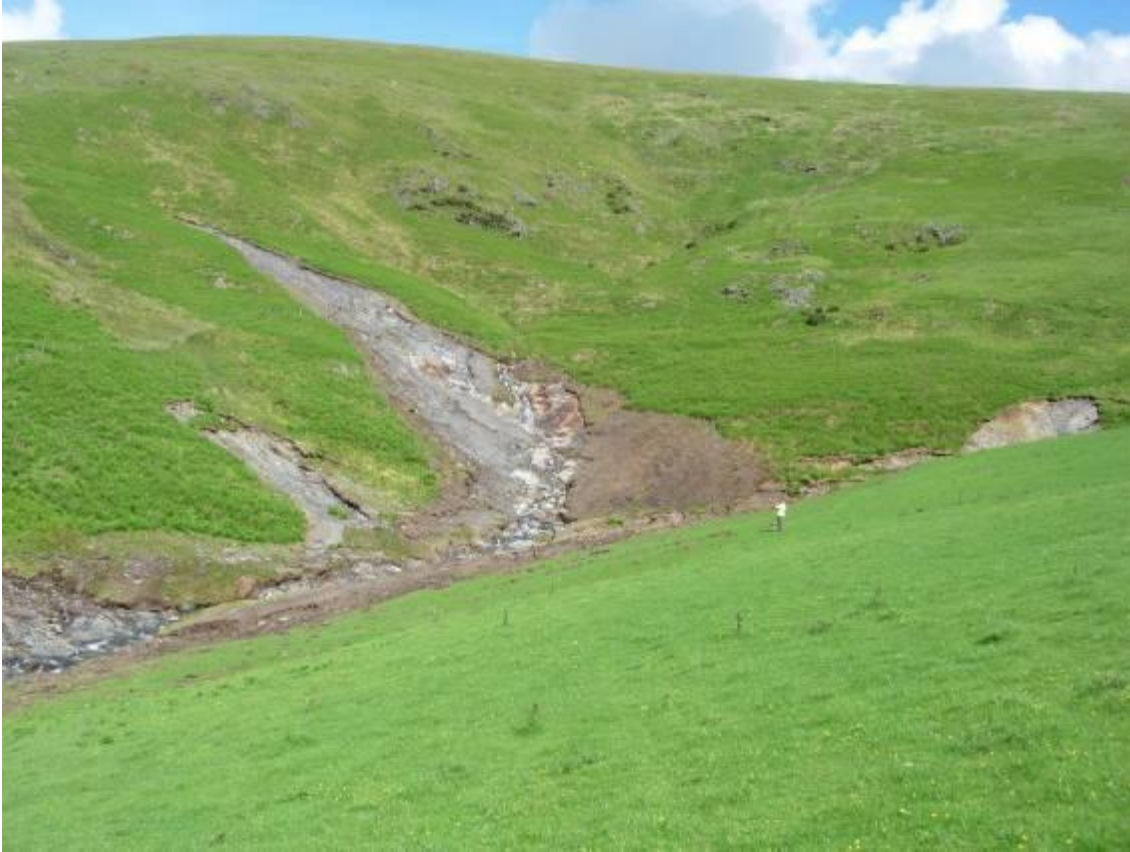
Figure 3.4 Landslide upstream of the dam (Photo courtesy of Alan Warren)

The silt blocked the low-level drawoff, causing the reservoir to fill. Floodwater then overtopped the dam crest, causing erosion at the top of the downstream face. The owner contacted the emergency services and the downstream village was evacuated. It was not possible to bring the fire service pumps to the site to reduce the water level. An emergency spillway channel was excavated at an abutment to draw the reservoir level down, and the damage to the dam was repaired. The downstream community was allowed to return to their homes later in the day when reservoir levels had been reduced.

The main lesson learned is that impounding reservoirs must be provided with appropriate overflow facilities to cater for flood events and protect the dam from being damaged or washed away. The incident is unusual in that landslide-induced debris slide blocked the drawoff pipe and contributed to the impact of the flood damage. Engineers involved in designing, operating or supervising small upland impounding reservoirs should consider the risks associated with landslides. Specific guidance on managing reservoir safety risk from the threat from debris flows is not currently available.

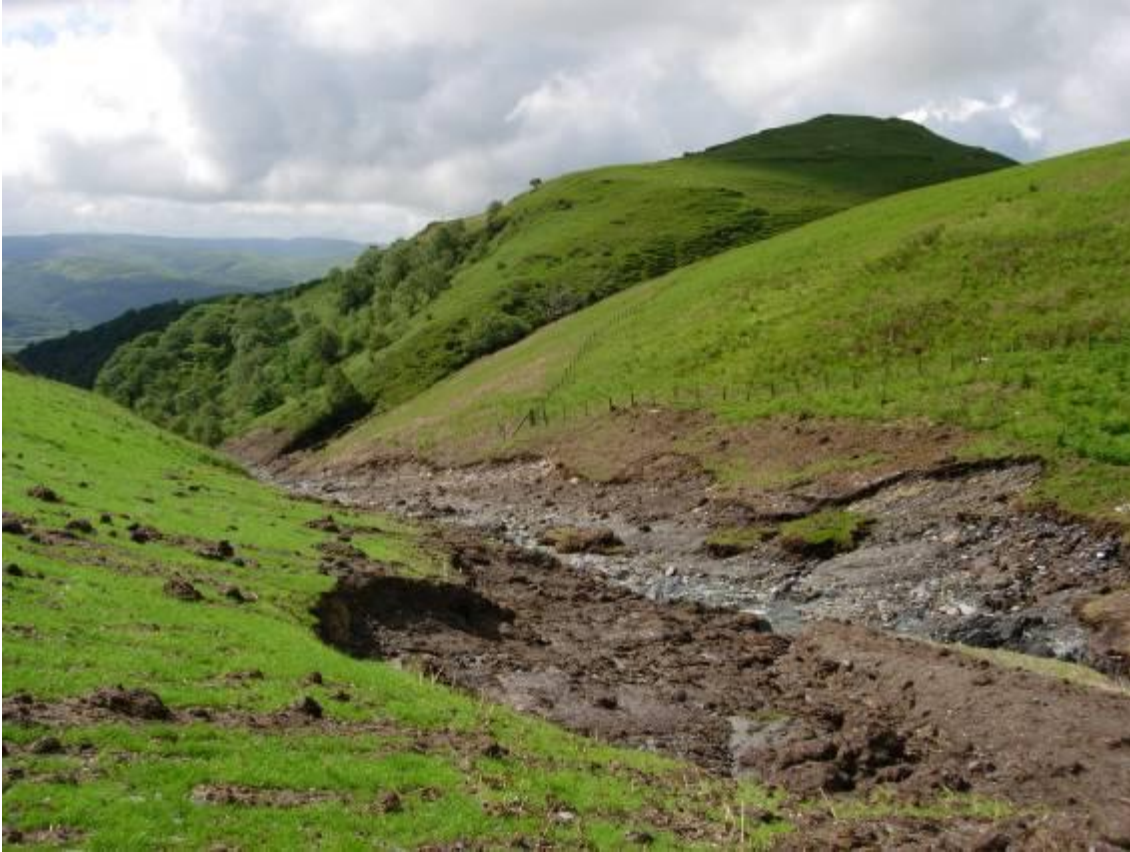
Figure 3.5 Channel damage downstream of the landslide (Photo courtesy of Alan Warren)

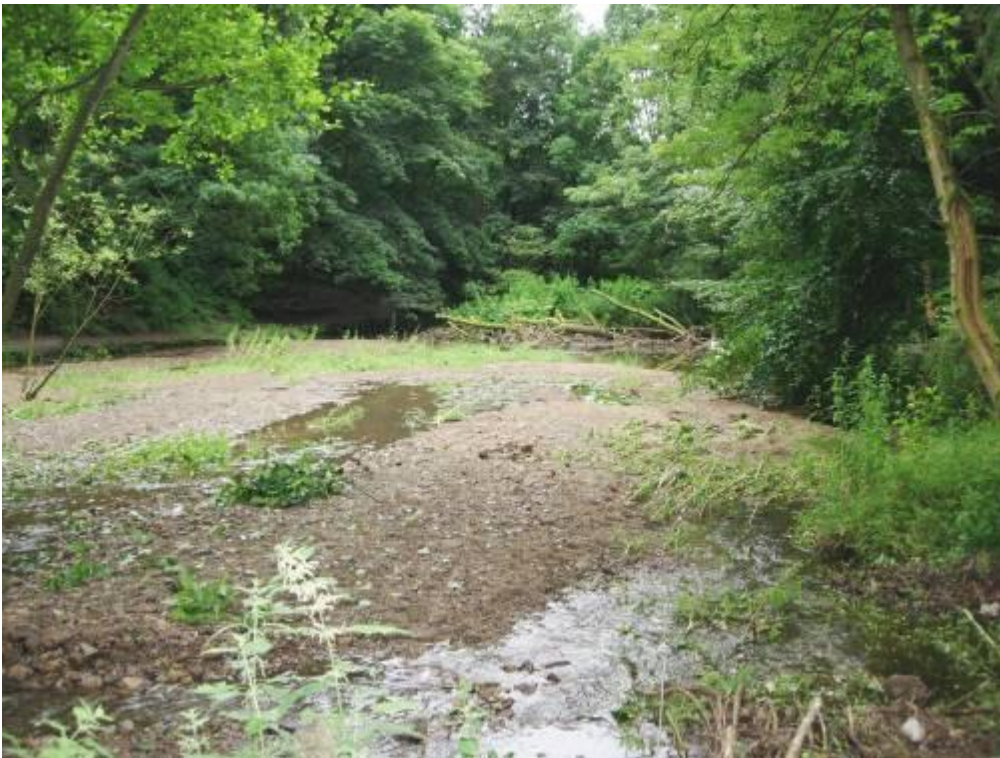
A cascade of two small reservoirs once served to supply water to a woollen mill. The mill has now been converted to offices. The reservoirs sit in a steep valley above a community and are owned by the local authority. The reservoirs are too small to come under the Reservoirs Act 1975. The upper reservoir was still in use, but had filled with silt.

Figure 3.6 View of the upper reservoir (Photo courtesy of Alan Warren)

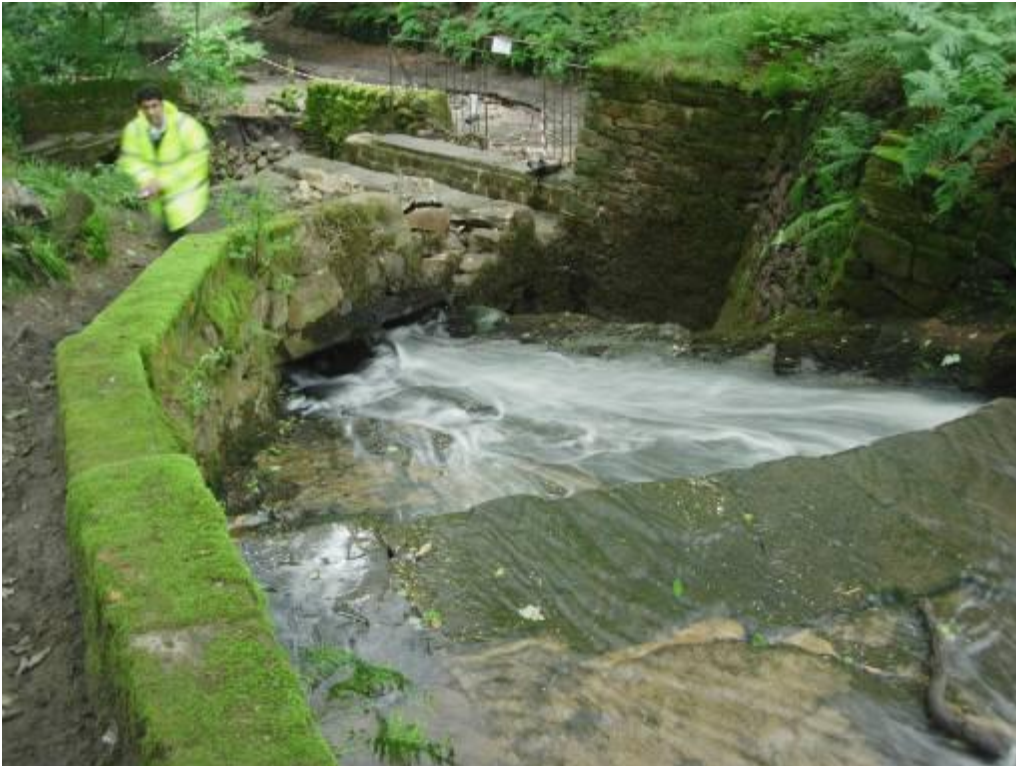
During the summer of 2012, a cloudburst occurred over the small steep catchment serving the reservoirs. The intensity of the storm and the debris being transported with the floodwater caused minor damage to the spillway structures on the upper reservoir.

Figure 3.7 Upper reservoir spillway showing damage to the wall (Photo courtesy of Alan Warren)

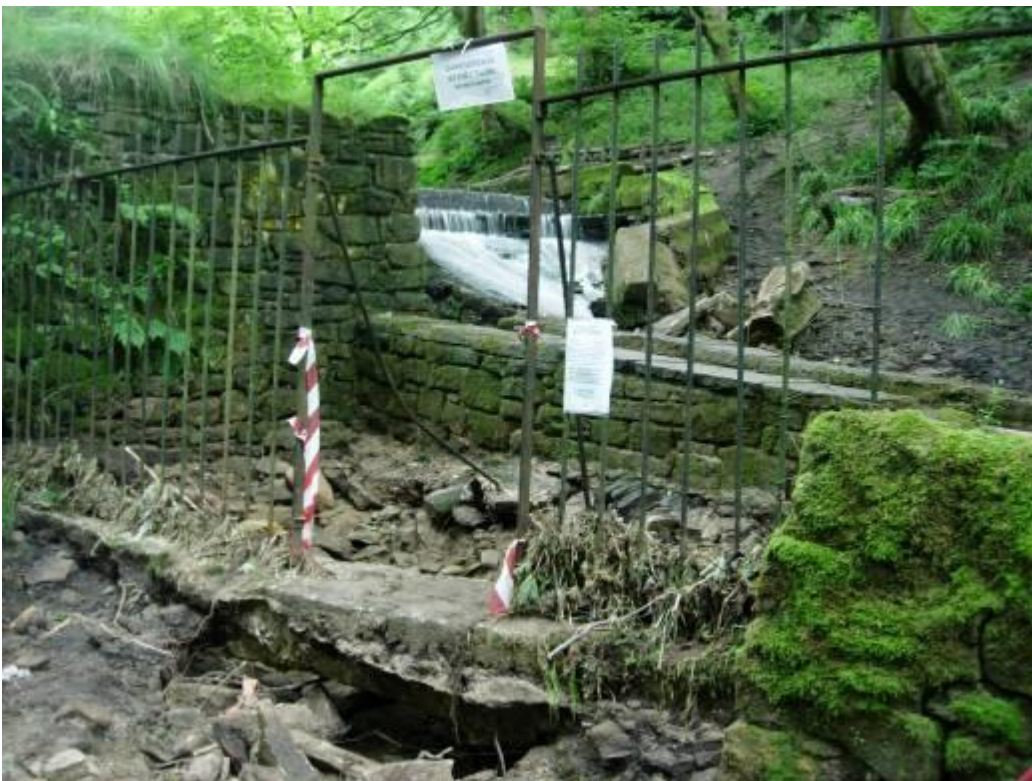
Figure 3.8 Damage to the overshoot channel of the upper reservoir (Photo courtesy of Alan Warren)

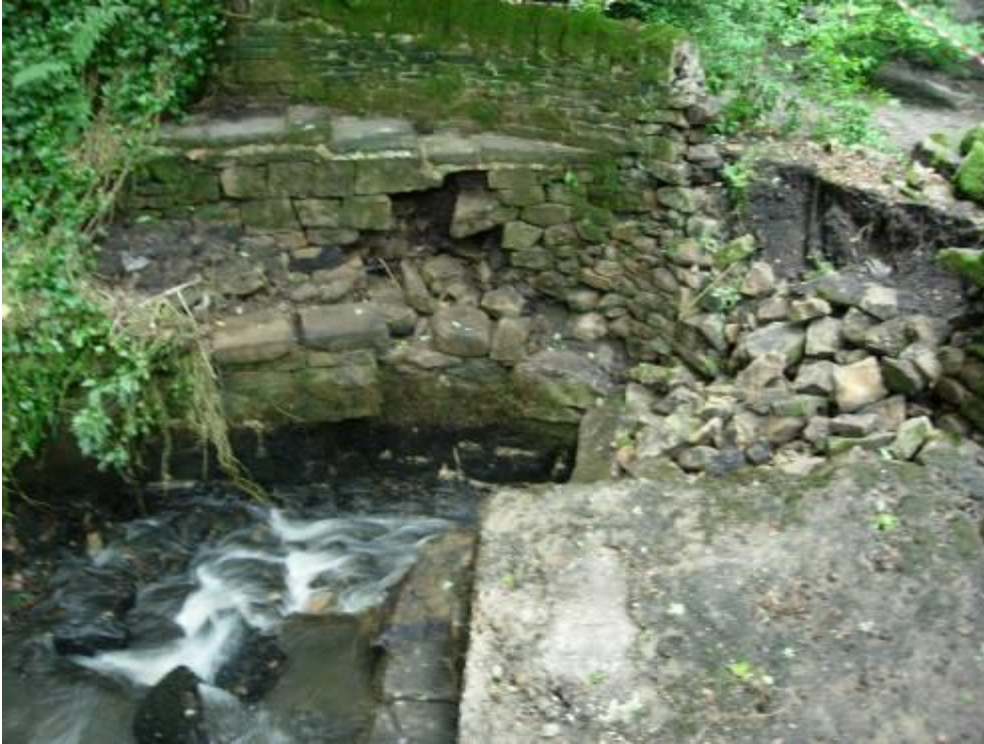
Figure 3.9 Damage to the upper reservoir stilling basin (Photo courtesy of Alan Warren)

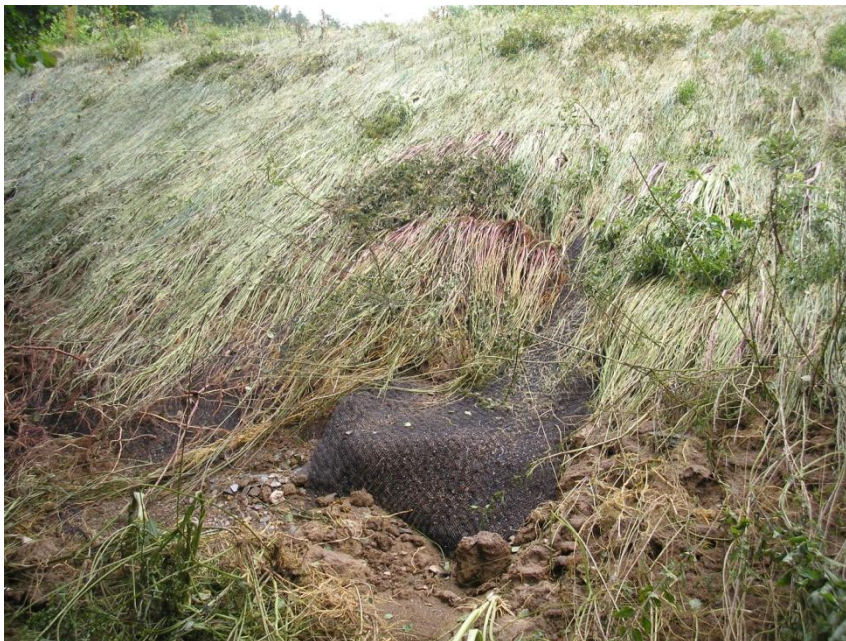
The spillway section of this reservoir featured gabion baskets to protect the core from an overtopping event and with fill placed over the gabion baskets. The downstream slope was designed to be replaced, as necessary, when the spillway section operated. This design was chosen to meet the owner's aims to preserve trees in the area for ecological reasons. This meant that the slope was relatively steep and prone to erosion. The grass on the slope was infrequently mown to encourage wildflowers. Following intense rainfall in the catchment, the spillway section of the dam embankment overtopped and some erosion occurred at the downstream toe.

Figure 3.10 Scour damage at the downstream toe (Photo courtesy of Richard Cox)

The steepness of the downstream slope and the poor condition of the grass cover is believed to have contributed to the extent of the damage. Further damage occurred to the dam face later in the year due, in part, to problems operating the gate. This second incident is still under investigation.

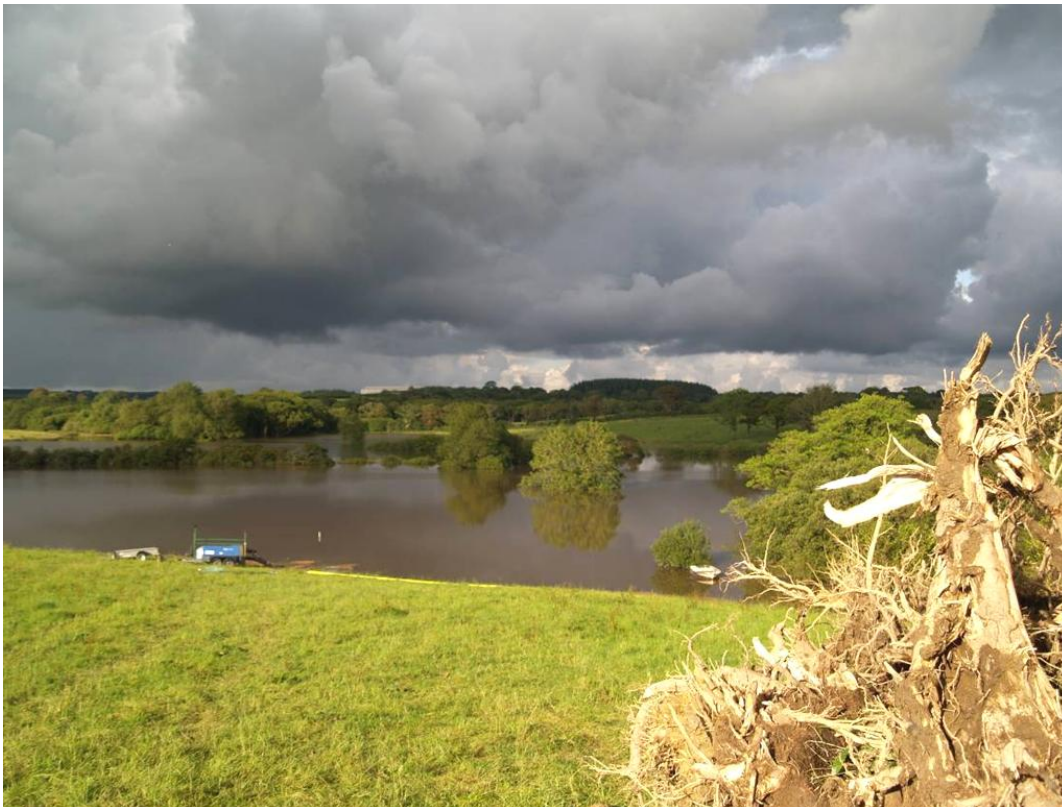
This abandoned 180-year old canal embankment had a masonry culvert to allow drainage of the natural catchment past the embankment. The culvert had not been inspected or maintained in a very long time. The culvert collapsed, causing an uncontrolled impoundment to form upstream of the embankment.

Figure 3.11 Impoundment against the canal embankment due to the collapse of the masonry culvert (Photo courtesy of David Harker)

The impoundment covered about eight hectares and had a maximum depth of 4m. The failure of the embankment would have put both people and the environment at risk, so the Environment Agency excavated a notch through the embankment whilst pumping flow from the impoundment over the crest. This work was overseen by a panel engineer. While the work was being done, an intense storm occurred over the catchment area, causing the reservoir area to re-fill to a depth of about 5.5m and to spill over the notch area. Additional pumps were brought to the site to empty the impoundment and the embankment continued to be excavated, keeping the notch wide and level to reduce the risk of a breach by flood overtopping. Evacuation of downstream residents was considered, but not carried out.

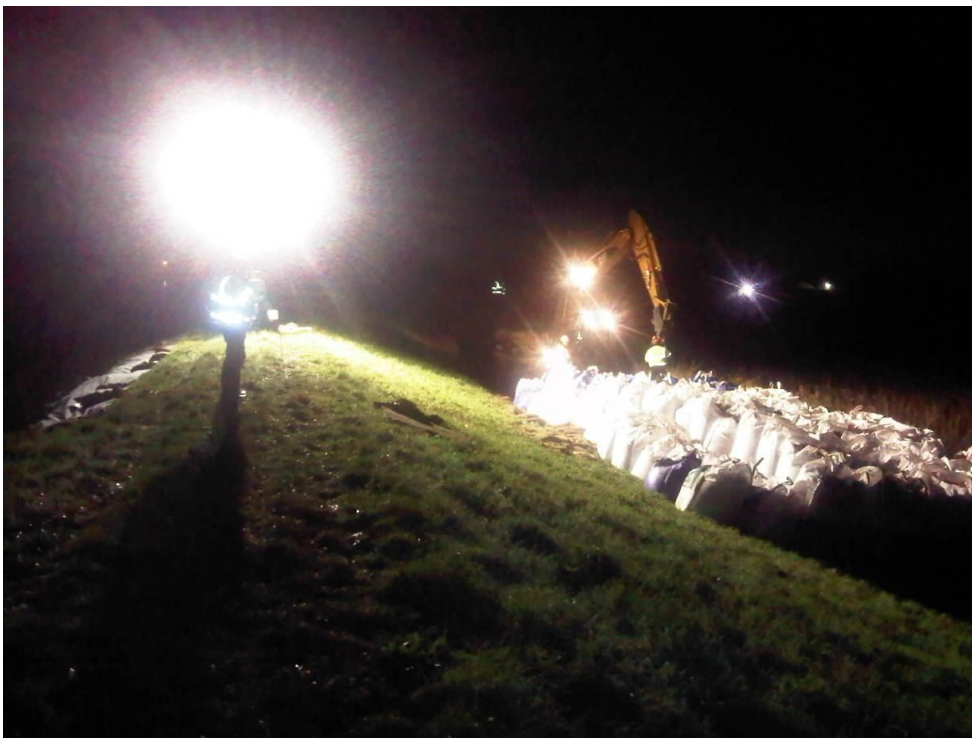
A member of the public found a leak through the lower part of the river bank and a sinkhole just below the crest. The owner placed a polythene sheet on the river side of the section of bank affected and some sandbags on the outer slope. A panel engineer was called to the site.

Figure 3.12 Emergency works to stabilise the slope (Photo courtesy of John Falkingham Associates)

The river water level receded and a permanent repair was carried out, by installing steel sheet piles and reconstructing the outer shoulder using clay fill. In carrying out this repair it was noted that the depth of the topsoil on the crest was up to 750mm thick, probably due to the river banks being raised in the past using dredged material. The thick layer of topsoil on the crest may have encouraged burrowing animals and meant that the upper part of the embankment wasn't watertight during periods of high river/tidal levels.

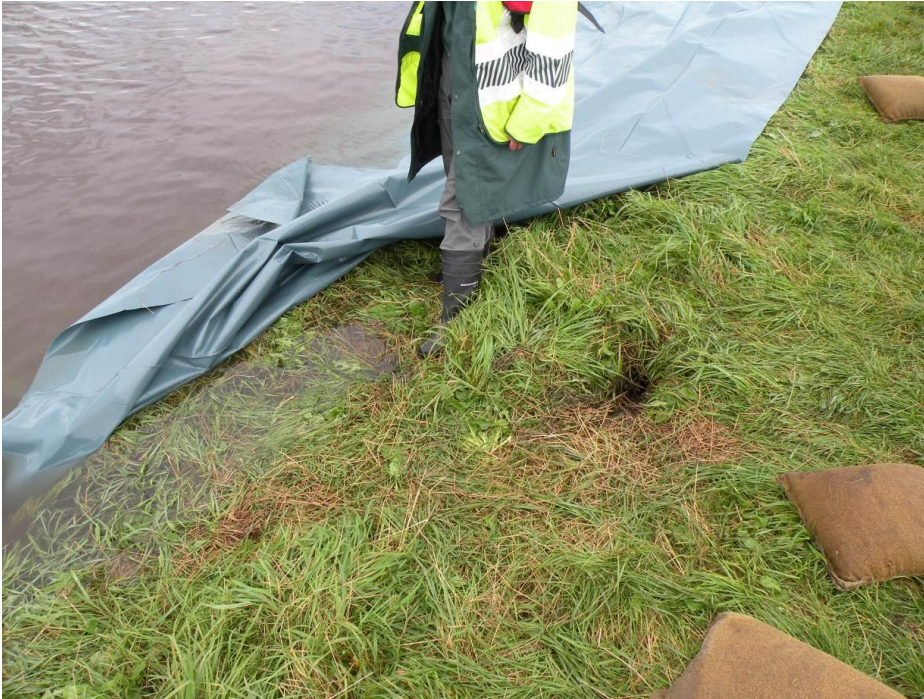
The emergency services were alerted and plans were put in place to evacuate parts of a nearby town. A number of animal holes were found under the area of the polythene sheeting and on the lower part of the outer slope from the leak.

Figure 3.12 Animal holes on the crest of the river defence embankment (Photo courtesy of John Falkingham Associates)

There was some indication that movement had taken place near the sinkhole. It was evident that the leaks had happened through the animal holes and that there had been some degree of erosion in the outer shoulder. A large number of 1-tonne sandbags were placed on the lower section of the outer slope as an emergency repair.

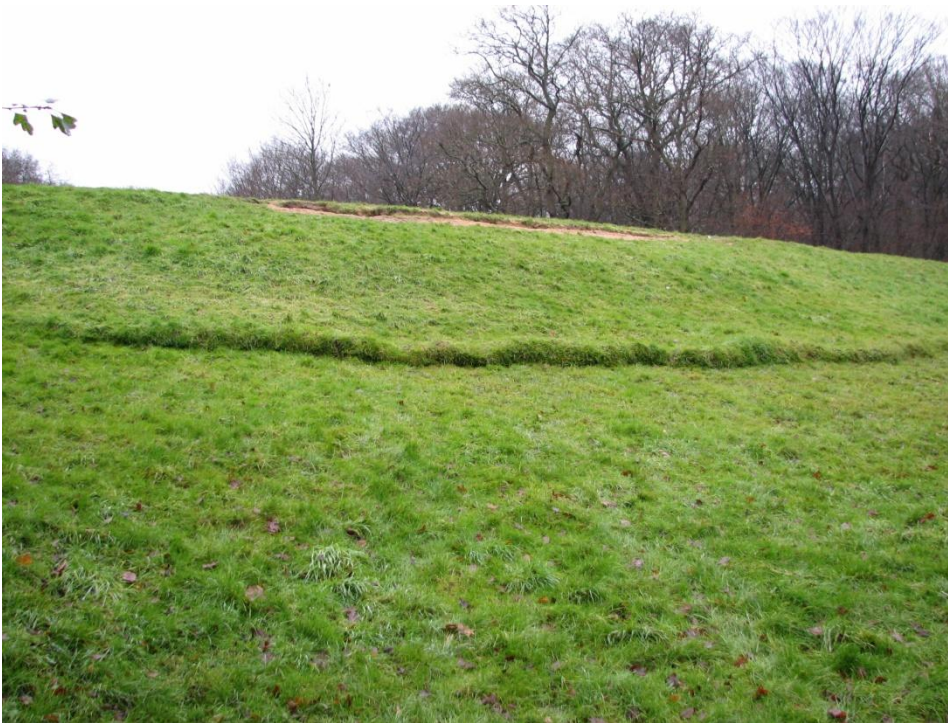
During a routine visit following a period of heavy rain, the undertaker noticed an 18m long crack just below the crest on the downstream face of the embankment.

Figure 3.14 Instability of reinforced topsoil layer on the embankment downstream face (Photo courtesy of Andrew Pepper)

It appears that a saturated layer of grassed topsoil, reinforced with an erosion control mat and approximately 200mm thick, had slipped on the surface of the underlying clay fill. The shallow surface slip posed no significant threat to the embankment security. However steps were taken to reduce the probability that this section of embankment would be overtopped during an extreme flood event, until repairs could be completed. The slope gradient was approximately 1V:3H. Investigations revealed that the underlying clay layer was very soft and grass roots hadn't grown into the clay layer. The saturated topsoil layer had slumped off the clay fill. The undertaker intends to replace the soft clay fill and to install an alternative method of erosion control using gabion mattresses.
