Learning from experience

Post-incident reporting for UK dams
2009 annual report

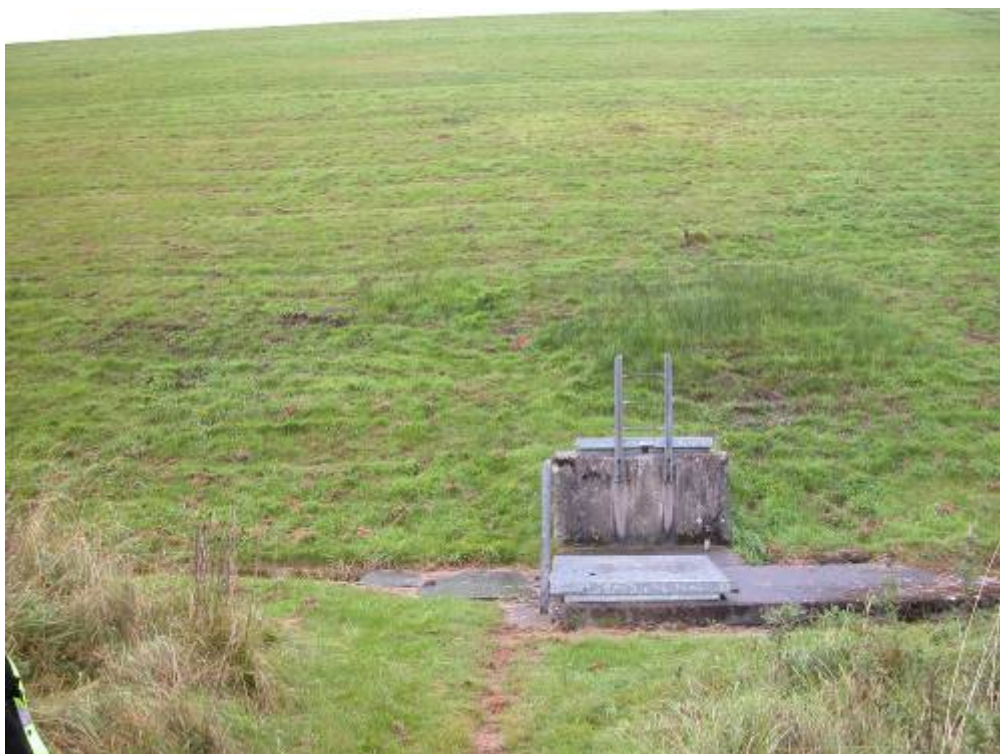
Incident 337 (2008)

Dam type	Earthfill embankment
Reservoir legal status	Statutory reservoir
Dam height (m)	24
Incident type	Increased internal water pressure causes instability
Incident severity	3

A long-standing wet area near the downstream toe of the dam was found to have deteriorated further, causing slumping. There were concerns that local instability would occur and an inspecting engineer was called to the site. The engineer recommended that slumped material was replaced and a french drain installed through the seepage horizon. The source of the seepage water was thought to be percolation of surface water through the downstream shoulder of the dam embankment.

This incident demonstrates the value of regular surveillance. Areas of seepage which show no change over many years can worsen.

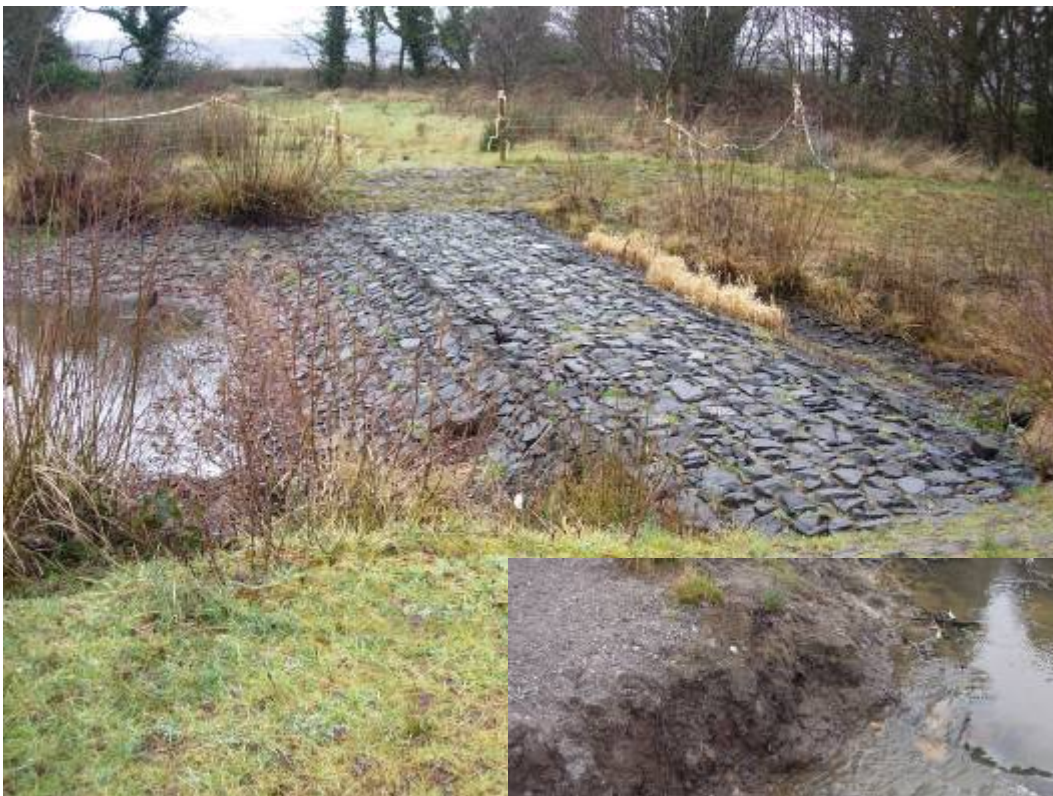
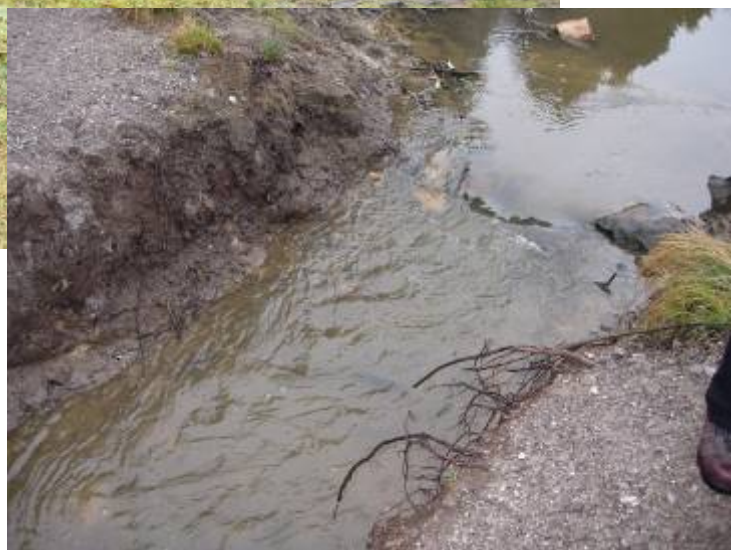
Incident 340

Internal erosion was found at a secondary dam which also acted as the reservoir spillway. This embankment was replaced in 1994. It had been constructed using gabion-baskets, covered over with clay and surfaced with a concrete revetment system. Settlement of the crest and the appearance of a hole in the revetment indicated internal erosion. A channel was cut through adjacent ground to lower the reservoir water level in a controlled manner.

This incident underlines the importance of seeking professional services in relation to the design of dam embankments as the embankment design was flawed.

The safety of the secondary dam (above) was preserved by cutting a channel (right) to draw down the reservoir.

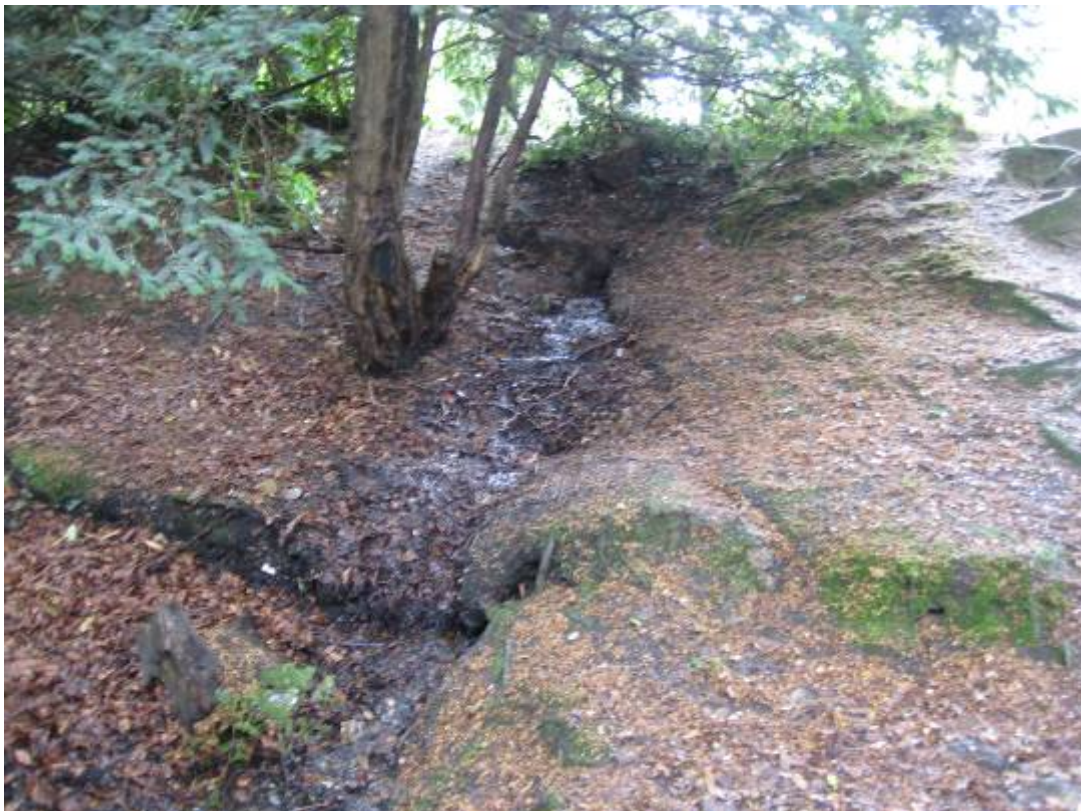
Incident 338

Dam type	Earthfill embankment
Reservoir legal status	Non-Statutory reservoir
Dam height (m)	4
Incident type	Internal erosion through embankment
Incident severity	3

Repairs were carried out in 2005 to fill in voids caused by rotten tree roots in an ancient well-vegetated embankment. Sheet piling was installed along the upstream face to reduce the amount of water that might pass through the voids in the future. To limit costs, sheet piling was only used over two sections of the embankment length but not the entire length. In 2009, seepage was found emerging from the downstream face about 1m below the dam crest. The source of the seepage was at the edge of one of the sheet piled sections at the upstream face and the flow was passing through a soil pipe within the embankment. The reservoir level was lowered in response.

Voids in embankments can lead to internal erosion incidents. In this case, piping developed between a void and the end of a length of sheet piles at the upstream face. Comprehensive grouting and sheet piling had not been carried out previously and this incident demonstrates that incidents can re-occur if preventative works are not comprehensive.

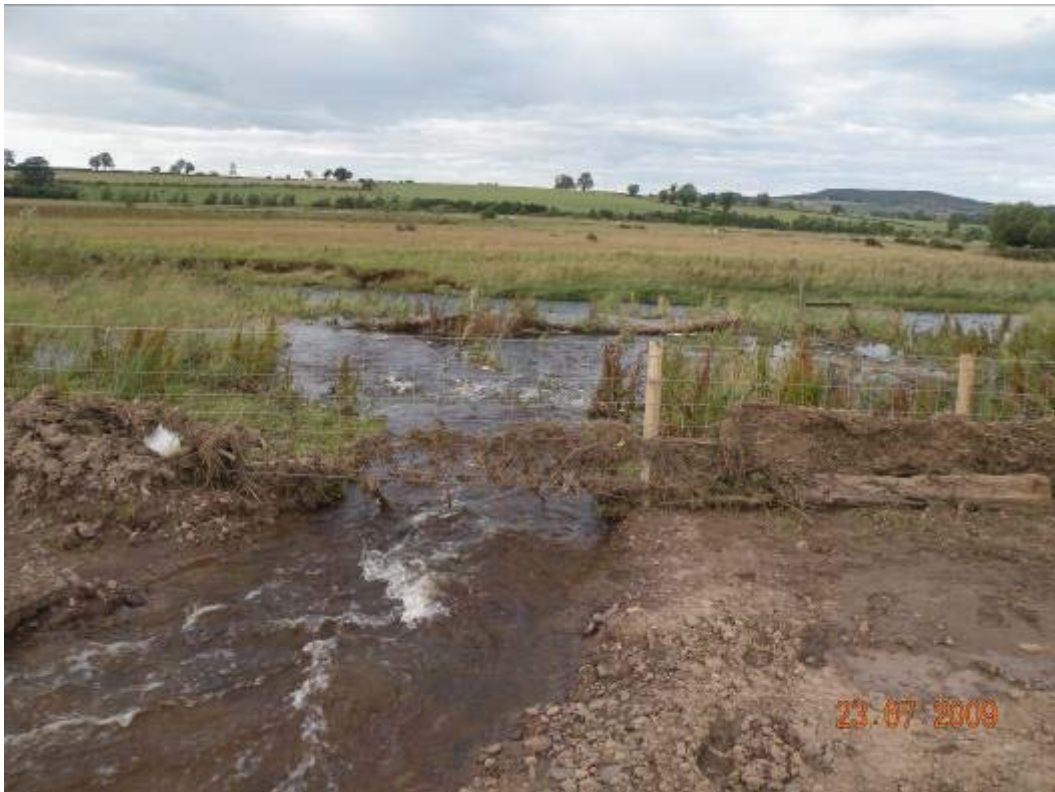
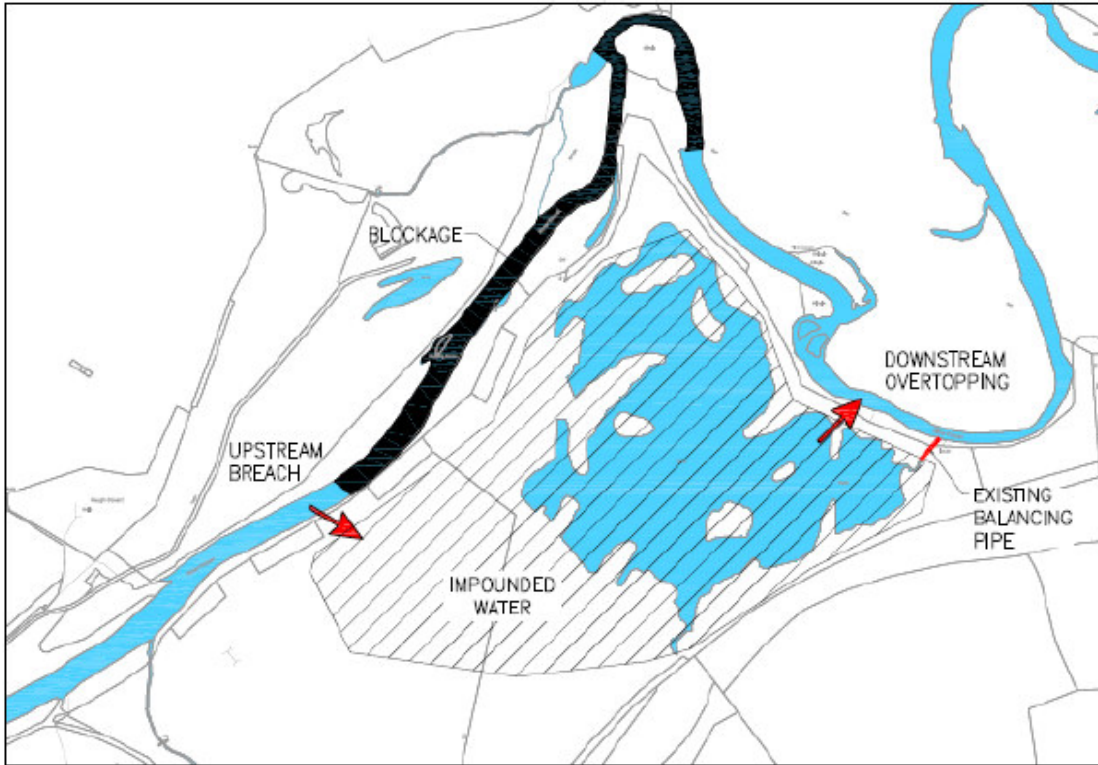
Incident 344

Dam type	River bank
Reservoir legal status	Non-statutory impoundment adjacent to a river
Dam height (m)	2
Incident type	Inflow flood, erosion by overtopping
Incident severity	2

This incident shows how the threat of uncontrolled release of large volumes of water can arise at non-registered impoundments. It demonstrates the need for flood risk managers to be aware of the risk posed by low-lying areas adjacent to rivers where an impoundment could be created under flood conditions.

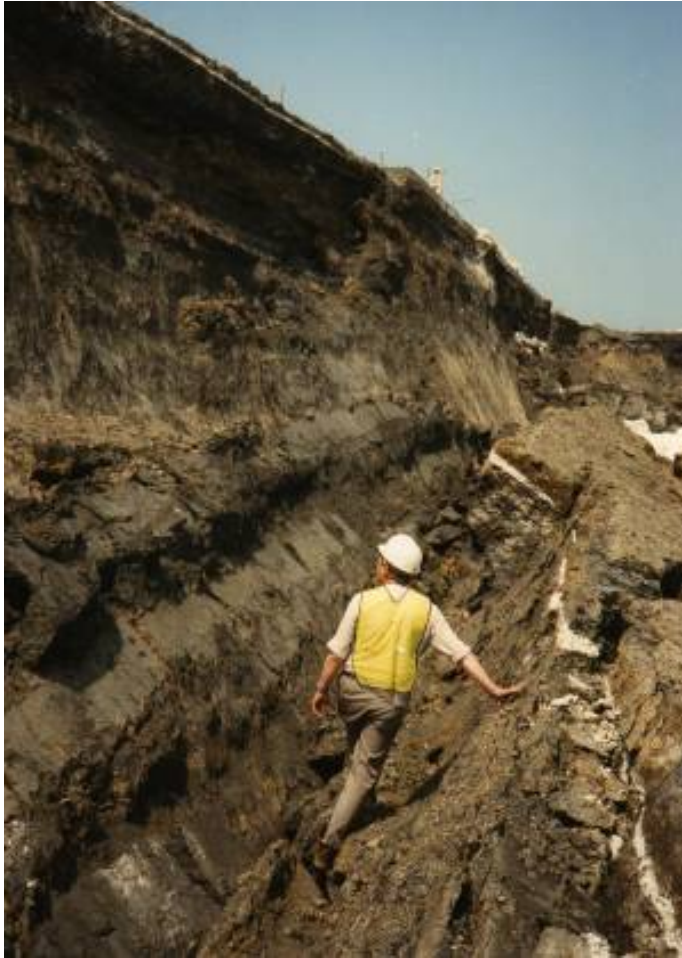
Figure 4.2: Carsington Reservoir, 1984

The investigation of the failure by Professor Vaughan led to a better appreciation of the significance of progressive failure, and the overestimation of stability by limit equilibrium analysis.

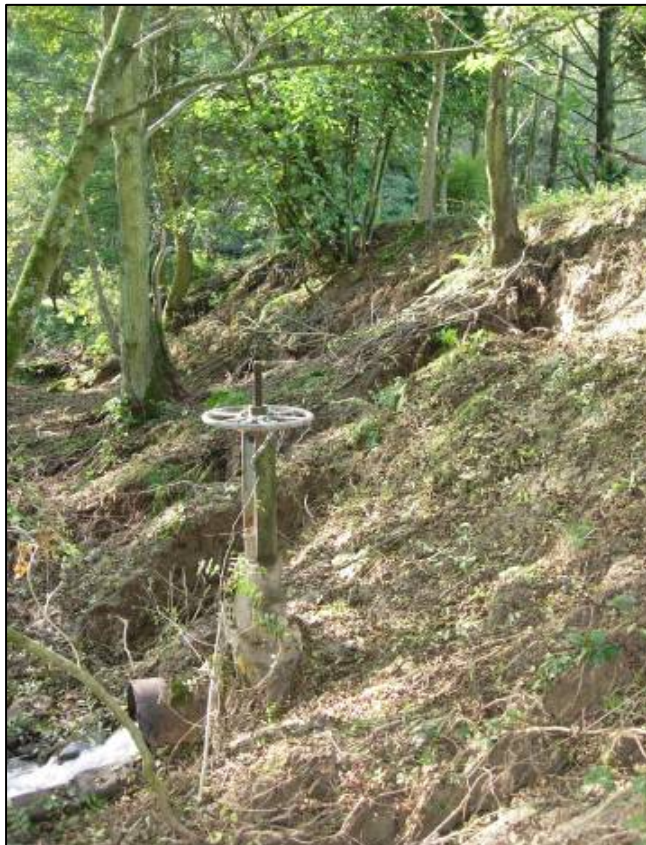
Figure 5.1 This dam was nearly washed away when it was overtopped in 2008.

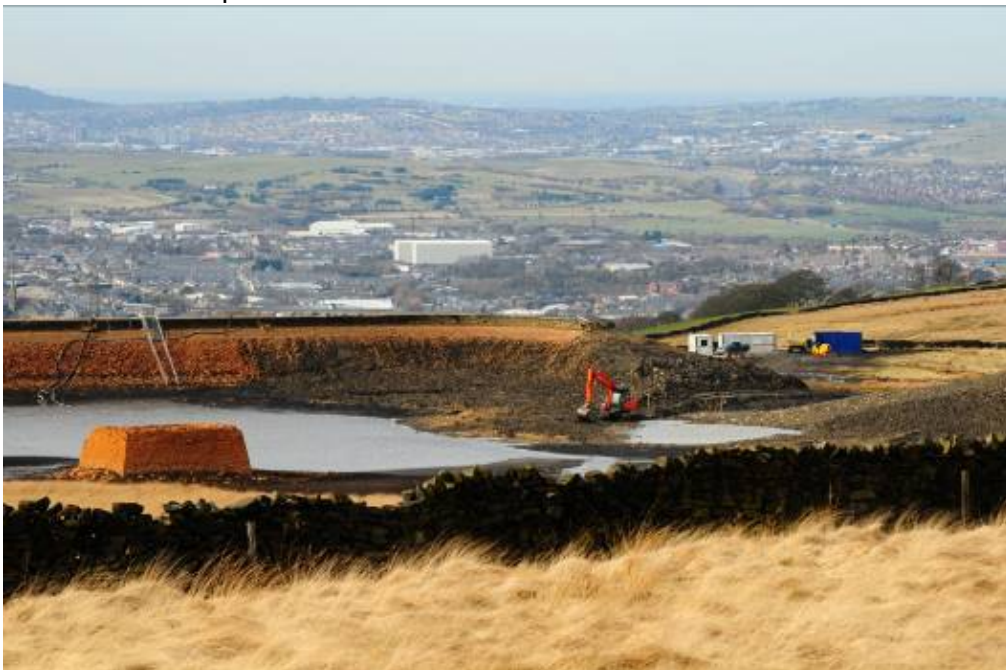
The Environment Agency arranged for statutory inspections of the reservoir to be carried out in 2004, 2006 and 2008 using its reserve powers under Section 15 of the Reservoirs Act 1975. The 2008 inspection found the dam embankment to be in poor condition. The reservoir clearly posed a risk to life and this was later confirmed through dambreak modelling studies.

The condition of the dam appeared to be deteriorating and a study recommended discontinuance of the reservoir by excavating a notch through the full height of the embankment. Discontinuance was carried out using the Environment Agency's emergency powers under Section 16 of the Act.

Figure 6.1 The 'notching-through' of Hameldon Reservoir

Work commenced in 2009 and a discontinuance certificate was issued on 14 April 2010. The risk to the public has been removed and the site made safe.
