PART 1.4 – FINDINGS

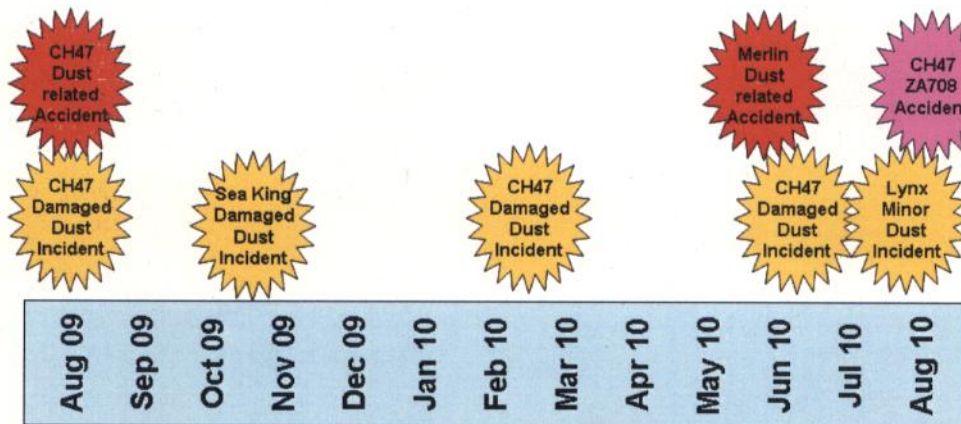
7. **Operational Context.** Helicopter operations in Afghanistan are flown against a high insurgent threat, often at the edge of the aircraft and aircrew operating capability, and in the face of significant operational pressures to support those forces that are at even greater risk on the ground. In the year prior to the ZA708 accident, the number of ground forces in the Helmand AO increased and the number of established HLSs rose from approximately 20 to around 100. As part of the 'clear, hold and build' strategy, many of these HLSs were adjacent to populated areas and thus faced an increased threat. Despite the threats and other risks to aviation, the use of helicopters still represented the 'least bad' option when compared with road resupply, which was vulnerable to IED and other attacks. The increased threat to aviation was often mitigated by ac operating at night, which in itself increases the risk to crews by the greater difficulty of the flying task - crews operate with a restricted field of view and reduced depth perception during NVD operations. The combination of threat, environmental and other demands found in Afghanistan result in JHC aircraft operating with a level of risk that is higher than in other recent theatres of operation. This is borne out by data provided by HQ JHC detailing dust-related incidents in the year prior to ZA708's accident, many of which were attributed to the 'natural operating hazards' of the theatre (Fig 1-9). **The Panel concluded that the demanding environmental nature of Afghan operations was a contributory factor to the accident.**

Figure 1-9 JHC data detailing significant dust incidents in the year prior to the ZA708 accident

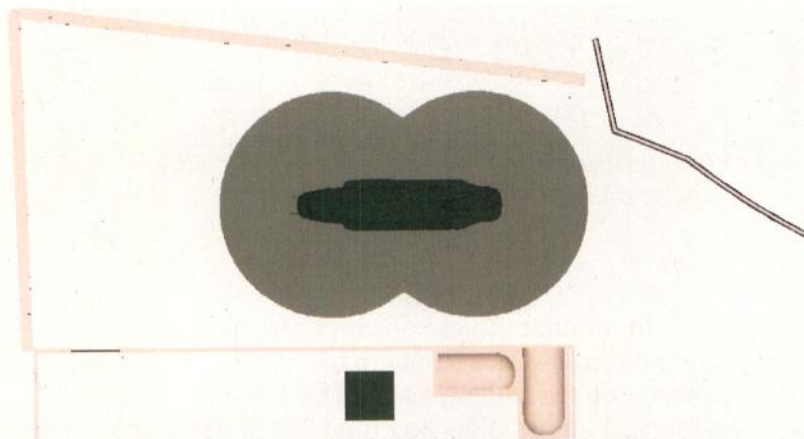
b. **PB Bahadur.** The HLS directory entry for PB Bahadur contained significant errors. The HLS image orientation was approximately 140° inaccurate, the grid was several hundred metres inaccurate and the data did not reflect the construction of a wall on the HLS. While some sites of a similar size to PB Bahadur, such as PB Haji Alem (size 30m x 40m), carried a warning stating that a blade clearance of only 12 ft could be maintained by a Chinook within the HLS, the Bahadur insert carried no such warning, despite the fact that it was actually smaller (Fig 1-10) than Haji Alem. The Panel found that the establishment of a new HLS should be accompanied by a MAOT ground recce of the site, but no such reconnaissance of PB Bahadur took place. Three MAOTs interviewed reported each other as having conducted the recce, but all denied doing it themselves. The Panel considered it most likely that the ground unit at the site had provided the data, which was then added to an aerial photograph taken on 8 May 10 by a MAOT from a Lynx helicopter, in order to complete the PB Bahadur insert.

Fig 1-10 Computer model 'plan' view of CH47 in PB Bahadur HLS (with FP wall built)

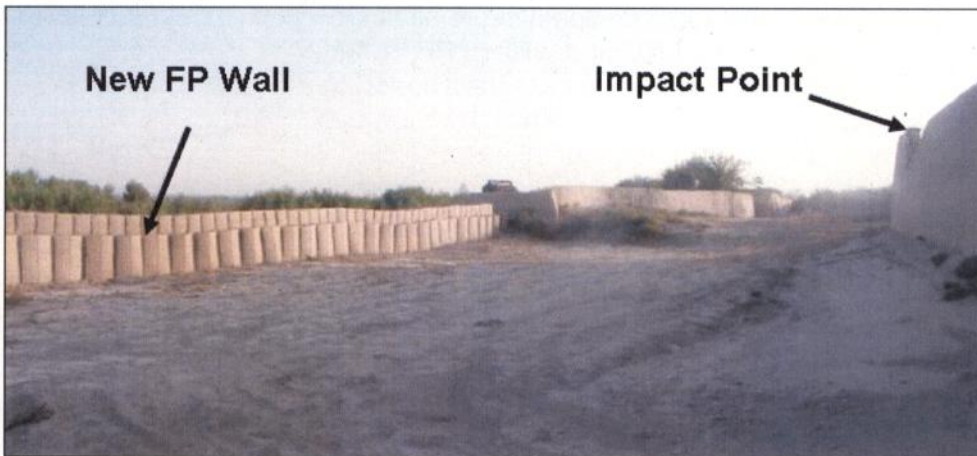
12. **Adjustments to the PB Bahadur HLS.** PB Bahadur fell far short of the ATP49 requirements and the Panel noted that one previous OC 1310 Ft had declined to operate into the site at night. Prior to any knowledge of the reduced size caused by the unexpected wall build, CO JHF(A) directed it as a night-only HLS in consideration of the substantial recent threat. However, the Panel found that in the days prior to accident sortie, Force Protection (FP) work was conducted at the HLS that included the construction of an additional wall. This reduced the HLS size to 49 metres long and 21 metres wide at the narrowest point – at the widest point, the HLS was 24 metres wide. The HLS size was now slightly smaller than the ATP49(E) requirements for a Lynx (the smallest JHF(A) ac), but, importantly, a Chinook landing in the absolute centre of the HLS would have been unable to maintain the absolute minima of 10 ft MSC (Fig 1-11). However, the FP work and HLS size change was not notified to JHF(A). (S41)

The Panel concluded that the omission to notify JHF(A) of the FP measures that reduced the HLS size was a major contributory factor to the accident.

Fig 1-11 The construction of a new FP wall and the impact point of the CH47 on the pre-existing wall

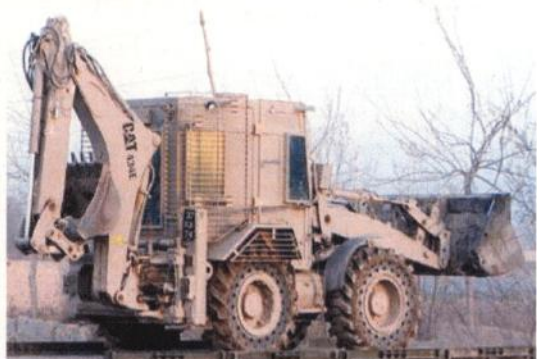
15. **Impact of FP Measures on Dust in HLS.** The Panel found that the construction of the new FP wall at PB Bahadur was achieved by the frequent and regular movement of armoured plant machinery heavy vehicles (Fig 1-12a) over and across the HLS between 5 and 9 Aug 10. The weight and non-pneumatic tyre design of this vehicle served to break up the surface of the HLS

and transform it from compressed mud and sand into talcum-powder like dust. The Panel found that while existing HLS management procedures in Theatre prohibited the use of vehicles on a HLS in wet weather, they were not clear about dry weather. In the case of Bahadur, the only entrance to the Bahadur PB compound was across the HLS itself and constant movement of vehicles across the HLS would have served to further exacerbate this situation. The Panel consider that the effect of this work was to significantly increase the levels of dust on the HLS (Fig 1-12b), which was unsuppressed (i.e. no matting or gravel); this dust was described as ankle deep by a MAOT officer during a visit to the HLS over the period 18-19 Aug 10, a week after the accident. ZA708 was the first aircraft to approach this HLS after the FP work was completed and, tasked with the carriage of an USL, would have been exposed to the dust for a significant period of time. **The Panel concluded that the omission to notify JHF(A) of the unsuppressed and excessive dust as a result of the FP work on the HLS and mitigate against its presence was a major contributory factor to the accident.**

Fig 1-12a Type of vehicle used for FP work

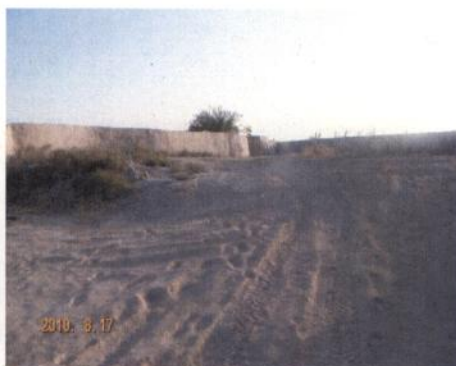
Fig 1-12b Excessive dust (note footprints)

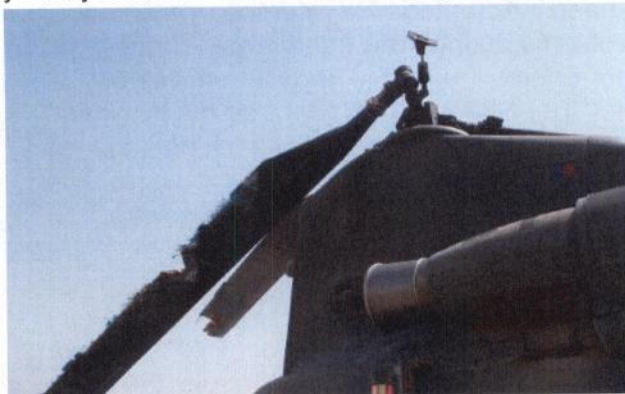
26. **Transmissions and Rotor System.** There were no unusual transmission indications for the duration of the sortie. Although the HP reported seeing possible transmission-related CAP captions during the overshoot manoeuvre after the accident, there was no evidence of this in the CVFDR data. HUMS data has shown that there were no unusual vibrations from the airframe or transmissions prior to the accident. Photographic evidence has shown that the aft 'green' rotor lag damper had detached from the rotor blade (Fig 1-13). It is likely that this occurred as a result of the impact of the aft rotor blades on the sangar structure in PB Bahadur. Oil samples were taken from all gear boxes and subsequently analysed, with no unusual findings.

Fig 1-13 Aft 'Green' Lag Damper Failure

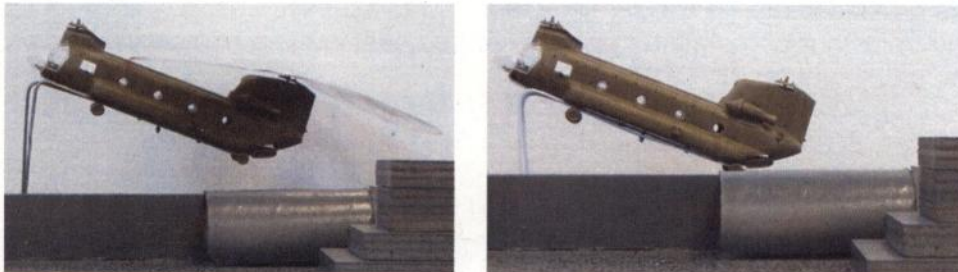
29. **Radalt.** Analysis of the CVFDR data indicated that the Radalt was indicating a height of 13 ft agl with the ac on the ground after the emergency landing. Further analysis showed that the Radalt had indicated 5.6 ft and 9.4 ft agl on the previous two weight-on-wheels (WoW) events. The Radalt was subject to detailed testing by the Defence Support Group (DSG) Sealand, where it over-read by 6 ft when bench tested 'on the ground', but gave correct indications for all other test signals up to 5000 ft. The Panel could not confirm whether this fault occurred as a result of the accident or was already present. Combined evidence of the video of the accident and analysis of the CVFDR/ HUMS data suggests that the Radalt was over reading by approximately 10 feet during the approach and load drop-off at PB Bahadur. During interviews, the NHP stated that the load came off the ground at Camp Bastion at 40 ft (Radalt indicated), but analysis of the fused data appeared to indicate that the load touch the ground at PB Bahadur at an indicated 50 ft. RNFSAIC, in consultation with Defence Equipment & Support (DE&S) are continuing a more detailed investigation in this area to determine the potential for the problem to exist on other platforms. However, RNFSAIC have, by use of trigonometry and modelling, proved that if the aircraft had been at 31.9 ft, as indicated on the Radalt, with the same attitude at the time that it impacted the wall, it would have missed the compound wall (Fig 1-14). While the dust USL procedure was still a visually flown manoeuvre, **the Panel concluded that the inaccuracy of the Radalt by approximately 10 ft was a contributory factor to the accident.**

Fig 1-14 Model depicting effect of over-reading Radalt prior to impact. At impact Radalt indicated 32 ft (which would have cleared the wall – image on the left); it was actually at 22.6 ft – image on the right
