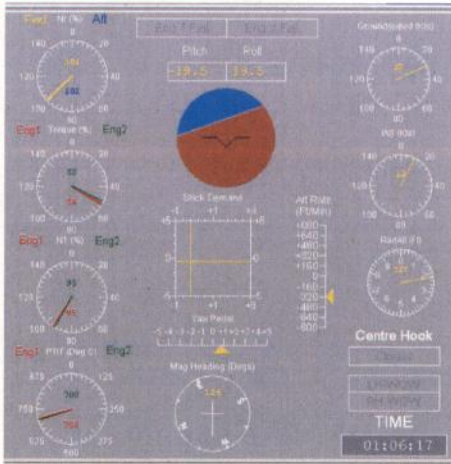
b. **Approach profile flown.** STANEVAL detailed that SOP 21 states that *'All dust landings start with a good approach.Once the gate parameters have been achieved the aircraft should be trimmed and the NHP's Radalt bug set to (S26),* amplifying this further by stating that the HP should *'Ensure the aircraft is accurately trimmed, especially laterally to ensure no drift.'* In contrast, they noted that this approach began with a very tight right turn to remain close to the PB (Fig 1-15b). The profile flown required significant amounts of roll, pitch and yaw inputs, with the aircraft not achieving a stable condition for the HP to then trim the aircraft and commence the approach; SOP 'gates' at **(S26)**, with the aircraft correctly trimmed, were not achieved. Additionally, upon rolling out on final approach, the aircraft appeared to maintain a degree of bank and pitch, a configuration that continued all the way to the drop point. STANEVAL highlighted that a stable hover was never achieved and the aircraft maintained a bank angle of around 10 degrees left side low, therefore setting up an increasing amount of drift in the dust cloud that would ultimately result in the impact. The Panel are of the opinion that the unstable nature of the approach profile flown significantly eroded the mental capacity of the HP to establish a hover attitude over the HLS, prior to vertically descending to place the load on the ground. **The Panel concluded that the conduct of a rapid approach profile that did not stabilise the aircraft on final approach or allow the pilot the mental capacity to adopt the hover attitude over the HLS was a major contributory factor in the accident.**

Fig 1-15a (CVFDR data) midway through finals turn.

Fig 1-15b – RN FSAIC data - Approximate path flown.

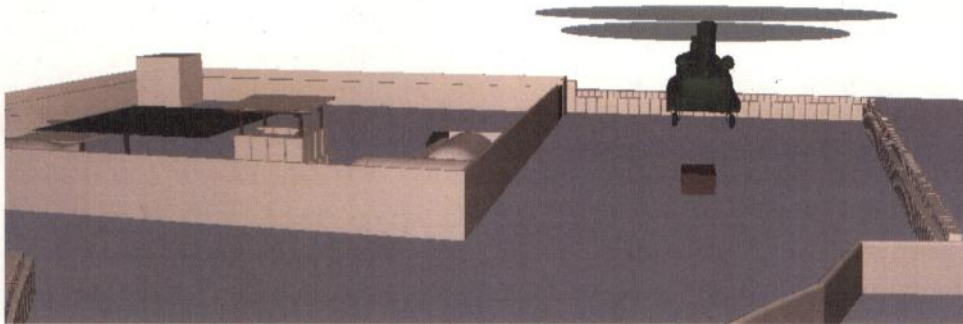
62. **Breach of MSC.** The compound wall on the left of the aircraft during the approach was approximately 3 metres high and was the structure that ZA708 initially collided with during the accident. The Panel has found that the rear of the ac was only 8.1 metres from this obstruction as it released the USL and that the rotors would have been overlapping the obstruction (Fig 1-16); an earlier impact with the rotor blades was therefore avoided by the use of the 3 metre stop. However, the Panel found that the ac drifted in heavy dust over the HLS, was unable to maintain MSC and struck the wall. **The Panel concluded that the causal factor of the accident was the breach of MSC within the HLS, with uncorrected drift leading to a collision with the PB wall.**

Fig 1-16 Computer model view of ZA708 during load drop

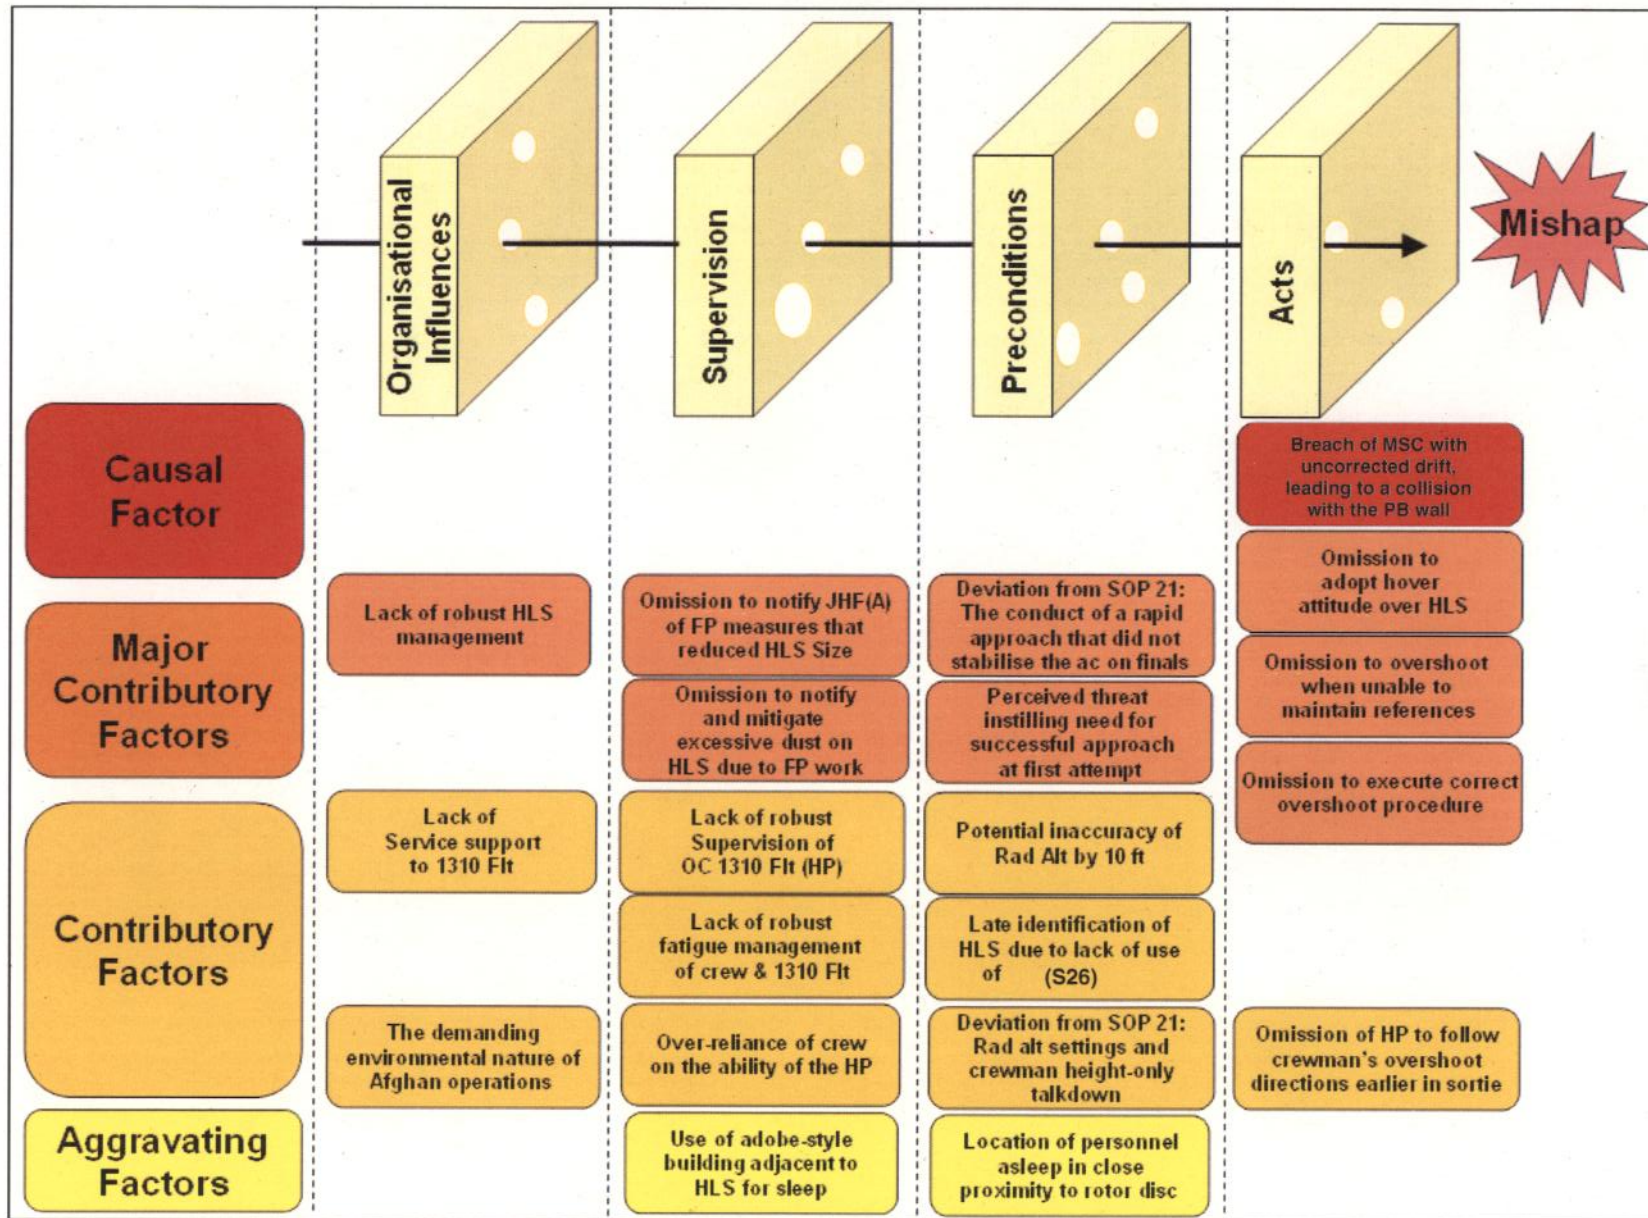
64. **Cause.** The causal factor of the accident was the breach of MSC within the HLS, with uncorrected drift leading to a collision with the PB wall. Para 62

Fig 1-17 Summary of factors detailed under Reason's Model
