A quarterly guide to equipment care

Issue 82 | 2012

Welcome to KiT! 82 Winter 2012

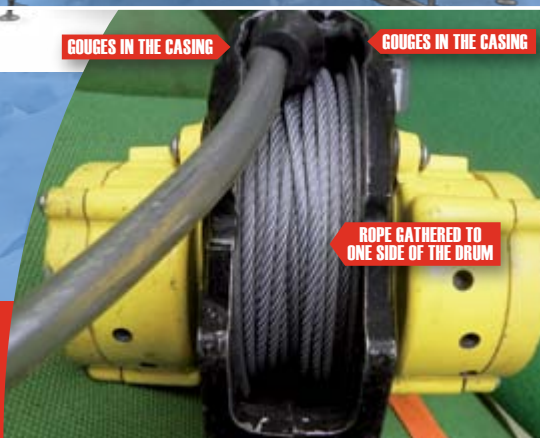
INCORRECTLY FITTED

The descent controller had been incorrectly fitted to the climbing wall.

During operation the cable became mis-layered on one side of the cable drum, it became snagged on the drum and failed to retract leading to the slack cable. This was a direct result of the device being fitted 90° out of correct alignment.

It was noted that the casing of the equipment suffered gouges indicating that the equipment had been incorrectly fitted for an extended period of time.

All holding units should carry out an immediate review, to ensure that the equipment is Fitted and Operated in accordance with the Manufacturer's Manual and subject to before use inspections.

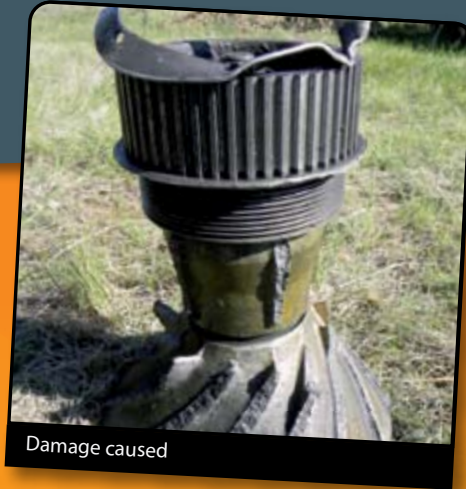
Damage caused

This is the remains of a CVRT cooling fan assembly - the damage to the vehicle when the fan failed was extensive, which made it impossible to determine the sequence of events that led up to the failure. There are a number of points worth noting:

- The transmission had been renewed shortly before the failure - it is possible that the transmission was not correctly aligned so that the fan driven pulley was not parallel with the driving pulley. AESP 2350-T-220-522 Chapter 4 refers.
- There is evidence of fretting on the fracture surfaces of the fan blades, which suggest that some of the fan blades were cracked prior to the failure. The fan should be inspected for cracks during MEI
- The fan belt tension may have been excessive - this imposes excessive loads on the fan bearings and would eventually cause the fan to run out of true. The fan belt tensioning procedure is detailed in AESP 2350-T-220-522 Chapter 3

The fan drive belt should be adjusted so that there is total free play of 14 mm (9/16 in.) when measured at the mid point between pulleys.

AESP 2350-T-220-522 Chapter 3 does not state the effort required to achieve this deflection - **Experience suggests that the belt should run loose and therefore minimal effort should be used.**

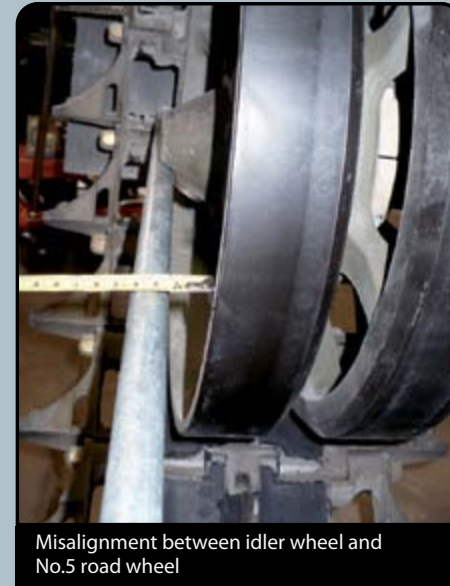
Misalignment between idler wheel and No.5 road wheel

The picture shows a misalignment between the idler wheel and the No.5 road wheel.

The misalignment was due to a bent idler arm bracket, the force required to bend this substantial component can only have been generated by an impact with an immovable object, which should have been noticed by the crew. The impact may have cracked the hull around the bracket mounting threads.

This damage would have caused the vehicle to track to one side, which would have required a constant steering input from the driver. The track would have worn unevenly and at a greater rate than is normal.

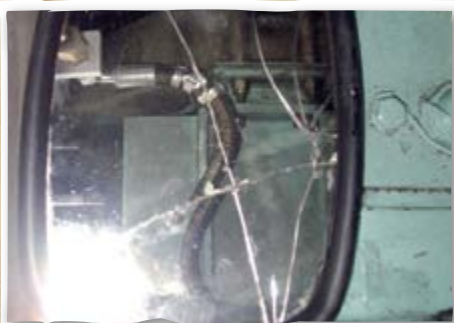
DSG Bovington have reported that there is a possibility of the main brake hose fouling against the underside of the Electric Fan Control Box (EFCB).

Brake hose fouls EFCB

Failure of the brake hose would cause a loss of brake fluid and a consequent loss of brakes.

Any fouls or wear to the hose should be reported to:

CRARRV Availability Manager - [REDACTED] and an EFR raised.

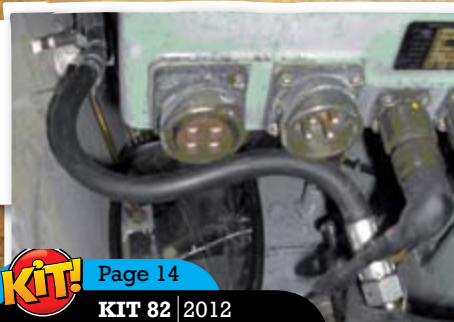
Alternative routing

DSG Bovington are routing the hose differently.

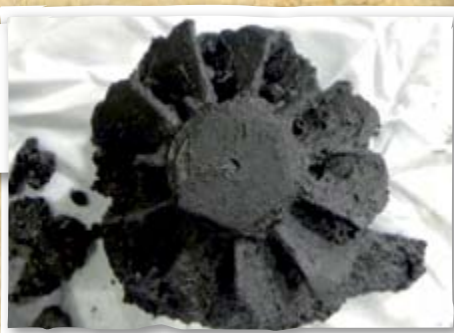
Turbocharger Failure

This is the turbine wheel from a CRARRV 6A engine. Due to excessive play in the turbocharger bearings, the wheel had sheared from the shaft, as a result of colliding with the main body of the turbo. The impeller (compressor) wheel had bent blades and evidence of frictional wear from high speed contact with the housing – further evidence of excessive play in the bearings.

The cooling off period is designed to maintain a flow of engine oil to the turbochargers to assist in cooling them down from 800 °C to approx. 100 °C. Prematurely shutting the engine down causes the engine oil, lubricating the turbocharger bearings, to boil - this leaves the bearings, rotating at 100,000 rpm, running dry - this rapidly increases the bearing wear rate and leads to catastrophic failure.

Turbocharger failure results in an immediate loss of power and a high probability of a fire, as the lubricating oil will spray over the hot exhaust manifolds.

AESP 2350-P-120-201 Chapter 1-11 states: (5) EQUIPMENT DAMAGE. **Run the engine at 800 rev/min for 3 to 5 minutes, to allow the engine to partially cool before switching off.**

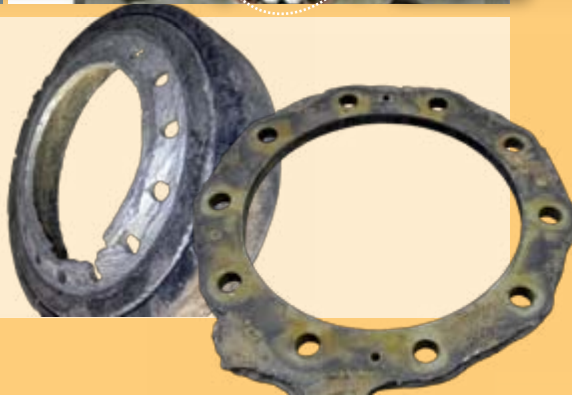
This vibration damper failed because the bolts used to secure the drive coupling were too long - **the witness marks are clearly visible** - this strained the flange and the cyclical load eventually led to a catastrophic failure and loss of drive.

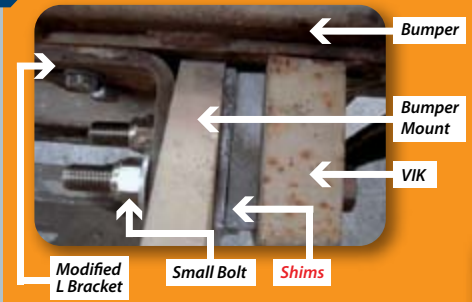
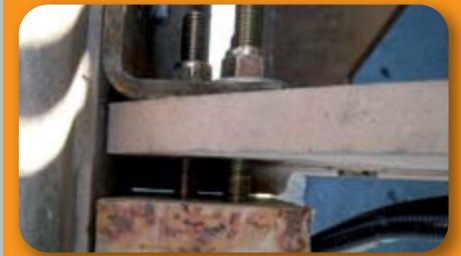
The spacers are critical to spread the load, if they are not used the bolts tend to shear, this picture illustrates an incorrect fit.

The small bolts have been shearing when used without the shims. Using the spacers reduces the movement of the VIK, meaning bolts are far less likely to shear.

The VIK should be fitted using as many spacers as required to pack the gap tightly between the VIK and the bumper mount.
