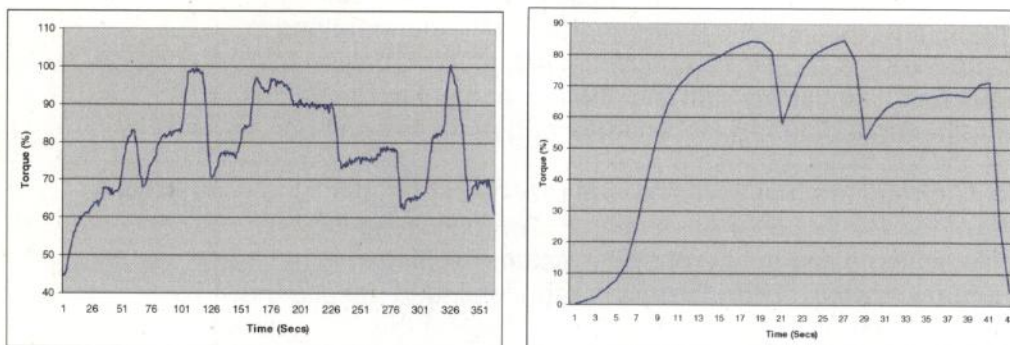
1.4.50. The Panel sought to understand what caused the abnormal torque indications as it may have influenced the HP's decision to return to EEC Normal rather than land in EEC Manual. The Panel, in conjunction with the MilAAIB, worked with Honeywell and ITP to establish what may have been the cause of these indications. The Panel obtained comparative data from a flight test flown on ZF511 in order to identify a characteristic response. A comparison of ADR data between ZF349 and ZF511 is shown at Fig 12, which shows sharp spikes in torque for ZF349 and a gradual rise in torque in ZF511 demonstrating the anomalous response experienced by the HP.

Fig 12 - Sample of ADR Data in EEC Manual from ZF349 and from ZF511.

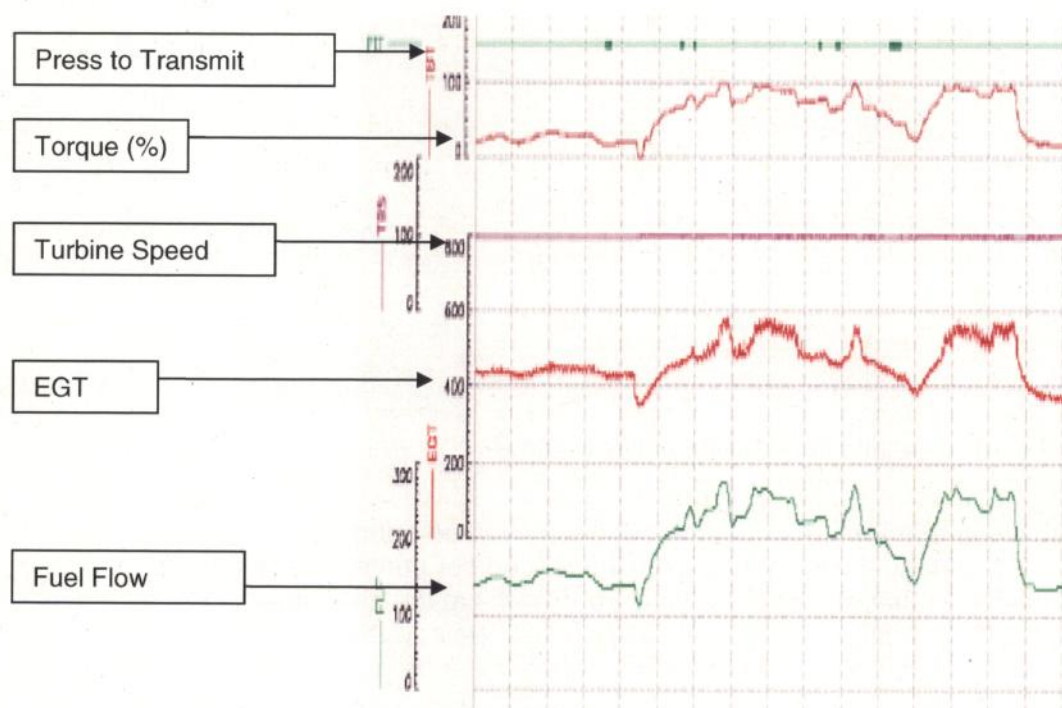
Fig 13 – Screen Shot of ADR Data Showing Engine Parameters Moving in Sync in EEC Manual.

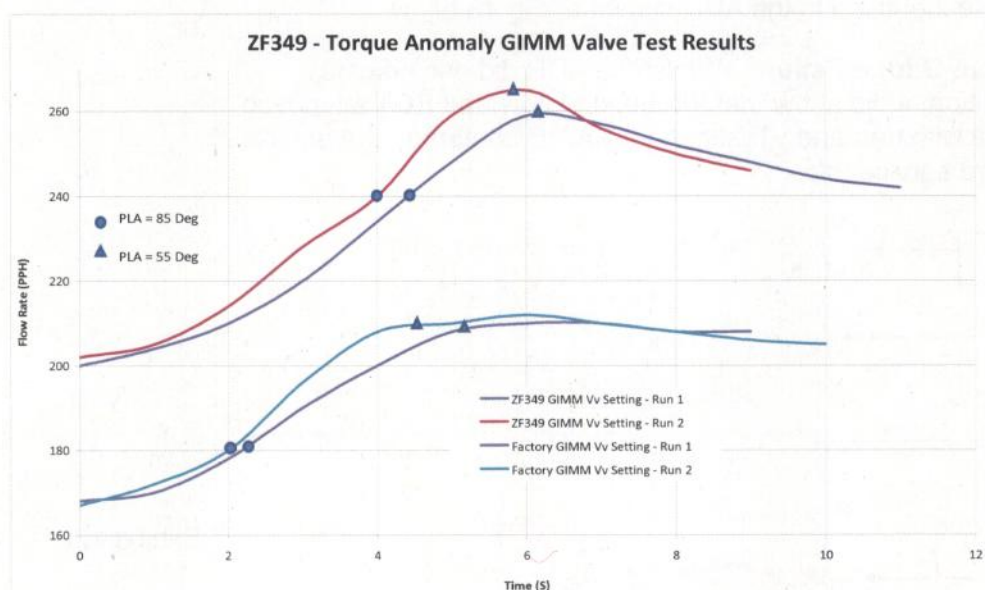
(1) The required fuel flow rate was reached short of full travel of the Pilot's Lever Assembly (PLA), replicating the throttle, which could not be easily arrested resulting in a marked overswing. This increasing rate continued despite the PLA being retarded and was only arrested when the PLA was at mid-quadrant whereupon the rate dropped sharply. With the GIMM valve set to factory settings, the overswing experienced was less prominent and at mid-quadrant the drop off was gradual. These tests provided the explanation for the spiked response experienced by the HP. The results are presented graphically below in Fig 14.

(2) When ZF349's GIMM valve was set on 26 Nov 12, the atmospheric conditions prevented the torque limiting test in EEC Normal from being achieved but this did not prevent satisfactory completion of the ground runs required for the engine change.

Fig 14 – Results from GIMM Valve Testing.

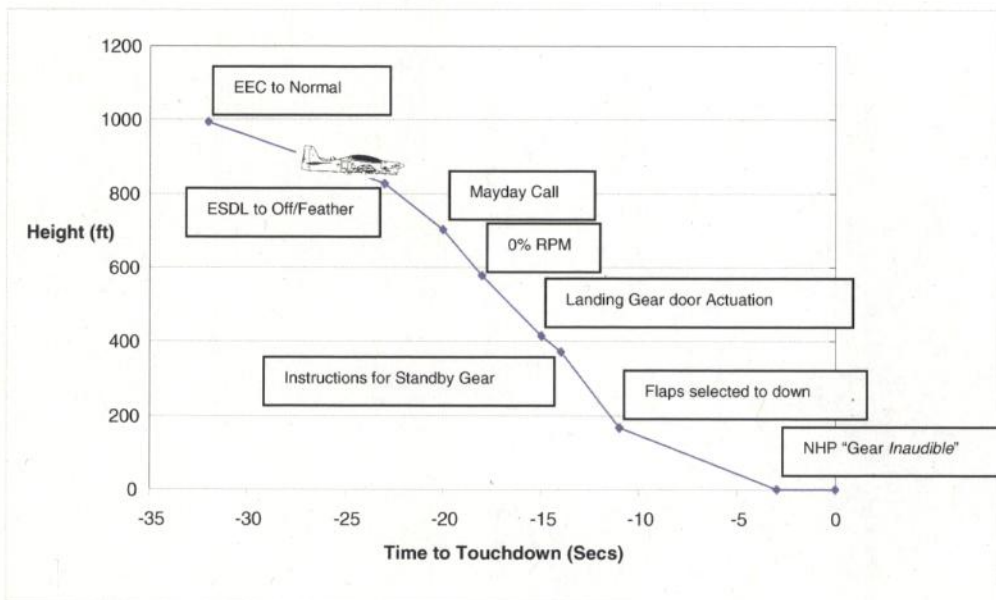
1.4.57. Fig 15 below provides a précis of the accident sequence from the moment EEC Normal was reselected to the point that the aircraft touched down on the runway some 32 secs later. Having determined the Cause and examined whether there was the potential for recovery, the Panel analysed the accident sequence in detail using the ADR data from the moment the ESDL was selected.

Fig 15 – Précis of the Accident Sequence – the Rate of Descent Depicted is Illustrative.

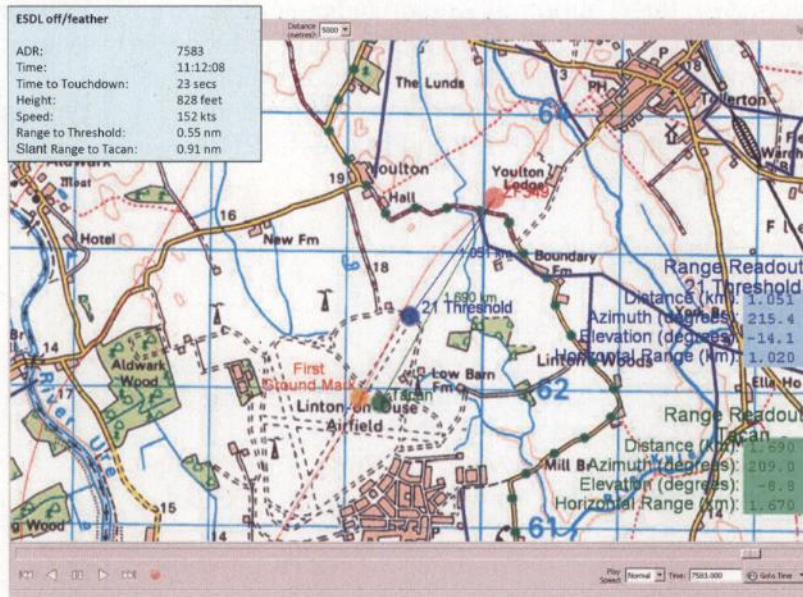
1.4.58. Suspecting an engine failure, the HP selected the ESDL to Off/Feather 9 secs after the re-selection of EEC Normal and committed to a forced landing on Rwy 21. This occurred at a height of 828 ft and 152 kts at 0.55 nm from the threshold (see Fig 16). Operation of the ESDL closes the mechanical fuel shut-off valve, disables the NTS system, initiates the fuel purge system and operates the feathering valve to allow the propeller to feather, thus reducing drag. Flaps were still available as they are electrically operated but the landing gear could now only be lowered using the standby system. Fig 17 shows a cockpit view of the aircraft's position in relation to Rwy 21 when the ESDL was operated.

Fig 16 – Aircraft Position when the ESDL was Operated.

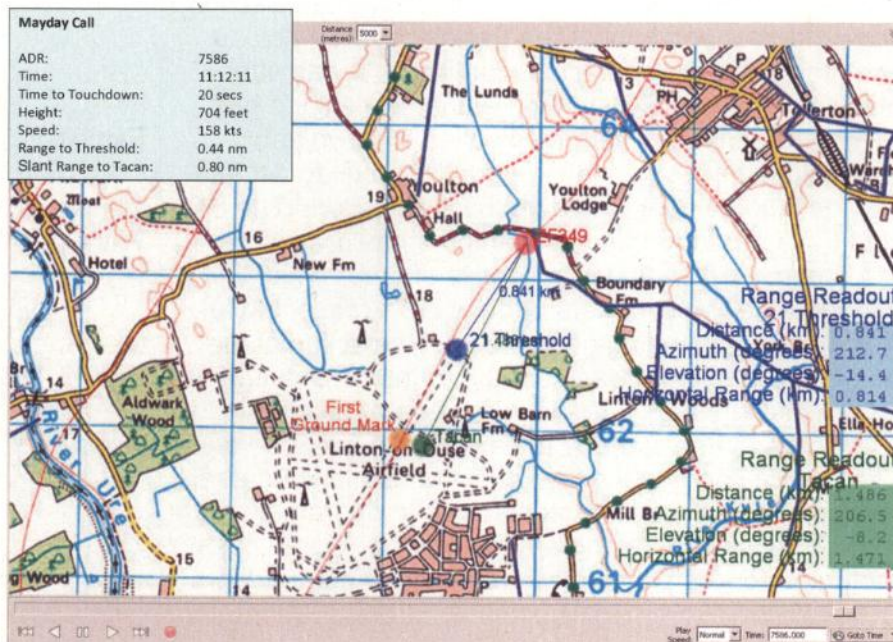
1.4.62. Fig 19 shows a map view of the aircraft's position when the Mayday transmission was made. The HP made a brief Mayday transmission on the Tower frequency at approximately 700 ft. She transmitted, 'Mayday L19 PFL' although this transmission was described as 'unintelligible' by the Tower Controller. The post-accident transcription of the Tower frequency showed this transmission to be clipped as 'Mayday L...'. The Panel noted that this would not normally be an issue as 'Mayday' is the key descriptor to trigger an emergency response but, given that her transmission was clipped and unintelligible, the Panel wished to emphasise the standard practice of transmitting 'Mayday' 3 times where time permits and without prejudicing the safe flight of the aircraft. The Panel viewed that had the aircraft been away from the circuit an incomplete Mayday call may have delayed an emergency response. Therefore the Panel considered that an incomplete Mayday call was an **other factor** but endorsed the teaching to fly the aircraft first.

Fig 19 – Aircraft Position During the Mayday Transmission.

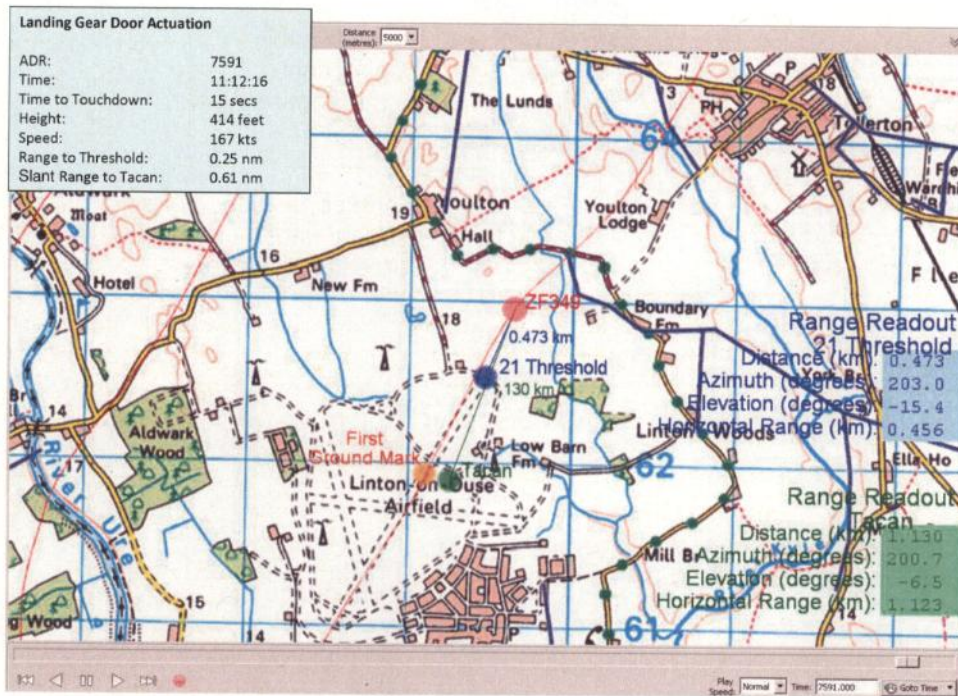
1.4.64. **Operation.** The LGSL was found in the down (operated) position and was selected prior to the standby system which was not in the sequence described in the FRC's. The Panel was unable to determine the exact time at which the HP selected it down as the position of the lever was not recorded on the ADR; the ADR only marked door actuation. However, static testing of the undercarriage system on ZF349 showed 2 secs elapsed between the selection of down on the main system and door actuation. The Panel was then able to interpolate on the ADR when the LGSL was selected, confirming it was after operation of the ESDL. Having selected ESDL to Off/Feather the engine had reduced to 0% RPM approximately 0.5 secs before selection of down and although there was enough residual pressure in the hydraulic circuit to actuate the doors and the up-locks, the landing gear would not have travelled. The HP was cognisant of that fact but she reported that she wanted some drag. The doors were actuated at 414 ft and 167 kts, 22 kts in excess of the normal landing gear limitation. Although the Panel understood the HP's reasoning for wanting to induce drag by lowering the landing gear, the HP's selection of the normal system ahead of the standby system was contrary to the FRC drill. The Panel could not determine why the landing gear should be operated in this order and whilst the FRC drill calls for the standby to be selected first, operating the normal system out of sequence had no technical affect on the landing gear. The Panel made the **observation** that it was counterintuitive to operate a standby system prior to the normal system during an emergency. Fig 20 below shows an illustrative view of the aircraft's position when the landing gear doors were actuated.

Fig 20 – Aircraft Position when the Landing Gear Doors Actuated.

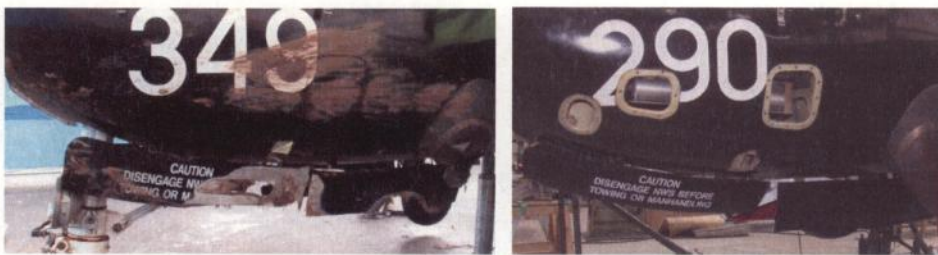
Fig 24 – Comparison Between Nose Wheel Doors on ZF349 and ZF290.

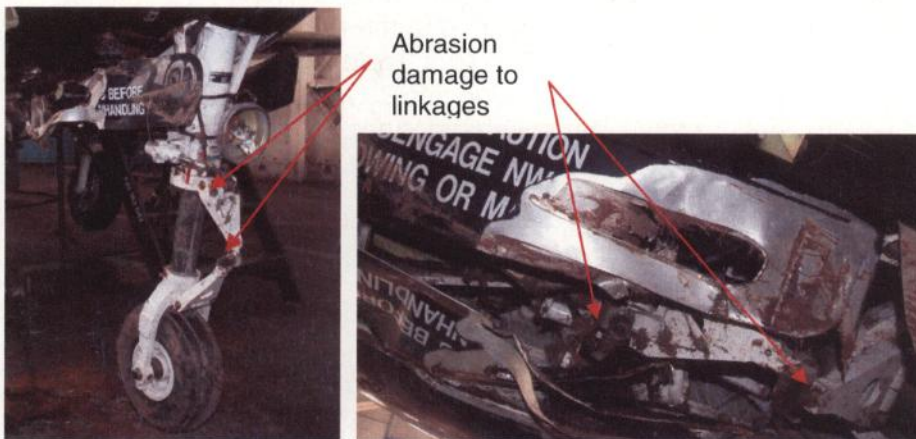
Fig 25 – Nose Leg Abrasion Damage.

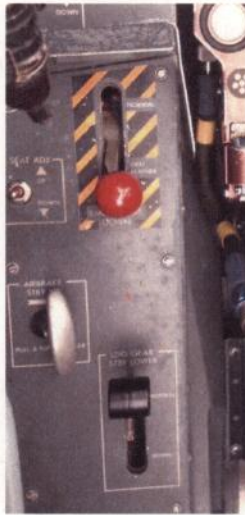
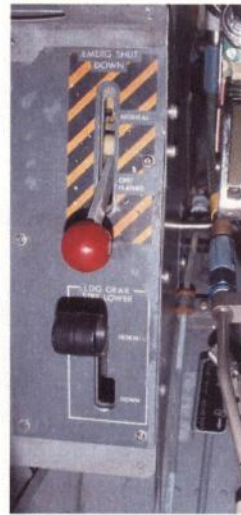
(1) **The SSL was Not Operated.** Having been found in the forward position it was possible that, despite the instruction from the HP, the NHP did not operate the SSL. Ergonomic evaluation of the front and rear cockpits established that the SSL lever was situated in a similar position in each cockpit (Figs 26 and 27). The Panel measured the distances between the centres of the ESDL at Off/Feather and the SSL in ZF349, in a second aircraft (ZF290) and in the simulator (see Table 2 below). Bombardier recognised that, ergonomically, selecting the SSL in the rear cockpit was potentially more difficult. However, during ergonomic testing the HF subject confirmed that they could identify the correct lever both from feel and, once they had their hand on the lever, by sight, corroborating the NHP's statement. The variation in SSL position relative to the ESDL and the ease with which the SSL could be operated supported the NHP's statement that she had correctly identified and operated the lever. Therefore this theory was discounted.

Aircraft	Front Cockpit (mm)	Rear Cockpit (mm)
ZF349	125	45
ZF290	135	55
Simulator	125	-

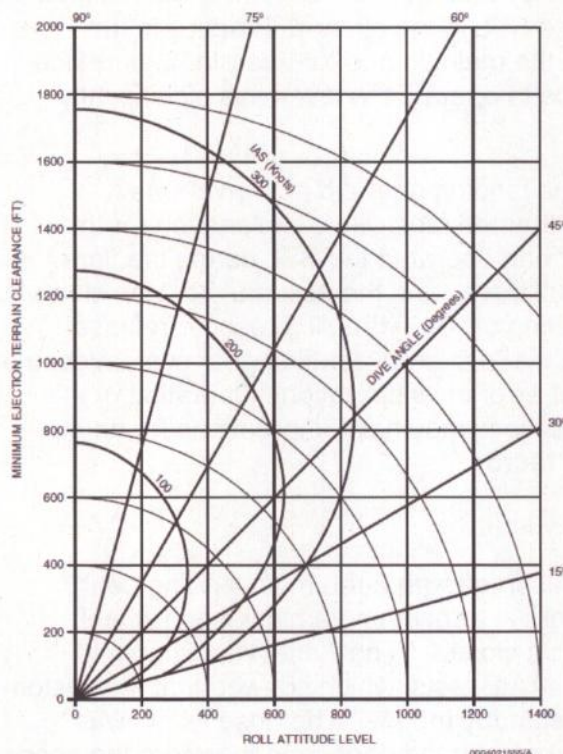
Fig 28 - Minimum Command Ejection Terrain Clearance vs IAS and Dive Angle (Roll Attitude Level).

1.4.71. Fig 28 shows that, in this instance, the 300 ft ejection decision height would be appropriate, although the last opportunity for successful ejection using command eject would have been at approximately 240 ft assuming a fixed dive angle of 10° and 165 kts approach speed. Once below this figure, the geometry of ejection would have to be improved by arresting the rate of descent, converting the excess speed to height before adjusting to level flight to
