Post-incident reporting for
reservoirs

Annual Report 2011

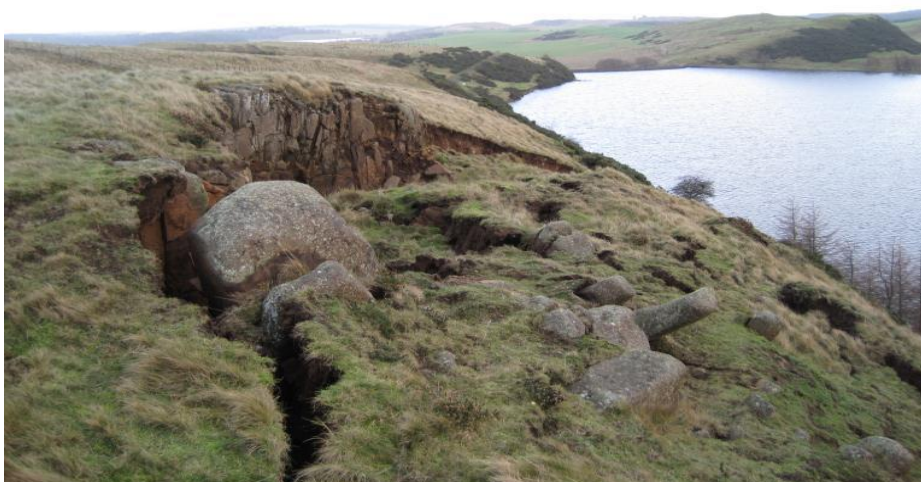
A member of the public told the reservoir undertaker about land movement that had taken place above a public footpath around the reservoir. The supervising engineer was consulted and the decision was taken to close the track to the public and draw the reservoir down by 0.5m. The land surrounding the reservoir was surveyed. Engineers calculated the impact of the land slipping into the reservoir and what size wave would be caused. The calculations showed that any potential landslide would not cause the dam to breach. After discussions with an inspecting engineer it was decided that the reservoir water level should be returned to normal.

The undertaker was concerned about the land around the reservoir and commissioned a survey in 2001. This survey and the associated photographs proved useful in the investigation of this incident. It allowed the engineers to see how much movement had happened in the eight years since the survey was carried out.

Photograph of the land movement, incident 352. Courtesy of the Canal & River Trust (formerly British Waterways)

The undertaker carried out a full investigation before reporting the incident to us and has now modified their routine surveillance to include the area that was affected.

This incident highlights the need to record and communicate known threats to reservoir safety to everyone who needs to know. In the case of statutory reservoirs the records should include any unusual threats that may not be obvious in case staff, engineers or ownership of the reservoir changes.

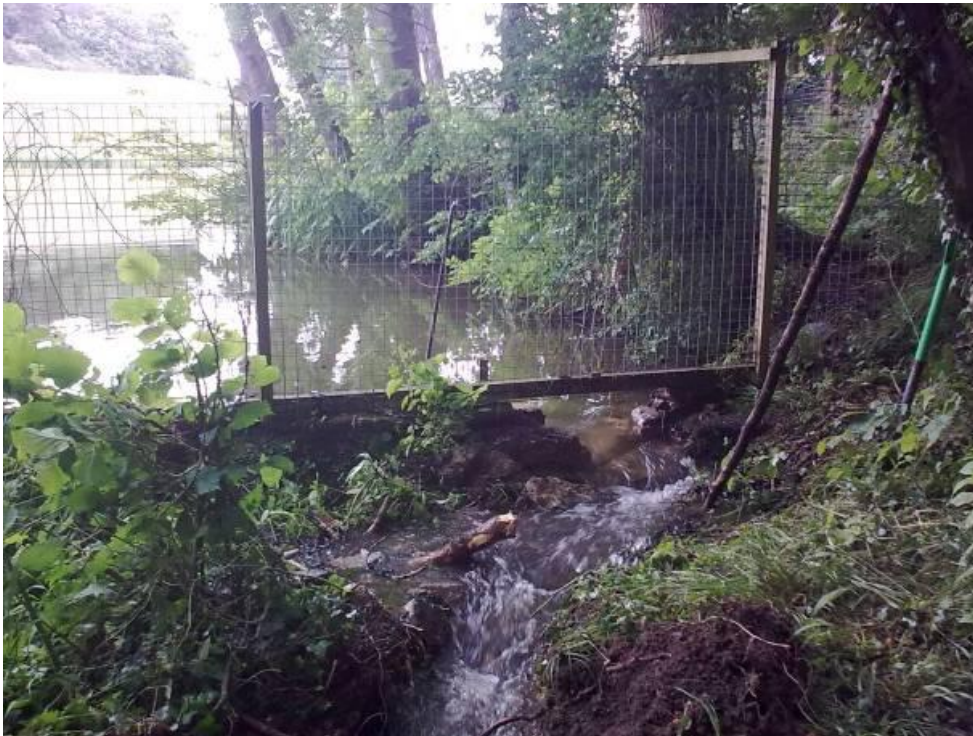
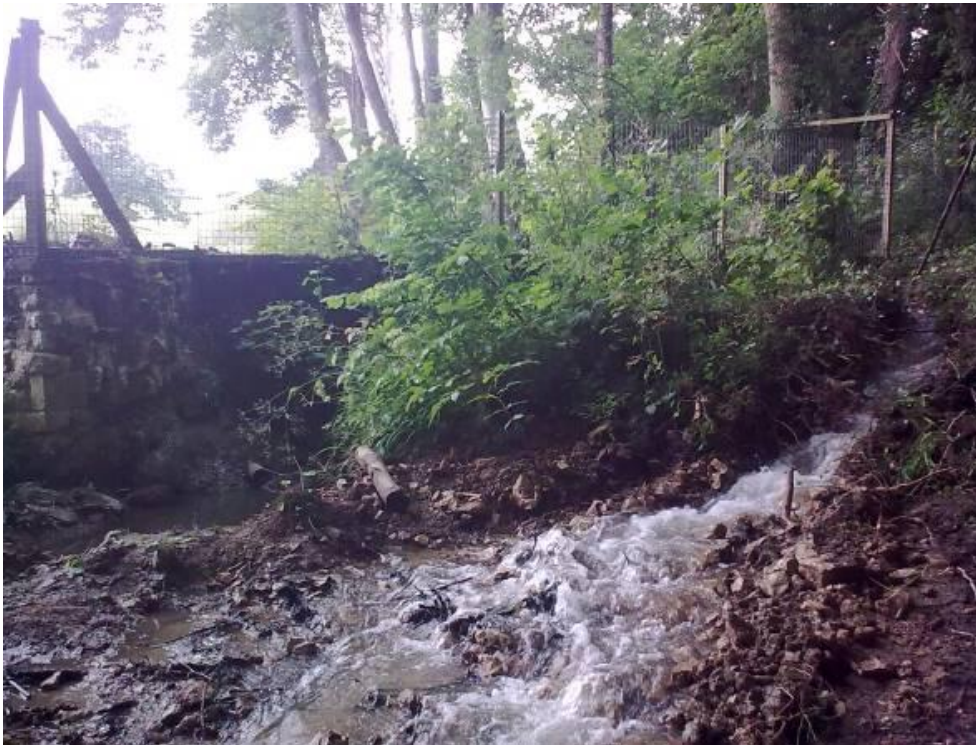
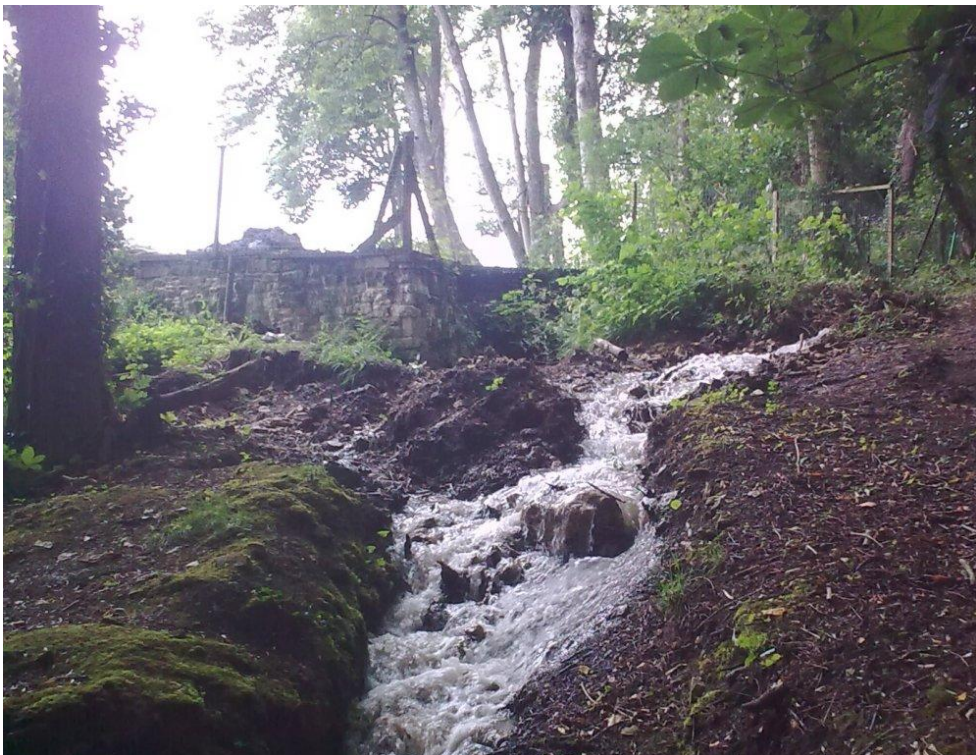
Water was seen spurting from the downstream masonry face of an earthfill embankment. The reservoir overflow facilities were found to be inadequate to control the level of the water. A sewage treatment plant downstream of the dam was evacuated while the water level in the reservoir was reduced using a temporary spillway.

Photographs showing the temporary spillway arrangements

This incident shows how important it is to make sure that adequate spillway facilities are provided and that dams are maintained and repaired.

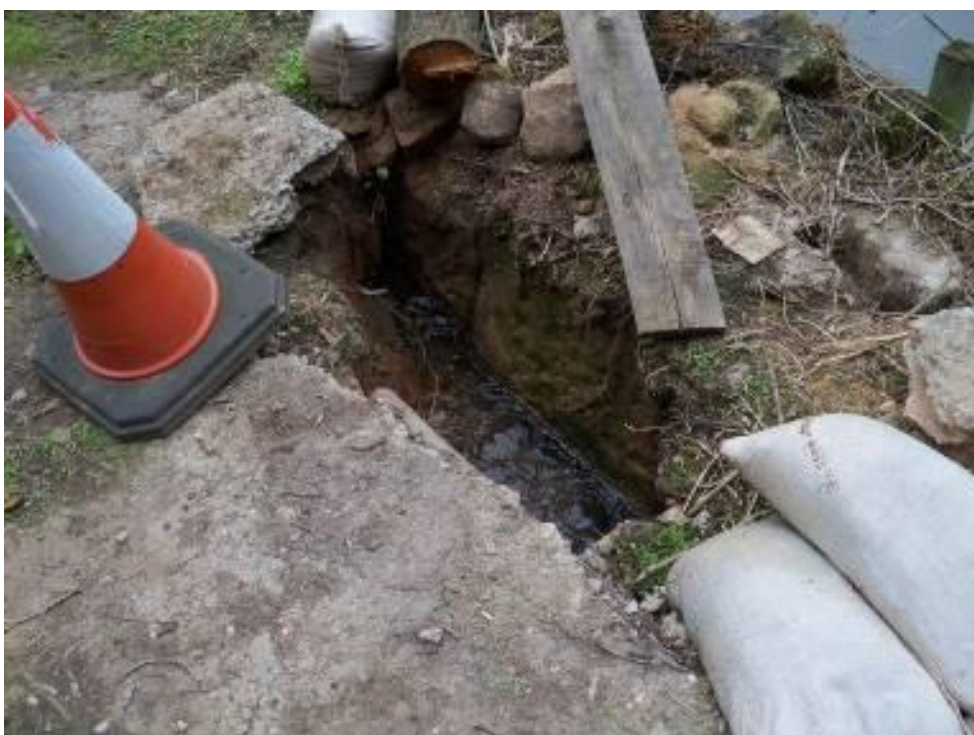
A slip in the upstream shoulder of a small embankment threatened the stability of the dam. There was evidence that previous dam repairs had been attempted using concrete.

Photograph showing a hole in the embankment with water flowing through

| Lessons identified |
|--|
| This incident shows the importance for all dam embankments to be designed, constructed and maintained in consultation with professional engineers. |
