RESTRICTED – SERVICE INQUIRY

PART 1.3 – NARRATIVE OF EVENTS

1. **Overview.** Operating as part of Joint Helicopter Force (Afghanistan) (JHF(A)), Chinook HC2A ZA708, was conducting a high priority resupply task during the early hours of 10 Aug 10. This task was in 2 phases and was planned to commence and complete at Camp Bastion, Helmand Province. Phase one was the delivery of a 2.5 tonne under-slung load (USL) and 16 passengers from Camp Bastion to Nahidullah Patrol Base (PB) in the Task Force Helmand Area of Operations (TFH AO). Phase 2 involved a refuel at Camp Bastion followed by the transportation of a 3.5 tonne USL to the helicopter landing site (HLS) at PB Bahadur (also in the TFH AO). Both phases were originally planned to take place during the hours of darkness, in a period of low ambient light levels. Delays incurred during phase one had put the aircraft (ac) 10 minutes behind schedule, which, with the advancing dawn, resulted in increased light levels for the latter part of the sortie. During the USL and passenger drop-off at PB Nahidullah, the crew encountered significant dust recirculation, but were still able to complete this phase of the task. During the second USL

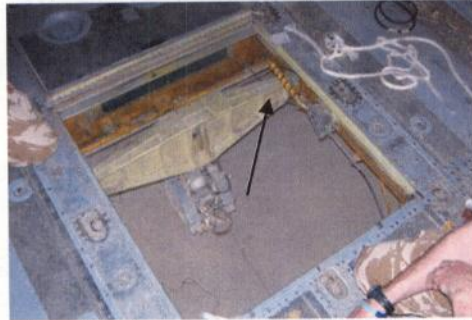
Placing the USL on the ground successfully, the No 1 Crewman attempted to release the load using the Winch Operator's Grip (WOG); however, the ac's centre hook did not respond. The No 1 Crewman then used the manual load release system (Fig 1-1), located in the hatch area of the cabin, to successfully release the USL.

Fig 1-1 Manual Load Release Lever in Hatch Area (Arrowed)

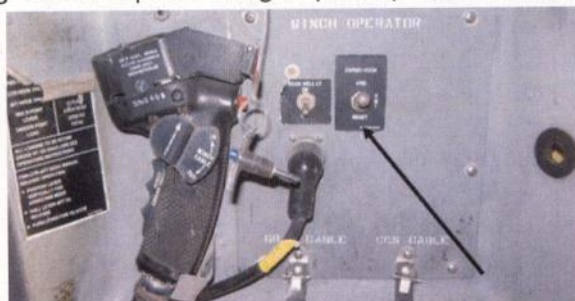
Fig 1-2 WOG in Stowed Position - Note Proximity of Arming Switch (Arrowed)

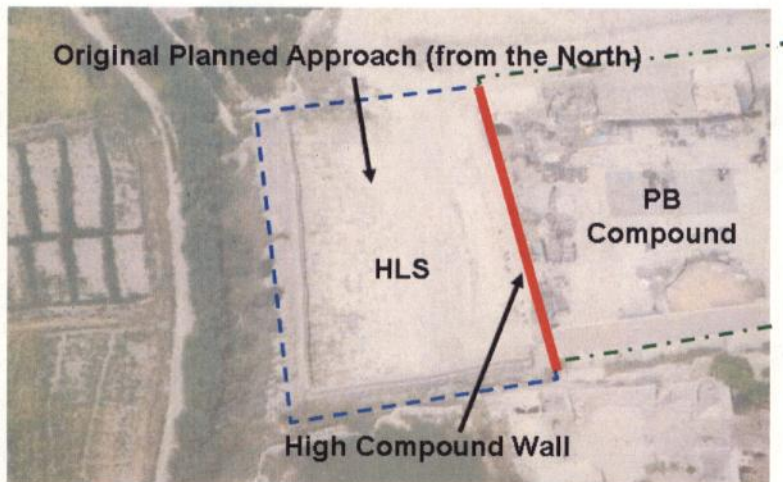
9. **Use of 3-metre extension strop.** Before flight, the Chinook crew identified that the size of Bahadur HLS was particularly restrictive, with the LP being adjacent to the compound wall of the PB (Fig 1-3). For this reason, the No 1 Crewman suggested that they should use a 3 metre strop to ensure that the requirement for a Minimum Separation Criteria (MSC) of 10 ft was adhered to during the load drop-off procedure. The HP's decision to use the strop balanced the benefit of increased separation from the obstacles at PB Bahadur against the risk that during a USL drop-off in dusty conditions, the increased height of the ac caused by the 3 metre strop would make it more difficult for the crew to maintain visual hover references through the recirculating dust. Due to the briefed insurgent threat to aviation in the area of the HLS, the crew considered that only one attempt to deliver the USL was safe; if the load was not successfully dropped on the first attempt, the HP would have been reluctant to make a second approach, which may have meant the troops would go without a resupply on this occasion.

Fig 1-3 Aerial Photograph of PB Bahadur HLS (Arrowed)

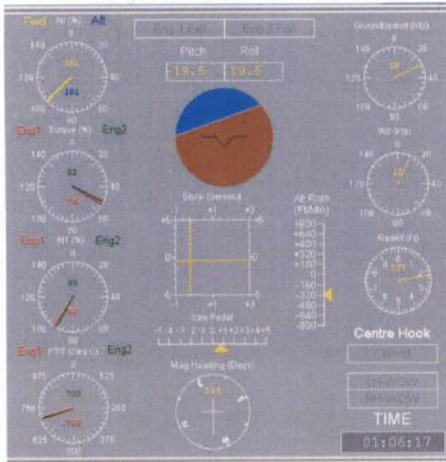
11. **Final Task – Finals turn.** The HP initially turned to the left through approximately 20°, using 10° angle of bank (AoB), while continuously decelerating in order to position the ac for the turn. The ac then conducted a tight turn onto finals, utilising approximately up to 20° AOB, 20° nose down (Fig 1-4a) and up to 4 inches of pedal deflection (i.e. 2 inches right foot forward). The ac passed 100ft with approximately 25 kts groundspeed (GS) while still turning.

Fig 1-4a (CVFDR data) midway through finals turn.

Fig 1-4b RNFSAIC data - approximate path flown.

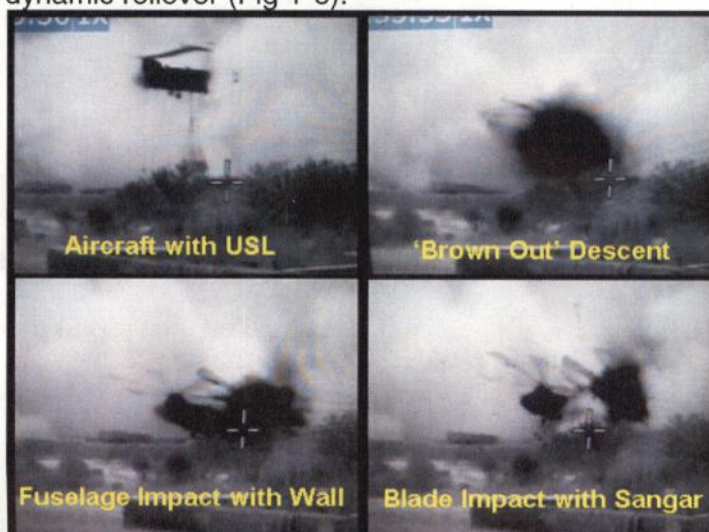
14. The ac yawed left through approximately 40° about the impact area of the fuselage. Shortly after the roll to the left was initiated, the aft rotor blades made contact with a sangar structure within the compound, momentarily reducing the ac rotor speed (Nr) to approximately 84.75%. The Panel consider it is probable that the high blade pitch angle combined with the collision of the aft rotor blades with the sangar, acted to impart a sufficient roll moment to the ac to counteract the effect of dynamic rollover (Fig 1-6).

Fig 1-6 Impact Events – thermal imagery (viewing through an element of the dust)

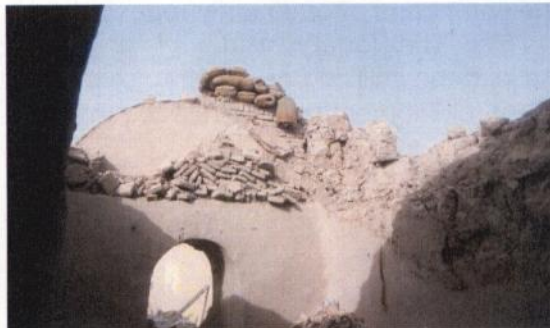
16. **Post-Impact Events at PB Bahadur.** One serviceman was sleeping within the building and was buried by rubble from the collapsed roof and wall (Fig 1-7). All PB personnel started to excavate him using bare hands and shovels. Once his head was uncovered the medic applied first aid and then clearance of the rubble continued. It then took 40 minutes to fully extricate him from the debris and he was evacuated from the site at 0544, arriving at Camp Bastion Hospital at 0556.

Fig 1-7 Collapsed Roof of Accommodation Building

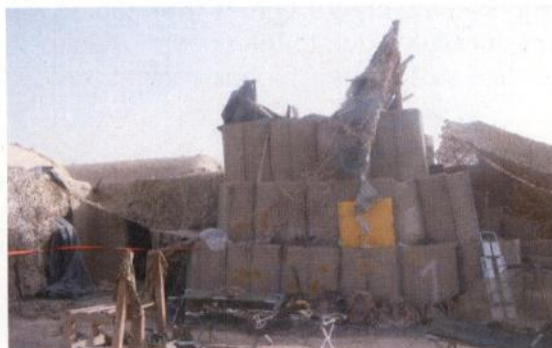
b. **Public.** The collision of the ac fuselage with the compound wall caused the collapse of a portion of the wall and of the roof of an integral building of adobe-type construction. The impact of the aft rotor blades against a 15 ft high sangar structure within the compound destroyed the wood and corrugated iron sangar roof (Fig 1-8). A (S26)

was mounted inside the sangar with its spare barrel stored close by; the spare barrel was found to be bent, damage most likely caused by the accident. Mobile Air Operations Team (MAOT) and the SIB personnel deployed to Bahadur several days after the accident to take witness statements as well as to confirm the actual dimensions and physical state of the HLS.

Fig 1-8 Damaged Sangar at PB Bahadur
