Land Equipment Programmes

Welcome to KiT! 84 Summer 2013

KiT! CONTENTS
KiT 84 | 2013

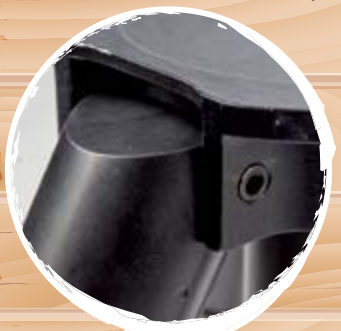
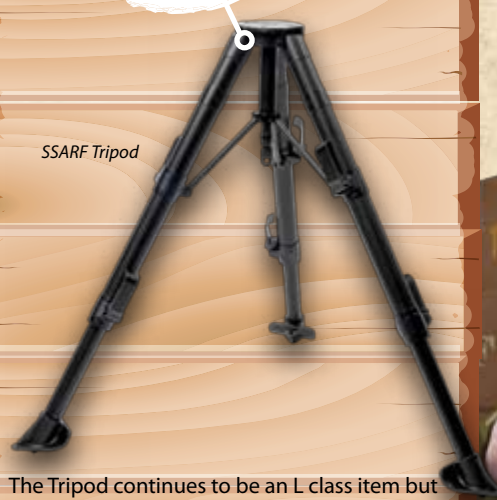
There have been instances of failure with the SSARF Tripod NSN 6650-99-401-5112 The pins that secure the Tripod legs (1) have become loose and have fallen into the Tripod body.

The Tripod continues to be an L class item but instances of pin failure are to be reported to:

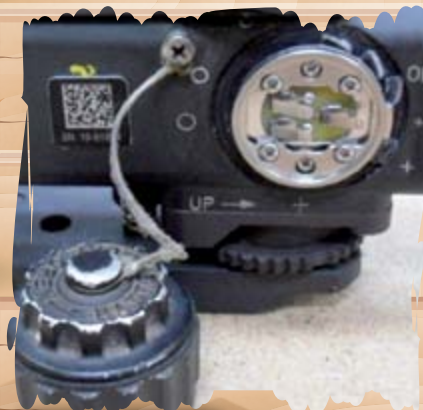
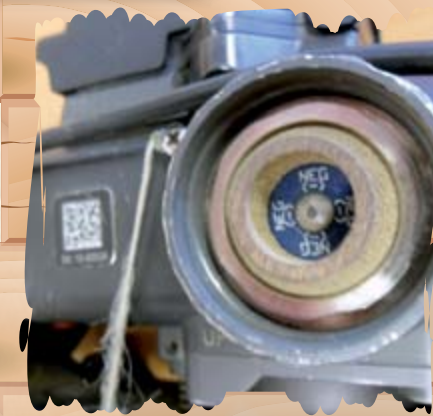
A number of FIST LDS have been returned with damage to the Graticule Illuminating / Battery Housing.

Common issues:

- Damage due to strikes/knocks
- Over tightening of the battery cap
- Cross threading of battery cap allowing ingress of moisture/debris
- Corrosion of battery terminal resulting in intermittent illumination faults.

Users are asked to:

- Take care when placing the weapon in stowage or on hard surfaces
- Inspect the battery seal/gasket NSN: 5330-20-006-6103 for signs of perishing and replace if necessary
- Remove any debris from the battery cap threads before replacing battery cap to prevent cross threading.

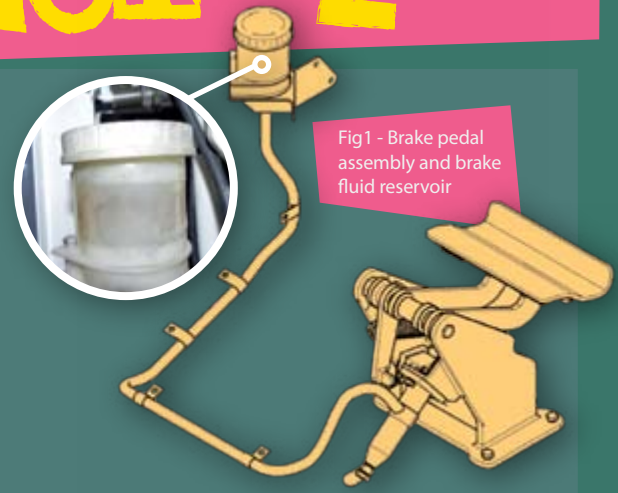
Fig 1 - Brake pedal assembly and brake fluid reservoir

There have been two reported incidents of a loss of braking performance on Trojan. The first incident, SEFIT report stated that: ...the main brake hydrostatic line was bled. Bubbles in the hydraulic oil indicated that there was air in the system. The vehicle was then subjected to further functional testing as per the 512.

At higher speeds the vehicle brakes operated as designed however at lower speeds and when stationary the brakes failed to hold the vehicle.

- There was air trapped in the supply line to the brake master cylinder from the brake fluid reservoir
- There was degradation of the hose connecting the reservoir to the master cylinder.

The design authority issued MAPM 141; this instruction detailed an additional procedure to bleed the supply line to the brake master cylinder - The relative positions of the fluid reservoir and master cylinder and the attitude of the master cylinder make it difficult for trapped air to rise into the reservoir.

Units are advised that the supply line should be bled if poor low speed braking performance is experienced.

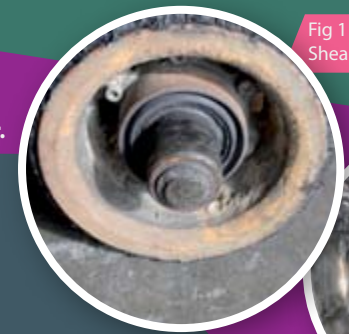
The double top rollers fitted to CR2 and T2 are prone to failure - **Current usage is 88 per year.**

- The bolts securing the mounting bracket to the hull work loose
- The bolts securing the mounting bracket to the hull shear
- The top roller axle shears - Fig 1
- The top roller axle weld fails - Fig 2

Fig 1 - Sheared shaft

It is likely that the high failure rate is due to the track tension that can be achieved on CR2 and T2, the HTT rams operating at a pressure of 80 bar - generates a force of 14.4 tonnes acting on the idler wheel. The sheared and loose bolts can be identified by visual inspection, the failures of the shaft and welds are apparent only if the top roller is disassembled and crack detection techniques used.

The running gear is maintained in accordance with the platform 601 - it is vital that sheared/loose top roller bracket mounting bolts are identified as soon as possible to prevent excessive loading on the remaining bolts and shock loadings to the assembly

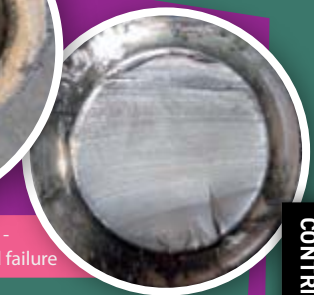
Fig 2 - Weld failure

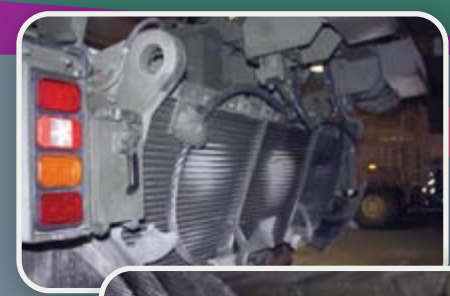
Fig 1

The current tow rope stowage position - Fig 1, attached to the rear louvers, causes damage to the tow ropes due to the tight radius that the tow rope has to be bent round to clip it into the brackets. Fig 2 shows the effect of this bending stress, the core of the rope is clearly visible.

An alternative stowage position, along the side of the vehicle - similar to CR2 - is being assessed at Bovington by the Babcock Defence and Security T2 team and will be adopted if no issues are identified.

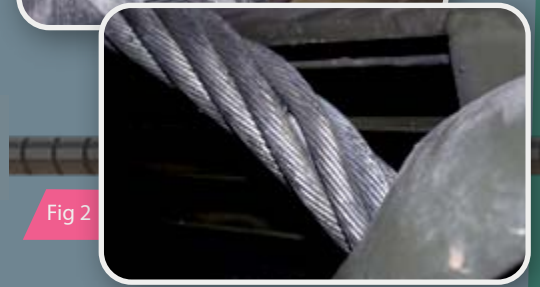
Fig 2

This rope should not be used as it has been placed under a strain outside of the design parameters and may fail catastrophically. The opening up of the strands also allows dirt to penetrate into the rope, which will cause abrasive wear.

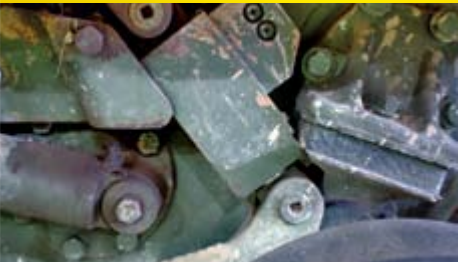
Failure to retract the lockouts before moving off causes catastrophic damage to the ram, which cannot be repaired.

Drivers and operators are reminded that the lockouts must be disengaged once the crane has been stowed and before moving the vehicle.

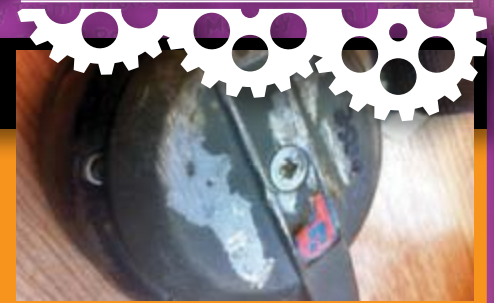
From September 2011 SECURON identified with PMT the **buckle lever retaining screw was loosening** due to knocks and vibration. SECURON modified new buckles to facilitate the introduction of Loctite to the locating screw threads.

Regular inspection of the harness should check to see if the lever locating screw is loose, indicated by it protruding through the decal, or by checking for tightness should the decal be missing.

On such occasions the screw should be removed, cleaned and Loctite 243 or TL70 applied and the screw refitted and tightened tighten to 0.6Nm.

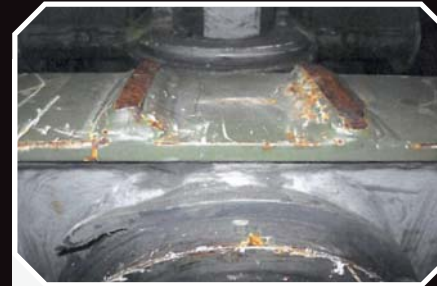
UNAUTHORISED MAIN WINCH STOWAGE MOD

Vehicles have been presented for repair with the stowage bracket for the Main Winch Rope removed.

This is an unauthorised Modification and should not be carried out without formal approval.
