KIT!

A quarterly guide to equipment care

Issue 80 | 2012

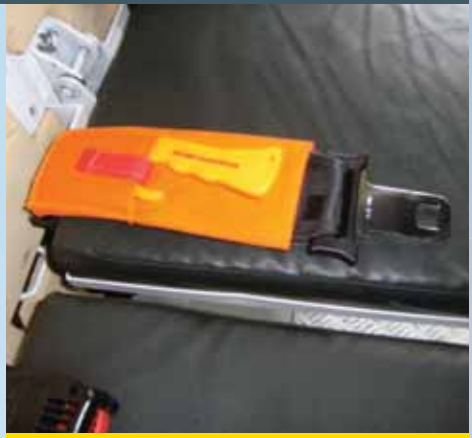
Fig 2

All Other crew locations are to be on the male end of the lap belt, Fig.2.

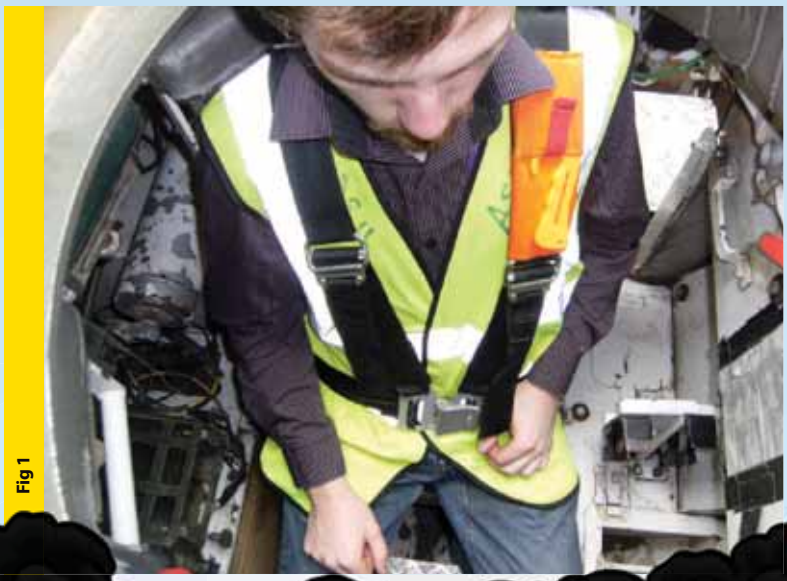
Fig 1

All Dvr and Cdr and BD4 Crew seat belt cutter locations are to be on the left shoulder strap, Fig 1.

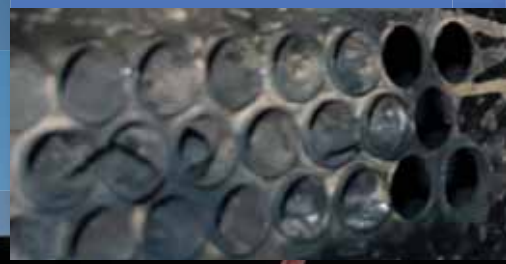
There have been a few incidents where the Donaldson exhaust valve has failed; this has led to damage of the cyclones within the Air Filter housing. However, in this instance the filter would still be fully serviceable.

There will be an updated General instruction to follow, but the User should follow procedures detailed in AESP 2350-T-255-821, Gen Instruction No.61. This basically translates to - carry out any 'blow through' or replacement items by visual inspection of the Air restriction indicator or if heavy black smoke is exiting from the exhaust.

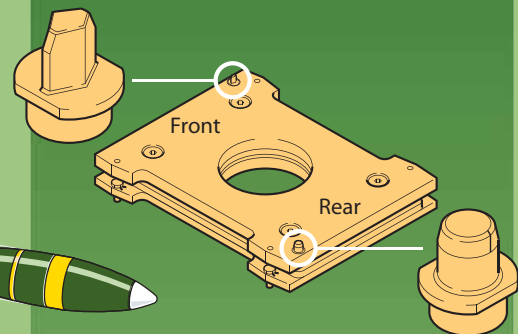
There have been an increased number of incidents where the INU shock isolation tray locating dowels have become loose and subsequently lost. This problem can arise when an INU is removed from the tray and the locating dowel remains embedded on the underside. There are two types of locating dowel on the shock isolation tray: a round dowel and a diamond dowel.

Under no circumstances should a Light Gun be fired using APS if either dowel is missing or both dowels are the same shape.

REME should ensure that INUs sent for repair do not have any locating dowels attached to the underside. The shock isolation tray should be examined every time an INU is removed. If new dowels are required then the following NSNs should be used: table above.

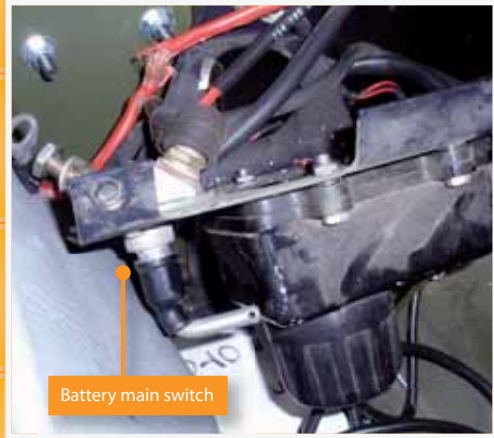
A vehicle reported for failing to start was found to have severe damage to the positive electrical cable from the battery main switch, resulting in an electrical short circuit.

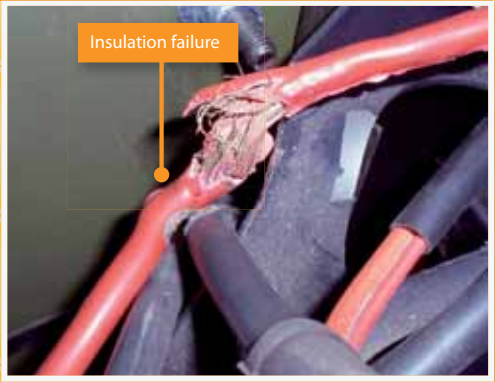
On examination of another vehicle - although there was no identifiable point of failure on the cables at the battery main switch, their routing appeared to put them under stress and at risk of friction damage. The routing and security of the battery main switch cables are being investigated with the Design Authority.

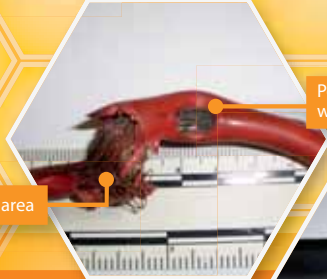
Crushed area

There was extensive heat damage to approximately 1 metre of the cable, also evidence of crushing and severe damage to the insulation. However it is highly likely that the initial damage to the insulation, which facilitated the short circuit, was caused by friction and vibration between the positive and negative cable.

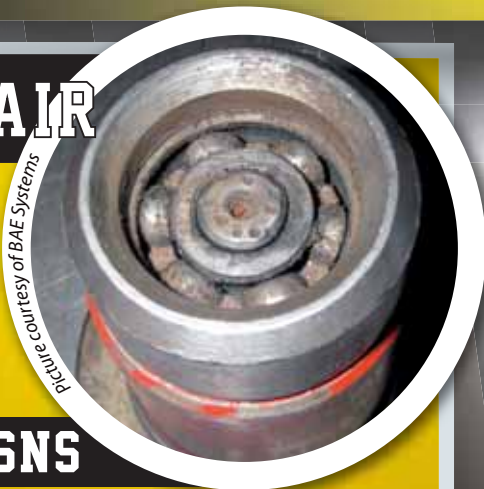
This end plug from a Warrior LH final drive has been repaired locally by distorting the end of the shaft with a centre punch – the bearing was loose.

This repair is acceptable as a short-term measure because a replacement part was unavailable BUT a replacement part should have been fitted as soon as possible to restore the vehicle to the correct build standard.

A record should also have been kept of the repair so that it was not forgotten (the bearing is not visible when the end plug is fitted to the final drive).

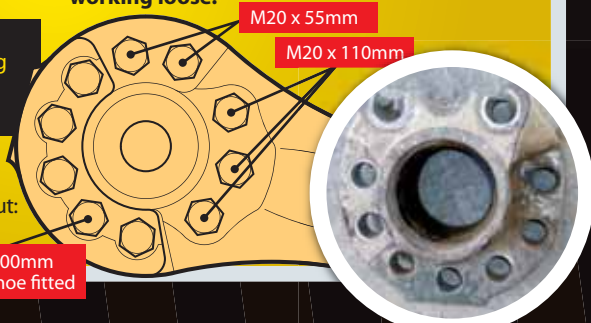
The axle arm is prone to shearing along a line that runs through the M20 x 110 mm bolt securing holes on TES (H) variants (See Fig 1). Investigations of failed arms have revealed that the M20 securing bolts have worked loose (possibly not visibly loose) allowing relative movement between the axle arm and the suspension unit. This movement causes fretting to occur and this in turn creates stress raisers, which lead to the formation of cracks and eventual catastrophic failure.

Units have been advised to check all axle arms for cracks in the vicinity of the securing bolt holes and to tighten the securing bolts to 380 Nm (280 lbf ft) IAW the 601.

Units are directed to carry out Serials 7 and 8 of the 601 weekly, as the vehicles are being subjected to loadings that are in excess of the original design parameters. **EFRs are required for any bolts that are regularly working loose.**

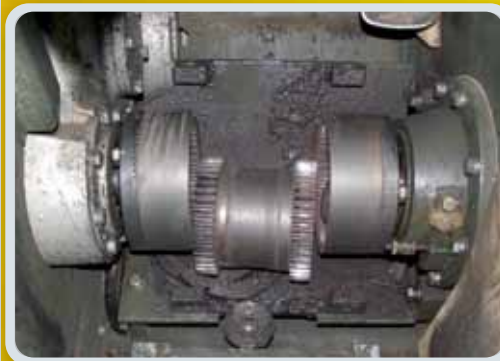
A recent Warrior serious failure resulted in a loss of steering. The LH drive coupling was found lying on the floor - the transmission output flange was correctly located in the transmission and the final drive input flange was in the disengaged position.

The circlip and end plug were resting against the locking bar, the end plug bearing had disintegrated and the rotating part of the end plug was deformed through constant contact with the drive shaft.

The M5 bolts securing the seal carriers were either sheared or had completely unscrewed.

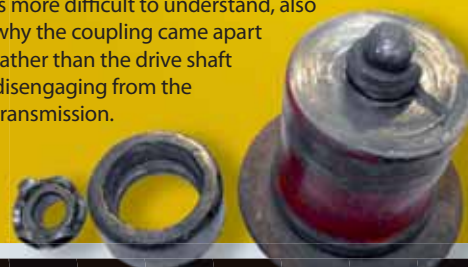
An incorrectly fitted circlip would have allowed the end plug to be displaced – however the axial loads on the drive shaft are negligible.

The damage to the rotating part of the end plug is more difficult to understand, also why the coupling came apart rather than the drive shaft disengaging from the transmission.

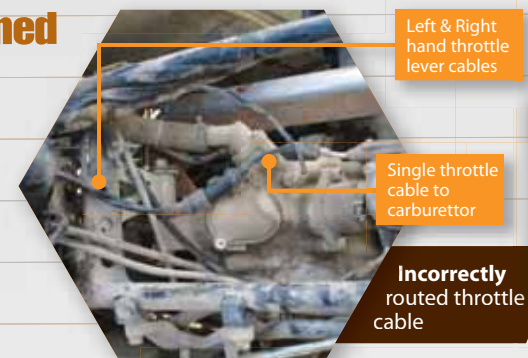
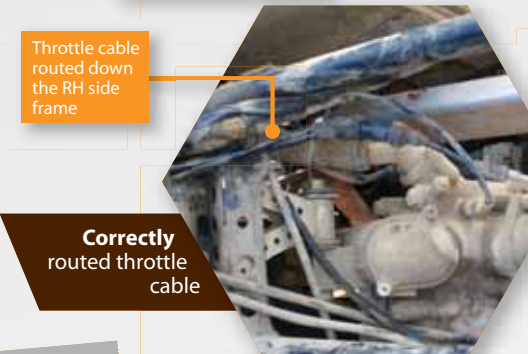
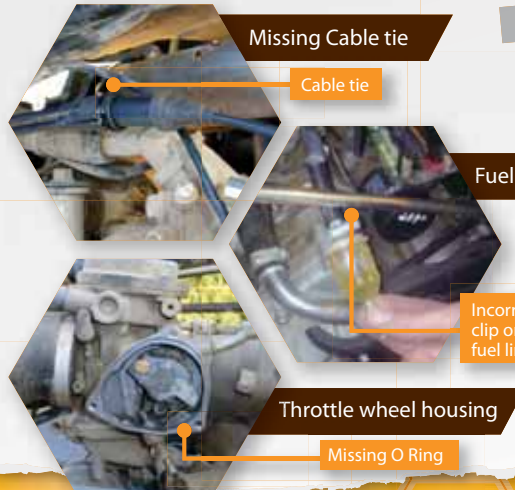
On examination it was immediately obvious that the throttle cables had been incorrectly routed. It was also found that there was no O Ring in the Throttle Wheel Housing - This acts as a dirt seal, without it the throttle wheel and housing was dirty and had corroded.

After this incident other Quads were examined, the standard of throttle and other cable routing was found to be poor in many cases, also the incorrect use of fittings and most alarming one instance where the fuel line appeared to have been touching the engine. Quads are petrol driven. Petrol has a flashpoint of 43 °C (109 °F). Clearly it should not be touching the engine.

All users of the Yamaha Grizzly Quad Bike are directed to inspect the left and right hand throttles and throttle cable routing to ensure they are fitted correctly before they next use this vehicle.

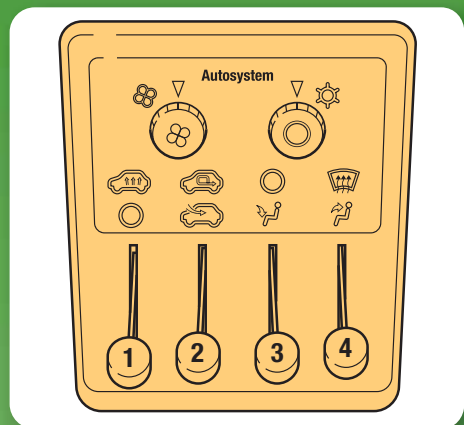
A number of auxiliary heaters were recently reported as having failed, but an investigation revealed that they had become locked due to incorrect operation.

When operating the **auxiliary heater**, it is important to observe the instruction in the crew handbook, which advises that the heater control lever (1) must be moved upward to the 'warm air' position prior to switching the auxiliary heater on. If the lever is left in the "cold air" position, coolant will not circulate through the auxiliary heater and this causes it to over-heat. When an over-heat condition is sensed, the unit automatically shuts down temporarily.

After 3 shutdowns, however, it becomes locked and requires a reset using specialised equipment.

It is recommended that the auxiliary heater is turned on at least once a month and allowed to complete one heating cycle. Should the auxiliary heater fail to operate correctly, turn it off and back on again (twice maximum) - if it still fails to operate, report the fault to REME.

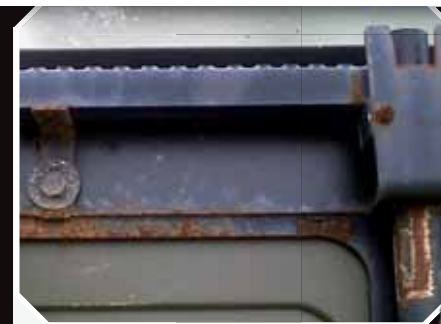
Old cab ladder

Mod Instruction No.7 Support Vehicle Cab Replace Ladder. The photos (next page) should make it easier for users to identify whether or not Mod 7 has been completed. Note the difference in length of the top support bracket.
