Aircraft Type and Registration:	Boeing 777-236, G-VIIO	
No & Type of Engines:	2 General Electric GE90-85B turbofan engines	
Year of Manufacture:	1999	
Date & Time (UTC):	16 August 2004 at 2317 hrs	
Location:	Off the coast of the USA during climb	
Type of Flight:	Public Transport (Passenger)	
Persons on Board:	Crew - 15	Passengers - 334
Injuries:	Crew - 5 (Minor)	Passengers - 1 (Serious)
Nature of Damage:	None	
Commander's Licence:	Airline Transport Pilot's Licence	
Commander's Age:	52 years	
Commander's Flying Experience:	16,796 hours (of which 3,755 were on type) Last 90 days - 186 hours Last 28 days - 83 hours	
Information Source:	Aircraft Accident Report Form submitted by the pilot

INCIDENT

Aircraft Type and Registration:	Boeing 777-21H, A6-EMF	
No & Type of Engines:	2 Rolls-Royce Trent 877 turbofan engines	
Year of Manufacture:	1996	
Date & Time (UTC):	19 February 2005 at 1415 hrs	
Location:	Birmingham Airport, West Midlands	
Type of Flight:	Public Transport (Passenger)	
Persons on Board:	Crew - 14	Passengers - 294
Injuries:	Crew - None	Passengers - None
Nature of Damage:	Right-hand engine pylon panel 427AL delaminated	
Commander's Licence:	Airline Transport Pilot's Licence

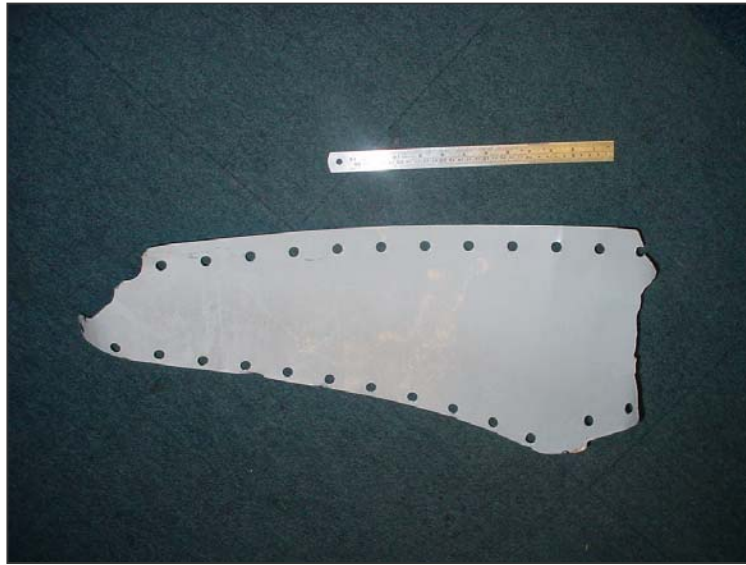
Figure 1

Prior to departing on a scheduled passenger flight from Birmingham to Dubai, a routine inspection of the runway for debris was under way at Birmingham prior to A6-EMF's ('MF') departure. The inspection began at the 'A1' hold at the far end of the runway, with the 'checker' vehicle progressing towards the threshold of the active Runway 33. Prior to completing this inspection, the driver was instructed to leave the runway at holding point 'F1' to allow 'MF' to be cleared for takeoff. The next aircraft was given conditional clearance by ATC to line up after 'MF's departure but was brought to a halt short of the runway, as the crew could see a large piece of debris on the runway itself, which they thought might have fallen from the departing Boeing 777. The debris was recovered and confirmed as being a metallic part from an aircraft (Figure 1).

Section of outer skin of right engine pylon panel 427AL found on the runway

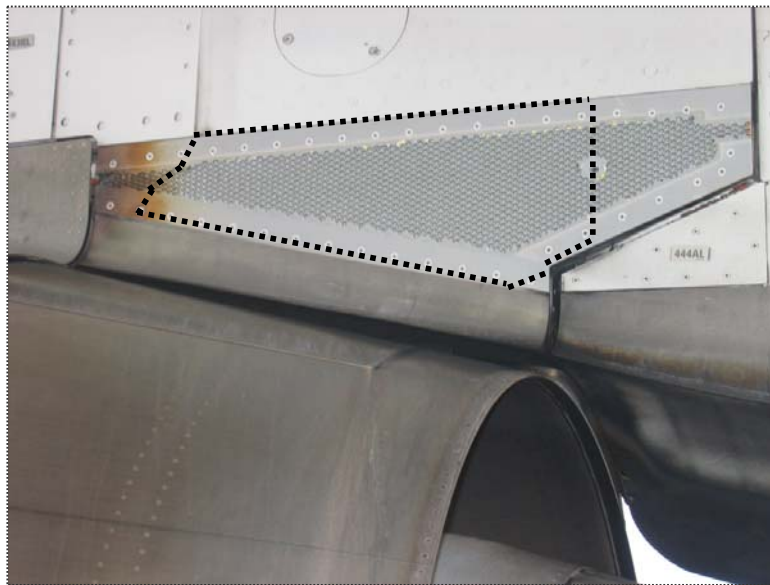
Figure 2

The damaged panel 427AL was returned to the operator immediately for repair, and thus could not be examined by the AAIB, but photographs showed evidence of apparent heat damage to its forward edge (Figure 2). The aircraft manufacturer believed the most likely source of heat to be a leak of core air from the engine.

damage to its forward edge. On examining the panel, the aircraft manufacturer concluded that it had been exposed to temperatures of up to 350°F (177°C). Whilst this is within the acceptable service temperature range for the adhesive, exposure of the panel to such temperatures would cause some reduction in the strength of the adhesive bonds which, combined with the harsh environment of aerodynamic loads, high sonic vibration loads, and cyclic thermal stresses, would have increased the likelihood of the panel delaminating.

Delaminated panel 427AL showing heat damage at forward edge.
Recovered section indicated

The operator has introduced a repetitive inspection of the pylon panels on this particular aircraft (A6-EMF), until the cause of the panel failures has been identified. The aircraft manufacturer is not aware of any reports of problems with these panels on any other Boeing 777 aircraft.

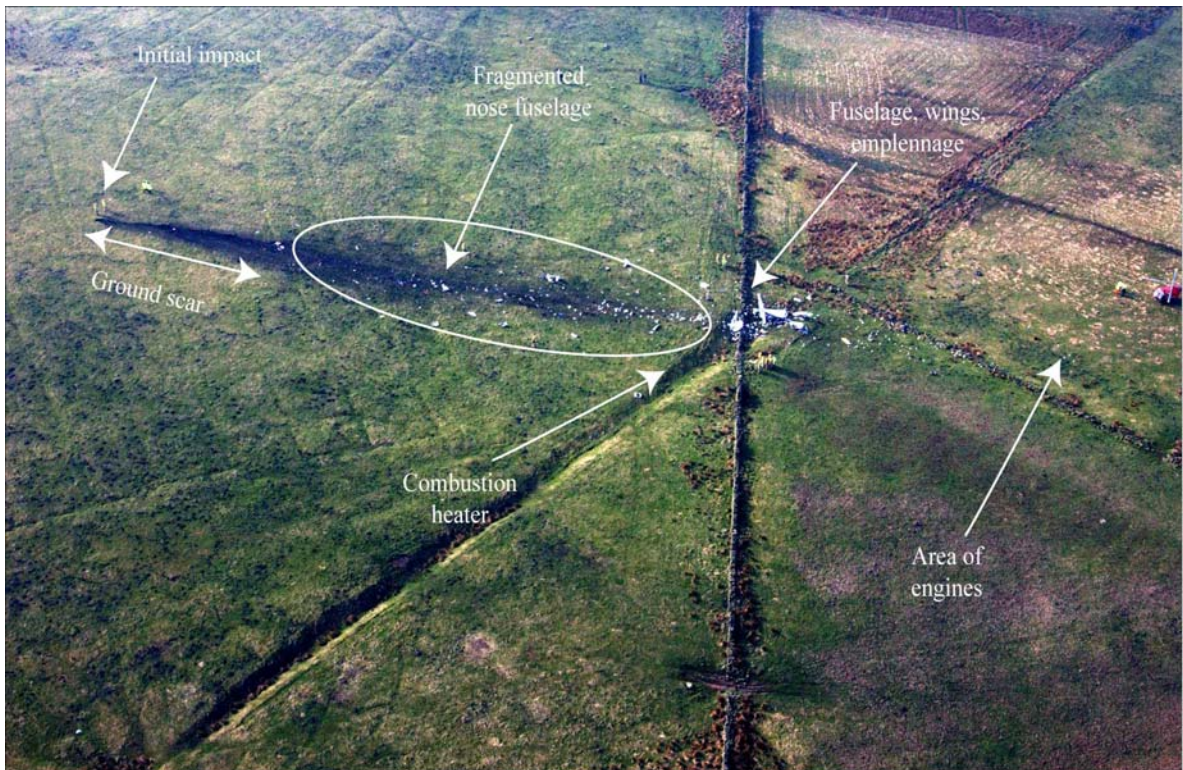
Figure 3 - Accident site - N6834L

The aircraft struck the ground in a field of rough grass on sloping moorland (Figure 3). The initial point of impact was on the right wing tip tank and a long ground scar showed the initial impacts of the right engine, the nose, fuselage, the left engine and the left wing. There was separation at this point of both propellers, both engines and both tip tanks, as well as fragmentation of the nose section. The remaining portions of the fuselage, wings and empennage came to rest around a stone wall after travelling 100 metres and the engines were found 135 metres from the initial impact.

Measurements from the ground marks showed that the aircraft was travelling in a direction of 300°M when it struck the ground, approximately 30° nose down and with a banked 45° to the right. Examination showed that the landing gear and wing flaps were retracted at the time of impact. Aerial photographs taken a few days after the accident showed extensive damage to the grass around the initial impact, demonstrating that there had been large amount of fuel onboard at the time of the accident. The pattern of the damage to the vegetation indicated that, as would be expected, the bulk of this fuel was in the main tanks, at the wing tips. The nature of the impact, at speed into soft ground and the fragmentation of the tip tanks, meant that there was no post-crash fire.

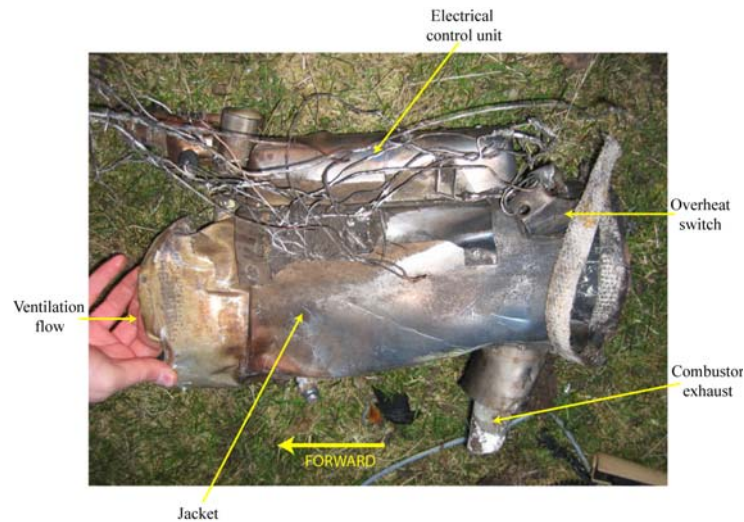
Figure 7 - Combustion heater, N6834L - left side

The combustion heater, examined in detail by the AAIB with a representative from the heater manufacturer present, showed extensive external heating damage (Figure 7).

The outer casing (or 'jacket') showed that the fire within the nose compartment was predominantly under the heater, towards the aft end. This is the area of the assembly closest to the fuel line from the aircraft to the fuel pump assembly, the fuel line attaching the fuel pump to the heater and the fuel drain line from heater itself. The connection in the leading edge of the right wing showed that the fuel supply line had not been replaced by the stainless steel line as provided for in the Cessna Service Bulletin MEB95-9.

Disassembly of the heater showed a normal pattern of internal combustion, with no leaks of the burner assembly other than an anomalous hole (approx $\frac{3}{8}$ " across) on the aft end plate. This hole had been made with considerable force and there was no mechanism that would have created it other than the aircraft's impact with the ground. It was also noted that there had been no recent maintenance in this area of the aircraft.

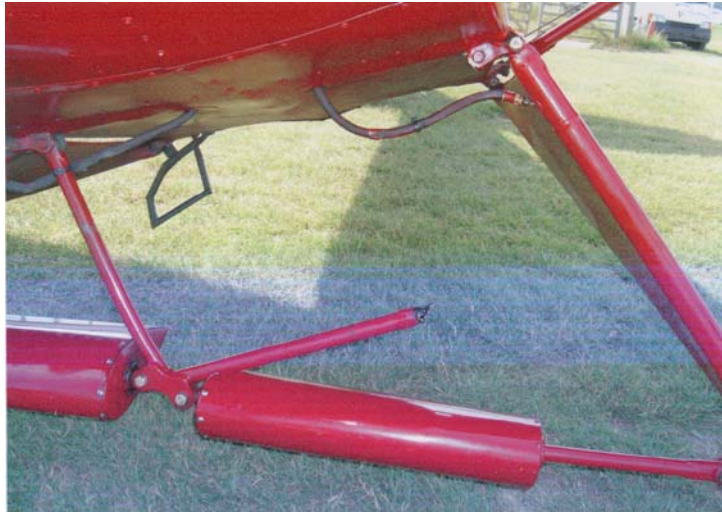
Figure 1 Undercarriage V Section Frame Failure

The landing gear support frame is manufactured from two steel tubes welded together to form a V section. The airframe attachment at the end of each tube consists of a bush mounted on the end of the tube, which is held in place by a shaped plate welded around the end of the tube. A comparison of the left and right attachment fittings, which were sectioned to facilitate inspection, revealed that the bush on the left fitting was missing, see Figure 2. The repair agency for the aircraft confirmed that the bush was not attached to the securing bolt that remained fitted to the aircraft. Witness marks inside the tube indicate that a bush had originally been fitted to the leg, which suggested that the bush might have come out when the frame had been removed from the aircraft. Reassembly of the V section frame without a bush installed would have left the securing bolt in contact with the welded plate, which then appears to have failed in overload during normal operations. The frame was last inspected during the annual maintenance undertaken six months and eight flying hours prior to the accident. Whilst there was no requirement during this inspection, to remove the fitting from the aircraft and inspect the bolt holes, the maintenance organisation have stated that the assembly felt secure with no sign of excess movement at that time.

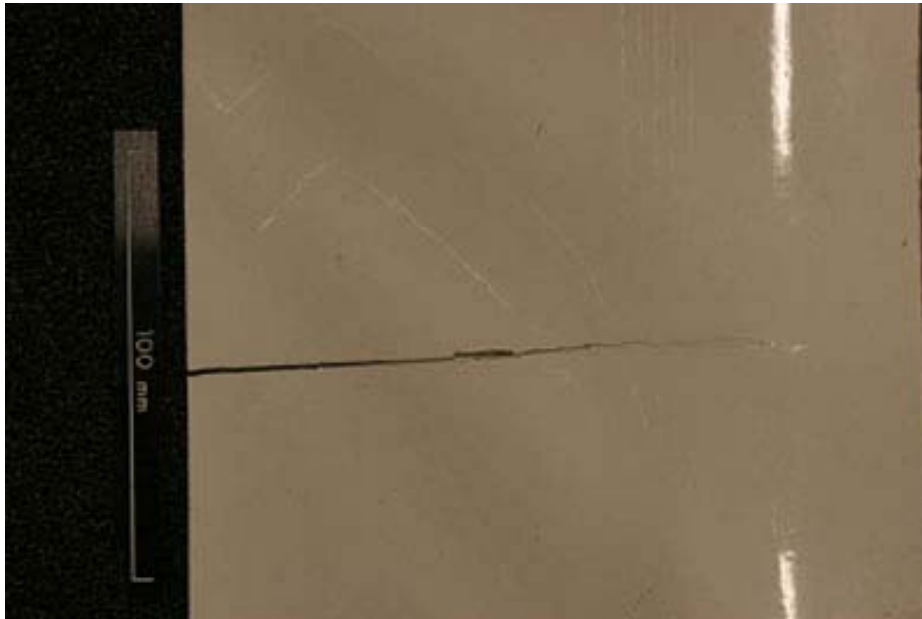
Figure 3

Photograph showing the crack observed on the upper surface of the rotor blade, as received, trailing edge on the left hand side of the photograph

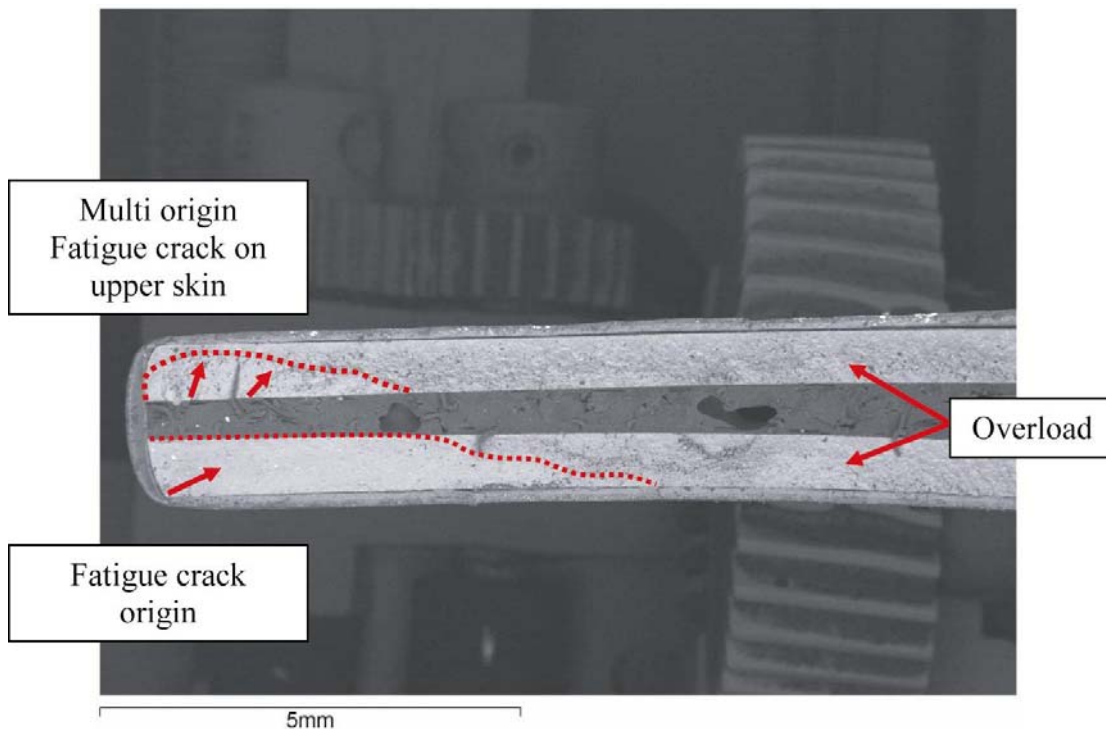
Figure 4

Backscattered electron micrograph of the fracture at the trailing edge location, showing the extent of the fatigue cracks

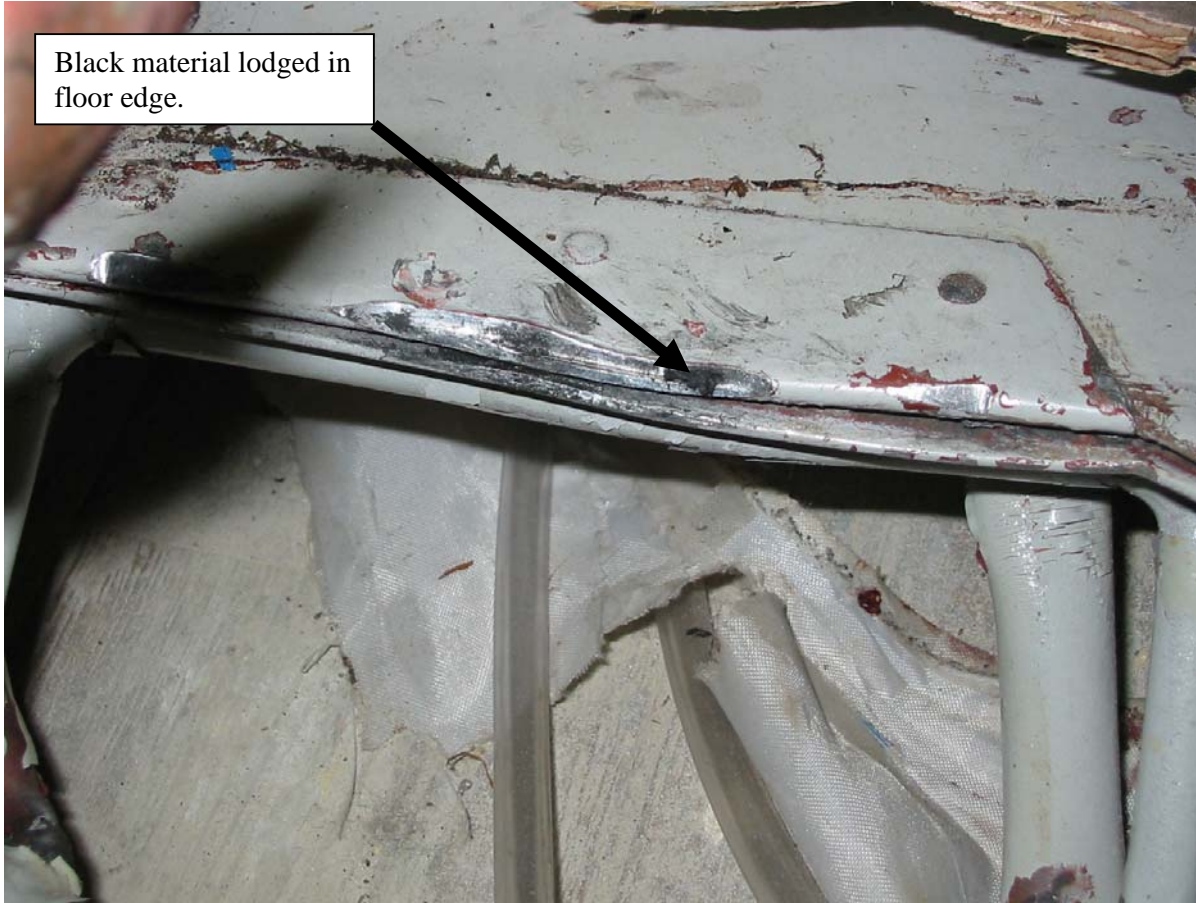
Figure 3

Black material lodged in floor edge.

It is recommended that the British Gliding Association reinforce the message that there must be no loose articles in aircraft when they are being flown.
