CONTENTS

(ALL TIMES IN THIS BULLETIN ARE UTC)

INCIDENT

Aircraft Type and Registration:	Airbus A320-214, G-BXKD
No & Type of Engines:	2 CFM56-5B4/P turbofan engines
Category:	1.1
Year of Manufacture:	1997
Date & Time (UTC):	15 January 2005 at 1635 hrs
Location:	London Gatwick Airport, West Sussex
Type of Flight:	Public Transport (Passenger)
Persons on Board:	Crew - 7 Passengers - 177
Injuries:	Crew - None Passengers - None
Nature of Damage:	Left nose wheel detached from aircraft
Commander's Licence:	Airline Transport Pilot's Licence
Commander's Age:	40 years
Commander's Flying Experience:	6,200 hours (of which 4,400 were on type) Last 90 days - 113 hours Last 28 days - 55 hours
First Officer's Flying Experience	4,392 hours (of which 2,566 were on type) Last 90 days - 82 hours Last 28 days - 36 hours
Information Source:	AAIB Field Investigation

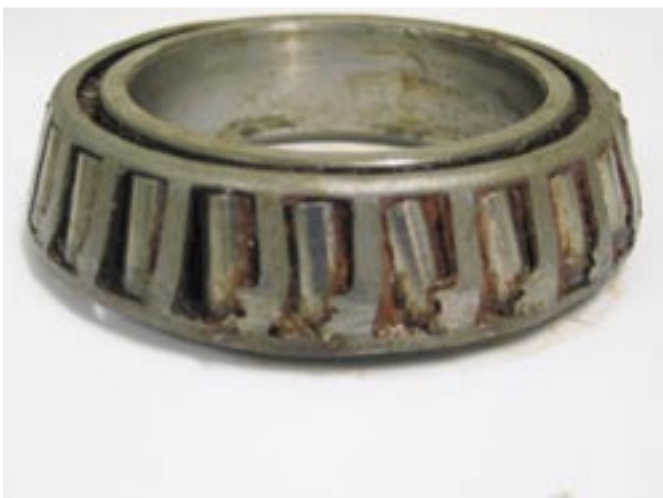
Figure 5

The outer bearing assembly, on the recovered left nose wheel, had been correctly fitted and the circlip was still in place; the quantity of grease in the bearing was considered to be adequate. The bearing cup was removed and grease samples were taken at a number of positions through the hub. It was noted that the colour of the grease gradually changed from the chocolate brown at the outside face of the bearing towards the more normal reddish colour on the inner face of the bearing. Fitters experienced in handling this type of wheel indicated that the grease was normally chocolate brown on returned wheels. From the bearing (Figure 5) it could be seen that the rollers had been forced under the bearing cage and that the softer cage had been distorted, with metal transfer having occurred between the cage and bearing cup. Metal smearing was discovered around the circumference of the bearing cone in a position consistent with the distortion and damage to the bearing cage. Apart from localised bluing at the large end of the bearing rollers and a light straw colour on part of the cone, there was no indication that the hub, axle or other wheel components had been subjected to high temperatures. Because of distortion to the outer bearing seal it was not possible to check the

Left hand wheel outer bearing

dimension of the seal using the seal gauge. The inner bearing cone was removed, inspected and found to be in a good condition.

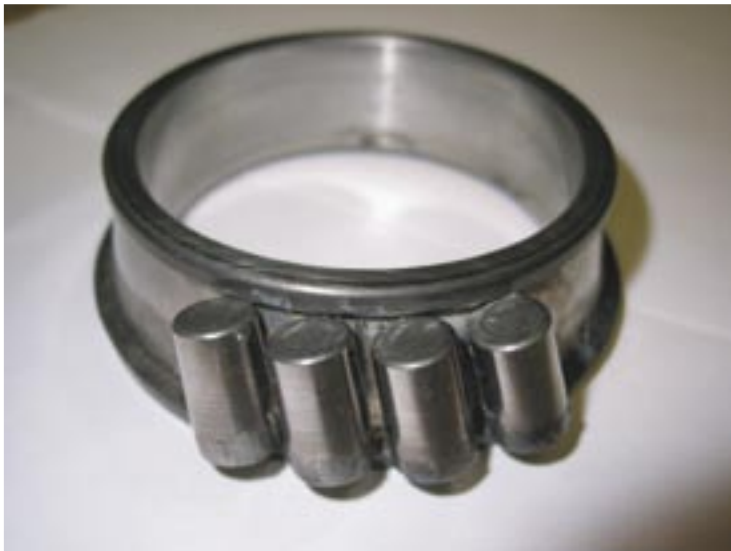
The outer bearing from the left nose wheel was stripped and examined by the manufacturer under AAIB supervision. It was established that the bearing had the correct part and hardness number. The bearing and grease seals were measured and, as far as could be ascertained, were considered to be manufactured to the correct dimensions. The outer grease seal and securing nut were separated and it was observed that there was wet grease between the contact surfaces. An inspection of the contact faces between the grease seal, securing nut and cone indicated that fusion between the cone and grease seal was caused by cold welding and between the securing nut and grease seal by melted paint from the grease seal.

Figure 6 (left)
Rollers welded to cone

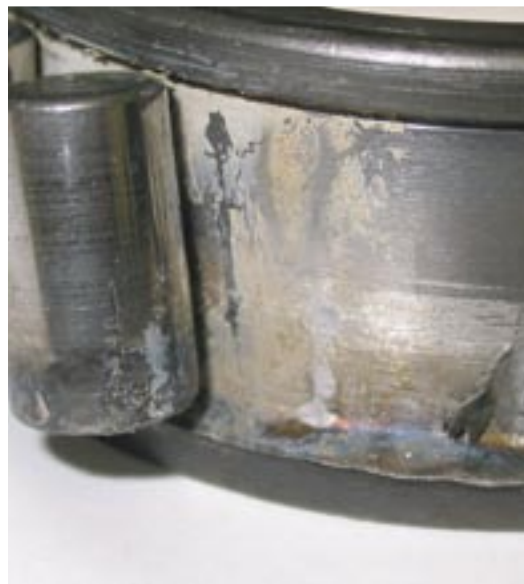
Figure 7 (right)
Distortion of cone large rib face

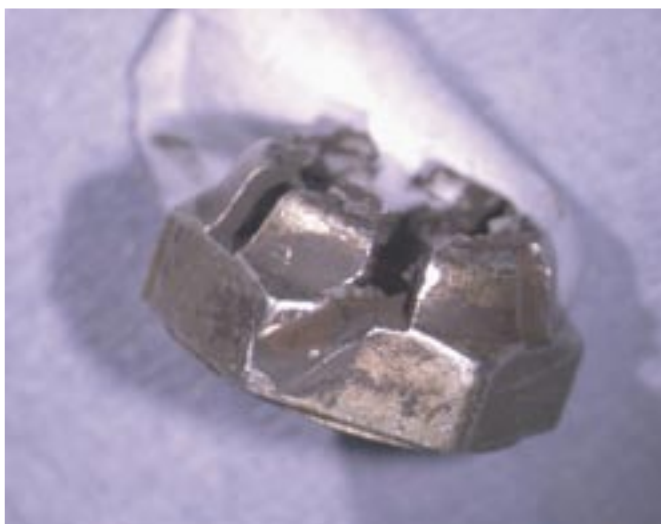
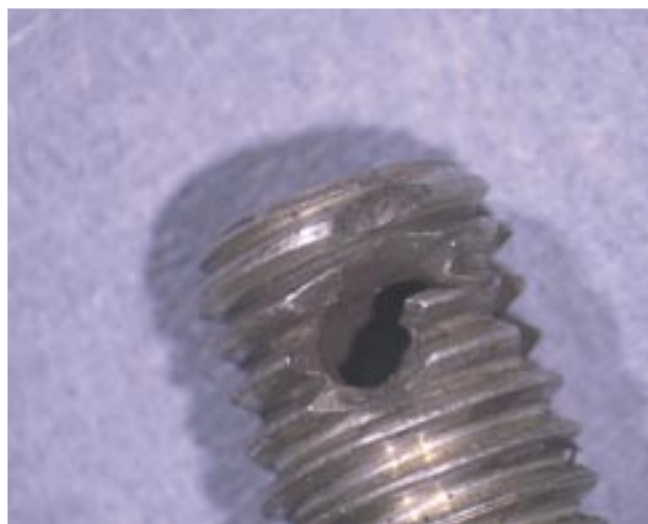
Figure 2

A coupling flange nut and bolt removed from a Thomas coupling fitted to an AS355 helicopter showing severe fretting caused by a loose-fitting split-pin

It is recommended that Eurocopter review the design, or maintenance procedures adopted for the installation, of 'flector' couplings to ensure that the potential for fretting of the split-pin/nut/bolt assembly is eliminated.

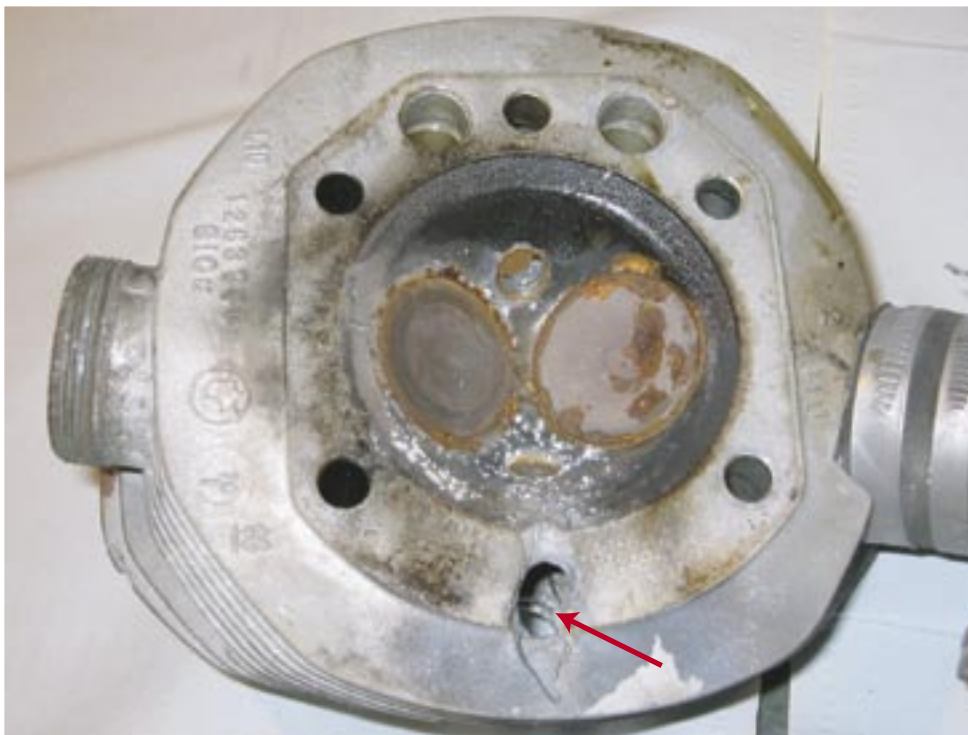
Figure 1

The engine was stripped in the presence of the PFA and representatives from a maintenance organisation specialising in the conversion of BMW motorcycle engines for aircraft installation. The left cylinder rocker cover was removed and the cylinder head nuts that tighten onto the cylinder through studs were removed. The torque values on the cylinder head nuts were noted to be less than that required in the manual (26-29 lbf ft). The cylinder head was then removed and a hole observed around one of the two cylinder head studs where hot gasses had burned through the head gasket and the outer cylinder casing (see figure 1 and 2). The right cylinder head nuts were also found to be tightened to less than the correct torque setting. The engine was otherwise mechanically sound and free to rotate.

Left cylinder head showing burn through of the casing around one cylinder head stud

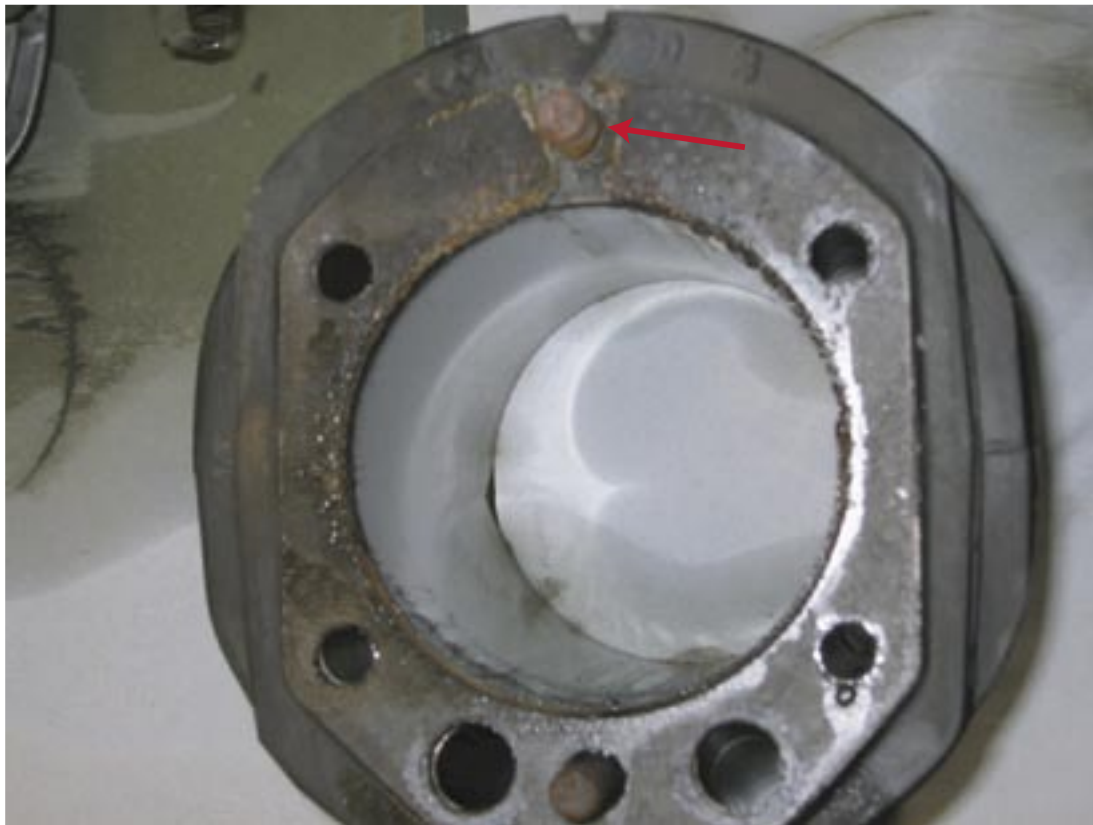
Figure 2

Left cylinder head gasket

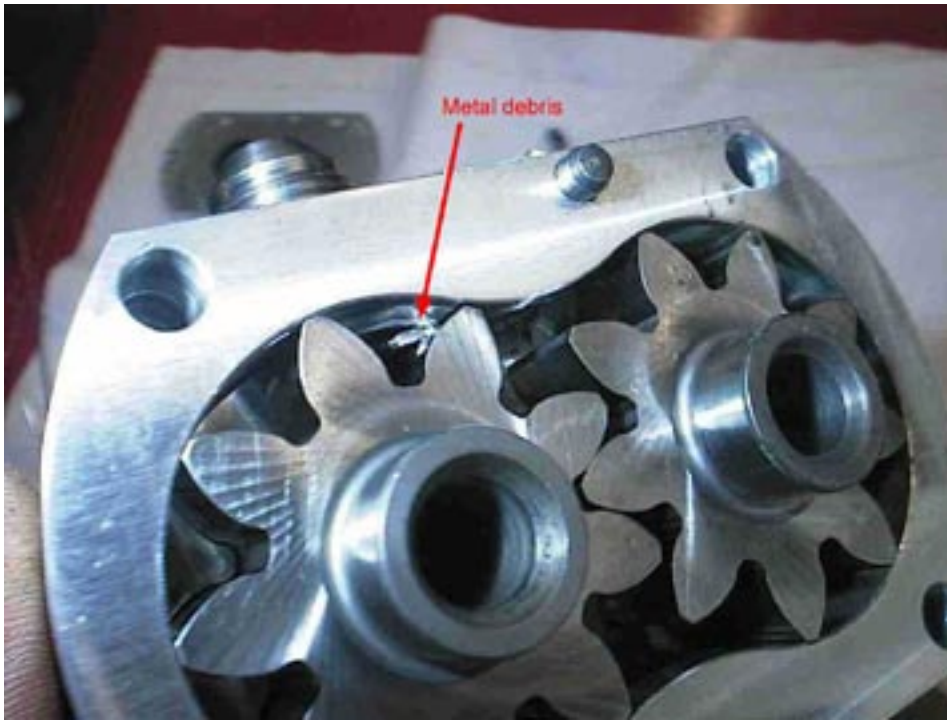
Figure 4

Metal debris wedged between gears of oil scavenge pump

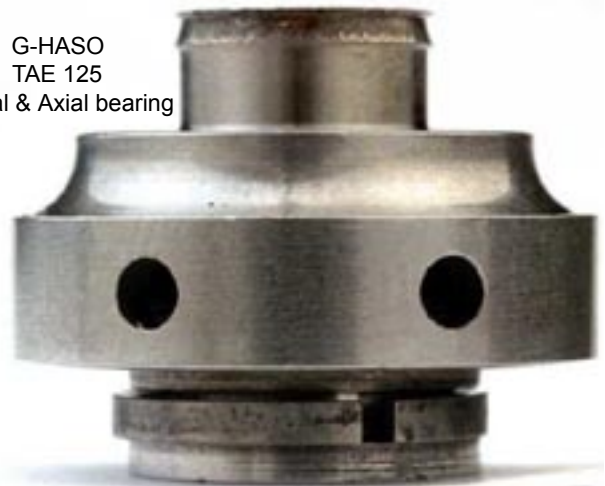
Figure 5

New radial & axial bearing on the left and failed radial & axial bearing on the right (note the missing thrust collar)

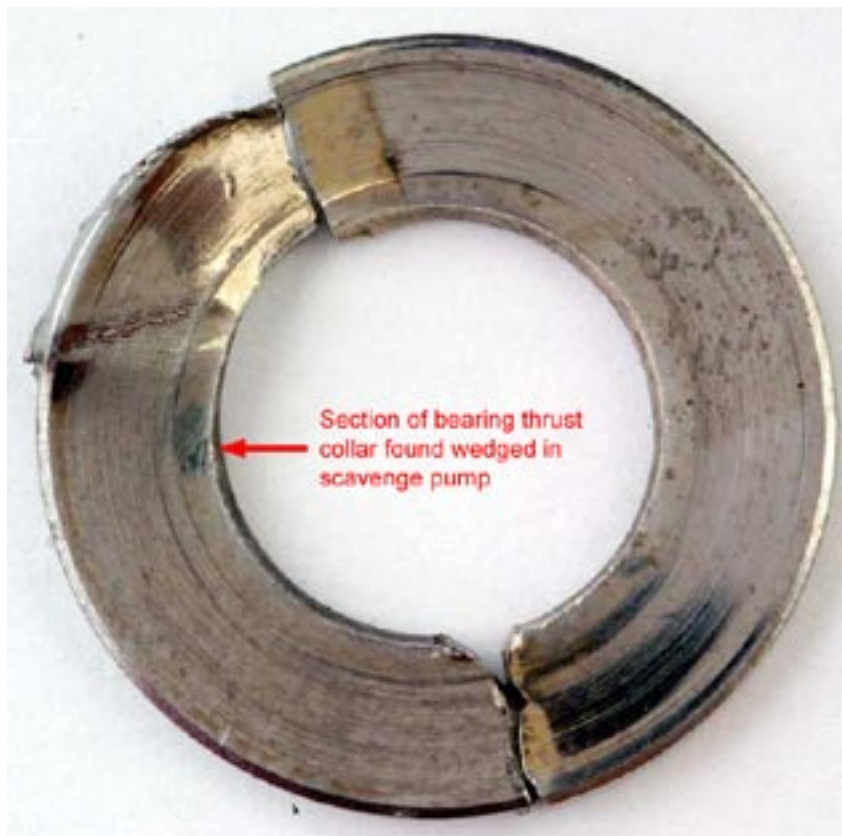
Figure 6

Failed thrust collar from radial & axial bearing (left section found inside scavenge pump; right section found inside turbocharger catchtank)

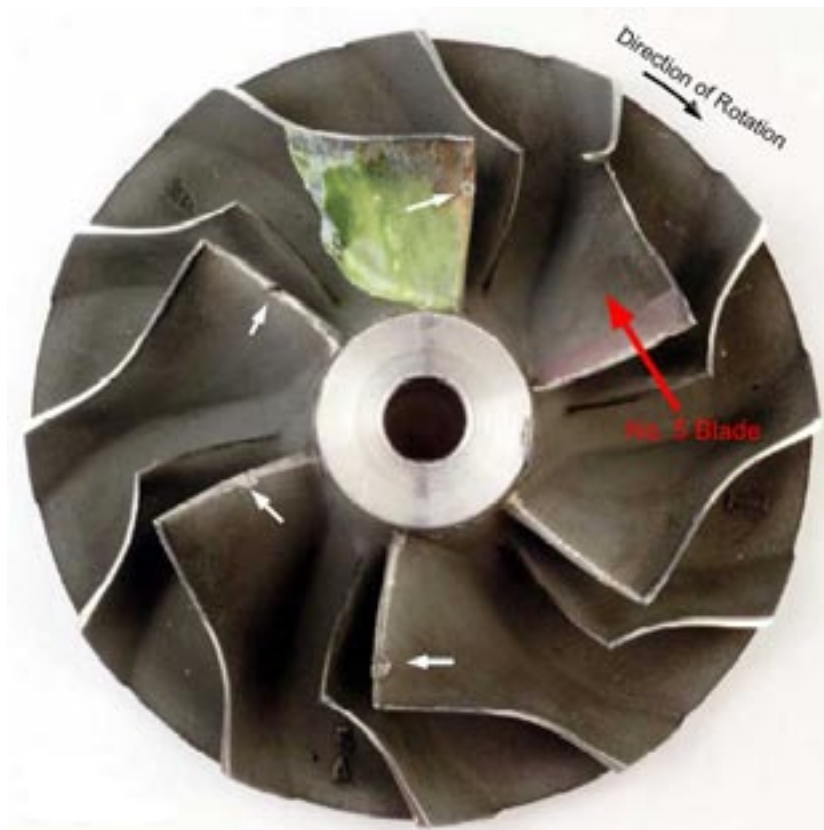
Figure 7

Four of the compressor blades had sharp nicks on their leading edges, as indicated with white arrows in Figure 7. Compressor blade No 5 had suffered the most damage with a 4 mm section of its leading edge torn away against the direction of rotation. Blade No 5 also exhibited small shallow impact marks on its concave side (hidden side in Figure 7) close to the leading edge damage. These impact marks were darker and therefore older than all the other shinier impact marks. The compressor casing exhibited rotational scoring marks where the compressor blade tips had rubbed against it, and a small (1.4 mm long) piece of debris was found in the gap between the casing and the inlet cone. This debris was analysed using energy dispersive x-ray which revealed that it consisted primarily of aluminium with small amounts of nickel and iron. Some of the damaged areas of the compressor were also analysed which revealed small amounts of iron at concentration levels exceeding those

Turbocharger compressor wheel
(note: green area is green dye applied at manufacture)

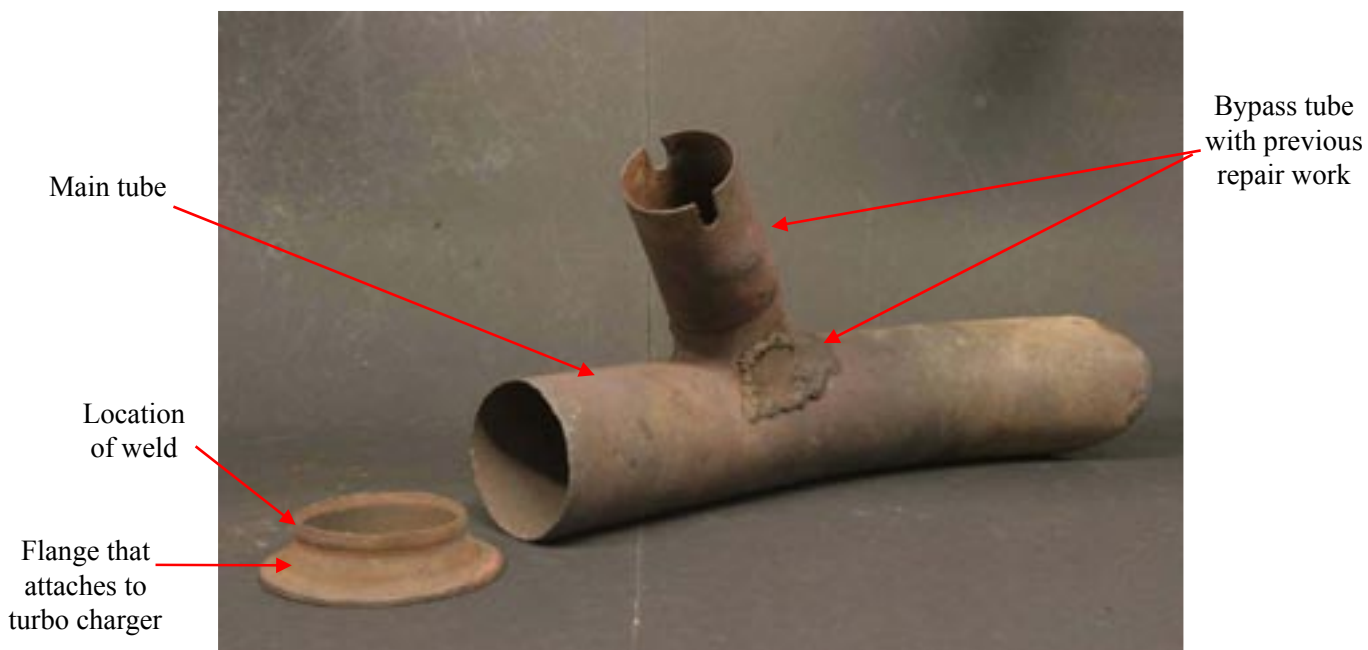
Subsequent examination revealed that this pipe had failed, allowing exhaust gases to heat the aircraft skin, leading to the smoke and fire. The location of the detached exhaust pipe and the damage to the engine cover is shown in Figures 1 and 2. The exhaust pipe was returned to the AAIB for examination and is shown in

Figure 3
Exhaust pipe 'as found'

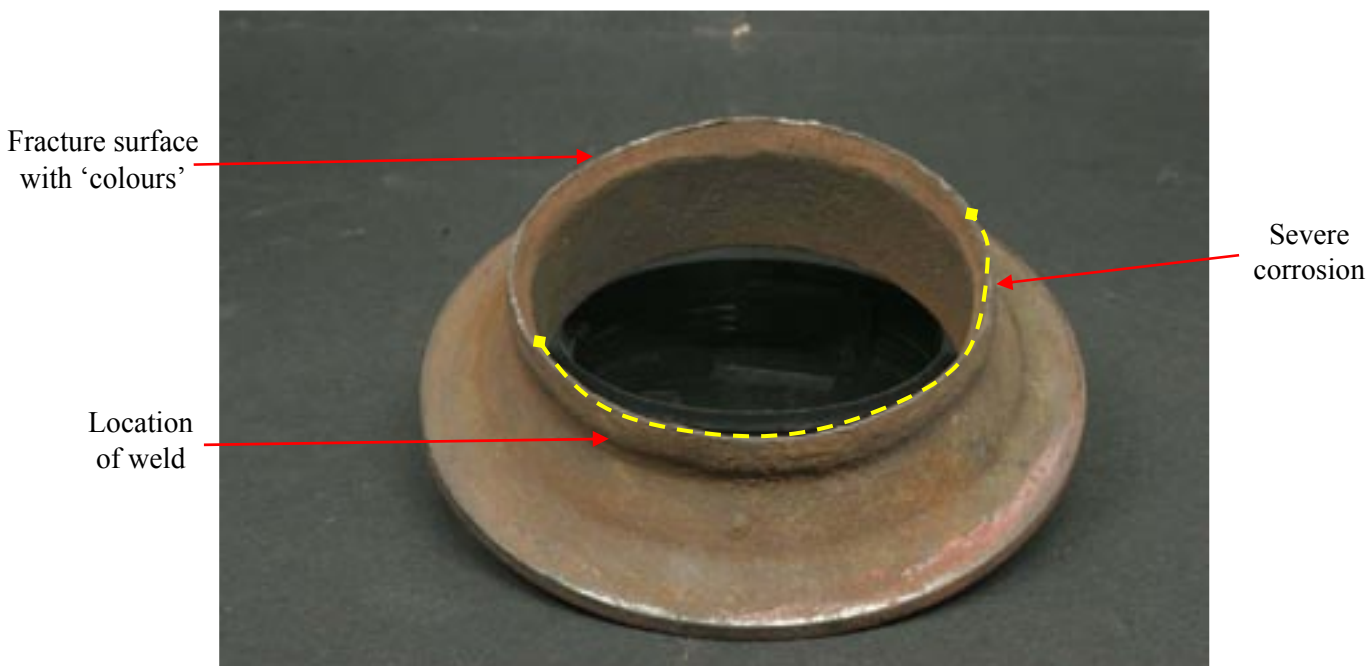
Figure 3. The pipe had failed circumferentially around the weld attaching the flange to the main tube (see Figure 4). The material of the main tube and the flange was specified to be 321 grade stainless steel and the filler weld material was specified as AMS5680 (347 grade stainless steel).

Figure 4
Exhaust pipe flange showing fracture surface and corrosion
