### SPECIAL BULLETINS / INTERIM REPORTS

**ACCIDENT**

<b>Aircraft Type and Registration:</b>	Agusta A109E G-CRST
<b>No &amp; Type of Engines:</b>	2 x Pratt & Whitney Canada PW206C
<b>Year of Manufacture:</b>	1998
<b>Location:</b>	St George Wharf, Vauxhall, London
<b>Date &amp; Time (UTC):</b>	16 January 2013 at 0759 hrs
<b>Type of Flight:</b>	Commercial Air Transport (Passenger)
<b>Persons on Board:</b>	Crew -1                      Passengers - None
<b>Injuries:</b>	Crew - 1 (Fatal)              Passengers - N/A
<b>Nature of Damage:</b>	Helicopter destroyed
<b>Commander's Licence:</b>	Air Transport Pilot's Licence
<b>Commander's Age:</b>	50 years
<b>Commander's Flying Experience:</b>	To be confirmed
<b>Information Source:</b>	AAIB Field Investigation

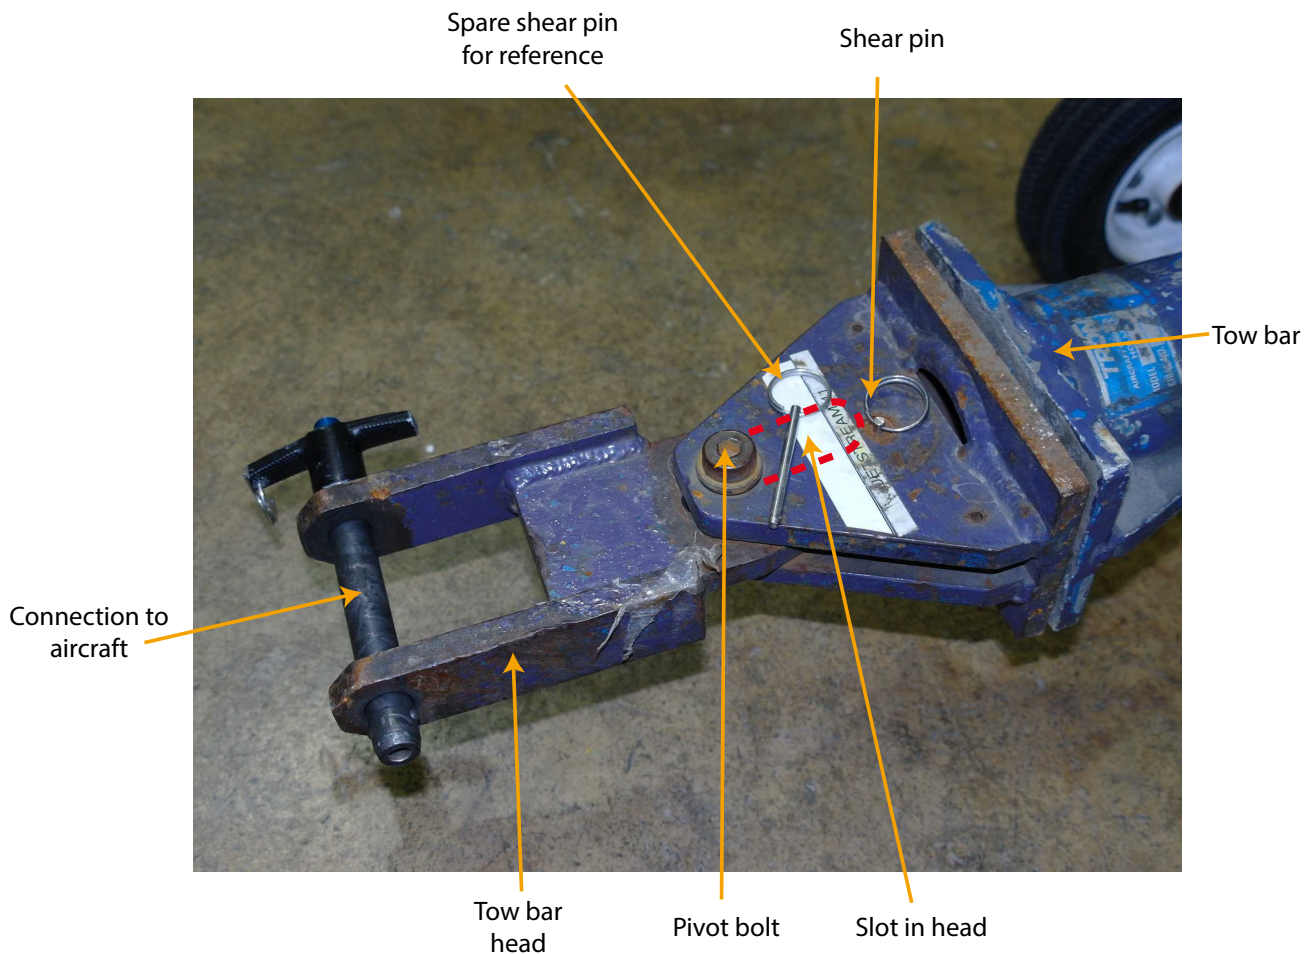
**Figure 1**

During the pushback, the ground agent was in contact with the pilot through his headset. One engine was started with the aircraft on the stand and the other was started during the pushback. He reported that he was watching the engine start when suddenly the nose of the aircraft moved to his right, the nosewheel turned and the towbar was no longer aligned with the aircraft. The shear pin on the towbar had broken and the towbar head had pivoted.

The pushback tractor was a Schopf Maschinenbau GmbH F100 Tug, which has an empty weight of 14,000 kg. The towbar was of a type approved for this aircraft and was fitted with the appropriate connecting head. The towbar incorporated a shear pin to protect the aircraft from excessive loads. The shear pin is designed to transmit normal loads but will break if a pre-determined load value is exceeded (Figure 1). If the shear pin breaks due to an excessive load in line with the towbar, the load will initially be removed but it will be reapplied as soon as the pivot bolt reaches the end of its slot in the towbar head.

Detail of towbar head, shear pin and head attachment to towbar

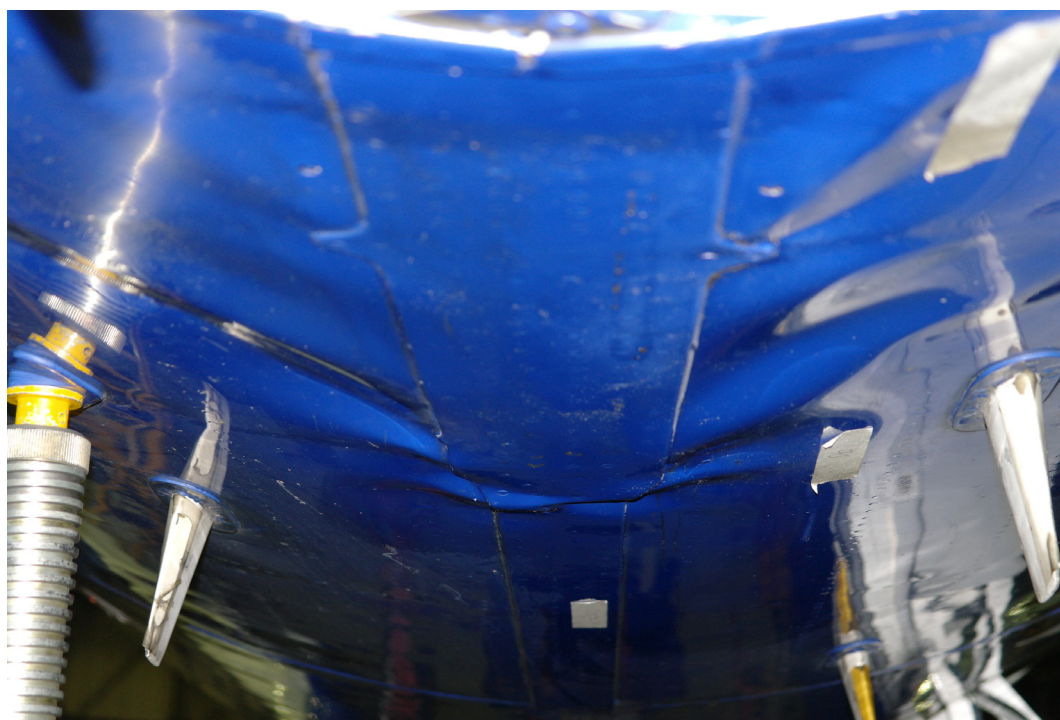
**Figure 2**

When the damage was found, the aircraft was removed from service and moved to a hangar for a full inspection and evaluation. The aircraft was jacked and the nose gear and some of the cockpit equipment removed to allow access. The rear pressure bulkhead of the nose gear bay, the lower fuselage skin and keel plate immediately behind the nose gear bay and its supporting frames were found to be damaged (Figure 2).

View, looking aft following removal of the nose leg, of damage to lower fuselage skin and keel plate aft of nose gear bay

It is highly likely that damage occurred during the pushback in Brussels on 28 May 2012. Witness evidence, recorded flight data and a video recording from a camera at the airport showed that the aircraft experienced a significant jolt that caused the towbar shear pin to fail. Further damage may have occurred as a consequence of operation with a weakened structure during subsequent flights.

The tug used for the pushback weighed 14,000 kg, which was much heavier than the 4,500 kg recommended in the AMM, and this would have given it much more momentum than a lighter tug when the towbar pin sheared. Consequently, the tug was capable of applying a large longitudinal force to the aircraft as the pivot bolt reached the end of its slot. The investigation did not determine whether or not the use of a lighter tug would have caused similar damage.

An FCI was issued to remind crews of the requirement to record defects in the Technical Log.

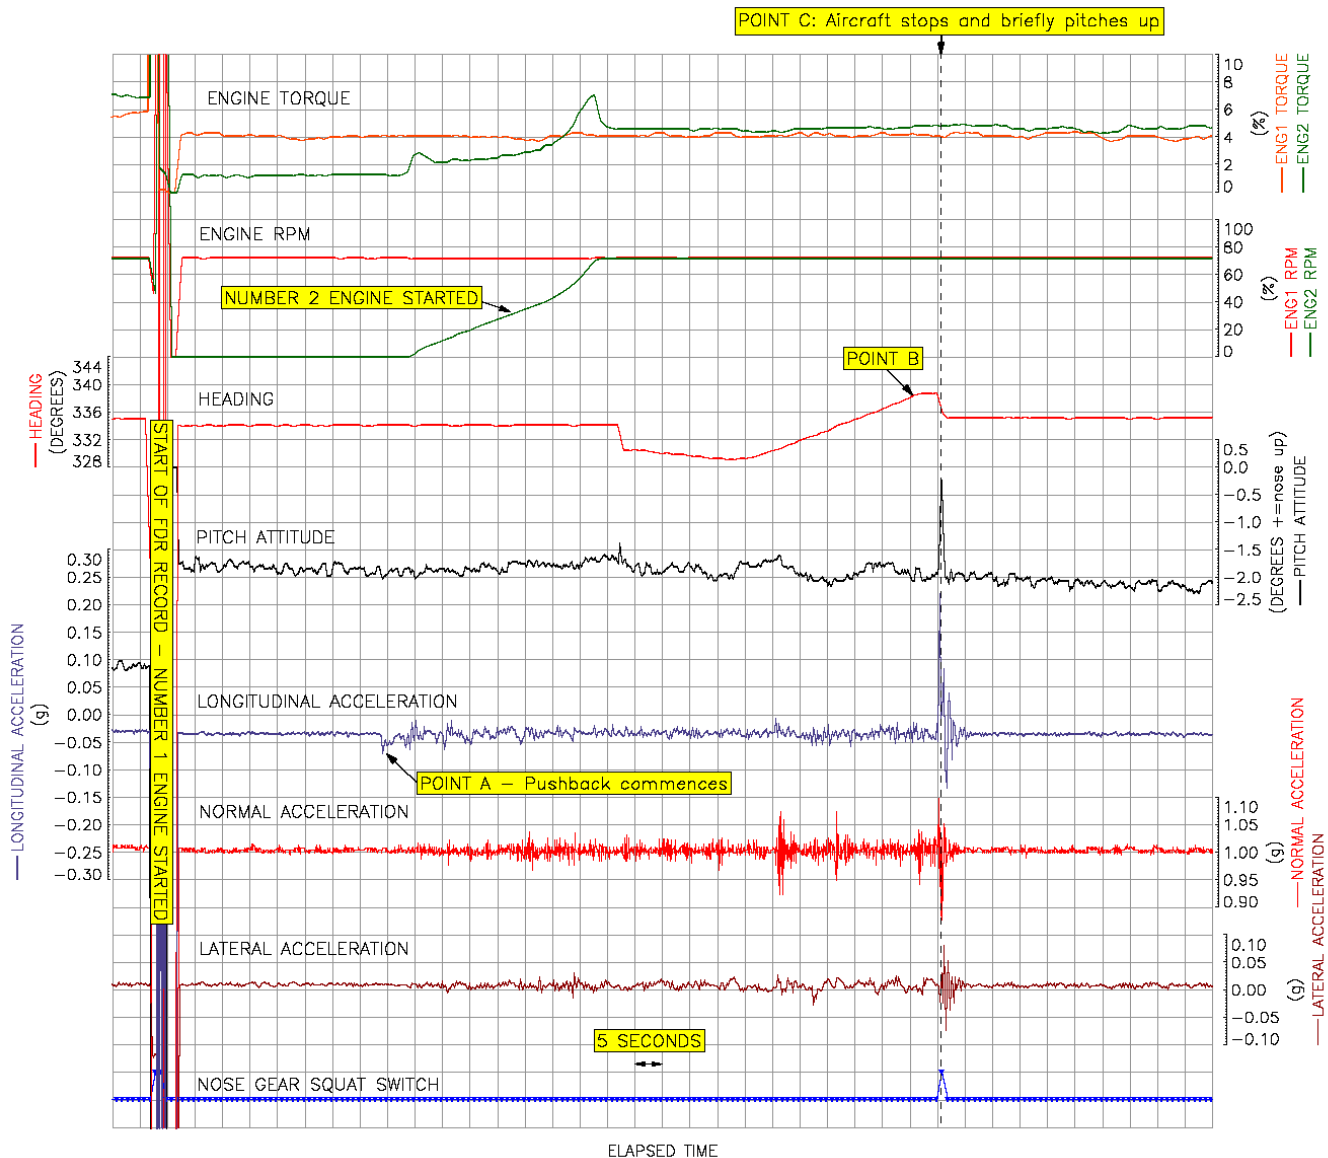
**Figure 3**

Because the towbar shear pin had broken during pushback at Brussels Airport on the 28 May 2012, the relevant FDR data was analysed. The FDR started to record when the number one engine was started while the aircraft was stationary on the stand. About 40 seconds

later, the pushback began (refer to Figure 3 - Point A), followed several seconds later by the number two engine being started. During the initial 43 seconds of the pushback, the aircraft heading remained constant at 334° before turning slightly onto a heading of 330°. Over the following 19 seconds, the aircraft heading remained constant to within 1°, after which the aircraft was turned onto a heading of 338° over a period of 34 seconds (refer to Figure 3 - Point B). Three seconds later, the aircraft came to a stop with its nose briefly pitching up by just less than 2°, but sufficient to cause the weight-on-wheels switch to change state briefly (refer to Figure 3 - Point C). During this short period, aircraft heading changed by 3° to a heading of 335°.

Pushback at Brussels Airport 28 May 2012

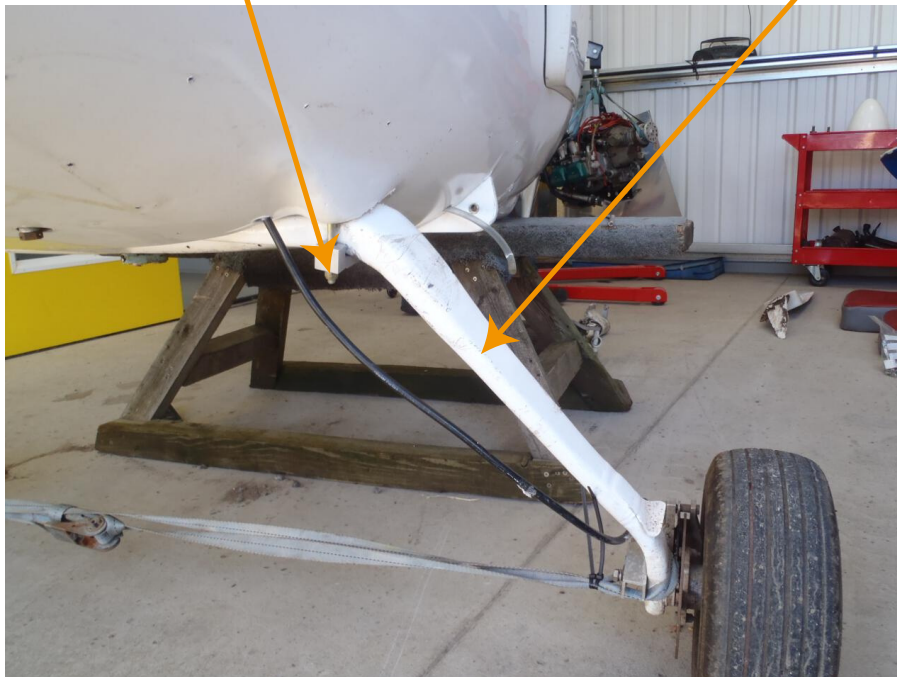
**Figure 1**

Outboard attachment bolts  
passing through the attachment bracket

Cantilever  
spring leg

Undercarriage attachment

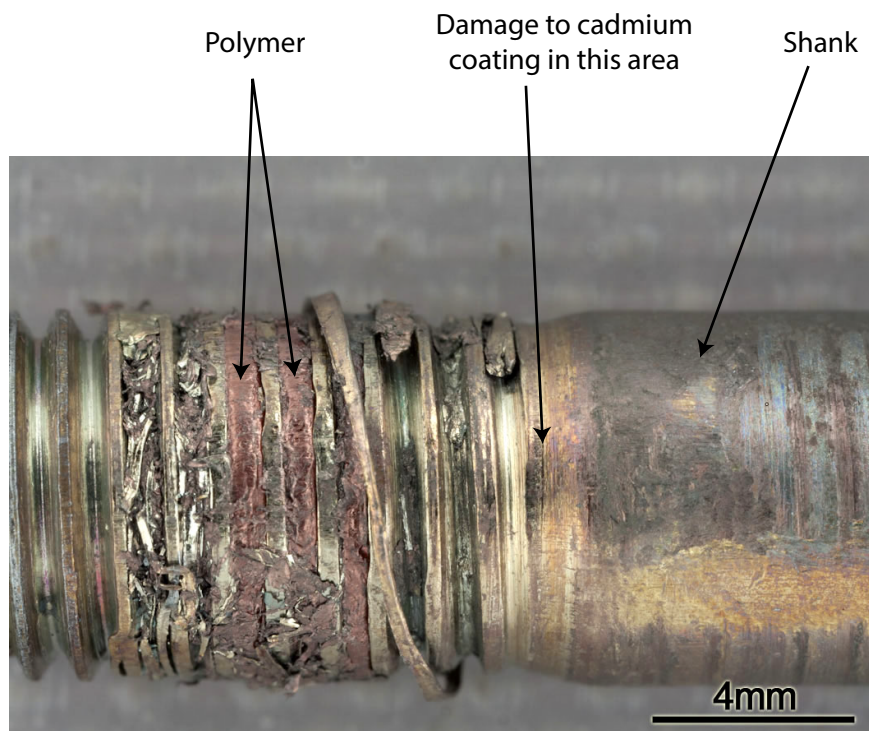
**Figure 2**

In 2003 the Popular Flying Association (PFA) identified a concern that the rear outboard undercarriage attachment bolt might not be sufficiently strong and that the bolts needed to be regularly re-tightened. Consequently, the

Thread on forward outboard attachment bolt
