CONTENTS

SPECIAL BULLETINS

COMMERCIAL AIR TRANSPORT

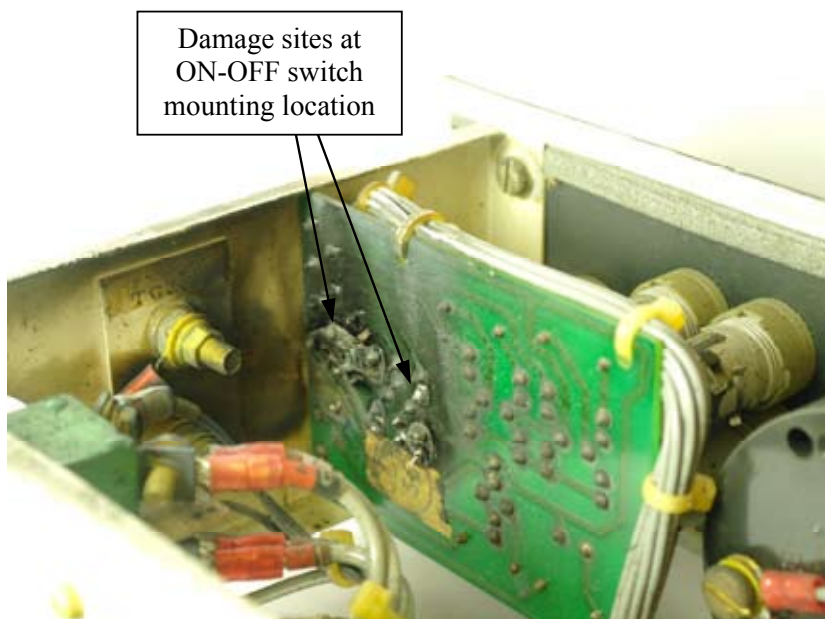
Figure 2

Electrical overheating damage to the oven controller PCB

The damage to the oven controller's PCB indicates that an electrical short circuit occurred at the connection between the PCB and the oven controller's ON-OFF switch. The nature of the damage to the soldered connections and copper PCB

tracks at this location prevented further investigation into the cause of the short circuit. The oven controller's 5 amp circuit breaker, which was operating within its design specification, tripped and prevented further current from flowing and intensifying the electrical overheating.

The overheating damage was limited to the oven controller's PCB and was contained within the controller enclosure. Smoke caused by the overheating circuit board escaped from the controller enclosure and circulated around the forward galley ovens, causing confusion regarding its source.

A review of the maintenance history of the oven controller module did not reveal any defects that may have contributed to the initiation of an electrical short circuit, which is the most likely cause of the electrical overheating damage to the oven controller's PCB.

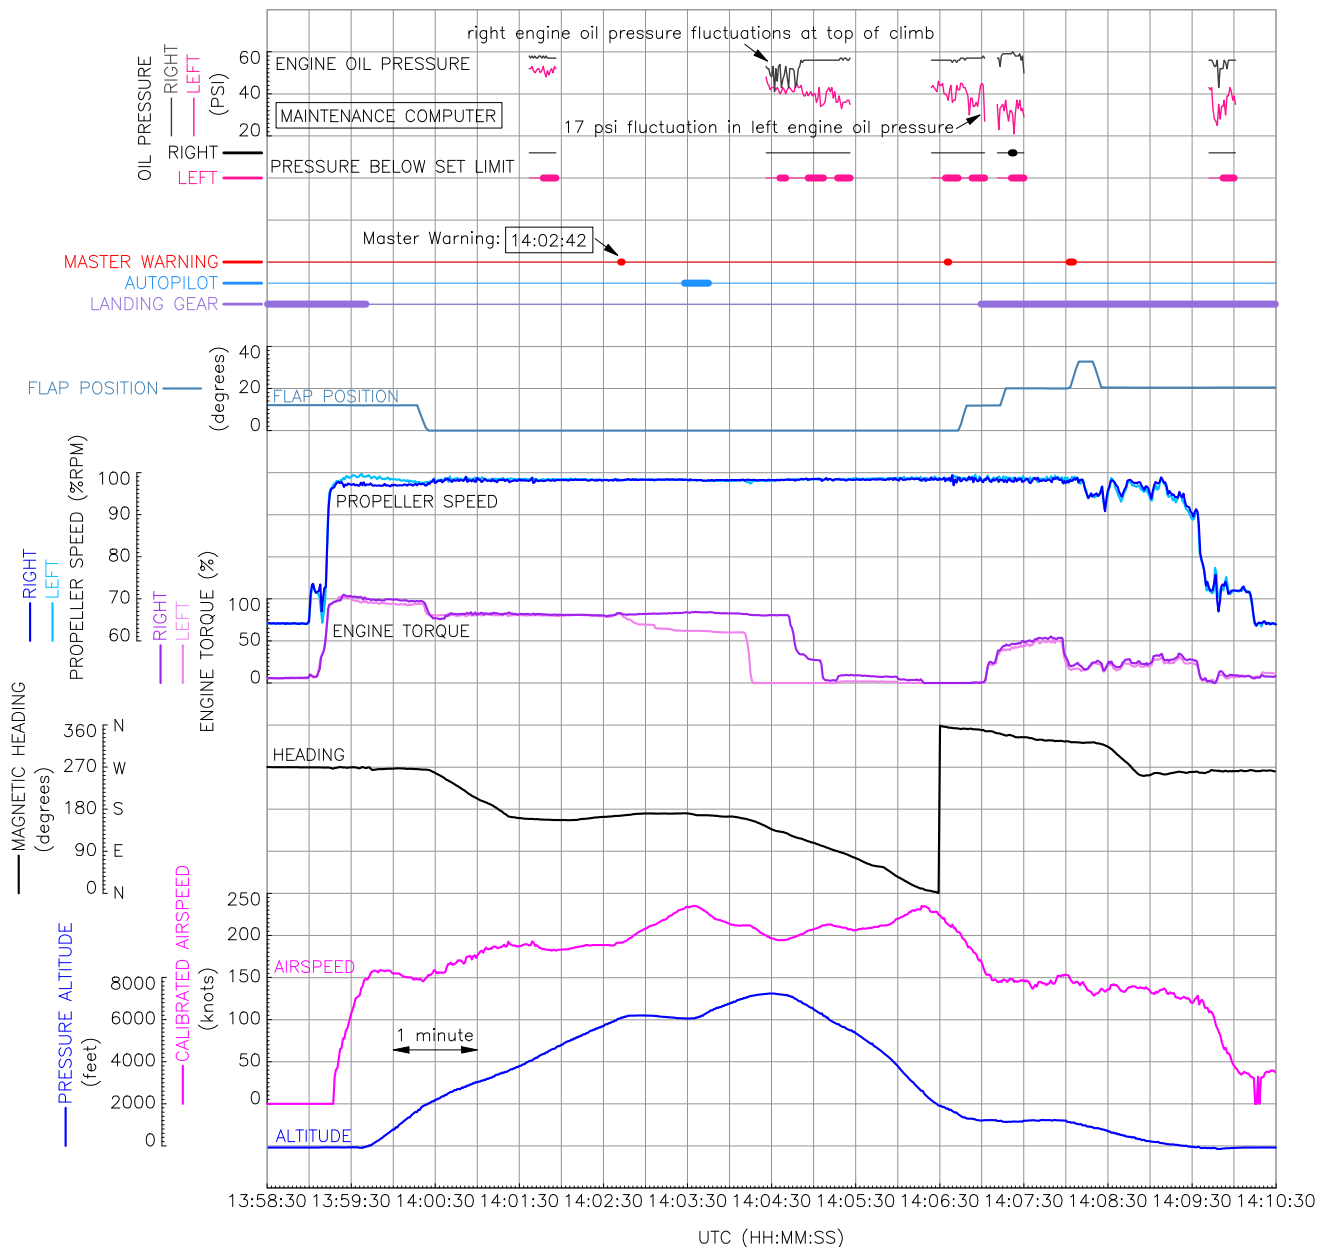
Figure 1

Salient FDR parameters and maintenance computer recordings for the serious incident to D-CIRT

The 'top of climb' was at just above FL70 before the torque on the left engine was reduced to near zero, followed by a stepped reduction in torque on the right engine for the descent. From top of climb, throughout the descent and landing, the maintenance computer detected a further 13 left engine oil pressure 'below-limit' conditions and one on the right engine. The associated extracts of engine oil pressures recorded by the computer show that the oil pressure difference between the engines grew as the left engine pressure fell to about 30 psi (ie a 50% reduction), although it fluctuated as much as 17 psi. Fluctuations were also recorded in the right engine oil pressure at top of climb, but stopped once the torque was reduced for the descent.

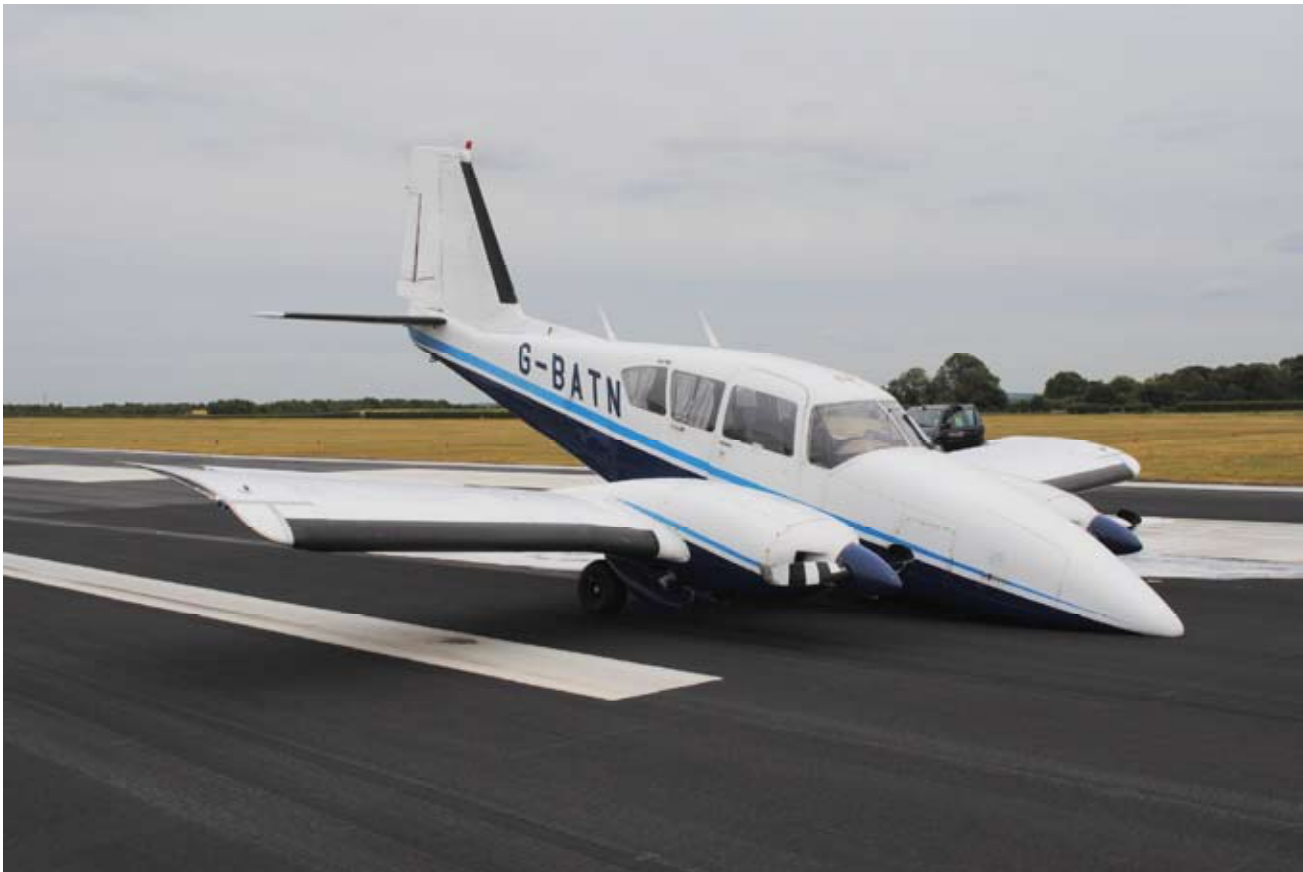
Figure 1
G-BATN on Runway 23

The nose landing gear retracted on landing because it was not fully locked down. It was considered that a lack of lubrication on the shanks of the downlock link plate bolts caused sufficient restriction to prevent the complete engagement of the downlock. For reasons for which could not be established the pilot was unaware that the gear was not locked down and he stated that it would be “very unlikely” that the green light was not illuminated at touchdown and the gear unsafe horn was sounding but that he had failed to notice.

The aircraft manufacturer commented that since 1995 there had been no reported events with the same symptoms. However, since this event the operator is considering introducing an additional maintenance activity for the periodic removal and inspection of the bolts to ensure that lubrication has successfully penetrated to the bolt shank and that no corrosion has developed.

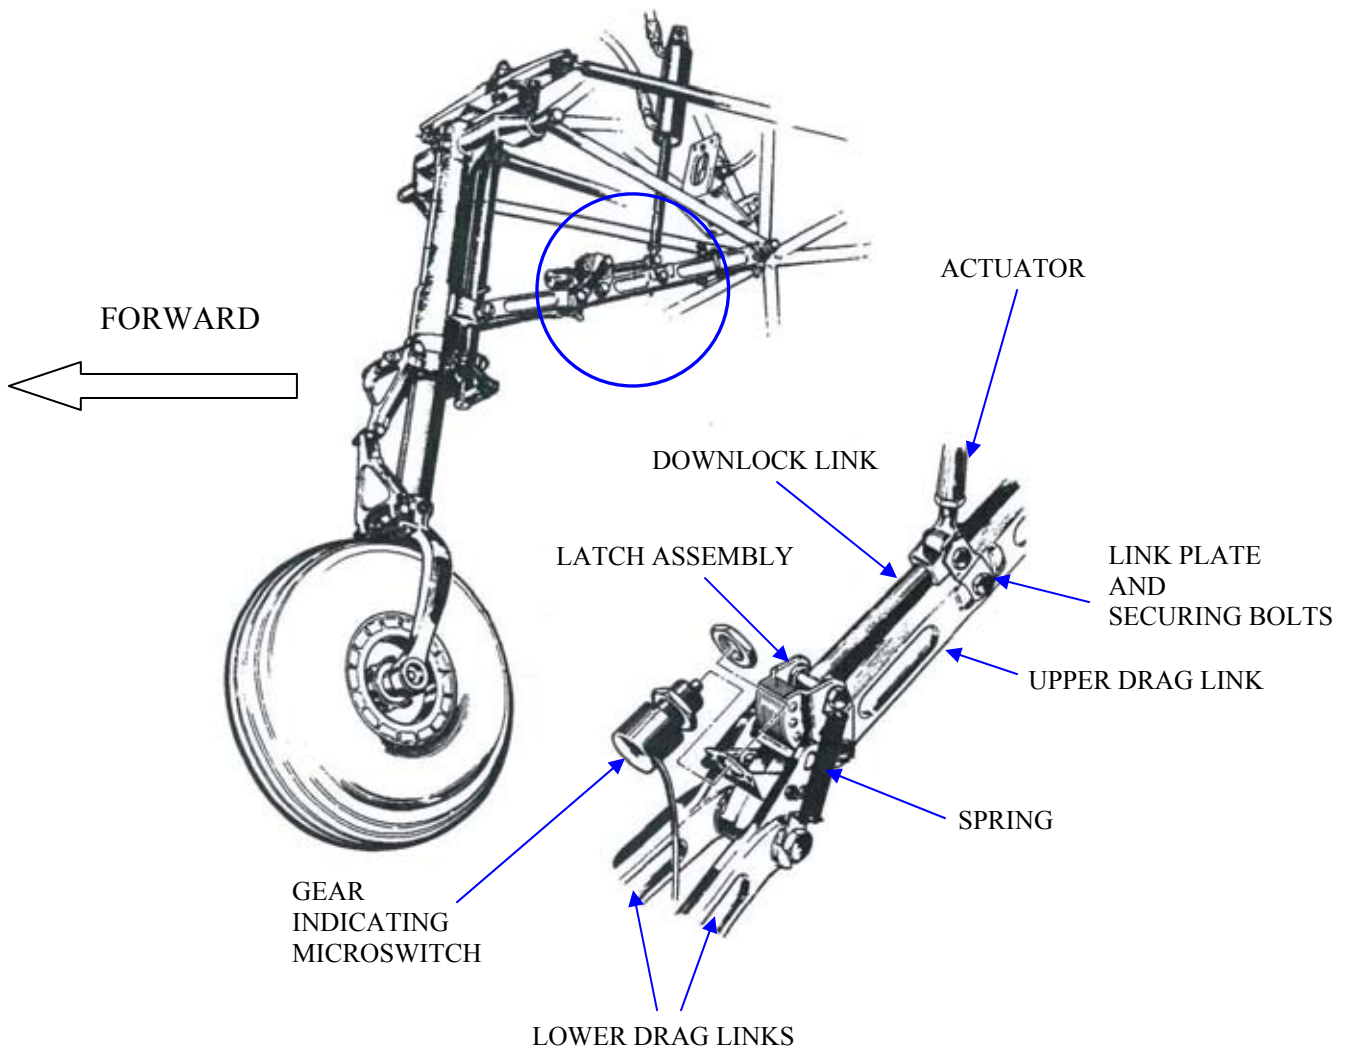
Figure 2

Nose gear leg assembly

The nose landing gear was inspected and the link plate attaching the actuator to the downlock link was found to be damaged. The bolts securing this link plate were removed and were reported to be:

'dry of lubricant and had visible surface rust on the bolt shank.'

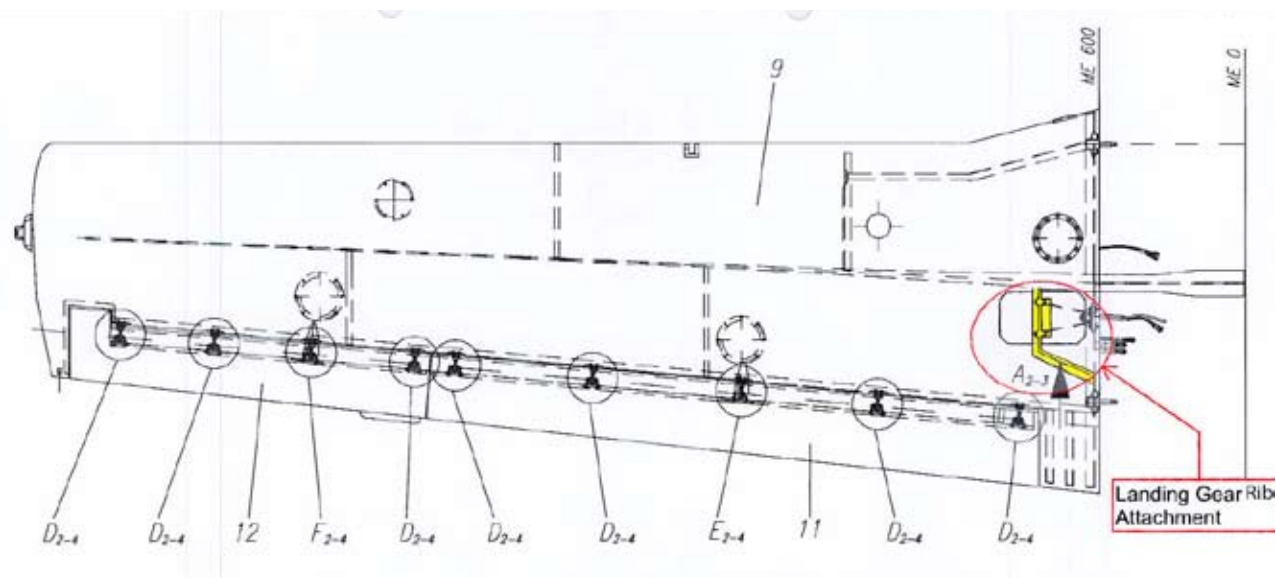
Figure 2

Detailed examination confirmed similar and almost symmetrical damage to both wings. The access port cover panels had fractures through the carbon fibre from

Diagram of Grob G115E wing structure.

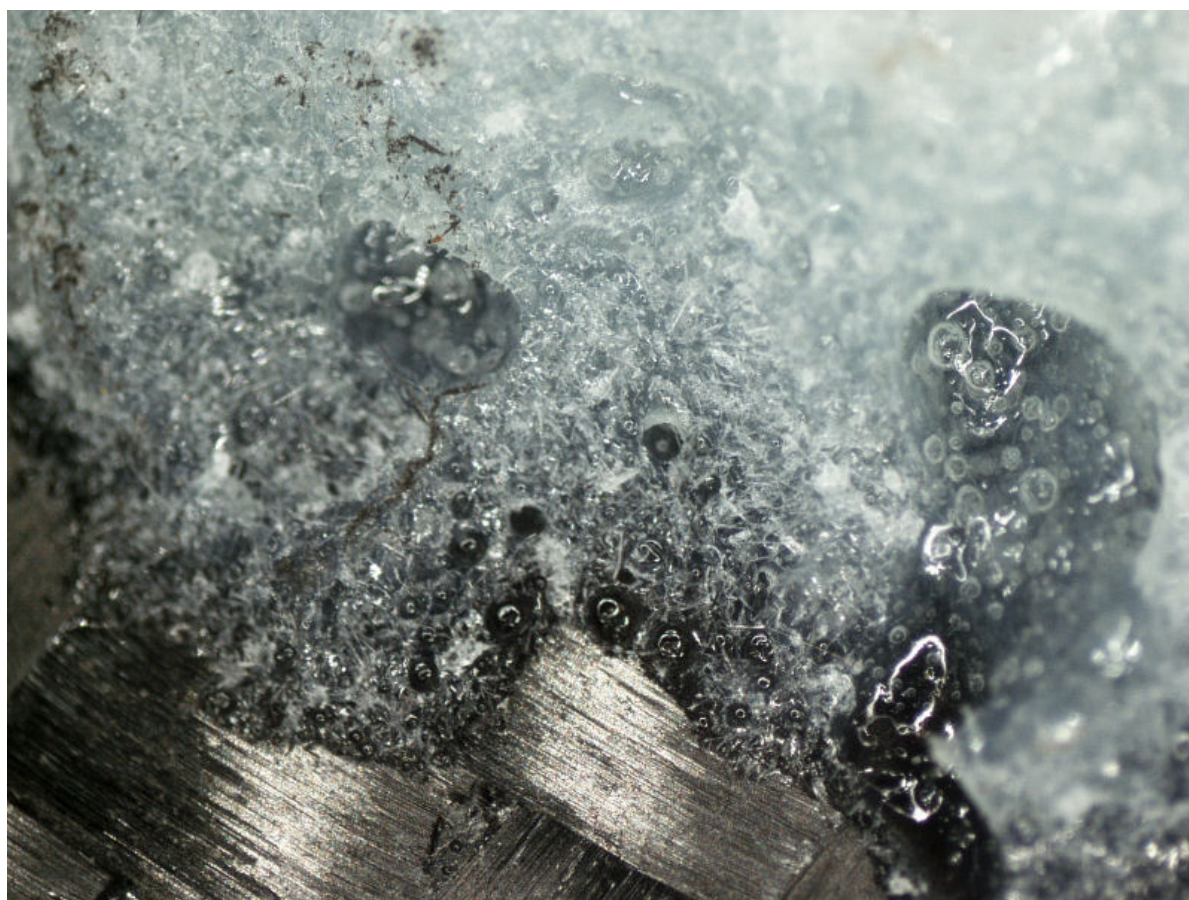
Figure 3

of the layer of adhesive forming the bondline was noted to exceed the manufacturer's design specification (and industry production standard) of 0.5 to 2.0 mm in many areas. A large section of the web joint had failed in an interlaminar manner. The resulting fracture surface exhibited features consistent with a shear failure, with relative movement between the rib and the web in the vertical and longitudinal planes (rib moving forward and down/web moving up and back). The ductile properties of the adhesive masked the fracture features on the other surfaces, preventing further analysis.

Magnified image of the white adhesive showing porosity

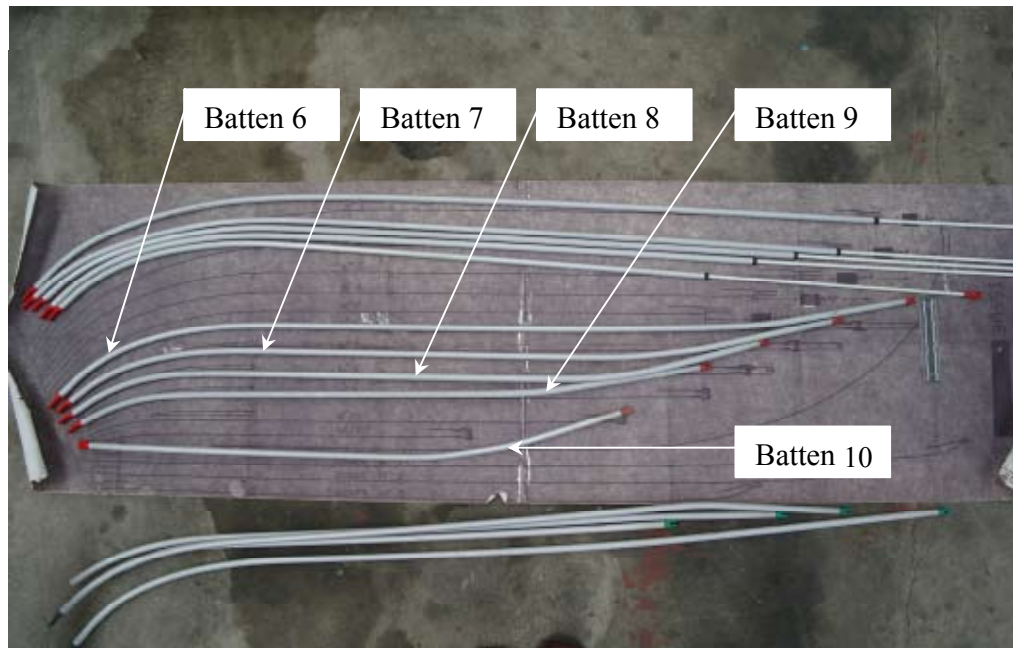
Figure 4

Batten profile for left wing showing trailing edge reflex on outboard battens
