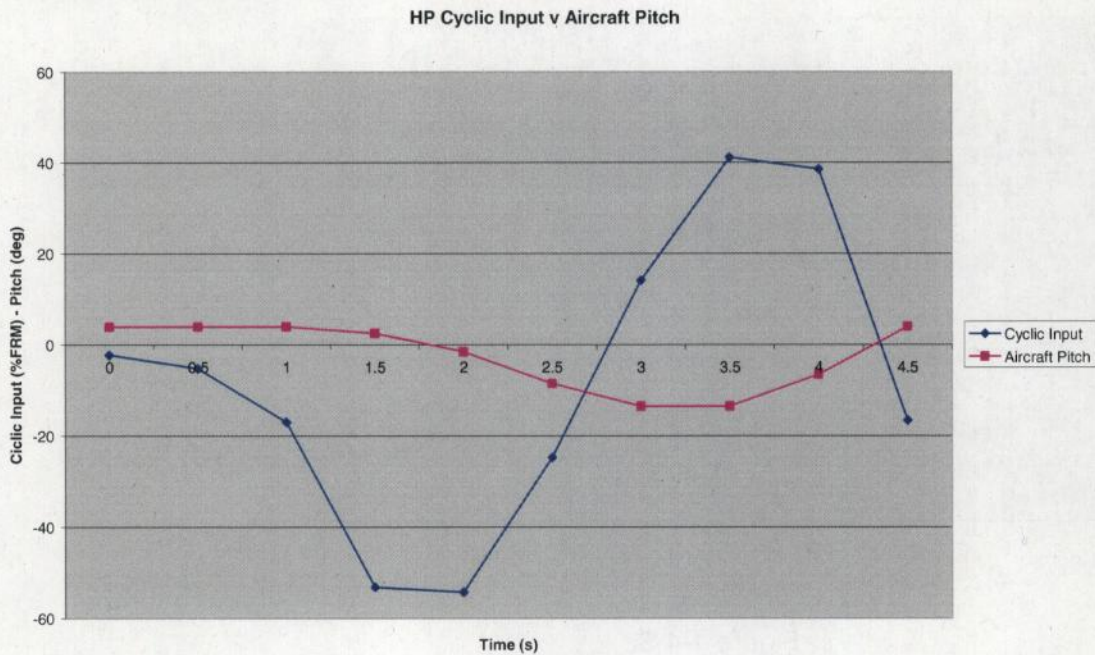
1.4.40 **Cyclic Input v Pitch.** Figure 1-4-6 graphically illustrates aircraft cyclic input and pitch during the HP's exercise.

1.4.41 Analysis of Figure 1-4-6 suggests a lag between the HP's input and the aircraft's reaction. This lag is not considered unusual for the Sea King Mk 4. The lag seen during the QHI's demonstration is similar. The lag experienced by both pilots is **not considered a factor** in the incident.

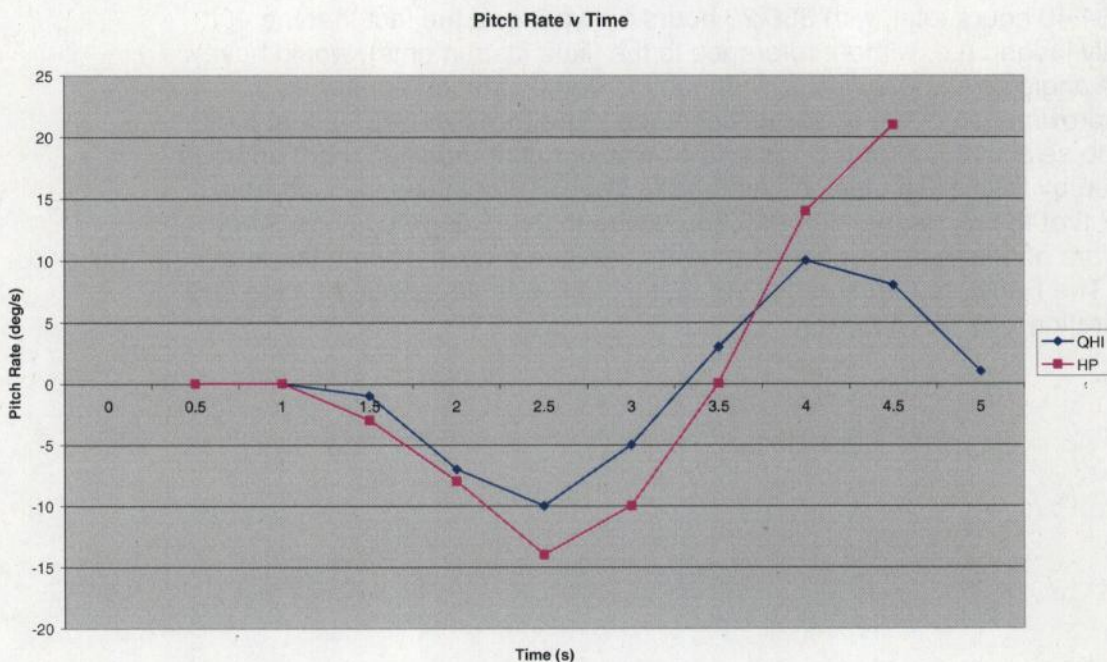
1.4.42 **Pitch Rate.** Figure 1-4-7 graphically illustrates aircraft pitch rate (i.e. the change in aircraft pitch in degrees per second) during both the QHI's demonstration and the HP's exercise.

1.4.43 The QHI attains a maximum of approximately 10 degrees per second on both the nose down and nose up motion of the aircraft. Additionally, the aircraft had almost stopped rotating (1 degree per second) by the time of the impact. This equates to an additional rate of decent of 21 ft/min at the tail wheel which will be considered further in para 1.4.50.

1.4.44 Conversely, the rotational velocity of the aircraft during the HP's exercise attains a maximum of approximately 14 degrees per second during the nose down motion and 21 degrees per second at the point of impact of the tail wheel with the ground. These pitch rates are consistent with the control inputs already described. More important, however, is the fact that the aircraft is rotating with a considerable angular velocity as it impacts the ground. This angular velocity will have a vertical component which must be added to the aircraft's rate of descent in order to establish the rate of descent experienced by the tail wheel as it struck the ground. The vertical component of the angular velocity has been calculated as 479ft per minute for the HP compared with a figure of 21ft per minute for the QHI's demonstration. The total RoD is calculated in para 1.4.51.

1.4.45 The Panel concluded that the rate of pitch change or angular velocity applied to the aircraft by the HP was an **aggravating factor** in the incident, as this significant rate of decent on the tail wheel made the outcome worse.

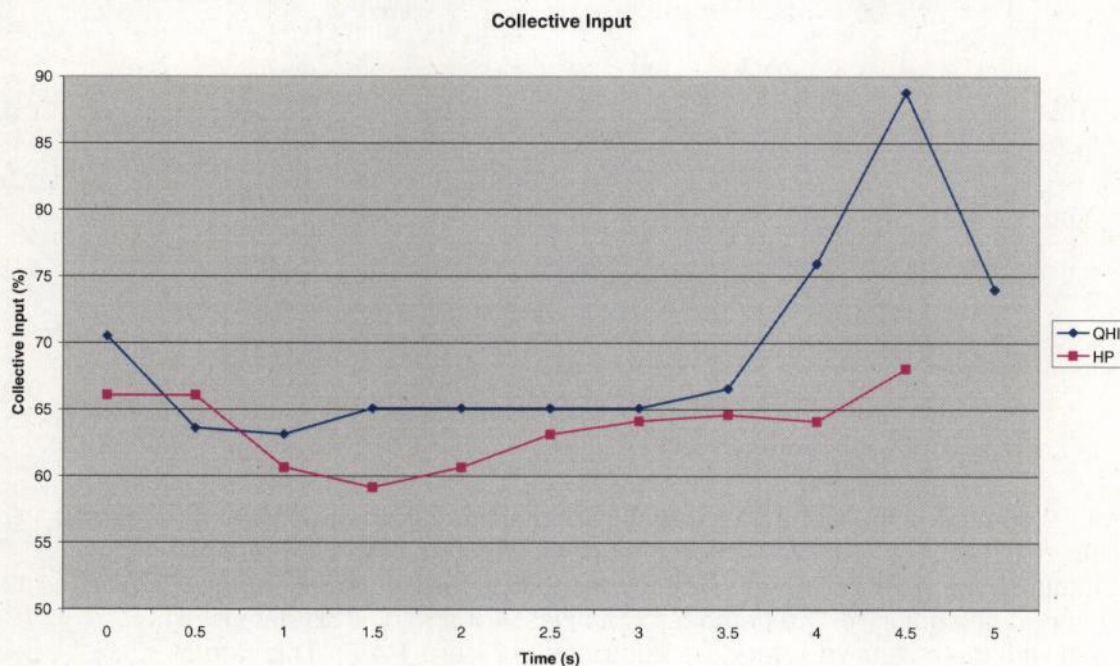
1.4.46 **Application of Collective Pitch.** Figure 1-4-8 graphically illustrates the amount of collective lever applied by both the QHI during the demonstration and the HP during the exercise.

1.4.47 The difference in the collective lever positions at the start of the exercise can be attributed to the same factors as in para 1.4.35, although again the Panel cannot identify how much influence, if any, can be attributed to each of these factors.

The QHI immediately checked down on the collective¹⁶ (in order to conserve Nr), from 71- 63% full range of movement (FRM) and, whilst he regains some collective to 65% FRM, he maintains this level until he makes a very large movement up to 89% FRM to cushion the landing. The HP's profile, whilst broadly similar, has some notable differences. The HP is slower to react with the initial check down (by 0.5 seconds). He did not maintain the collective lever position after checking down and steadily increases the collective input during the exercise. The effect of this increased collective input is likely to have been countered by the higher engine power setting. The HP does begin to apply a higher collective input to cushion the landing, but he impacts the ground before he completes the movement.

1.4.48 The Panel concluded that the HP's application of collective pitch was insufficient and too late to markedly reduce the rate of descent and cushion the landing. The lack of cushioning and the subsequent rate of descent was assessed by the Panel to be an **aggravating factor** in the incident as discussed in para 1.4.51.

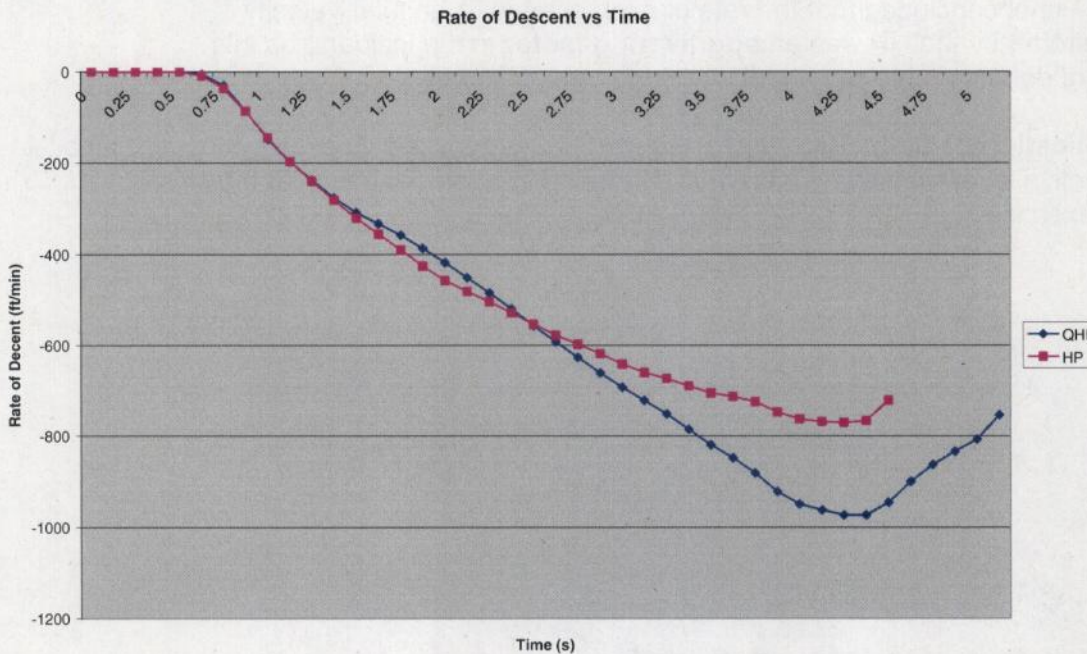
1.4.49 **Rate of Descent.** Figure 1-4-9 graphically illustrates aircraft RoD in feet per minute during both the QHI's demonstration and the HP's exercise.

1.4.50 The QHI controlled the aircraft to a significant maximum rate of descent of 974 feet per minute (ft/min) in a reasonably linear manner. He then slows the rate of descent to 753ft/min by the point of impact. Therefore the true rate of descent, at the tail wheel, at the point of landing for the demonstration was 774 ft/min. This data is entirely consistent with the collective lever data illustrated in Figure 1-4-8. This rate of descent at the point of impact accounts for the perceived firmness of the landing. When compared with the design maximum Vertical Velocity (Vv) on landing of 480ft/min, the QHI's landing should in fact have been considered a 'heavy landing' as it was well outside the design envelope of the aircraft, (1.61 times the Vv). The QHI did not register the landing as excessively firm. Additionally, the Sea King does not

1.4.51 The HP initially controlled the aircraft to a very similar RoD profile, which he then reduces towards the later stages of the exercise. He attains a maximum rate of descent of 771ft/min which is reduced to 722ft/min by the point of impact. It should be noted that this RoD is the vertical component only and does not account for the pitch change in the aircraft. Para 1.4.44 above concluded that the vertical component of the rotational velocity of the rate of descent was 479ft/min which, when added to the vertical component, subjected the tail wheel to a Vv of 1201ft/min at the point of impact. This equates to 2.5 times the Vv.

1.4.52 The Panel concluded that the RoD and the pitch change at the time of impact combined to be the cause of the majority of the damage sustained by the aircraft during the incident. Therefore the RoD was an **aggravating factor**.

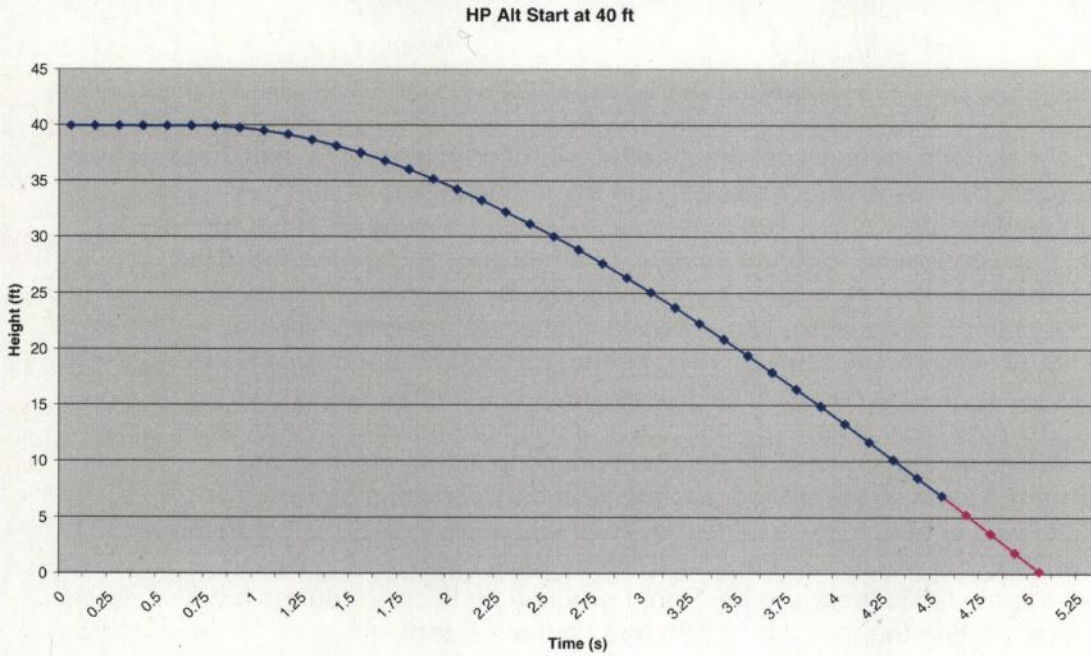
1.4.53 **Further Analysis of HP's Profile - Start Height.** Figure 1-4-10 shows the HP's exercise had it commenced at 40ft as described in the Flying Procedures.

1.4.54 By moving the height profile start point from 33ft up to 40ft (but not changing any other variables) and then extrapolating the profile in a linear manner, as shown by the pink line, the Panel concluded that the HP had approximately 0.5s less time to complete the exercise. Having established that the HP would have had an extra 0.5s to complete the exercise the Panel then added this time to the other elements of his flight profile and extrapolated the data, ascertaining what may have happened had he started at the correct height.

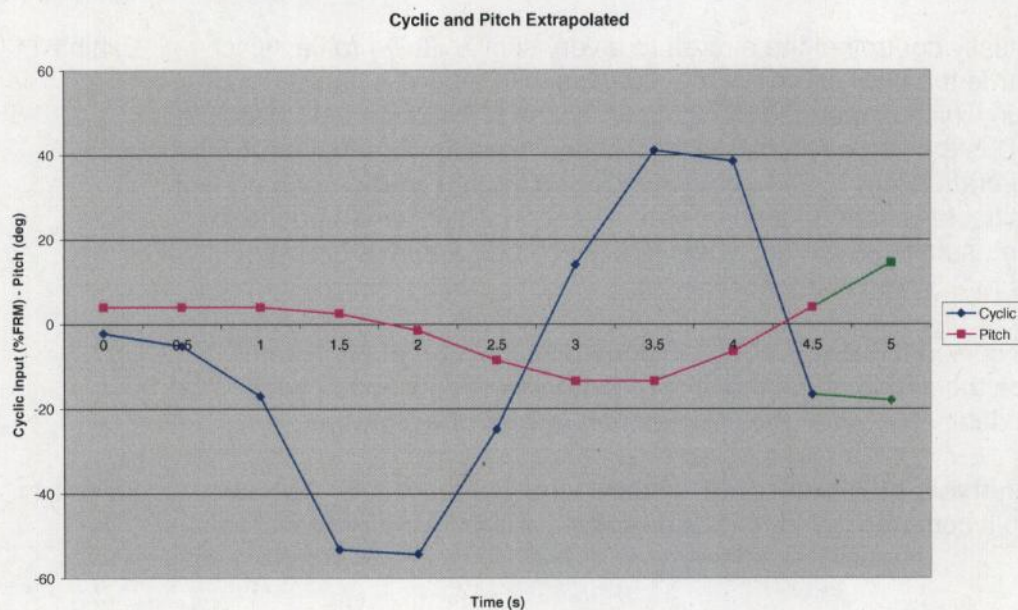
1.4.55 **Further Analysis of HP's Profile – Aircraft Pitch.** Figure 1-4-11 illustrates the HP's Cyclic input in pitch and the aircraft attitude had he had an extra 0.5s in which to complete the exercise.

1.4.56 It was the opinion of the Panel that had the HP had an extra 0.5s and 7ft to complete the exercise, but flown the aircraft with the same control inputs, the outcome would have been the same. The extrapolated graph above shows that the aircraft is likely to have continued to rotate nose up in a relatively linear manner. The HP had begun to apply some nose down input to the cyclic by the moment of impact, which the Panel consider that he is likely to have maintained, in order to level the aircraft for the landing. Figure 1-4-11 clearly shows that throughout the exercise the aircraft reaction to cyclic input is delayed¹⁷. This implies that the HP's nose down input at approx 4.25s may have decelerated the rate of pitch change but is very unlikely to have caused a nose down motion in the remaining flight time, thereby leading to the same outcome, suggesting that starting at 33ft was not a factor. However, the Panel was unable to determine the effect that starting at 33ft had on the HP's visual perception, and whether starting at 40ft may have changed the way in which he handled the aircraft. Therefore the Panel was unable to conclude the level of influence that that starting the exercise at 33ft had on the incident.
