MARINE ACCIDENT INVESTIGATION BRANCH

SAFETY FLYER

Ursine contact with *Pride of Bruges*

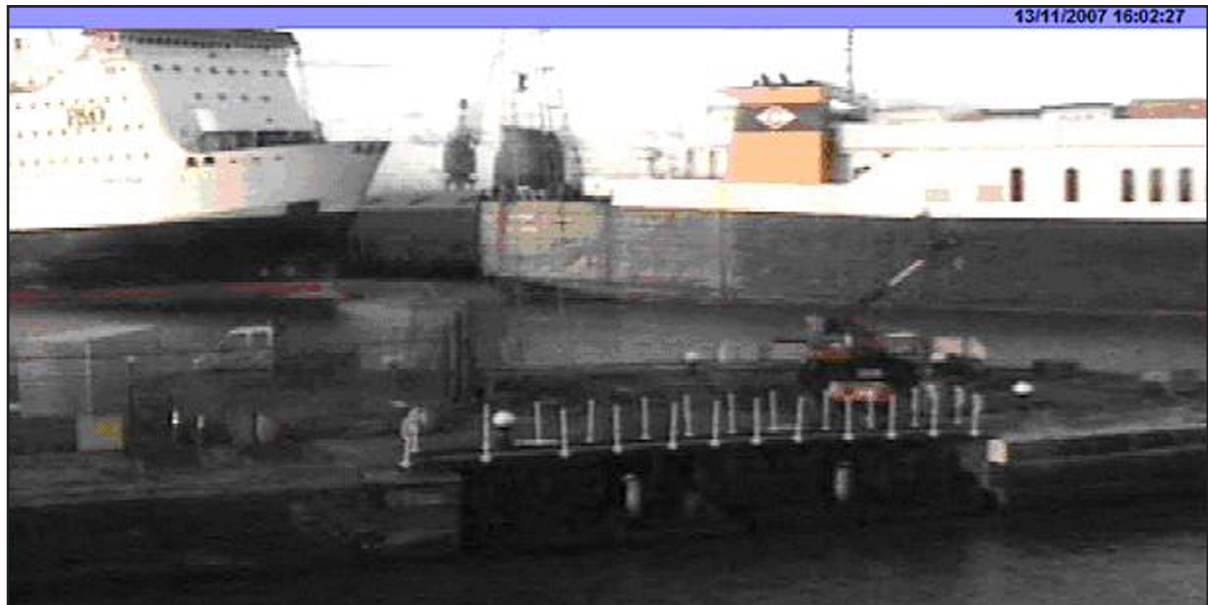
A second officer was stationed aft and was reporting, via a radio to the chief officer, distances of the stern in relation to berths and other vessels inside the dock. As *Ursine* came close to the berth, which, due to the angle of approach was not visible from the port bridge wing control position, the second officer reported that the distance from *Pride of Bruges* was closing rapidly. Just before contact occurred, the PEC holder went to the starboard bridge wing and saw that *Pride of Bruges* was in fact already secured on the berth he had assumed *Ursine* would be using. Contact occurred, with both vessels suffering damage; fortunately, there were no injuries.

Ursine pulls clear of Pride of Bruges - just after contact
