SPECIAL BULLETINS / INTERIM REPORTS

S7/2013 - AS332 L2 Super Puma,	G-WNSB	23-Aug-13	3
--------------------------------	--------	-----------	---

AAIB FIELD INVESTIGATIONS

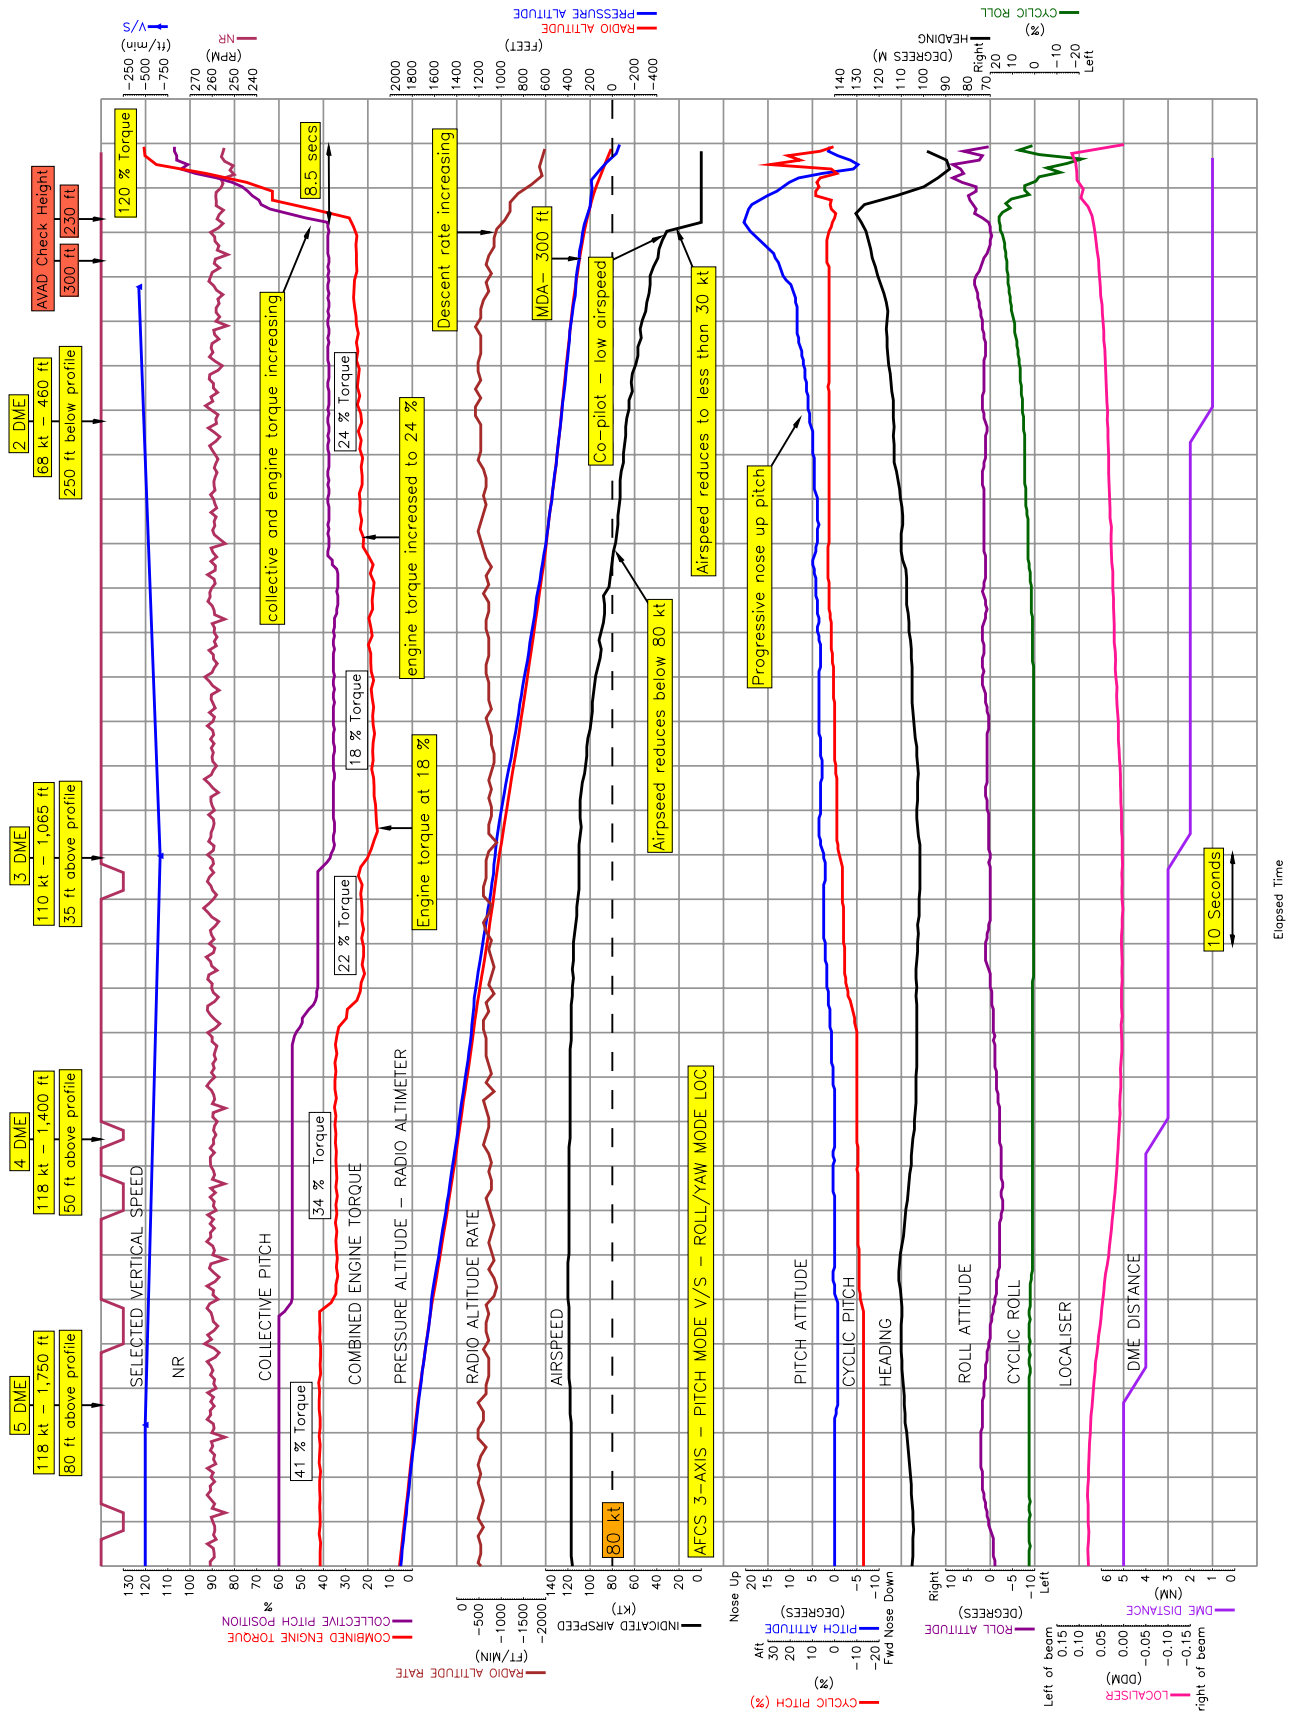
Figure 1

Recorded data parameters for the Final Approach

This initial analysis also showed that the combination of the nose-high attitude, low airspeed, high rate of descent and high power placed the helicopter in a vortex-ring state⁷ entry condition (VRS) during the final stages of the flight. The manufacturer’s modelling indicated that, in this condition, the reduced helicopter performance, together with the limited height available, meant that the impact with the sea was unavoidable.

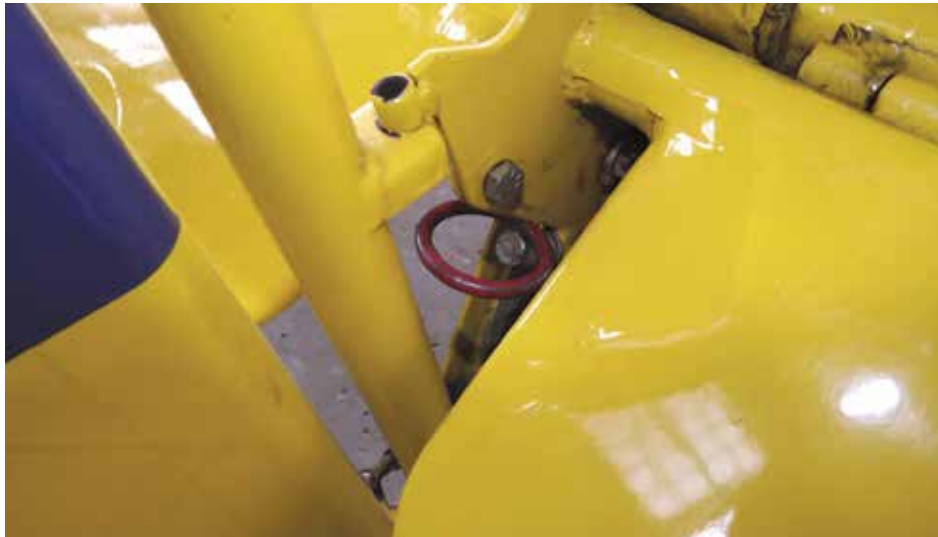
Figure 1

After removing the fairing around the stern post, a red painted steel ring approximately 45 mm in diameter was found jammed in the elevator up stop, Figure 1. This limited the maximum upwards travel of the elevator to 1½ degrees below the neutral position. The origin of the ring or how it entered the aircraft could not be determined.

View of loose article as found after landing
(Photograph courtesy of Nigel Huxtable)

could not be determined. Further investigation by the flying club has identified that the metal ring was from the aircraft's door emergency release pull. The ring has been replaced and an additional lanyard added to restrain it should it become detached again.

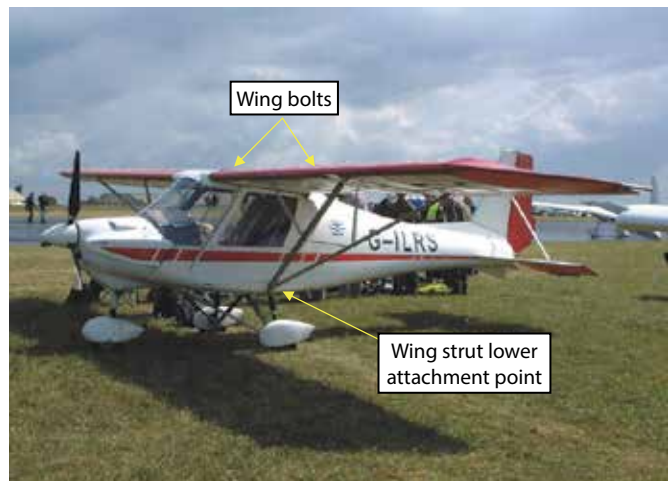
Figure 1

The cause of the wing rotating upwards was the incorrect fitting of the wing strut lower attachment bolt (Figure 1), which had only passed through the fuselage mounting bracket and not through the strut.
