20140710\_XZ936\_SI\_Interim\_Report-OS

10 Jul 14

## **INTERIM REPORT FROM THE SERVICE INQUIRY INVESTIGATING THE INCIDENT INVOLVING GAZELLE XZ936 ON 02 JUN 14**

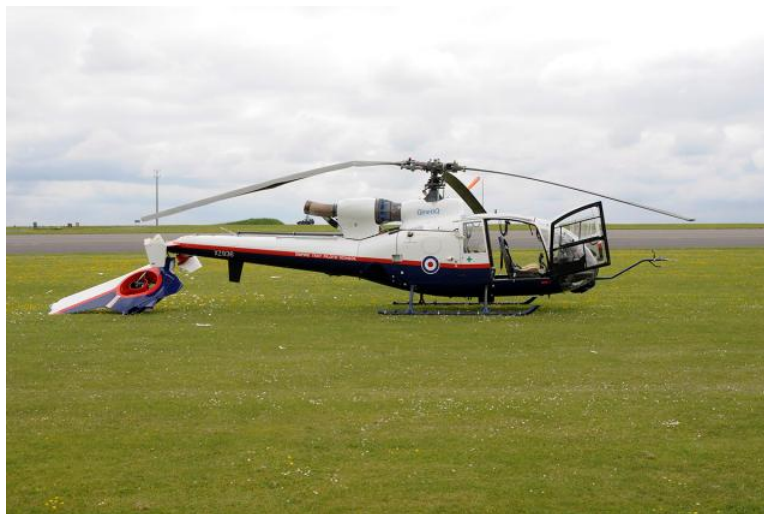
2. At approximately 1157hrs on 02 Jun 14, Gazelle Mk3 XZ936 was involved in an incident while carrying out Engine Off Landings<sup>2</sup> (EOLs) at Boscombe Down Airfield, Rwy 23 Grass. The rear of the tail boom detached due to impact from the Main Rotor Blades (MRB). The two crew were not injured. A team from the Military Air Accident Investigation Branch deployed to MoD Boscombe Down on 02 Jun 14 and the Director General Military Aviation Authority (DG MAA) convened a Service Inquiry on 10 Jun 14. This update presents the key facts determined up to the time of issue of this Interim Report. The Service Inquiry is ongoing and will publish its full findings in due course.

6. The Panel has found no evidence of technical failure prior to the incident and provisionally assesses that the cause of the incident was the lowering fully of the collective, with full aft cyclic applied and low Nr, which caused the disc attitude to be such that the MRB struck the tail.
