SS Richard Montgomery

Survey Report

2010

Maritime & Coastguard Agency
May 2012

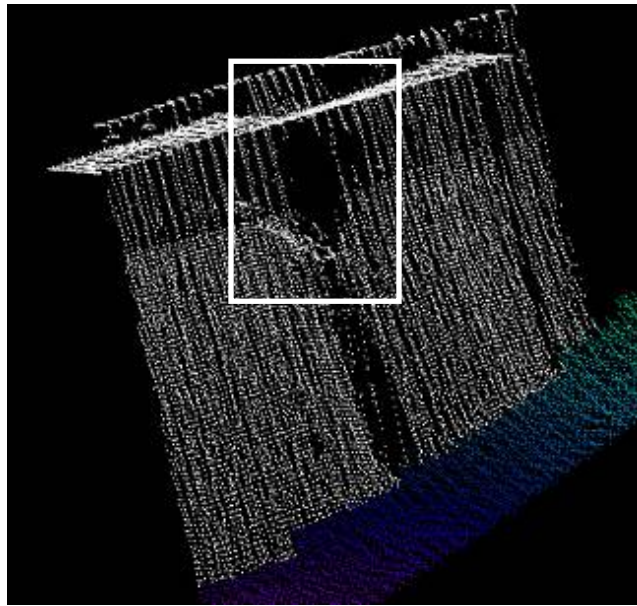
Fig. 6 - Area 1 – ID4 Crack in Hull on Forward starboard side.

The crack on the forward port side of the hull has been noted in surveys going back at least to the 1970s. When compared with data from 2009, the 2010

survey shows no apparent change in the size of this crack. The dimensions of the hole are approximately 1.27m by 2.20m.

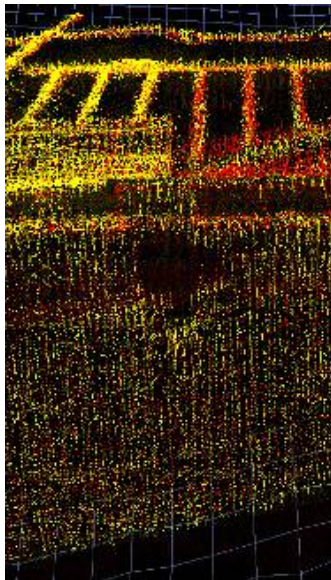
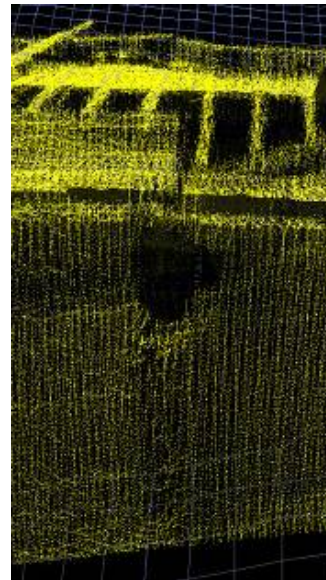
Fig. 7 Red = 2008 & Yellow = 2009

Fig. 8 Yellow = 2009 & Grey = 2010

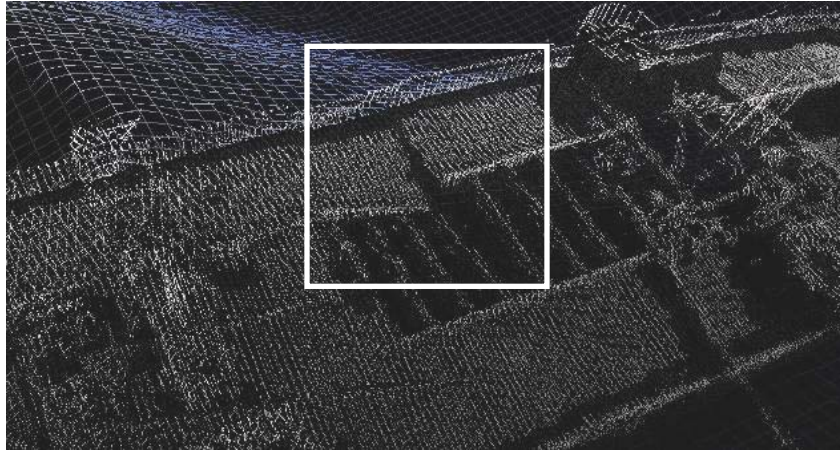
Fig. 9 - Area 2 – Deck plating at hold 2

The gradual collapse of deck plating above hold 2 is the section of the wreck which has shown the greatest change over time and the 2010 survey demonstrates that this continuing, albeit at an apparently slower rate than in 2008 and 2009. The collapse increased from 0.35m in 2006 to 0.5m in 2008 then to 1.10m in 2009 and now measures approximately 1.15m in 2010. Although the gradual collapse is continuing, the 2010 data potentially indicates a slowing in the rate of collapse or that it is being supported by another section of the hull.

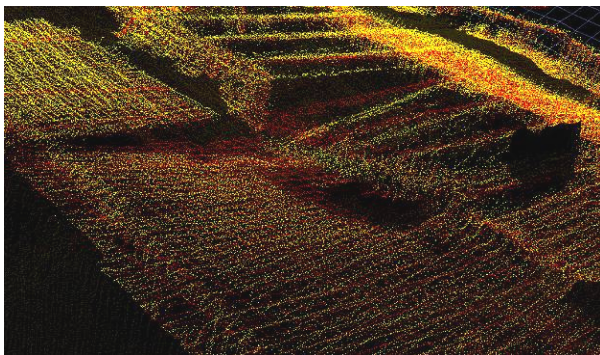
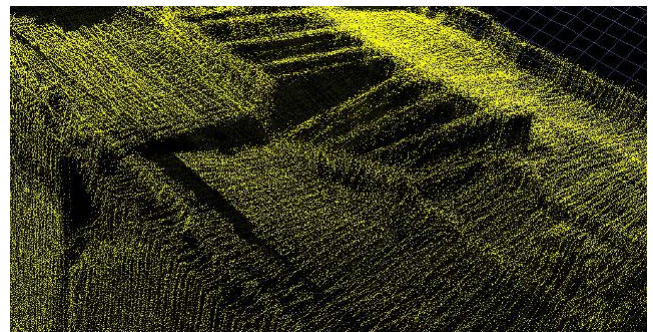
Fig. 10 Red = 2008 & Yellow = 2009

Fig. 11 Yellow = 2009 & Grey = 2010

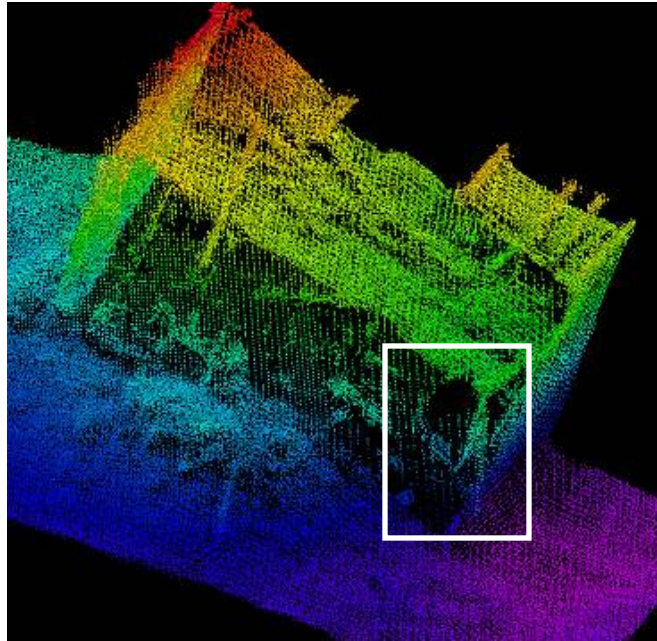
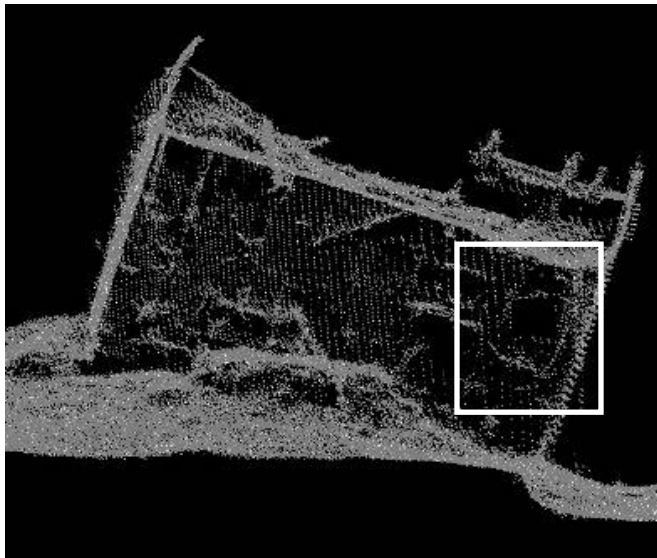
The aperture on the aft starboard side of the forward section was unchanged in size in 2009 and, similarly, the 2010 data does not indicate any changes in this area of the wreck. The following images show the bulkhead from two different angles. Both are taken from the 2010 data set.

Fig. 12 Hole in bulkhead aft of hold 3, 2010

Fig. 13 Hole in bulkhead aft of hold 3, 2010

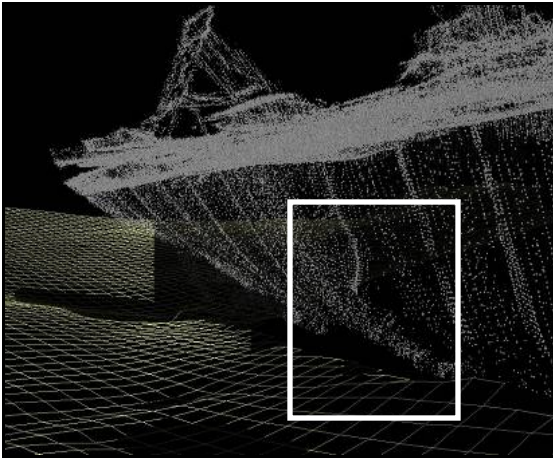
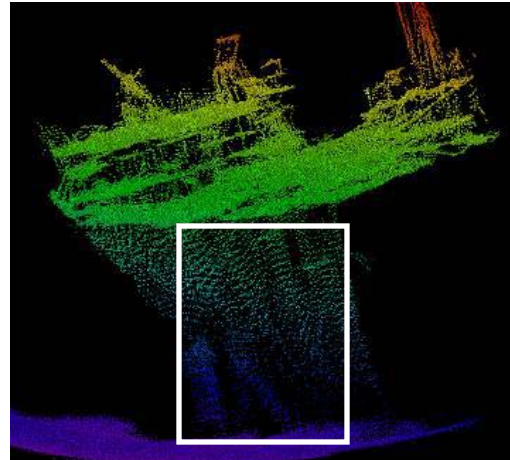
This split in the hull plating on the stern section of the wreck was identified in the 2009 survey using the multibeam unit in tilted mode. The 2010 survey data does not indicate any changes in this split. However, there was no tilted head function on the bow mounted sonar unit used for the 2010 survey and the density of data gathered in this awkwardly located area of the wreck makes it difficult to pick out the small detail of any potential changes.

Fig. 14 Split in hull plating, stern section, 2009

Fig. 15 Split in hull plating, stern section, 2010

5.8 It is recommended that monitoring of the wreck continues and that future surveys utilise a sonar head with a tilt capability where possible and are conducted in such a way as to ensure repeatability.

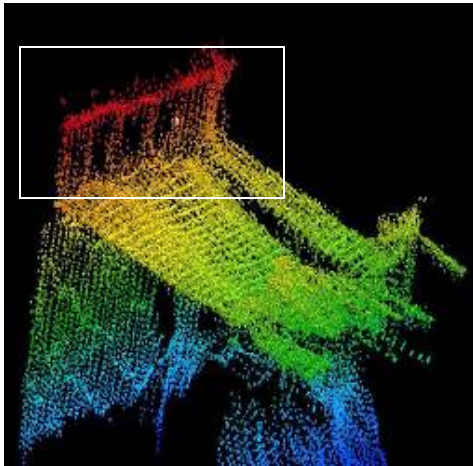
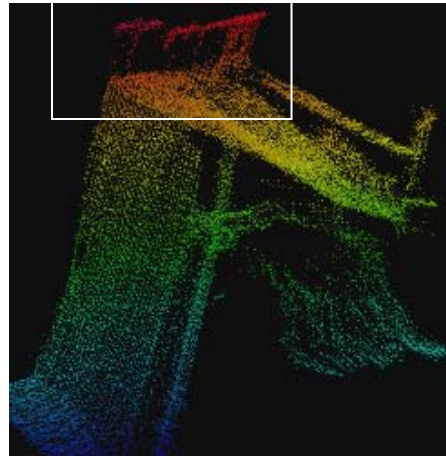
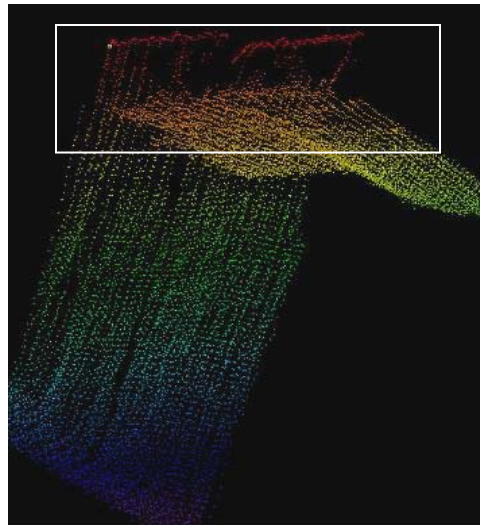
3.3.7 The 2008 survey data showed three holes in the port side gunwales adjacent to hold 2. In 2009, these holes appeared to be merging and the 2010 data shows that the holes remain in a similar condition to 2009.

Fig. 16 holes in gunwales, 2008

Fig. 17 Holes in gunwales, 2009

Fig. 18 Holes in gunwales, 2010

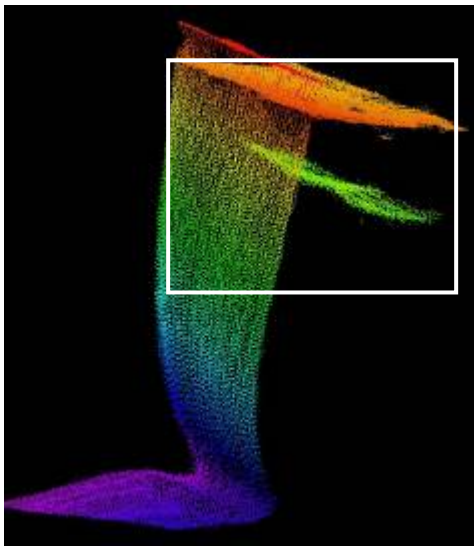
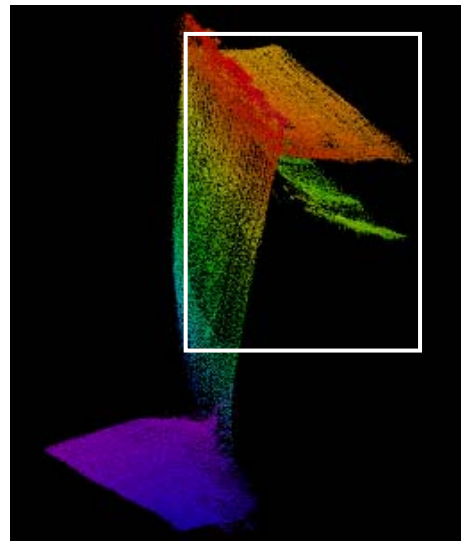
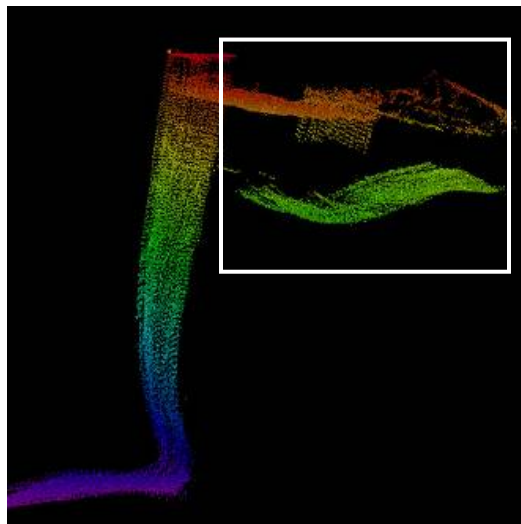
3.3.9 Previous surveys have noted indications of the 'tween deck cargo visible in Hold 1. This is again visible in the 2010 survey data set and shows little evidence of change from the previous survey.

Fig. 19 'Tween deck cargo, Hold 1, 2008

Fig. 20 'Tween deck cargo, Hold 1, 2009

Fig. 21 'Tween deck cargo, Hold 1, 2010

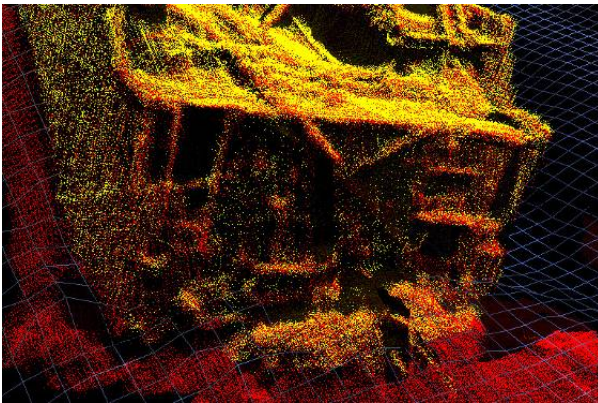
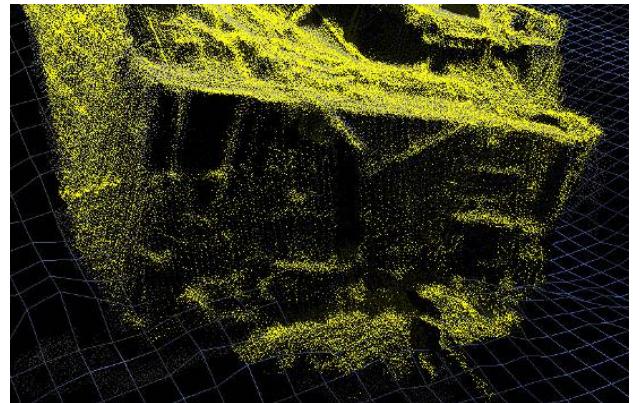
3.3.10 Some 'tween deck cargo has also been visible in Hold 3 in previous surveys. Hold 3 sustained significant damage when the vessel broke in two and sank and, therefore, the 'tween deck area at Hold 3 is more open than the other holds. The 2010 survey data was also able to visualise general debris and cargo material in this 'tween deck area, and it remains in a similar condition to previous surveys.

3.3.11 The images below show the damaged area at Hold 3 with two years of data overlaid in order to demonstrate any areas where change has and has not occurred.

Fig. 22 2008 data (Red) – 2009 data (Yellow)

Fig. 23 2009 data (Yellow) – 2010 data (Grey)

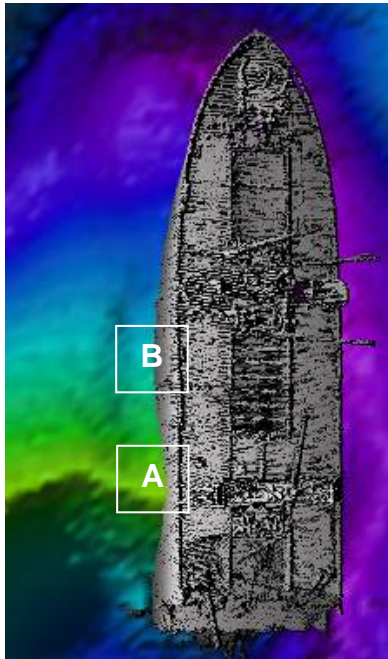
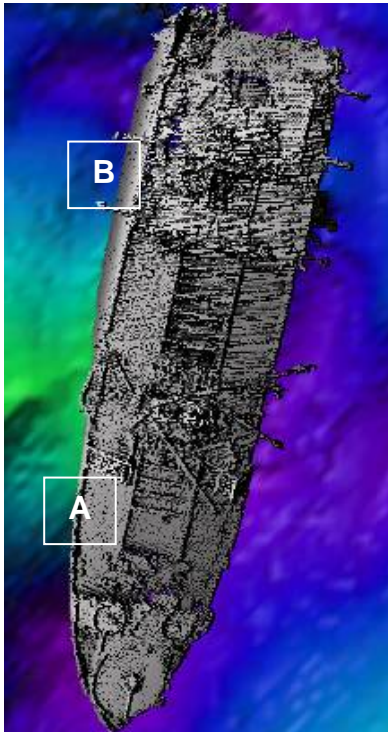
Fig. 24 Angle of orientation fore & aft of the crack at Hold 2

3.3.12 In order to help assess whether the hull forward of the crack at Hold 2 is at a different orientation to the hull aft of the crack, vertical angles of the hull on either side of the crack were measured as part of the 2009 survey. This showed that there was a slight difference in orientation. This was repeated with the 2010 survey data. The results showed that, as in 2009, there is a very small difference in orientation forward and aft of the crack. This difference appears to have increased slightly since 2009.

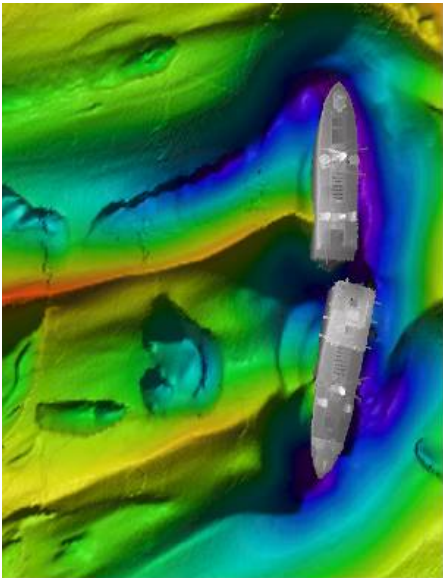
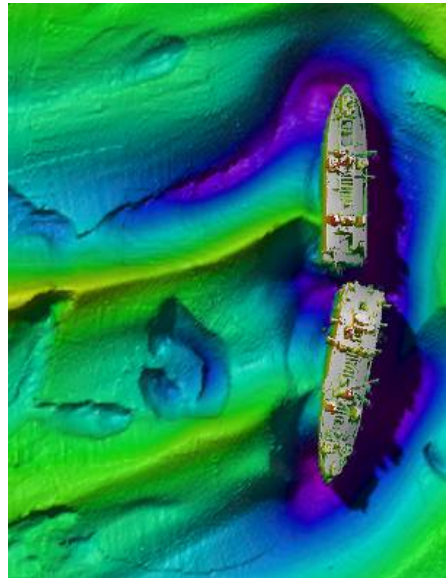
4.1.3 The scour pattern to the west of the wreck was identified as approximately 45m x 30m in 2009. The 2010 data shows that the scour pattern is still present and that its overall shape and position have remained constant over the year between the surveys. The dimensions are now approximately 45m x 35m.

Fig 25. Scour pattern 2009

Fig 26. Scour pattern 2010

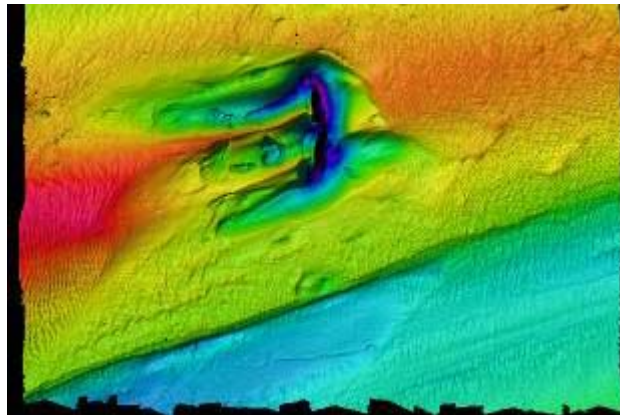
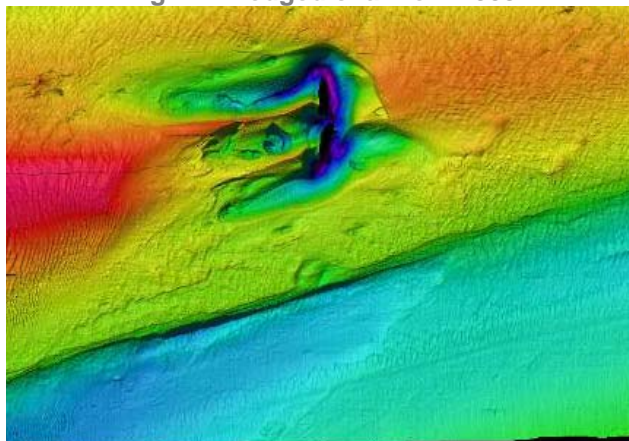
4.1.7 The dredged channel to the south of the wreck shows some signs of increased deposition along its central length.

Fig 27. Dredged channel - 2009

Fig 28. Dredged channel - 2010
