FLYER TO THE SHIPPING INDUSTRY

Crew evacuated following exposure to phosphine gas

Arklow Meadow: smoke from fumigant residue during discharge of maize cargo

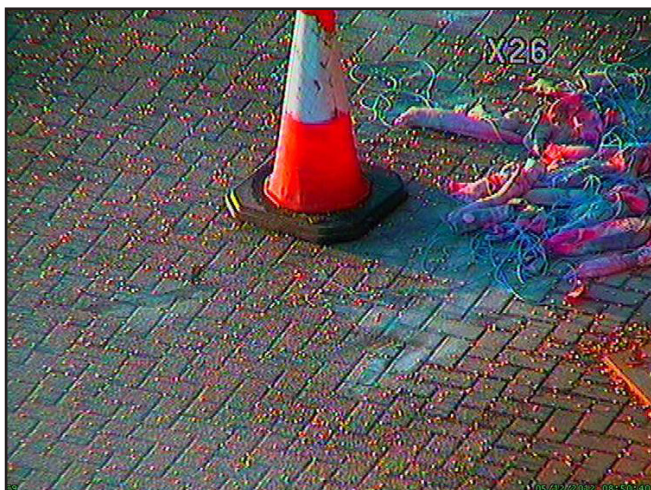
At this point, cargo operations were stopped and the spilled fumigant on the quay (**Figure 1**) was cordoned off. The fumigant retainers that remained by the vessel's holds were also collected and placed inside plastic bags. However, these soon started to smoke, so the crew were evacuated ashore. The local fire brigade was alerted and they reacted quickly to arrive on the scene. A 50 metre cordon was established around the vessel and houses and retail premises surrounding the port area were evacuated as a precautionary measure. Eight of *Arklow Meadow's* crew and a stevedore who had potentially been exposed to phosphine gas were taken to hospital for observation and decontamination.

Figure 1: Fumigant retainers and spilled fumigant

- A number of factors may cause a fumigant to remain active, regardless of the length of voyage. Where possible, all fumigant residues should be removed from the cargo holds before cargo discharge commences.

- The removal and disposal of fumigant and fumigant residues is potentially hazardous and should, wherever possible, be undertaken by a qualified fumigator.

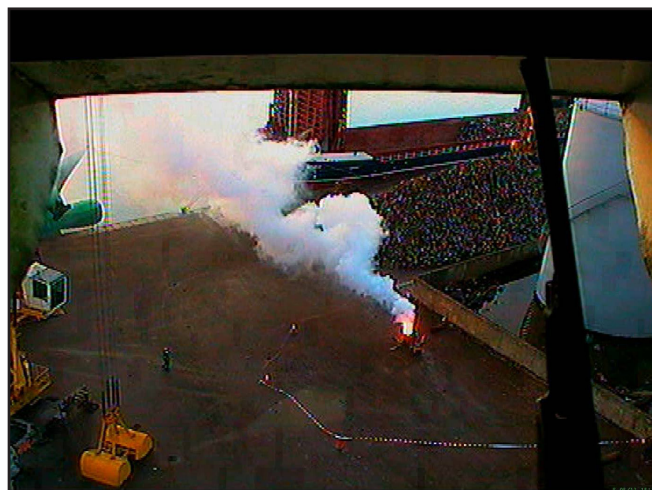
Figure 2: Disposal of the fumigant

A total of 89 fumigant retainers were recovered from the vessel and shore areas, leaving 21 fumigant retainers unaccounted for. The recovered retainers were neutralised by immersing them in water (**Figure 2**). It took 5 days for the level of phosphine gas in the vessel's cargo holds to reduce to an acceptable level.
