CONTENTS

SPECIAL BULLETINS

(ALL TIMES IN THIS BULLETIN ARE UTC)

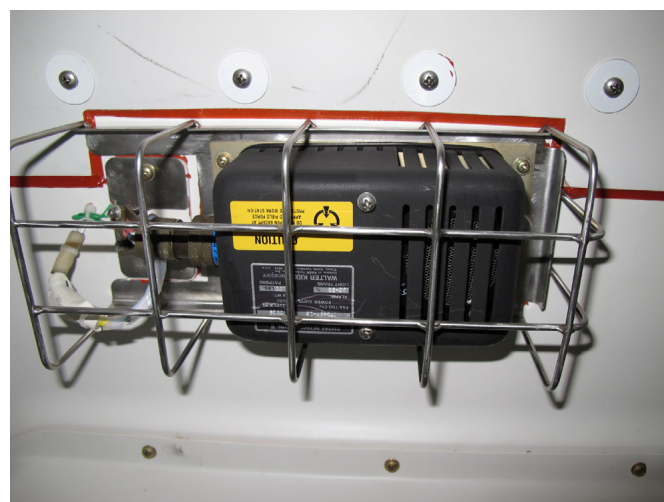
Figure 4

Forward baggage compartment smoke detector

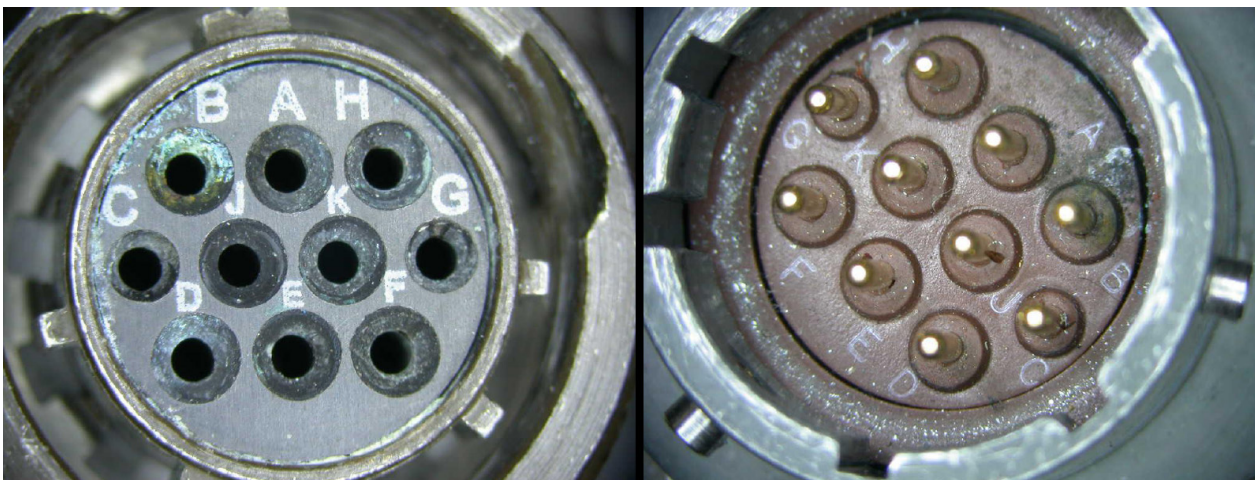
Figure 6

The manufacturer stated that if the deposits surrounding pin B were products of corrosion then this would indicate that moisture had been present, and if moisture caused a short circuit between pin B and the connector shell it would trigger a self-test. This would create the same effect as pressing the forward test button on the Fire Protection Panel, and would trigger the smoke warnings and arm the extinguishers.

The smoke detector was taken to an independent company specialising in electrical failure investigation. Using a scanning electron microscope with elemental x-ray analysis they determined that the deposits surrounding pin B on the smoke detector and on the corresponding hole B of the socket were products of corrosion. There was also evidence of corrosion deposits in several of the other socket holes.

Smoke detector socket (left) and plug (right) – corrosion deposits visible at hole B and pin B

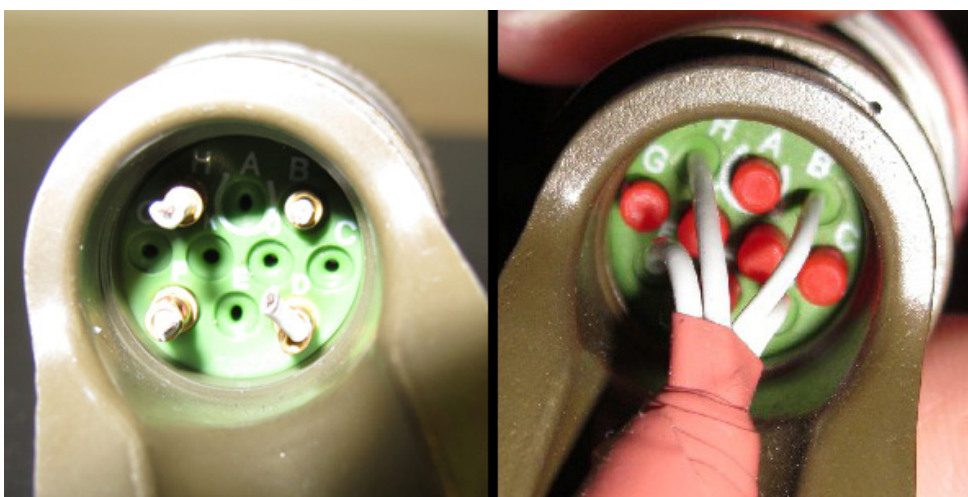
Figure 7

G-ECOF smoke detector socket (left) with blanking pins missing; another socket (right) showing installation of red blanking pins

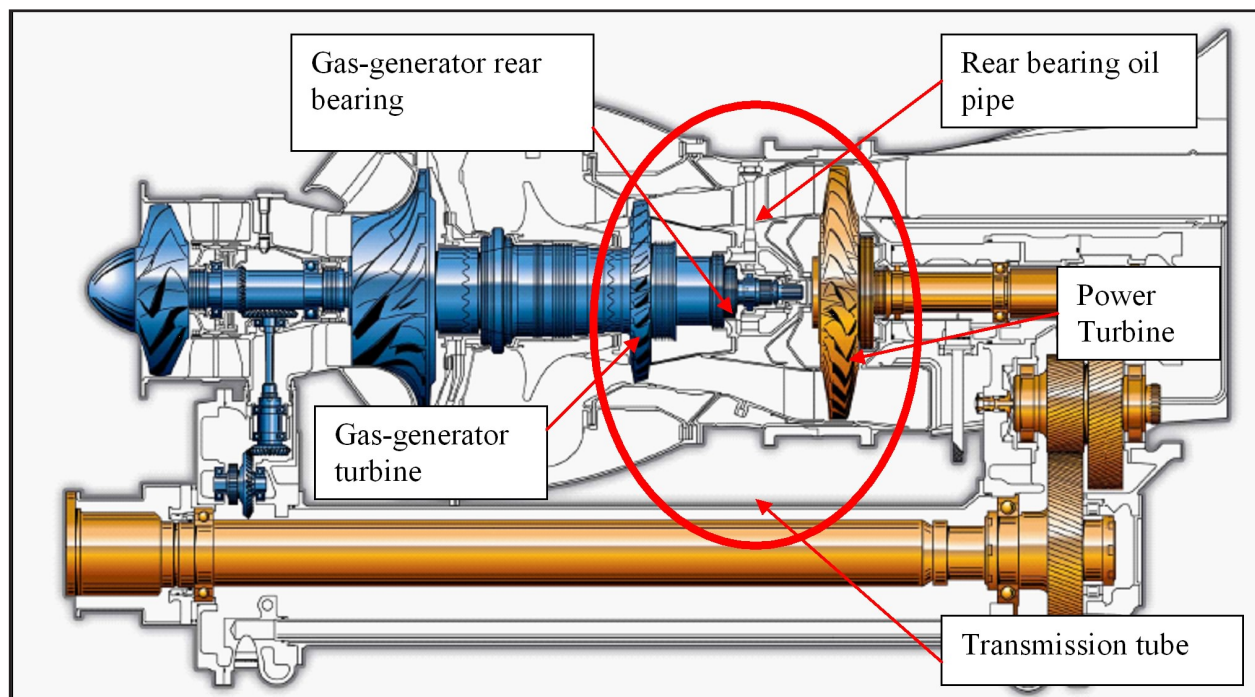
Figure 3

Location of the oil leak and fire

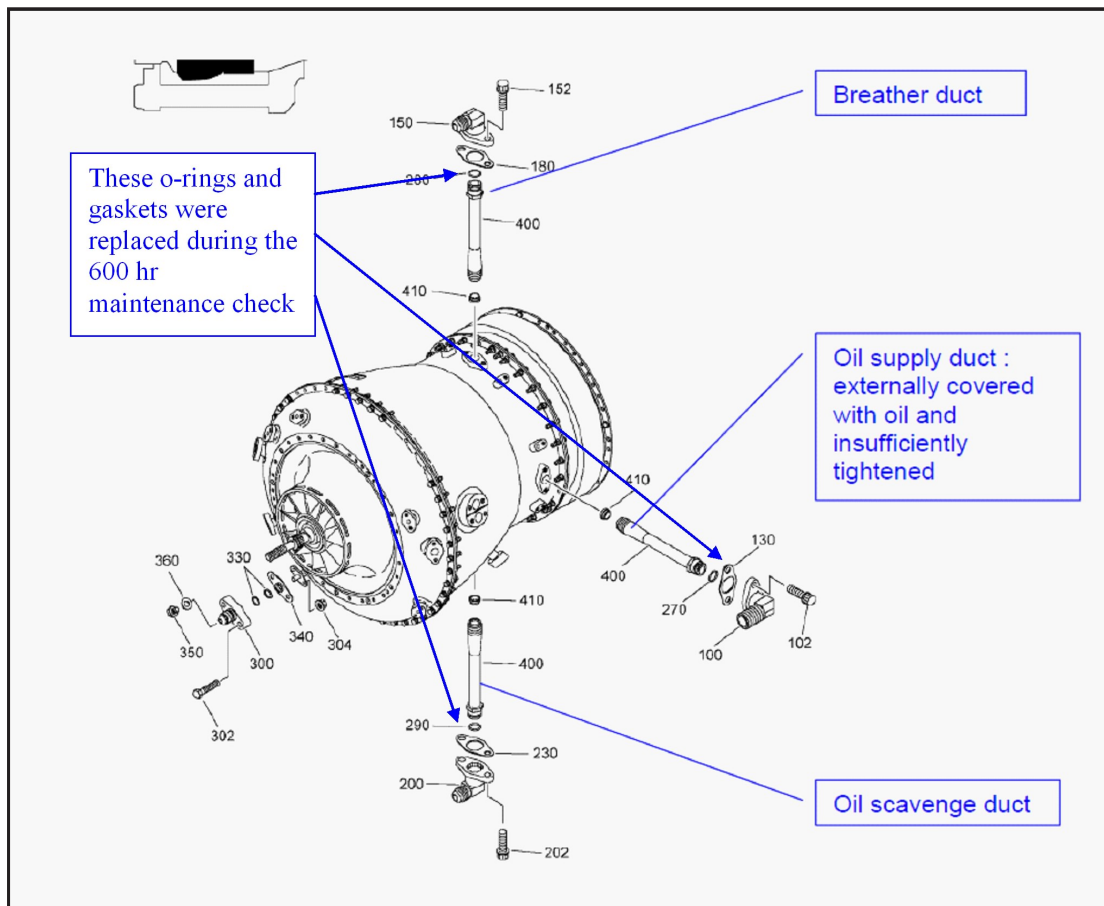
Figure 4
Engine strip findings

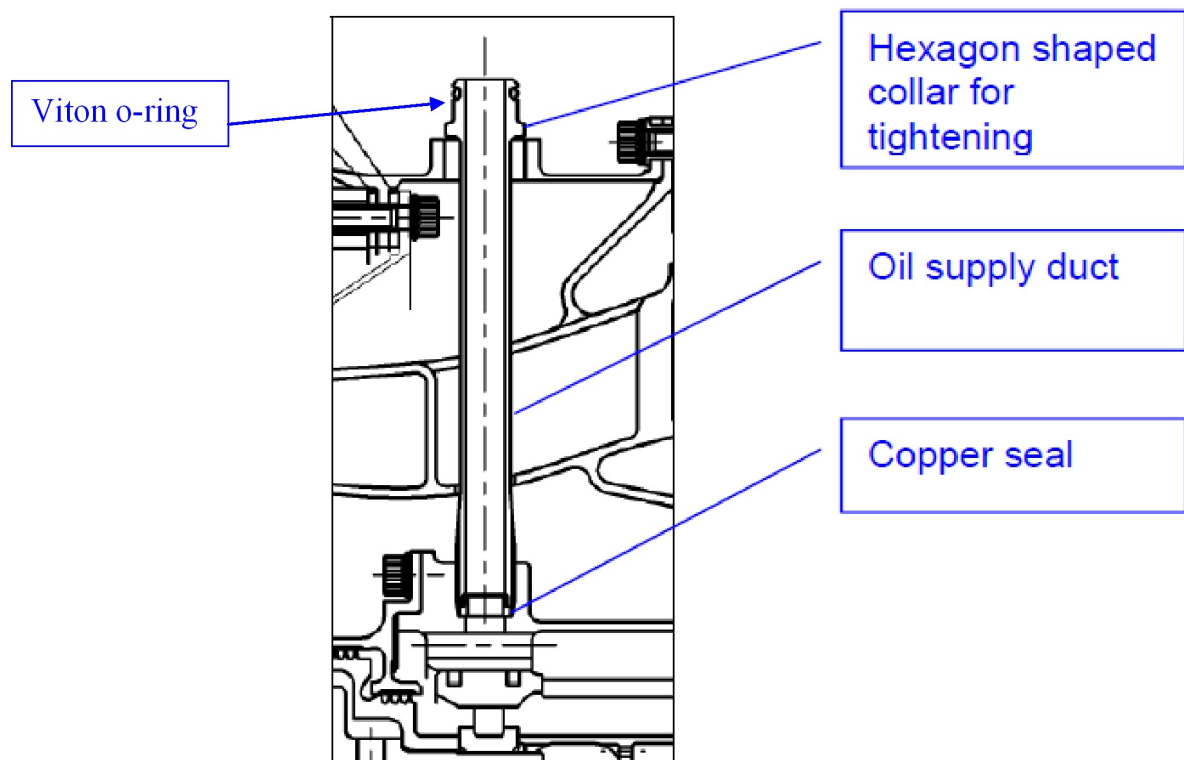
Figure 5
Bearing oil supply duct

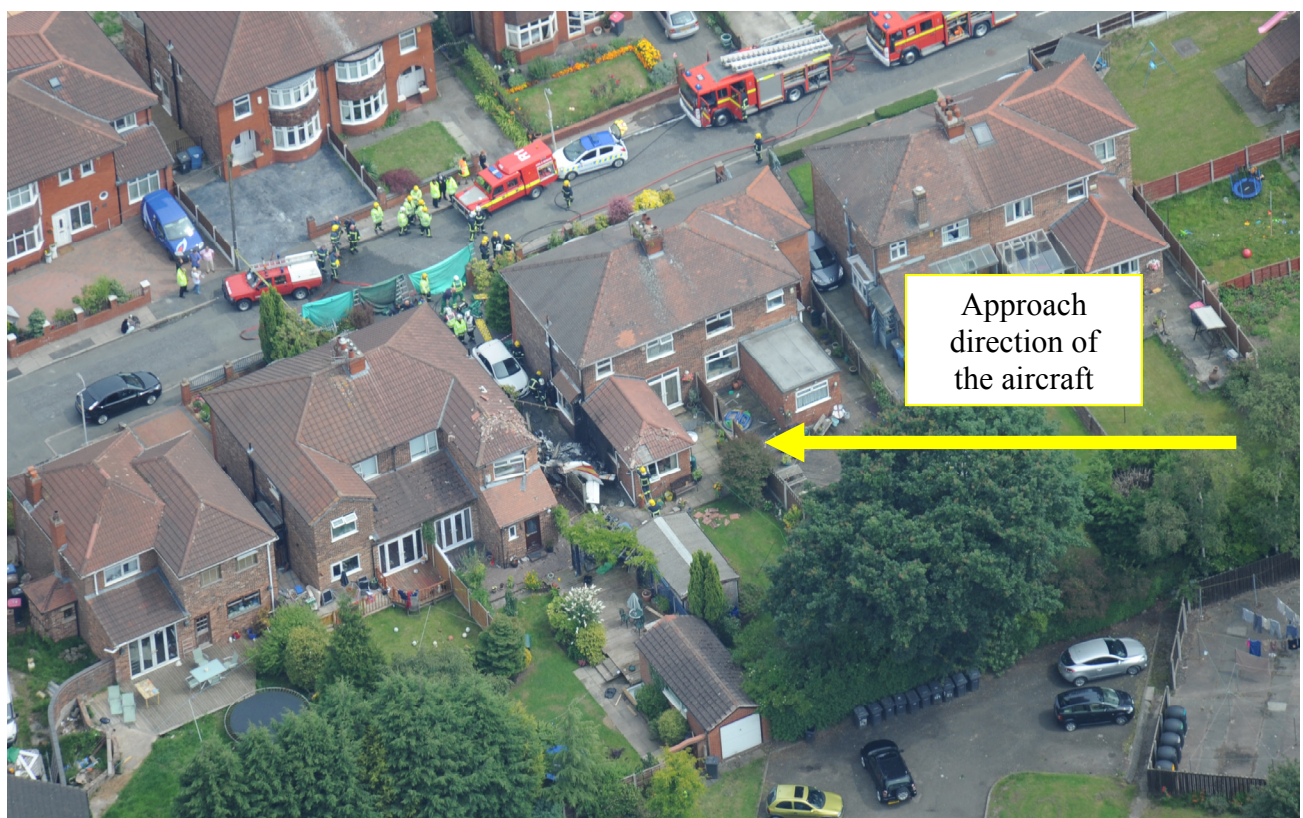
Initial inspection of the wreckage on-site showed that the throttle was approximately two-thirds open and the mixture lever was in the FULL RICH position. The carburettor heat lever was in the OFF position and the flap lever position confirmed that first stage flaps had been selected. The fuel selector was in the OFF position, as was the magneto key switch. The primer pump was found unlocked and slightly extended from its stowed position. The officers who attended from the fire and rescue services confirmed that they had not intentionally changed any switch or lever positions during the extraction of the aircraft occupants or to make the aircraft safe.

Figure 4
Accident site
