CONTENTS

AAIB FIELD INVESTIGATIONS

Bolkow 208C Junior	D-EGFU	02-Sep-11	3
Cessna T210N	XB-LLD	14-Nov-11	13
YAK-52	RA-3585K	28-Apr-11	21

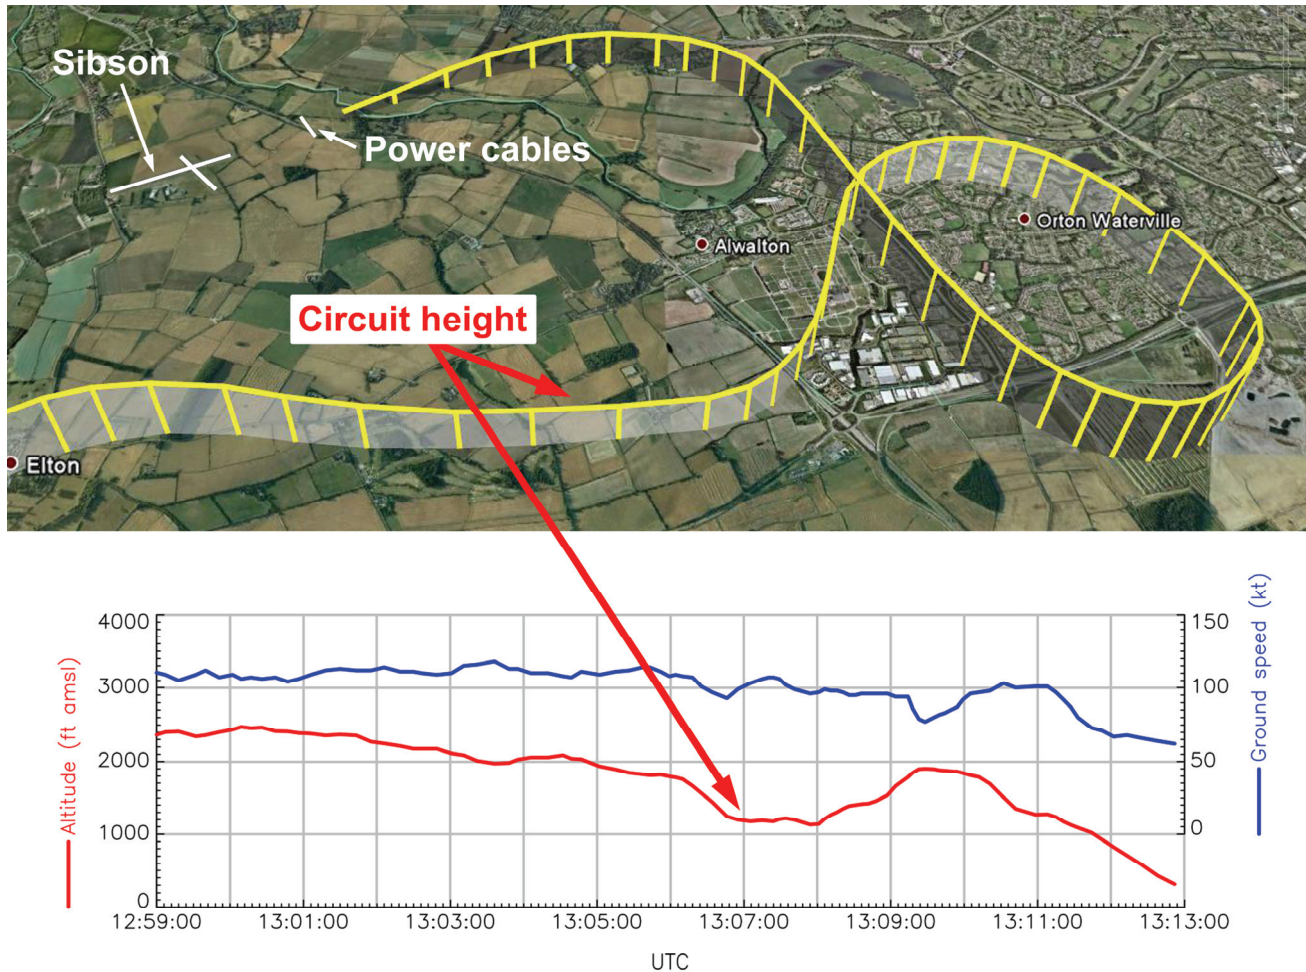
The unit recorded the aircraft taking off from Long Marston Airfield at 1224 hrs and flying in a direct track to Sibson Airfield at an altitude of about 2,300 ft. South of Sibson, the aircraft descended to about 1,200 ft and then tracked to the east before briefly turning north and then carrying out a climbing turn in a wide orbit over the area of Orton Waterville. Halfway through the orbit, the aircraft started to descend once more and joined the left base for Runway 24. The pilot then flew a gentle descending turn onto the final approach, establishing on the runway centreline at about 1.2 nm from the Runway 24 threshold. The last recorded point was approximately 300 m east of the power lines at 1312:52 hrs. Figure 1 shows the GPS recording in the vicinity of Sibson Airfield.

GPS track in the vicinity of Sibson Airfield

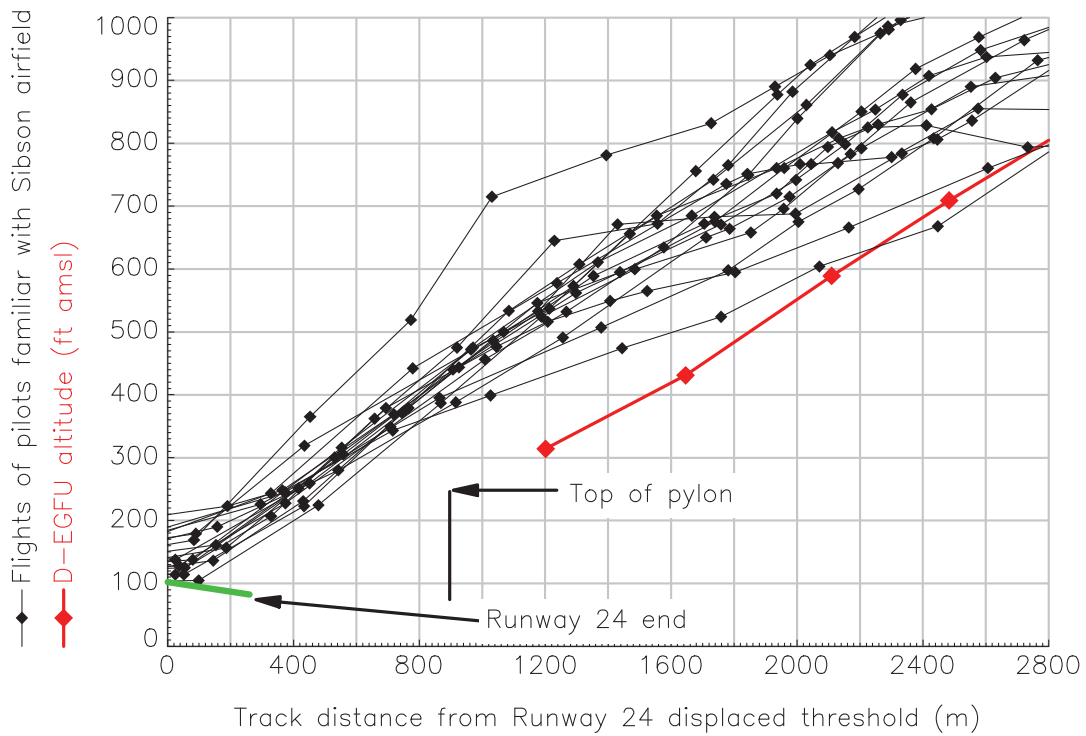
Figure 2 compares aircraft GPS height with track distance from the Runway 24 displaced threshold. Superimposed on the chart is the representative position and height of the pylon towers running closest to the runway and the part of Runway 24 between the start of the prepared runway surface and the displaced threshold. The tracks depicted in black were recorded on a number of aircraft flown by pilots familiar with Sibson Airfield. These flights cleared the pylon towers by approximately 150 ft or more. The red track is of the accident aircraft.

Comparison of the D-EGFU accident approach with approaches made to the same runway by pilots familiar with the airfield

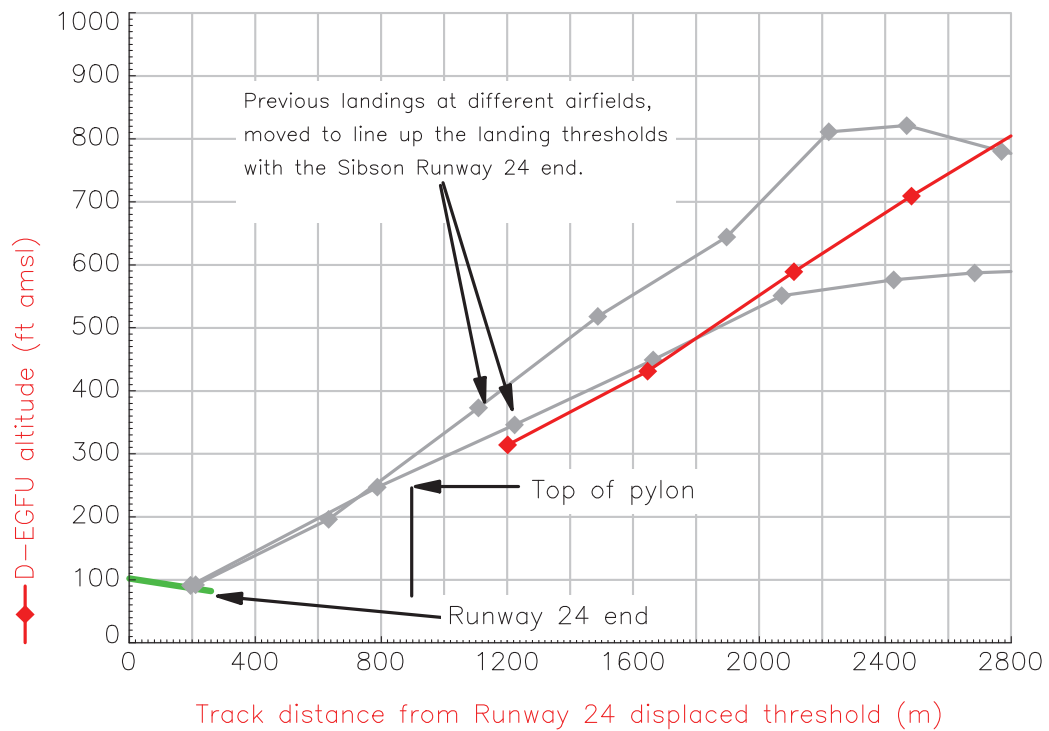
Two of the previous landings recorded by the GPS unit recovered from D-EGFU had been to runway thresholds that could be clearly referenced. Figure 3 overlays these approaches, together with the approach from the accident flight, aligning the other runway thresholds with the start of the prepared runway surface (not the displaced threshold) of Runway 24 at Sibson. The comparison, whilst not statistically robust, indicates a possibility that the aiming point for the landing may have been the start of the runway and not the displaced threshold.

Comparison of the accident approach with approaches at other airfields disregarding the displaced threshold

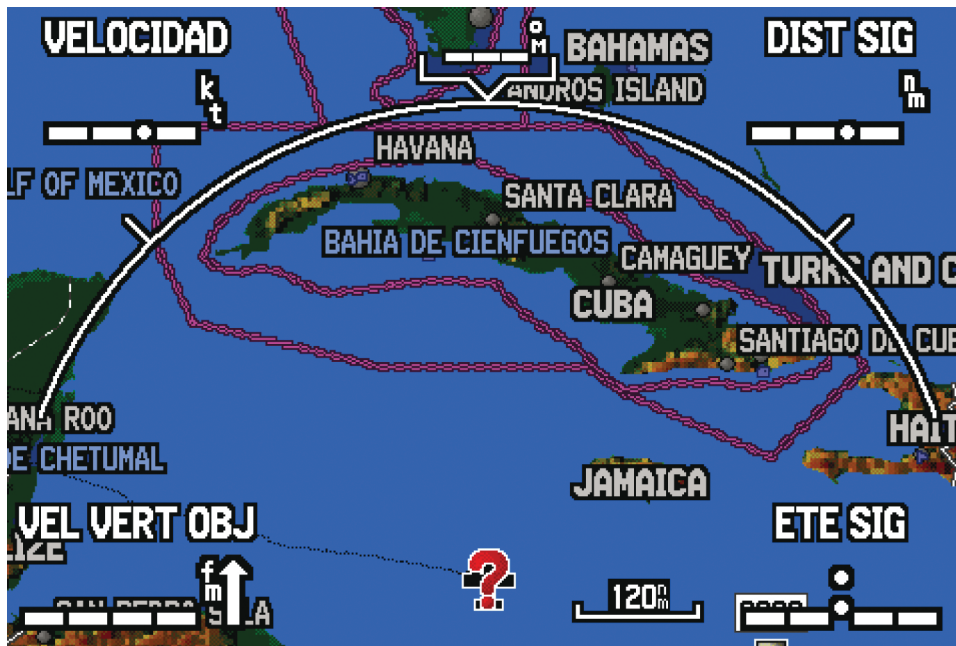
Figure 1

GPS map display showing track (thin black line at bottom left) to the point where power/signal was lost (indicated by question mark). (Note Cayman Islands are not displayed)

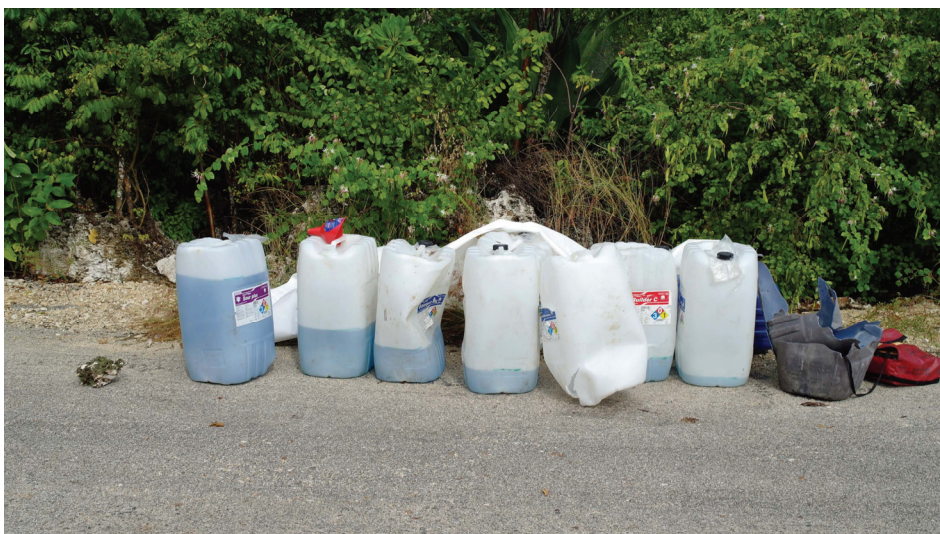
Figure2

The row of seats behind the pilots had been removed in order to accommodate the 10 plastic containers of fuel in the cabin. Three containers were ruptured and were empty; another was damaged but still contained approximately 12 litres. One was nearly full, containing an estimated 50 litres, with the remainder containing smaller amounts. The total fuel recovered was around 126 litres. The containers were fitted with screw caps, with pieces of polythene sheeting inserted into them, perhaps in an attempt to improve sealing or to minimise the escape of fuel vapour. A photograph of the fuel containers, taken after they had been removed from the wreckage, is shown in Figure 2.

Fuel containers carried in the aircraft cabin

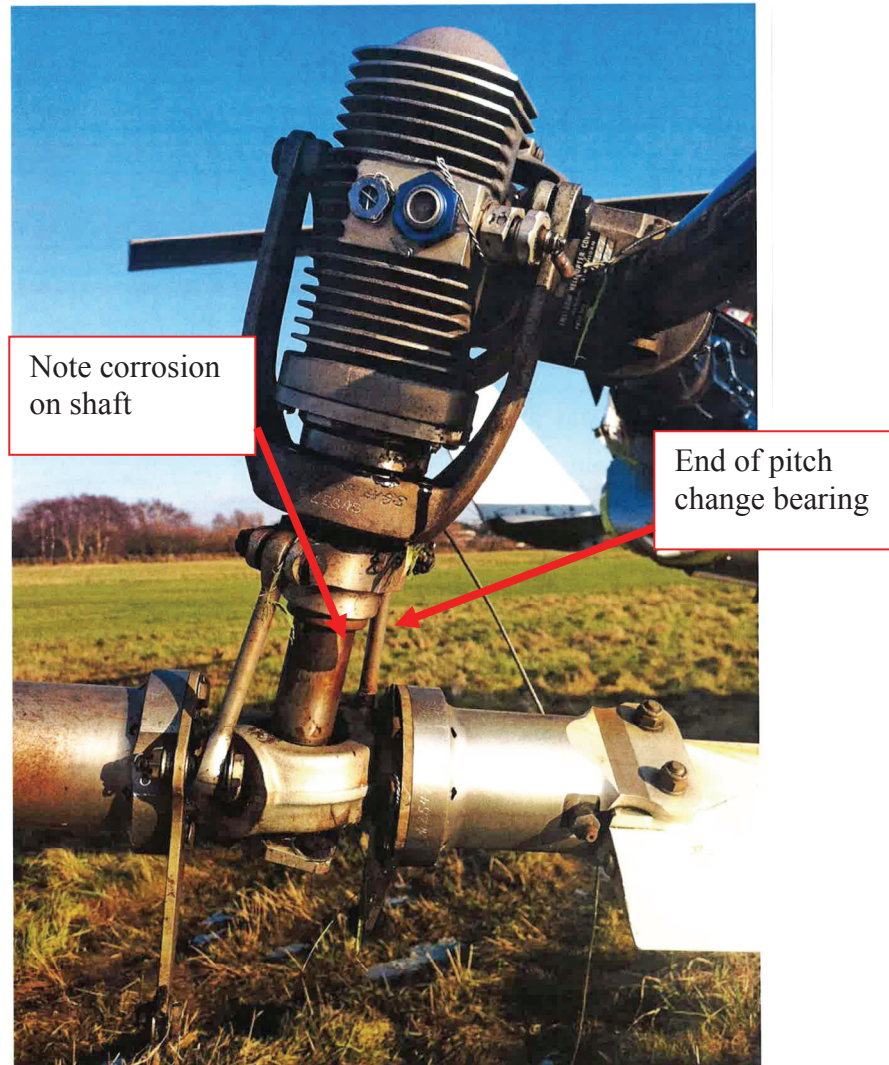
Figure 1

Before the aircraft was moved, it was noted that the yaw control cable on the left side of the tail boom had been

Tail rotor assembly after the accident

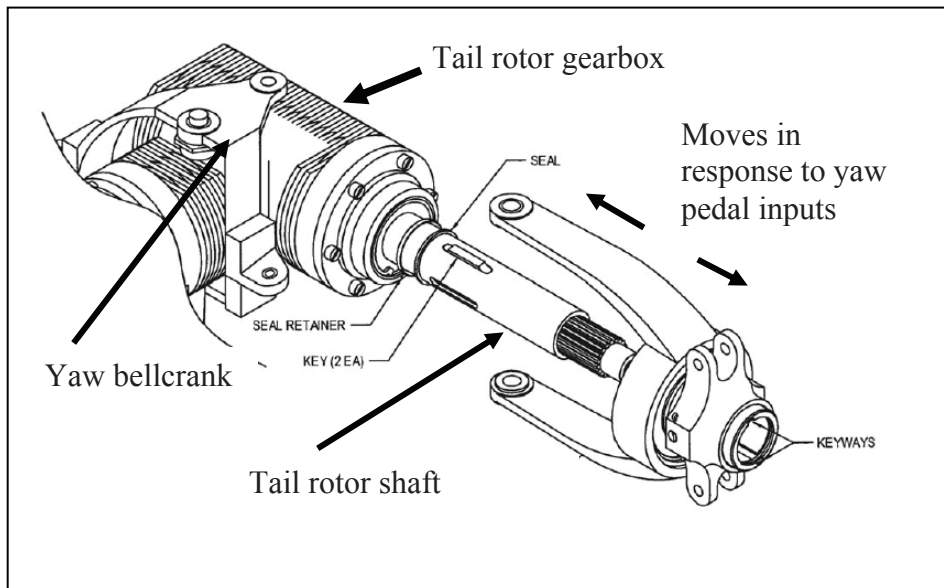
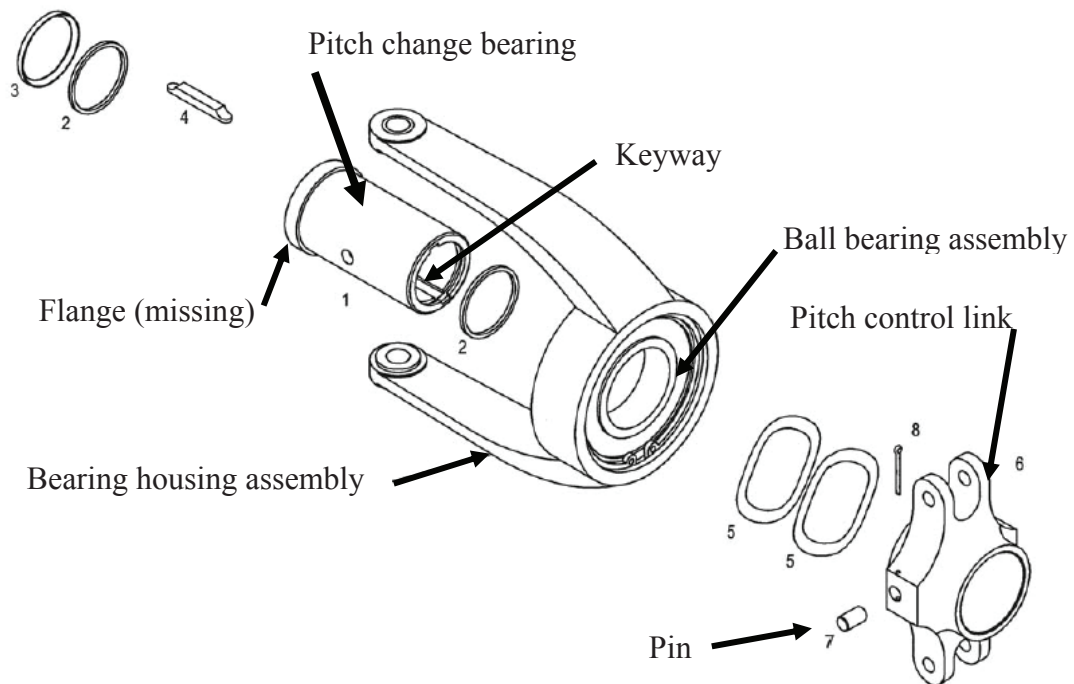
Figure 2

It was immediately apparent that the flange on the inboard end of the pitch change bearing had broken away and was missing. The separated portion would have to have broken into several pieces in order *not*

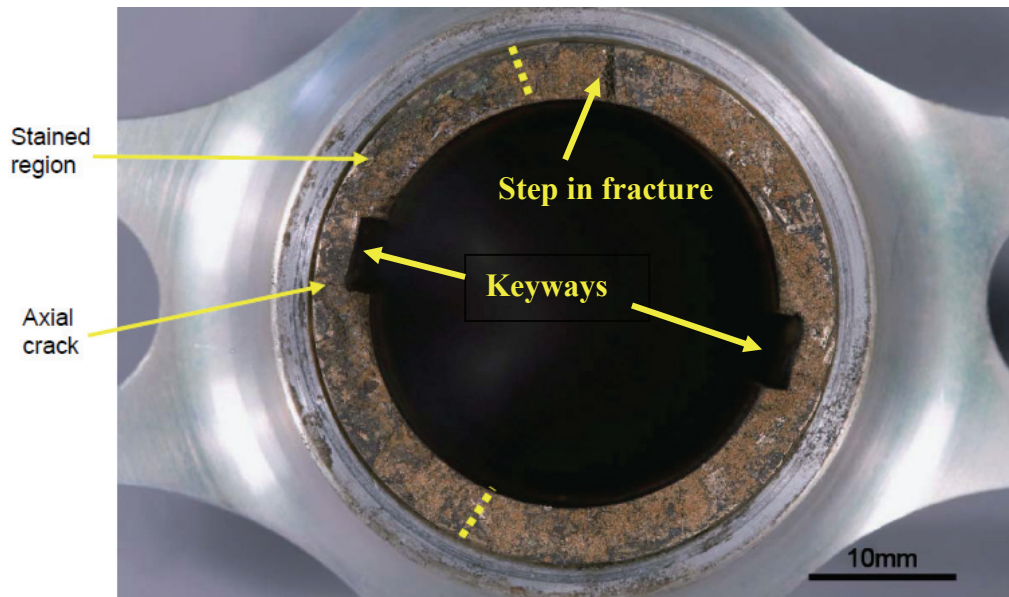
Figure 3

The bearing, which was manufactured from sintered bronze, was examined under a microscope and the fracture face was found to be covered with grease-like deposits, with the staining more prominent over

View of bearing fracture face

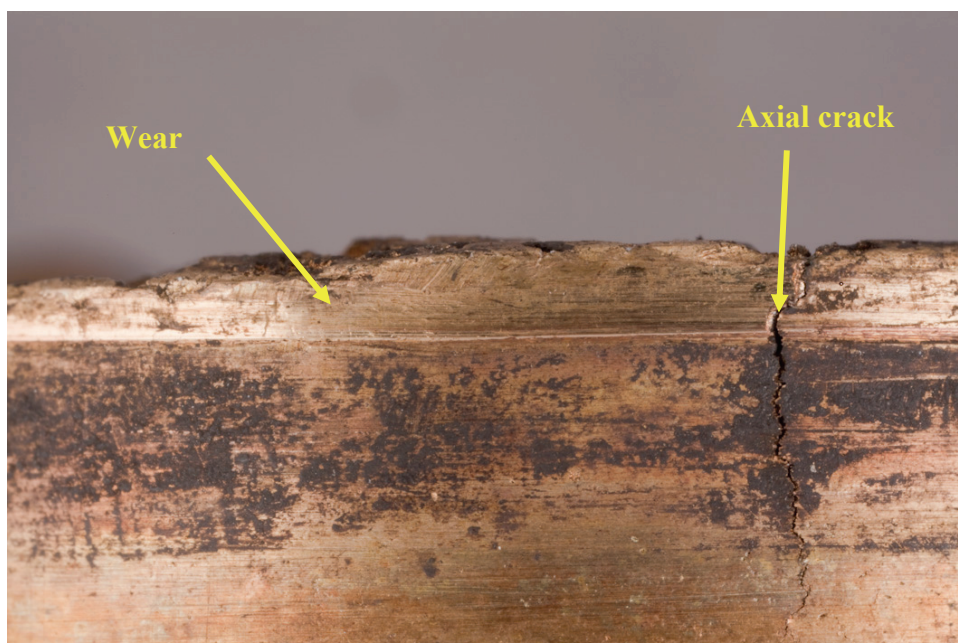
Figure 4

View of bearing outer surface, showing crack and wear mark

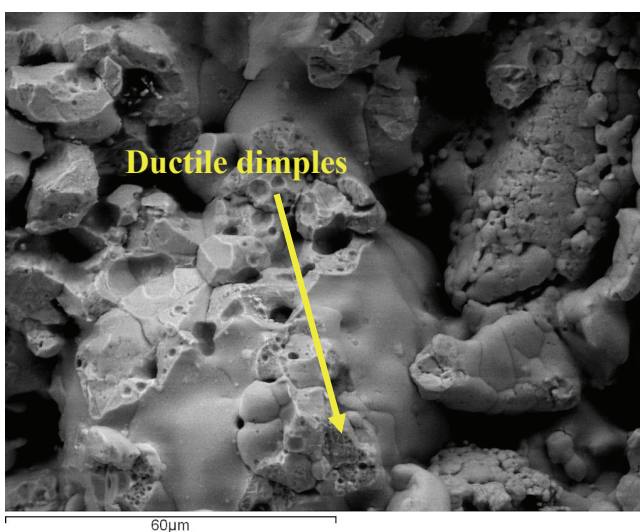
Figure 5a

The SEM examination revealed different features between the fracture surfaces of the stained and clean regions. Whilst the fracture was intergranular (ie following the surface of the powder particles) in both cases, ductile dimples, consistent with overload failure, were visible in patches in the clean areas, where adjacent particles had bonded. In contrast, the fracture surface within the stained region was masked by corrosion products, with an absence of ductile dimpling. There was insufficient evidence in this area to determine the mode of crack growth. Photographs of the fracture surfaces of the two regions are shown in Figures 5a and 5b.

Fracture surface in clean area

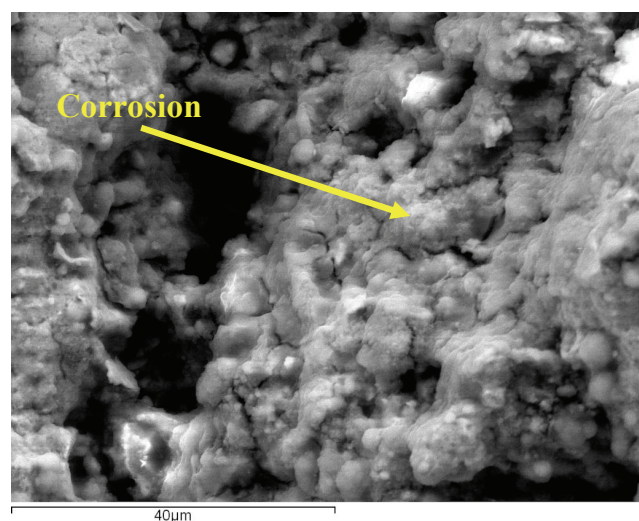
Figure 5b

Energy dispersive X-ray (EDX) analysis was carried out within the stained region of the fracture to determine the elemental composition of the corrosion deposit. This revealed the presence of chlorine, which is corrosive to bronze. A comparative analysis conducted on the clean area revealed that the main elements present were copper, tin and iron, which is consistent with AMS 4805. It was concluded that the chlorine was likely to have come from atmospheric moisture.

Fracture surface in stained area
