CONTENTS

SPECIAL BULLETINS

COMMERCIAL AIR TRANSPORT

FIXED WING

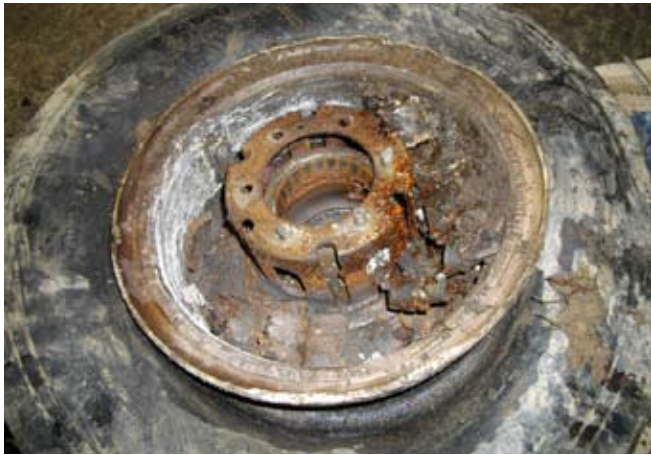
Figure 2
Right brake

The right brake had almost completely disintegrated (Figure 2) and loose pieces, mainly of friction material, were found in the wheel. The whole assembly showed signs of massive overheating and most elastomeric seals had disintegrated. The left brake had not broken up, but similar evidence of overheating had caused some melting and distortion of friction pads and stators (Figure 3).

Both brakes had suffered exposure to very high temperatures, causing melting and deterioration. The right brake had almost completely disintegrated but the left was also on the verge of disruption. It was evident that the right brake was losing fluid and that, in these circumstances, emergency pneumatic braking would also have been ineffective. The trail of hydraulic fluid and the fire reported by witnesses was consistent with hydraulic fluid coming into contact with very hot components of the right brake.

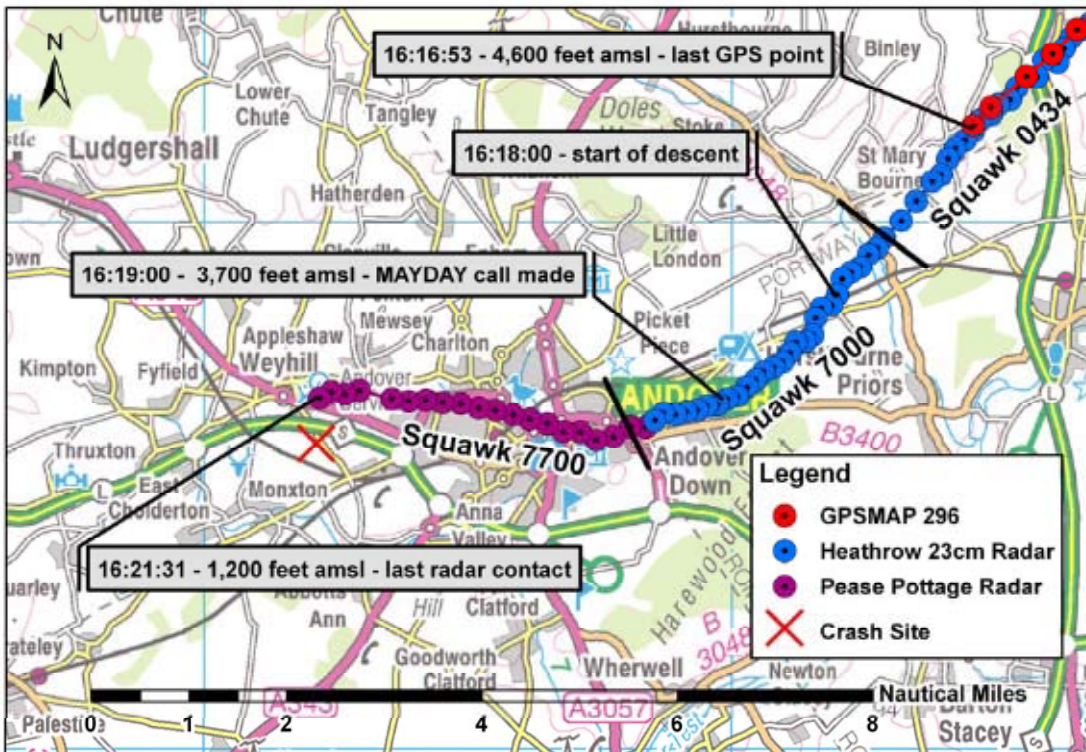
Figure 1

Figures 1 and 2 also show that the GPS stopped recording during the period the pilot was in contact with Farnborough LARS. For the GPS to stop recording in flight it was either operating on batteries, which happened to run out at that point, or the signal to the GPS satellites was lost while the GPS remained powered. The GPS was, however, panel mounted, which included a connection to the aircraft electrical power supply, and an antenna mounted on top of the instrument dash via BNC connectors and a coaxial cable. A check of the antenna at the AAIB showed that it was still serviceable.

Final portion of G-TOOT accident track from GPS and radar

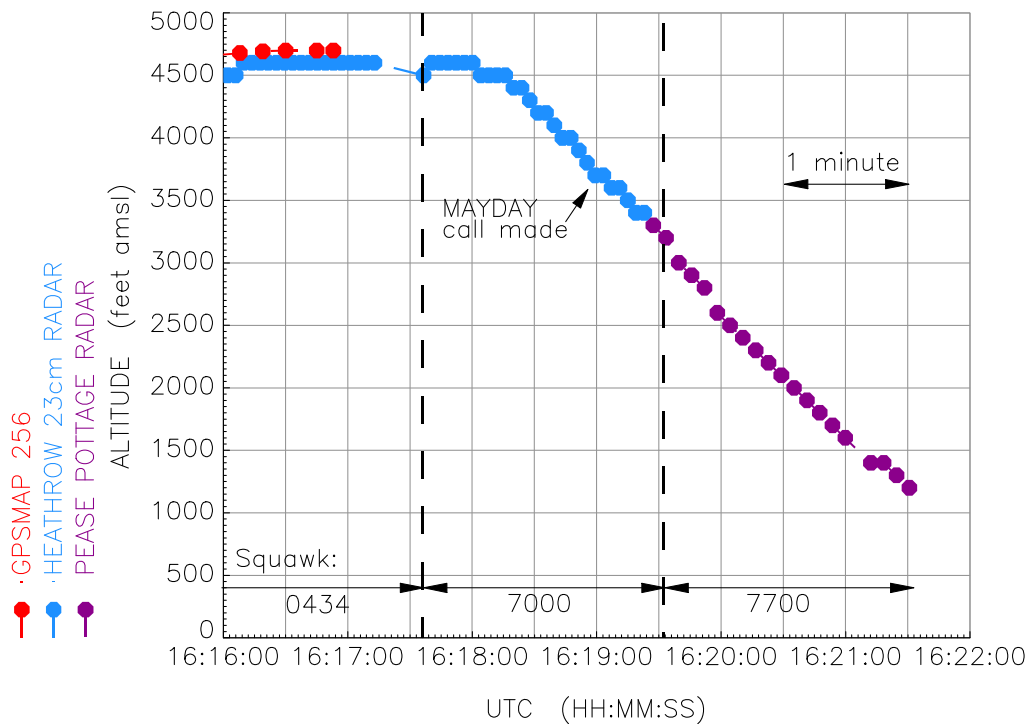
Figure 2 shows that the aircraft started descending 30 seconds after the squawk code of 7000 was selected. The descent rate was approximately 1,000 ft/min. The groundspeed during the descent (not illustrated) remained between 100 and 110 kt, slowing to 80 kt over the last 20 seconds.

G-TOOT altitude and Mode A squawk codes

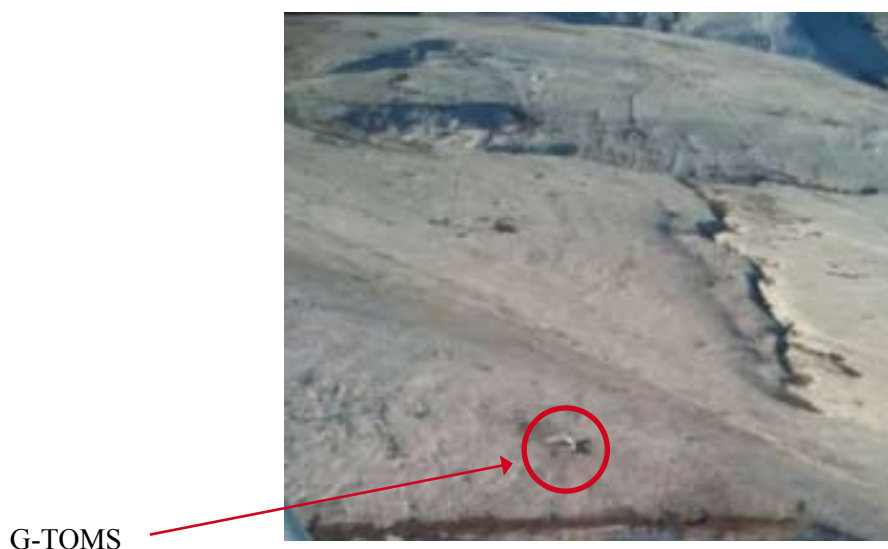
Figure 1

The pilot became lost in a snow storm and descended to establish VMC. He noticed that he was set to collide with terrain and opened the throttle to regain a safe altitude. There was no response from the engine and the aircraft made a heavy landing, which caused it to pitch over onto its canopy.

G-TOMS inverted on hillside
(photograph courtesy of Cambrian Flying Club)

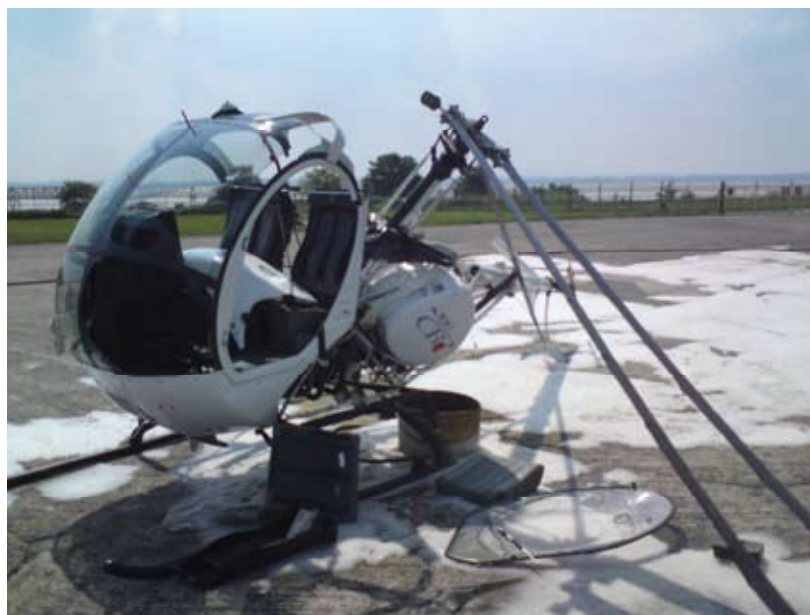
Figure 1

The manufacturer examined photographs of the helicopter and of relevant components, which were taken after the accident and confirmed that the damage to the aircraft was consistent with ground resonance.

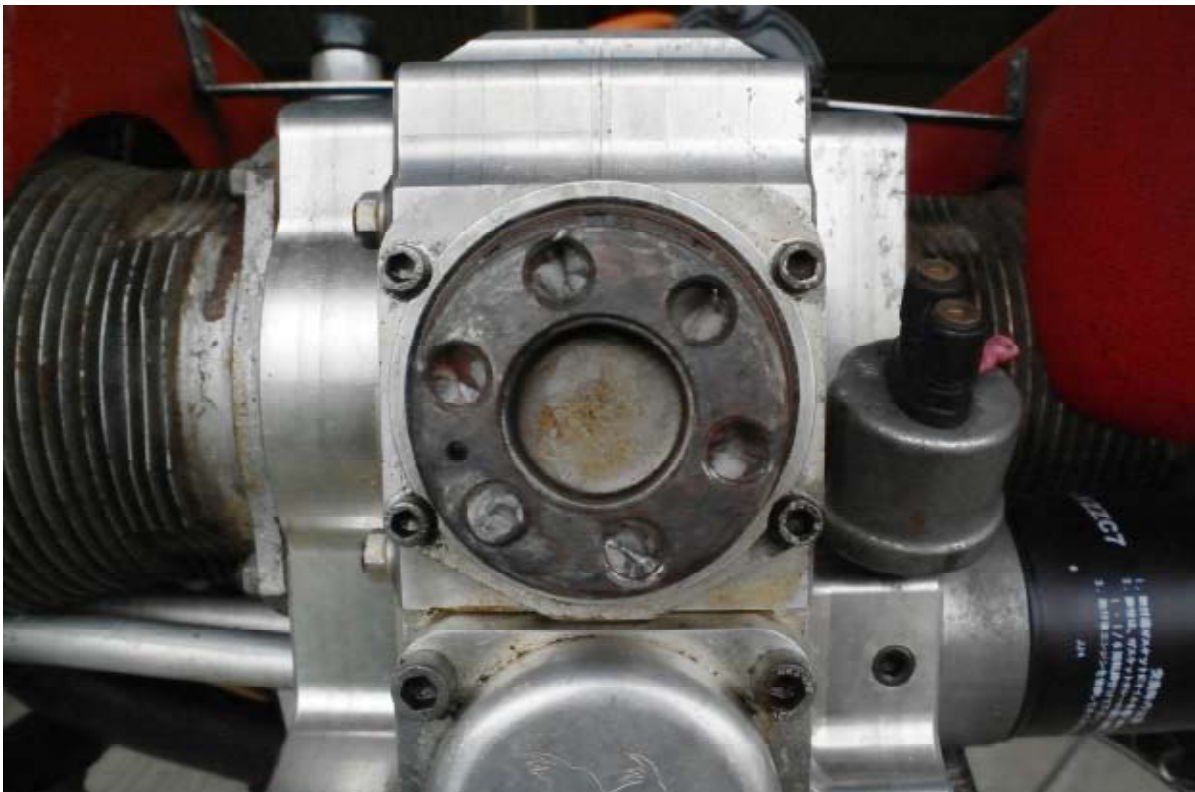
Figure 1

Front face of crankshaft showing shanks of failed screws still in-situ.

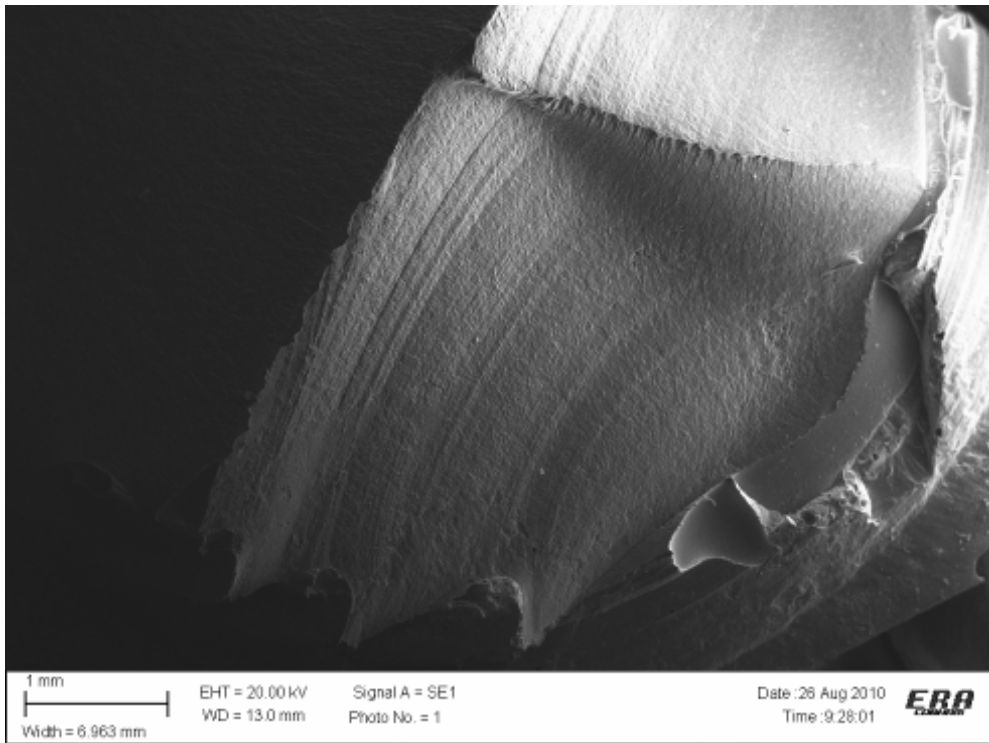
Figure 2

SEM image of beach marks indicating HCF with multiple initiations.
