CONTENTS

COMMERCIAL AIR TRANSPORT

List of recent aircraft accident reports issued by the AAIB 112
(ALL TIMES IN THIS BULLETIN ARE UTC)

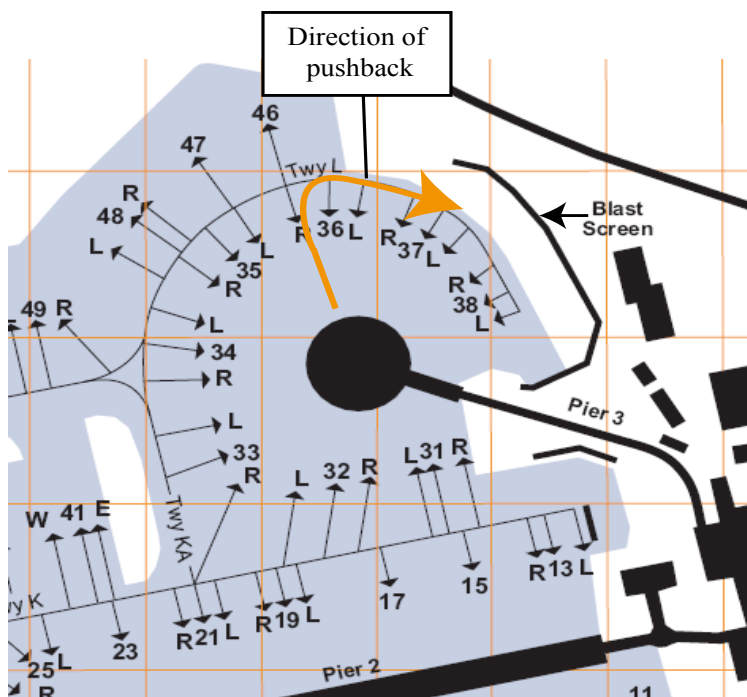
Figure 1

The right wingtip of the aircraft collided with a blast fence when the aircraft was pushed back into an area of taxiway with insufficient clearance for its wingspan. This and other large aircraft types were prohibited from parking on stands in this area but not from pushing back onto the taxiway adjacent to them. One safety recommendation was made.

The trailing edge of the right winglet had sustained skin damage in its collision with the blast fence. An inspection of the surrounding structure revealed no further damage and the aircraft was returned to service after repair.

Pier 3, Stands 31-38 and blast fence

Safety Recommendation 2006-137

It is recommended that Gatwick Airport Limited should issue a Managing Director's Instruction or equivalent notice advising all operators and handling agents that:

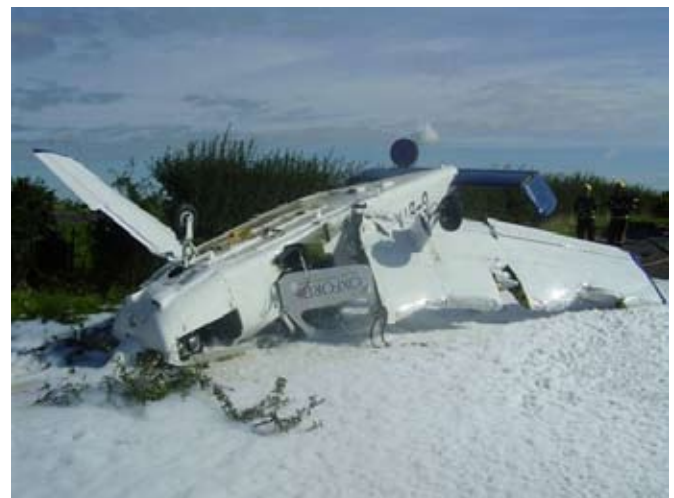
Figure 1

Photograph of aircraft wreckage

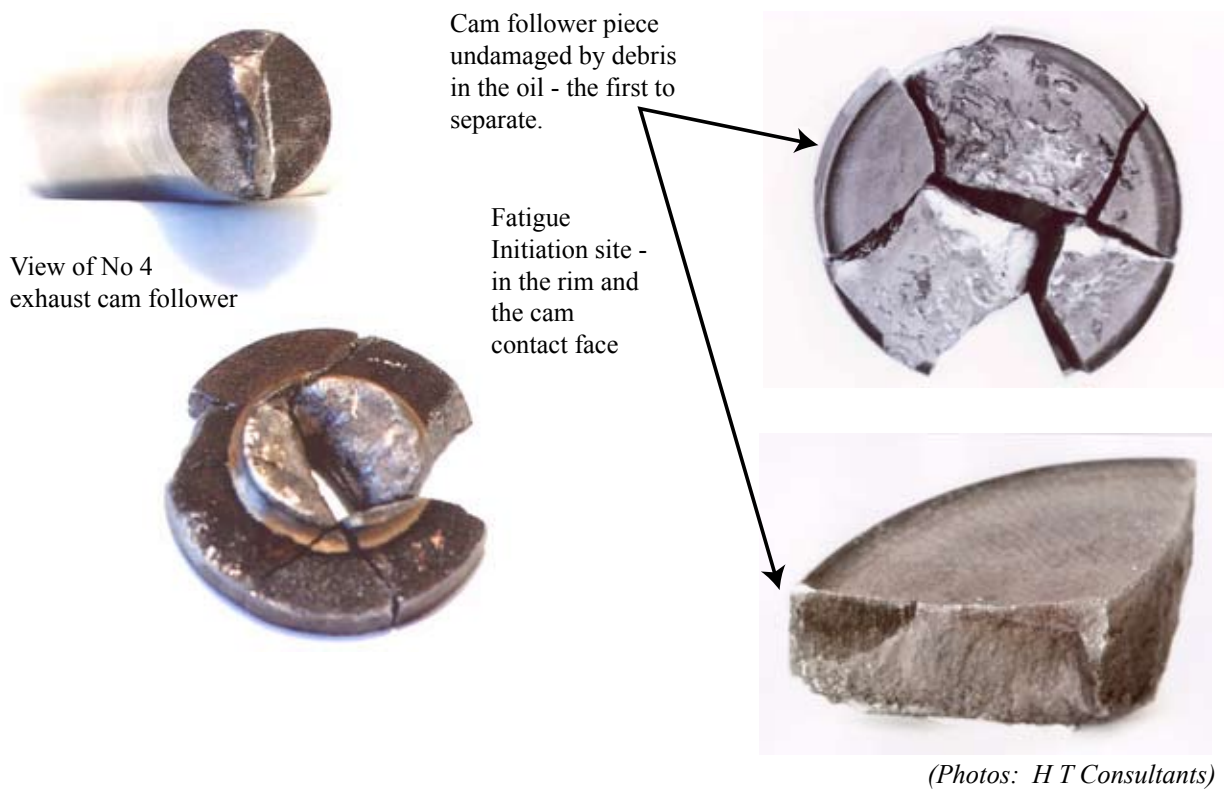
Figure 1
Damaged cam follower

the No 4 exhaust cam follower, the head of which had broken away from its shaft (see Figure 1) and was found in several pieces in the bottom of the oil sump. There was also consequential damage to the engine caused by the debris from the failed cam follower.

Examination of the camshaft showed that the surface of the rear lobe (No 4) had been mechanically damaged. The other lobes showed offset wear indicating that the shaft had not been sitting square with the related cam follower head for a considerable period of engine running time (see Figure 2). Microsection examination of the camshaft material showed that it had been carburised and case-hardened before final machining; microhardness tests on the case-hardened layer were satisfactory.

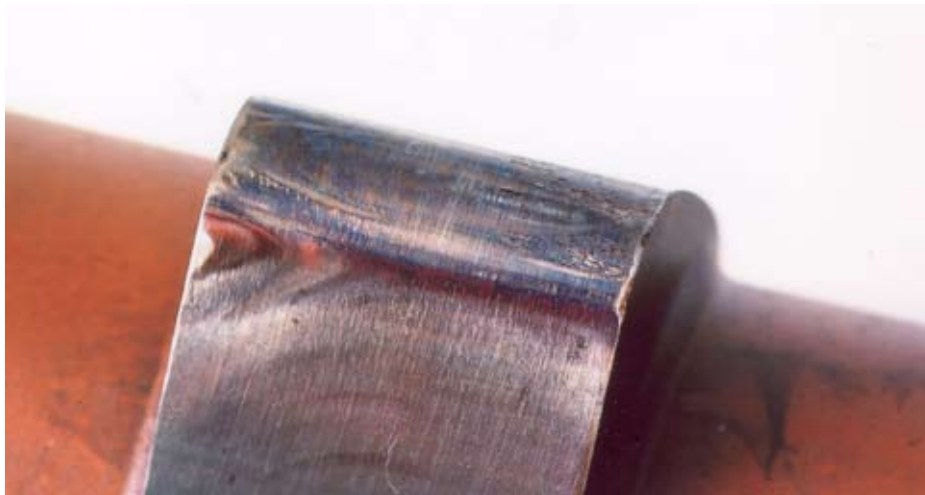
Figure 2

The crankcase showed no visual evidence of distortion; the right side had been mechanically damaged, consistent with high energy contact with the cam follower pieces. The camshaft bearing faces on both crankcase sides had been scored, most likely from debris circulating in the oil. The bearing lands on the camshaft were also scored, the nature of the damage indicating that it had resulted from cam follower debris in the oil.

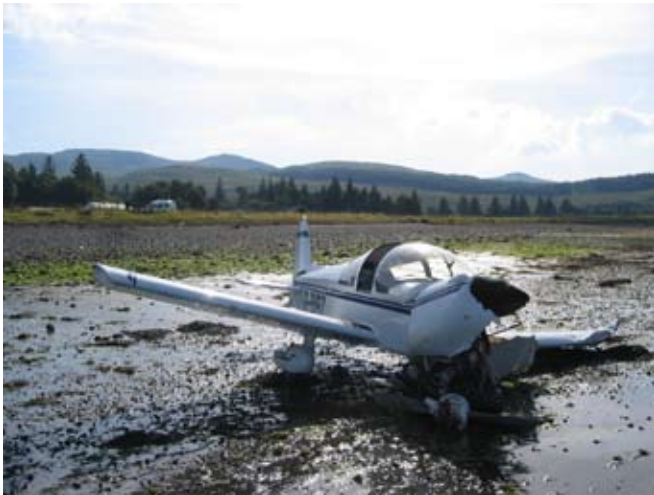
Figure 1

G-BIRZ on the beach

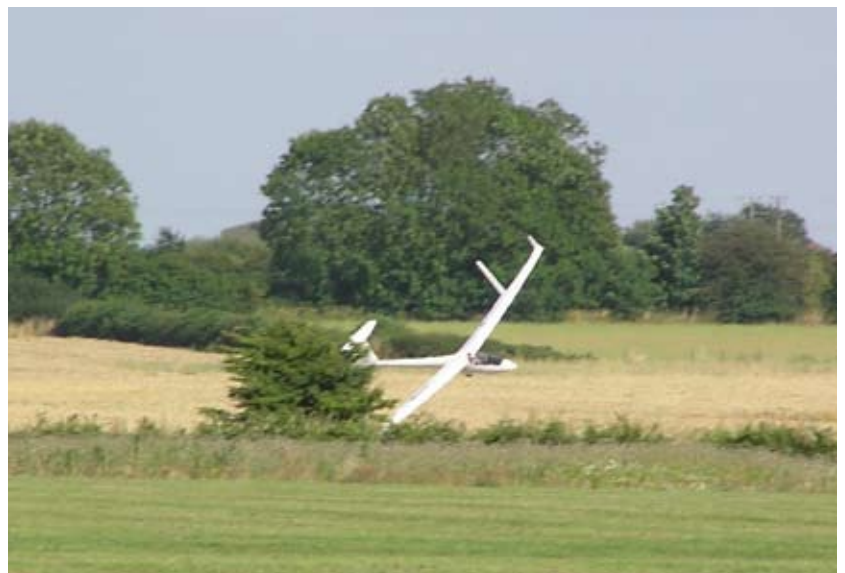
The glider came to rest in a standing crop of wheat, about 400 m to the south-east of Husband's Bosworth Airfield and to the left of Sibbertoft Road. Figure 3 is a picture of the glider just before it struck the ground. Inspection of the glider revealed extensive damage to the left wing, with pronounced damage about 3 ft inboard from the wing tip. The left aileron had completely detached and was found lying against the fuselage. The only other noticeable damage was to the right winglet, consistent with contact with the wheat. Detailed examination of the glider did not reveal any pre-accident defects with its structure or flying controls.

Glider just before ground impact

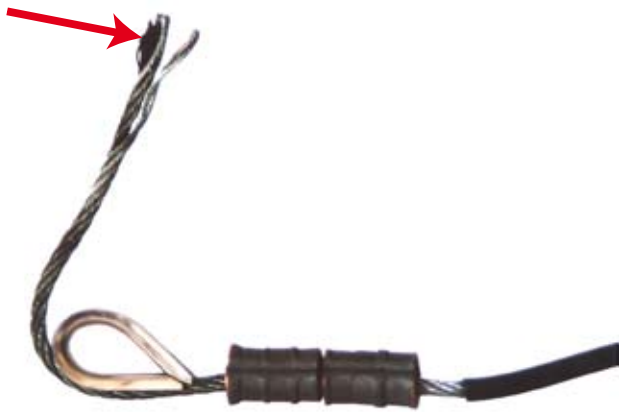
Figure 3

In the case of G-MYVW, the rear flying cables had pulled through the swage fittings at one end (see Figure 3), leaving just a thimble attached to each side of the 'A' frame.

Broken rear cable from G-MYVW

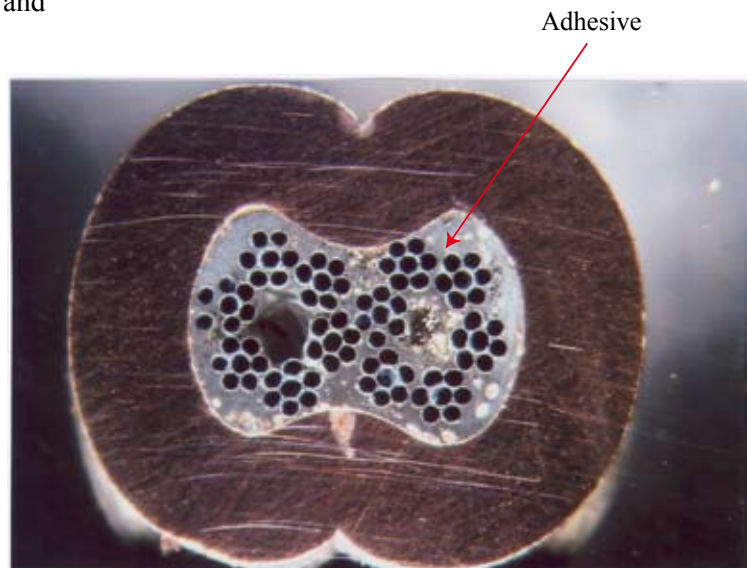
Figure 4

Section through an unfailed swage, showing poor grip of the cable strands by the ferrule. Note that the fibre core is not readily apparent (although present) and that the grey material filling the voids is cyanoacrylate adhesive, applied to stabilise the assembly during sectioning

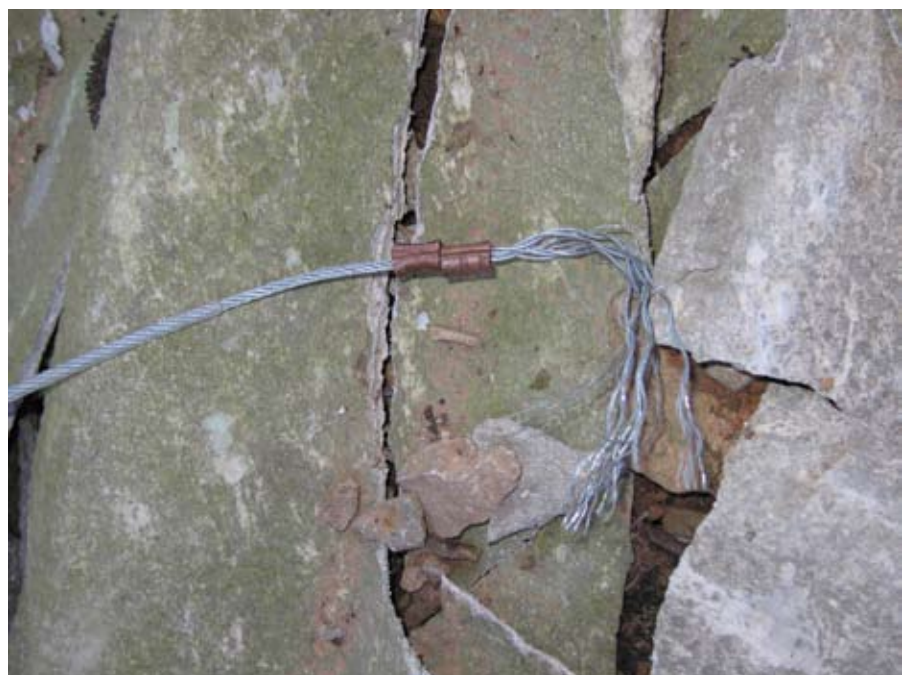
During the initial examination, failure of the ferrules to grip the wire rope at one end of each of the four rigging cable assemblies was evident. See Figure 2 for an example of failed ferrules (note the wire rope has pulled through the ferrules) and Figures 1a and 1b for a diagram showing the location of the four cables. No ferrules or plastic shrouds were found on the rear ends of the two

rear cables and these cable ends had damage consistent with having been struck by the propeller.

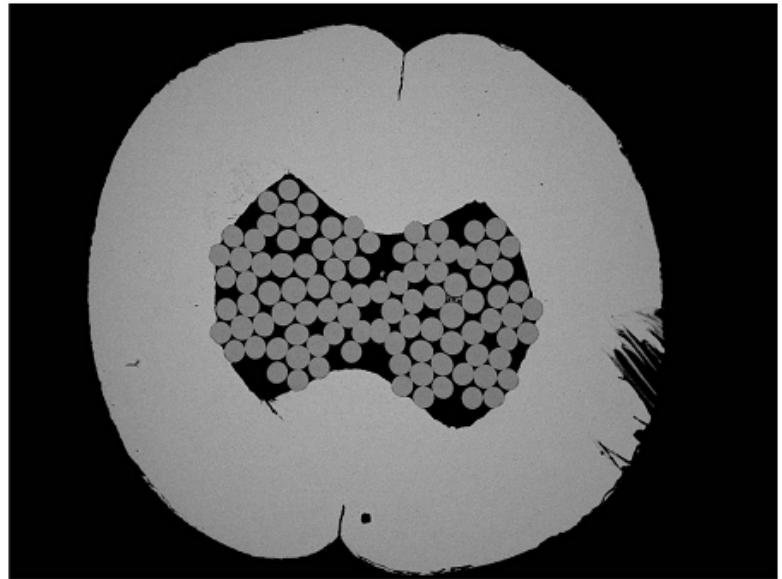
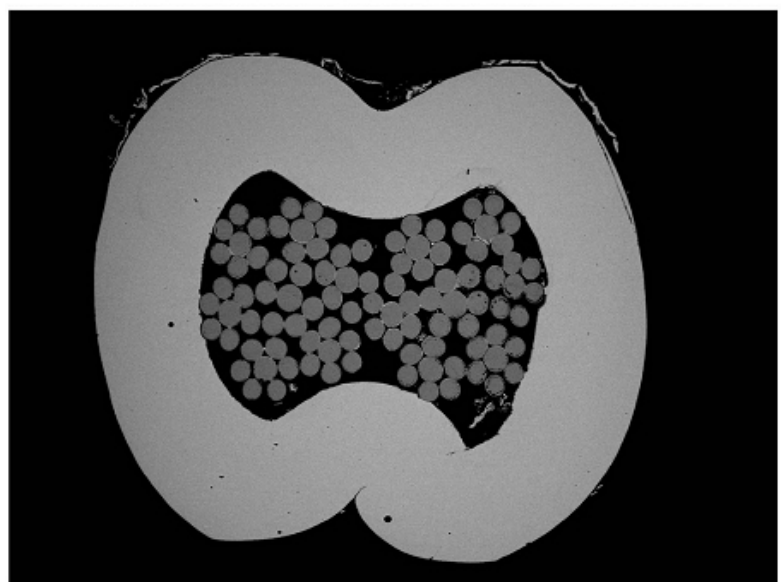
Figures 5a (top) and 5b (bottom)
Sections through crimped ferrules

The end of one cable assembly from G-BYNO that did not fail, and a comparable factory-supplied item were sectioned and polished. The sections were made through the ferrules and wire rope in the region of the neck produced by crimping. Figure 5a and Figure 5b show the sections from the factory-supplied cables and G-BYNO respectively. Comparing the two sections it is evident that for the factory-supplied items there is:

- more contact between strands of the wire rope and the ferrule;
- more contact between the strands and other strands of wire rope;
- less void space.
