CONTENTS

SPECIAL BULLETINS

COMMERCIAL AIR TRANSPORT

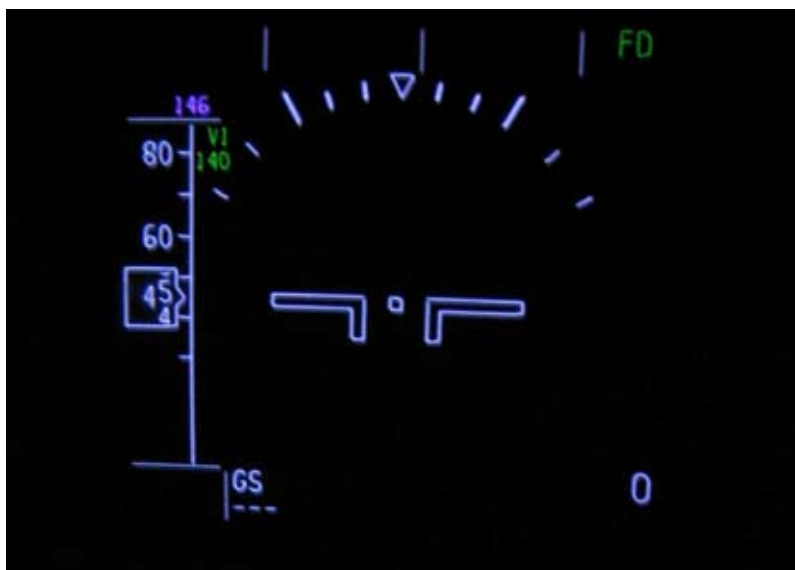
Figure 1
Representation of 'blank' EADI

When the IRSs are in ALIGN mode (IRSs data being NCD), the EFIS displays will show very limited information, Figure 1. For approximately two minutes before LOT 282 took off, the pilots' displays were probably in this condition. As the pilots were busy watching for other traffic and lining the aircraft up on the runway, it is possible neither one looked at the displays during this period. As the aircraft accelerated along the runway, it is likely that the commander's attention would have been focussed on his ASI. It was probably only when the aircraft rotated on takeoff that the co-pilot would have looked down or seen that no attitude or navigational information was available.

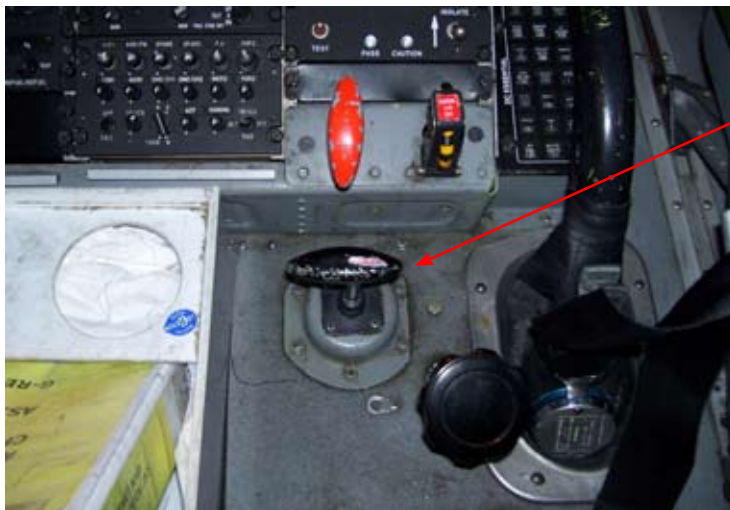
Figure 3 (left)

The crew checked and then realised that the nosewheel

Nosewheel locking pin -
engaged

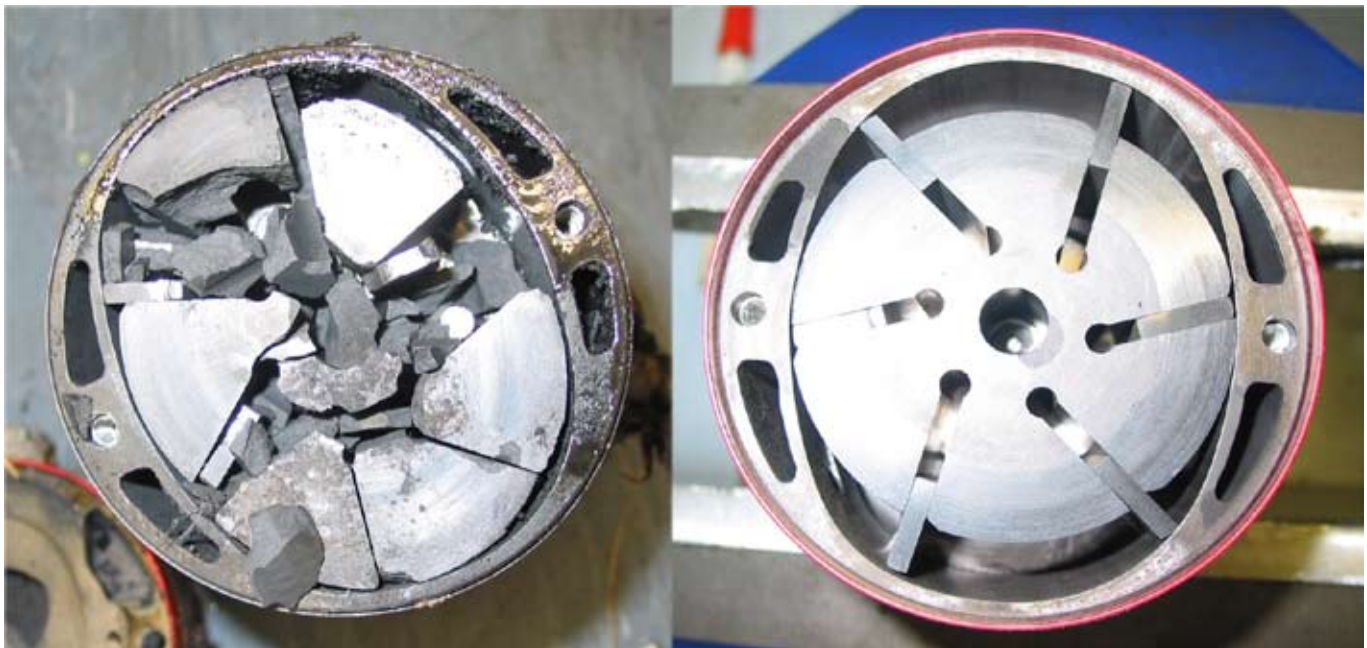
Figure 6

Damaged vacuum pump rotor and vanes from G-JMTT on left; intact version on right

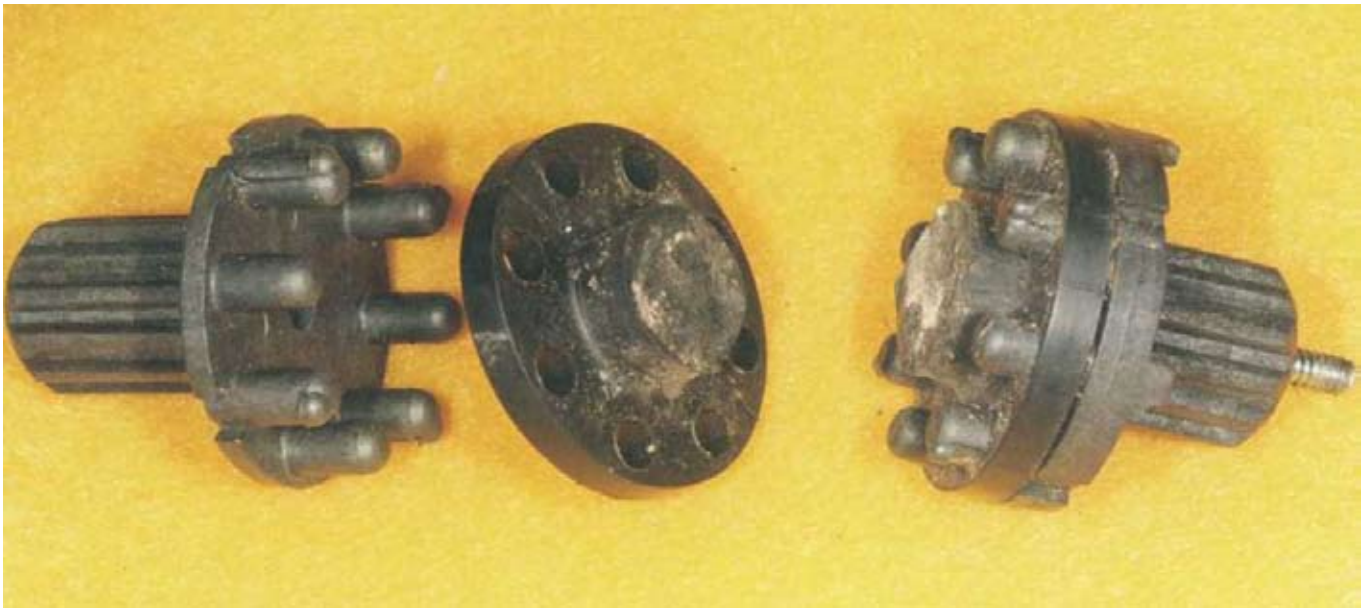
Figure 7

plastic flex centre coupling. This flex centre coupling serves two purposes: first, it absorbs torsional vibrations from the accessory gearbox drive and second, it contains a necked-down centre diameter which works as a shear point to prevent engine damage in the case of a pump failure. The flex centre coupling in G-JMTT's vacuum pump had fractured at the midpoint of its shear section due to torsional overload (see Figure 7). This can occur

Fractured flex centre coupling from G-JMTT's vacuum pump

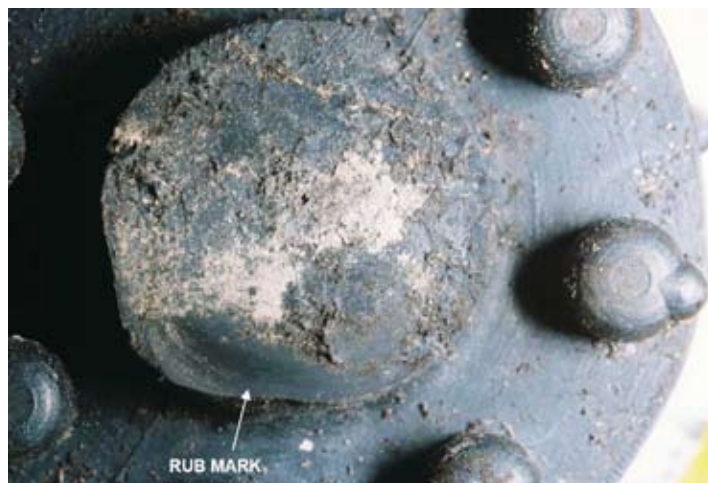
Figure 8

as a result of impact; however, both fracture faces had rub marks which indicated continued rotation of the engine-driven end after the coupling fractured (see Figure 8). The component manufacturer concluded that this rotational rubbing of the fracture surface indicated that the coupling fractured some time prior to impact, possibly even before the accident flight.

Rub mark on one of the fracture faces of the flex centre coupling

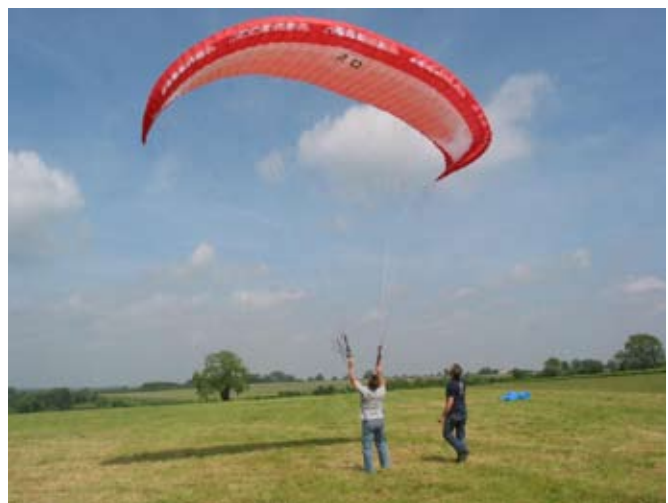
Figure 2

The wing was found to be in good condition and undamaged, with the exception of the right-hand brake line which appeared to have been cut. The integrity of the wing was verified by raising it and inflating it (Figure 2). Measurements taken by the AAIB showed that the lines were symmetrical on either side of the wing and that their lengths were close to the manufacturer's specified line lengths for this size of wing. Measurements of the wing upper surface area, with the wing laid out flat, gave an estimate of 18.98 m², close to the manufacturer's

Photograph showing test re-inflation of wing
