Aircraft Type and Registration:	Boeing 737-78J, YR-BGF	
No & Type of Engines:	2 CFM 56 - 7B22 turbofan engines	
Year of Manufacture:	2001	
Date & Time (UTC):	4 March 2004 at 1230 hrs	
Location:	Stand 214, London Heathrow Airport	
Type of Flight:	Public Transport (Passenger)	
Persons on Board:	Crew - 8	Passengers - 61
Injuries:	Crew - None	Passengers - None
Nature of Damage:	Damage to top of No 1 engine cowling	
Commander's Licence:	Airline Transport Pilot's Licence	
Commander's Age:	51 years	
Commander's Flying Experience:	17,000 hours (of which 1,900 were on type) Last 90 days - 200 hours Last 28 days - 60 hours	
	Note: the hours provided by the commander are approximate	
Information Source:	AAIB Field Investigation

Aircraft Type and Registration:	Boeing 747-436, G-BNLG	
No & Type of Engines:	4 Rolls-Royce RB211-524G2-19 turbofan engines	
Year of Manufacture:	1989	
Date & Time (UTC):	21 April 2004 at 1002 hrs	
Location:	Stand 127L, London Heathrow Airport	
Type of Flight:	Public Transport (Passenger)	
Persons on Board:	Crew - 18	Passengers - 326
Injuries:	Crew - None	Passengers - None
Nature of Damage:	Puncture to leading edge of port wing above No 2 Engine. No 2 engine damaged b

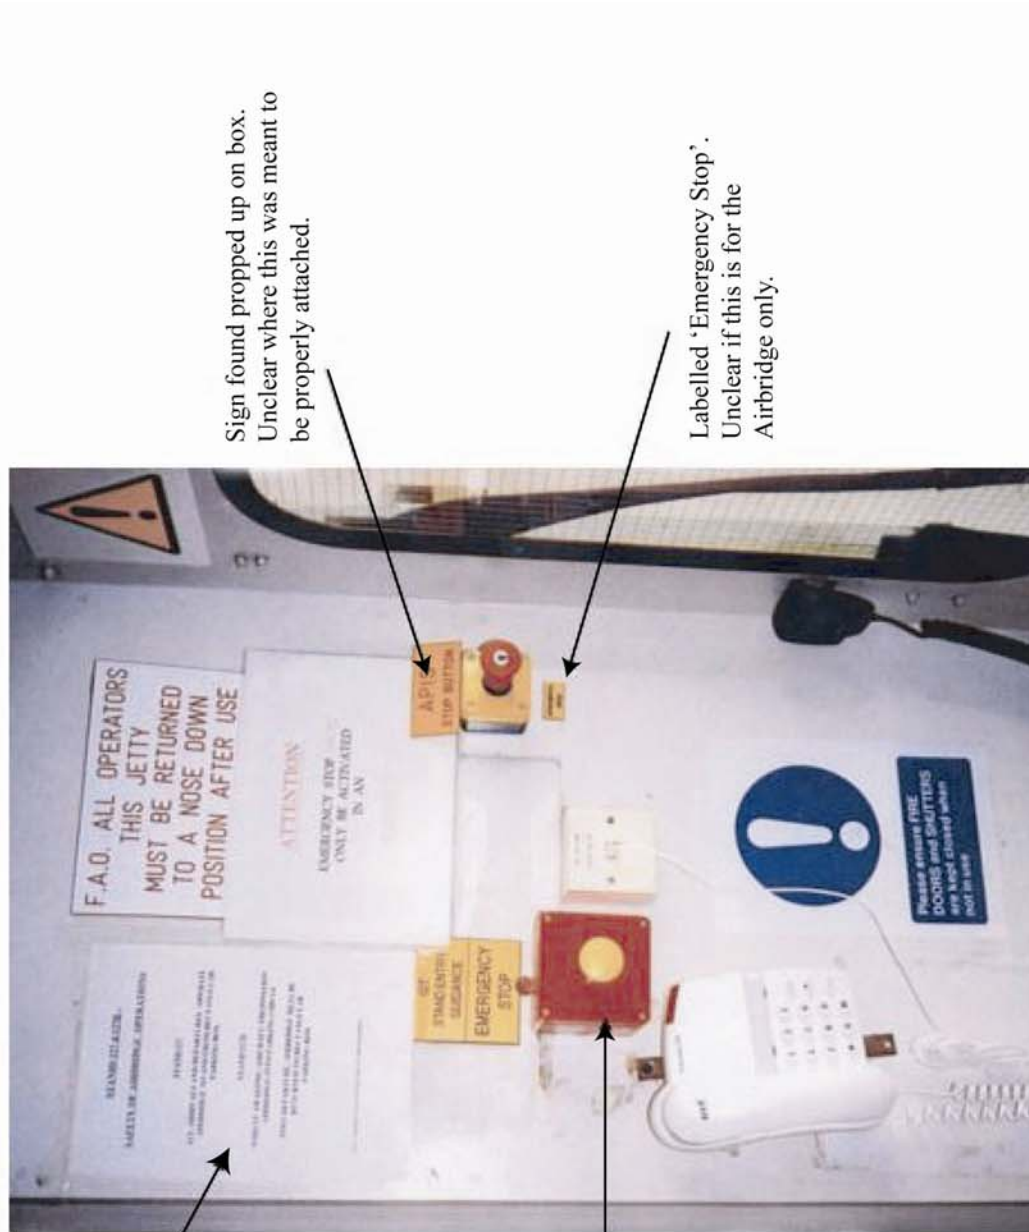
Figure 2

In a subsequent visit by the AAIB to Stand 127, on 23 August 2004, a STOP button had been fitted to the airbridge as part of the on-going program. This had however been placed in close proximity to another stop button intended to stop the airbridge moving in case of emergency and markings did not make it clear which of the stop buttons was for which purpose. Indeed, one label was found simply propped up on one of the switches, Figure 2.

Sign added after accident to G-BNLG

Sign found propped up on box. Unclear where this was meant to be properly attached.

It is recommended that Heathrow Airport Limited should expedite the program to install duplicate emergency stop buttons at all of its airbridge control stations and ensure that all such buttons are clearly and unambiguously marked.

It is recommended that Heathrow Airport Limited should ensure that operating instructions are prominently displayed on any aircraft stand, including the airbridge, where changes in the operation have been made or where the mode of operation is non-standard.

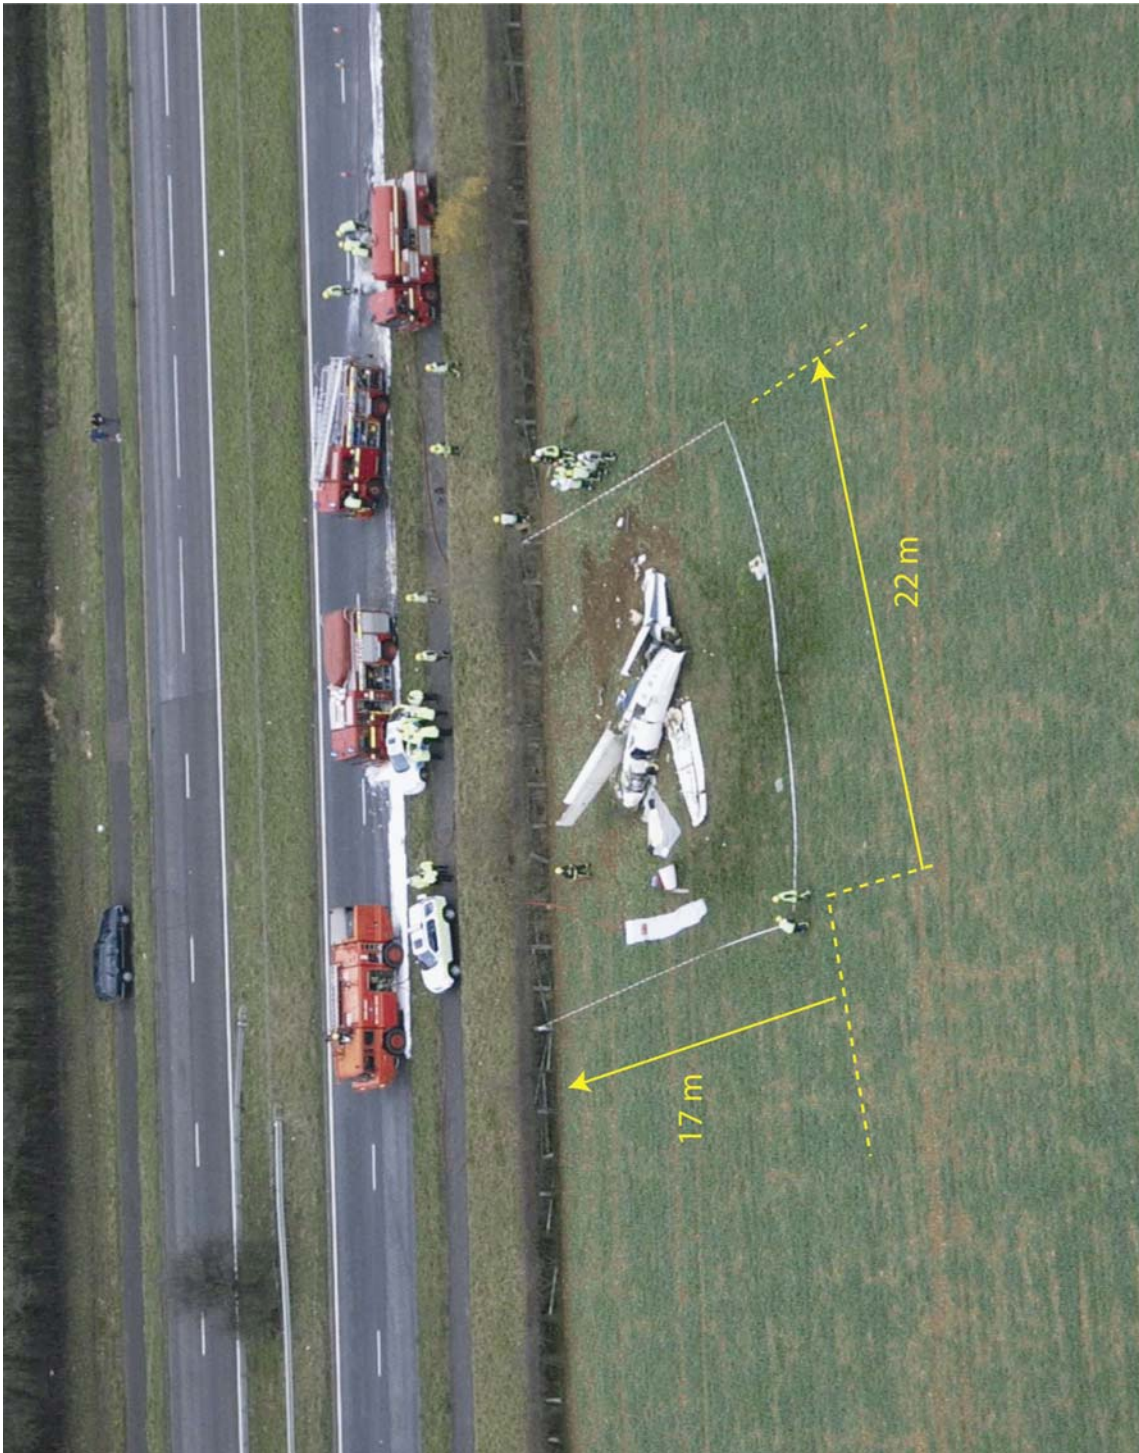
Figure 3

N30LT - Accident Site Details

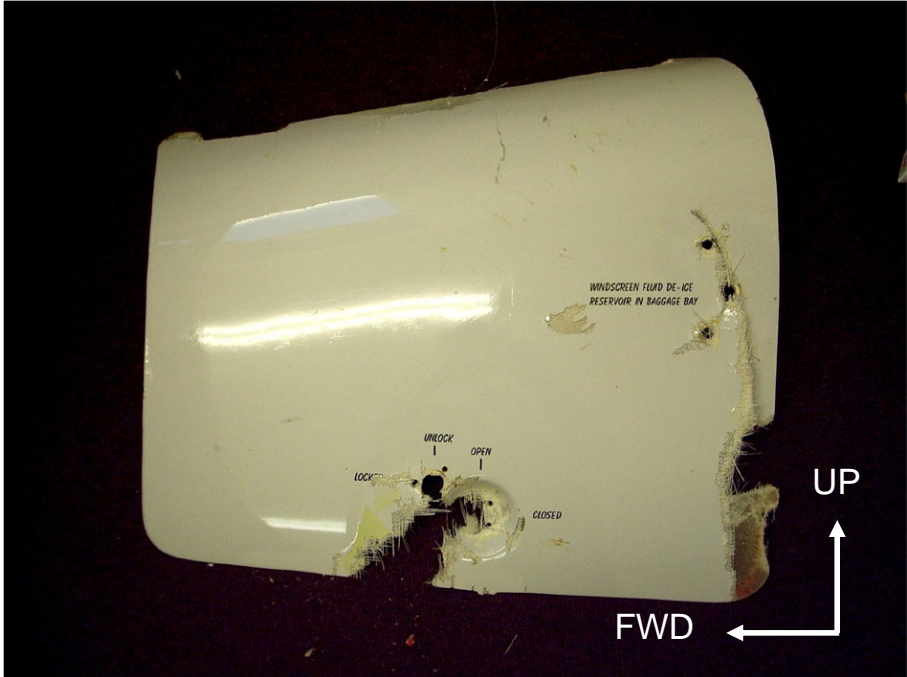
Figure 1

Damaged Nose Baggage Bay Door

The operator is modifying its PA-34 fleet to paint more visible alignment marks adjacent to the door handle, to make it easier to confirm that the door is latched. The fleet is also to be inspected for

proper functioning of the nose baggage bay door key/latch interlock function. The operator's PA-34 maintenance schedule will also be expanded to include this as a recurring inspection on the '100-hour' Check. A communication has already been issued to all instructors and students within the flying training organisation to make them aware of the implications of lock/key wear and the need to confirm that the nose baggage bay door is correctly latched prior to flight.

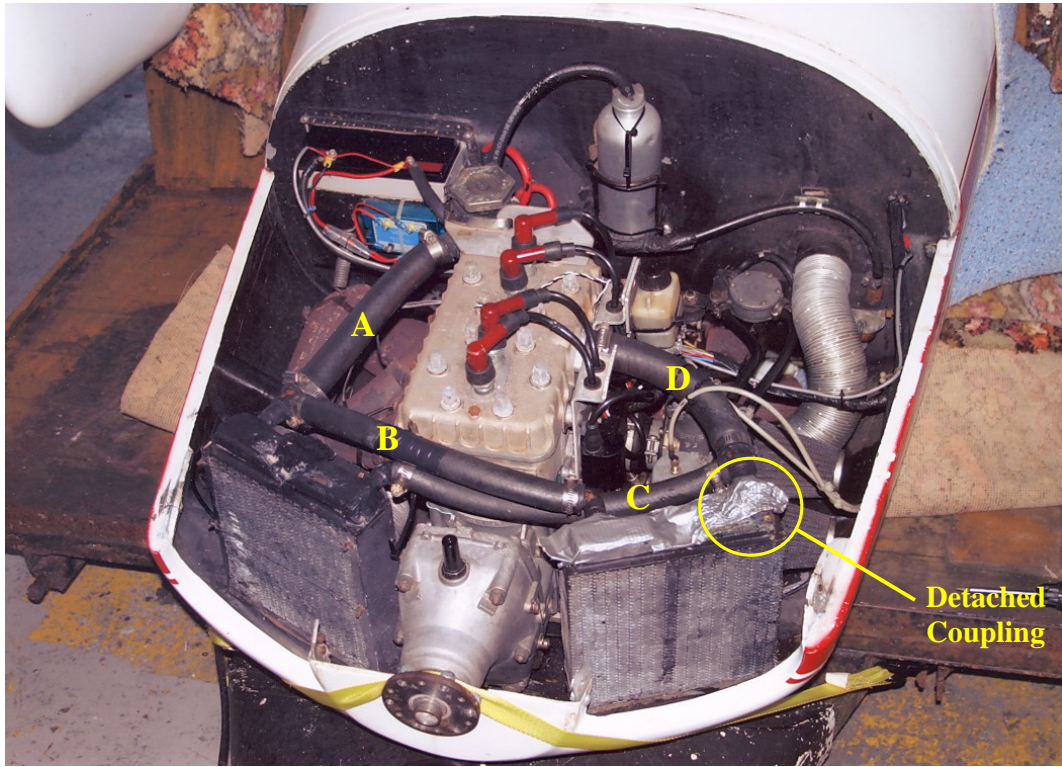
Figure 1 Engine and radiator layout inside G-MCMS post accident (photo courtesy P. Murray)

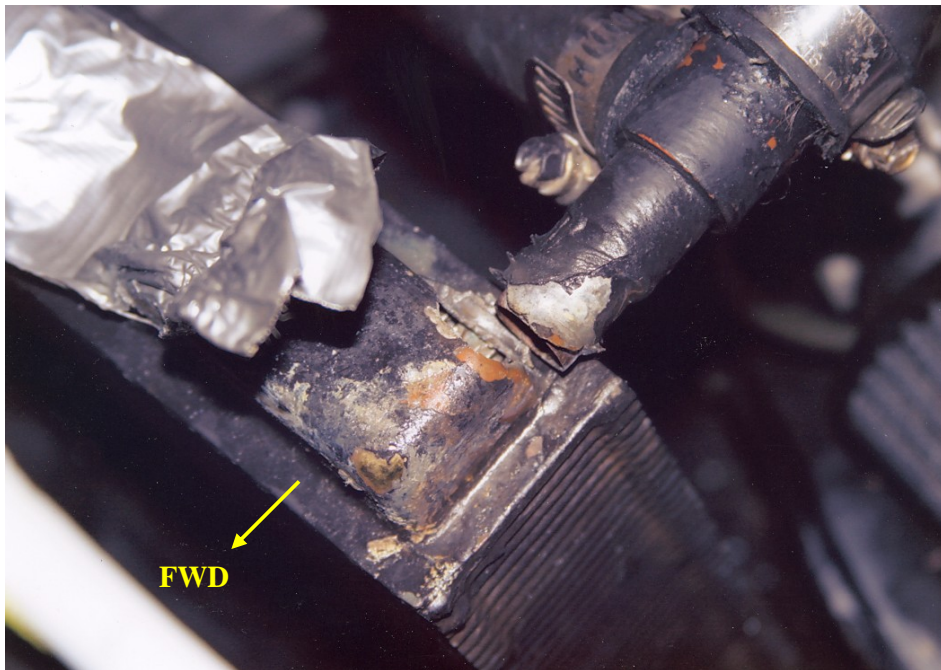
Figure 2 Detached coupling from outboard fitting of port radiator (photo courtesy P. Murray)

On 11 March 2005 the Popular Flying Association informed the AAIB that it accepted the Safety Recommendation. Its Engineering department is designing a modification which will reduce the vibration transmitted to the radiator via the hose and avoid any pre-stress in the hose connection. The modification will be issued to Pulsar owners shortly.

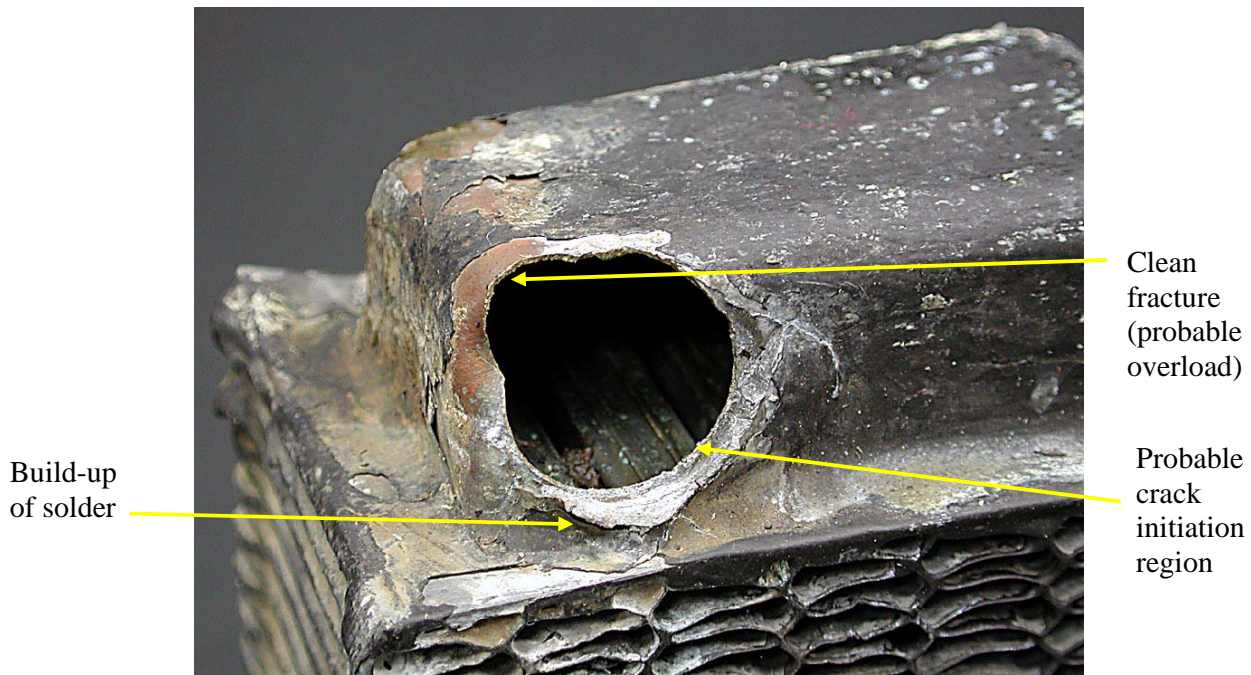
Figure 3 Detailed view of fracture surface on radiator (photo courtesy of QinetiQ)

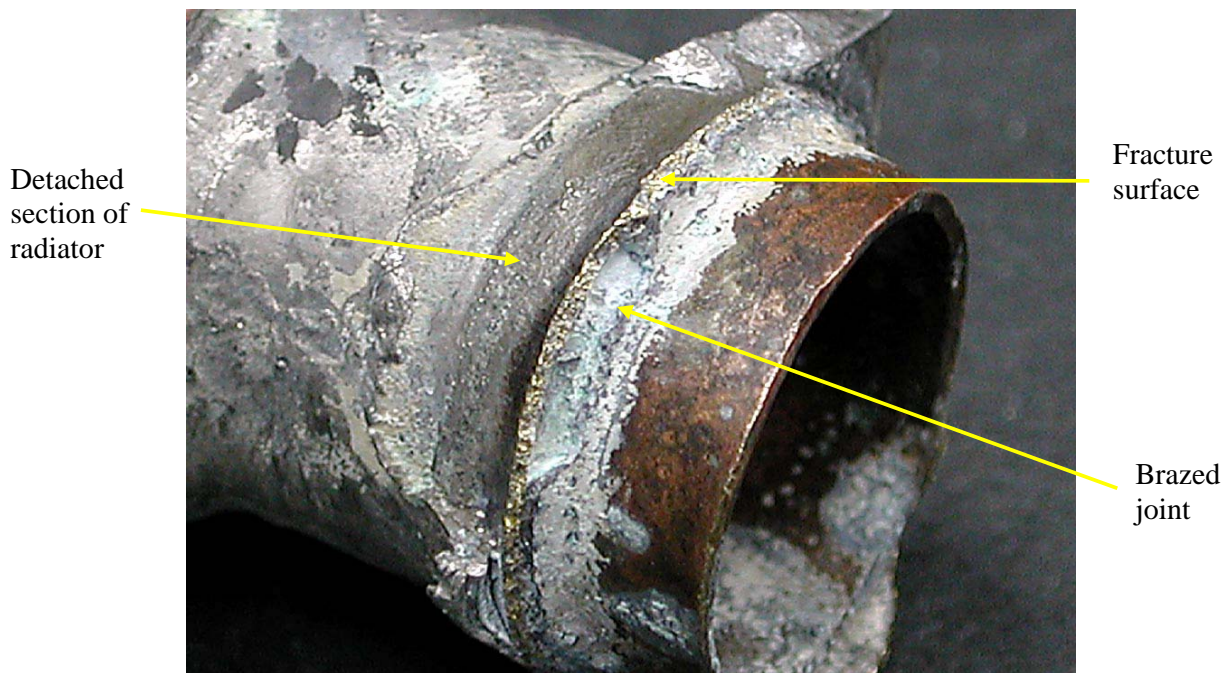
Figure 4 Detailed view of fracture on coupling (photo courtesy of QinetiQ)

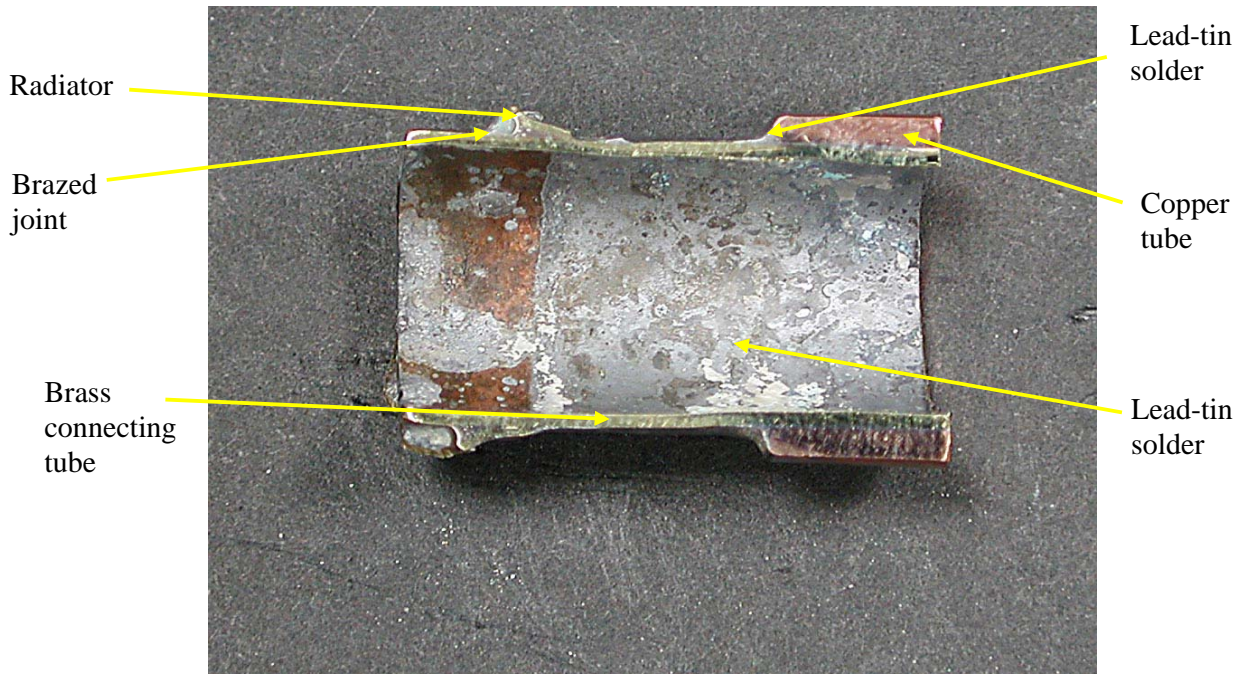
Figure 5 Cross-section through failed coupling (photo courtesy of QinetiQ)

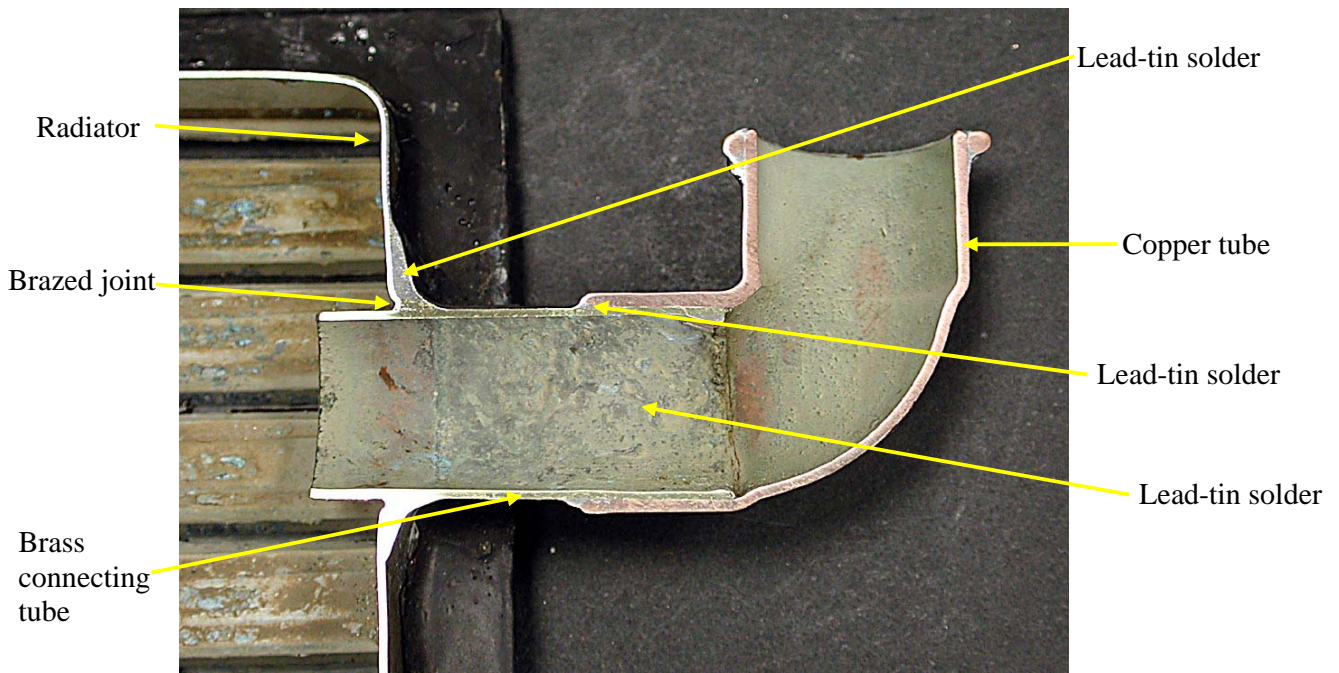
Figure 6 Cross-section through intact coupling on inboard end of port radiator (photo courtesy of QinetiQ)

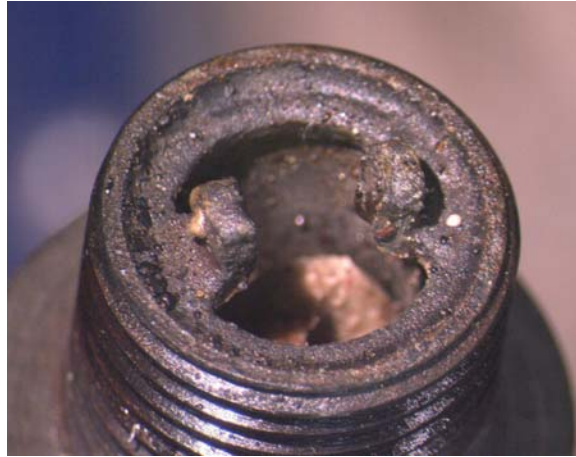
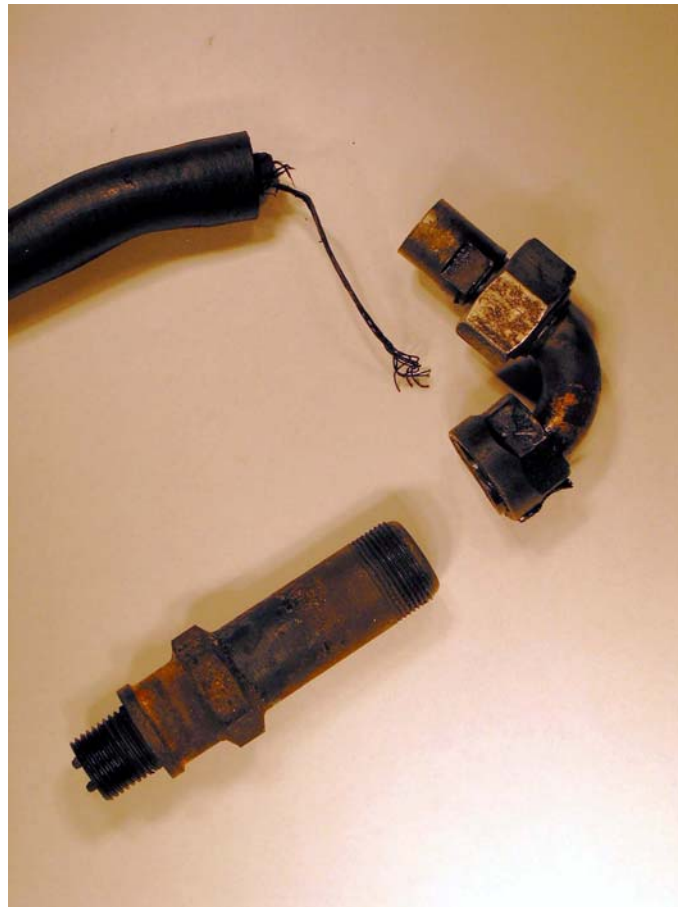
Figure 1

As mentioned in the report on G-BWOD, tests conducted in the USA revealed that it may be theoretically possible for an engine with a spark plug removed to continue to produce enough power to enable continued flight, hence giving an improved chance of a safe landing at an airfield. However, the emergency procedure for a rough running engine is to land as soon as possible, which is especially relevant in this case, given the risk of an engine fire due to the hot gases escaping through the damaged spark plug.

Details of the failed rear spark plug from cylinder No 5

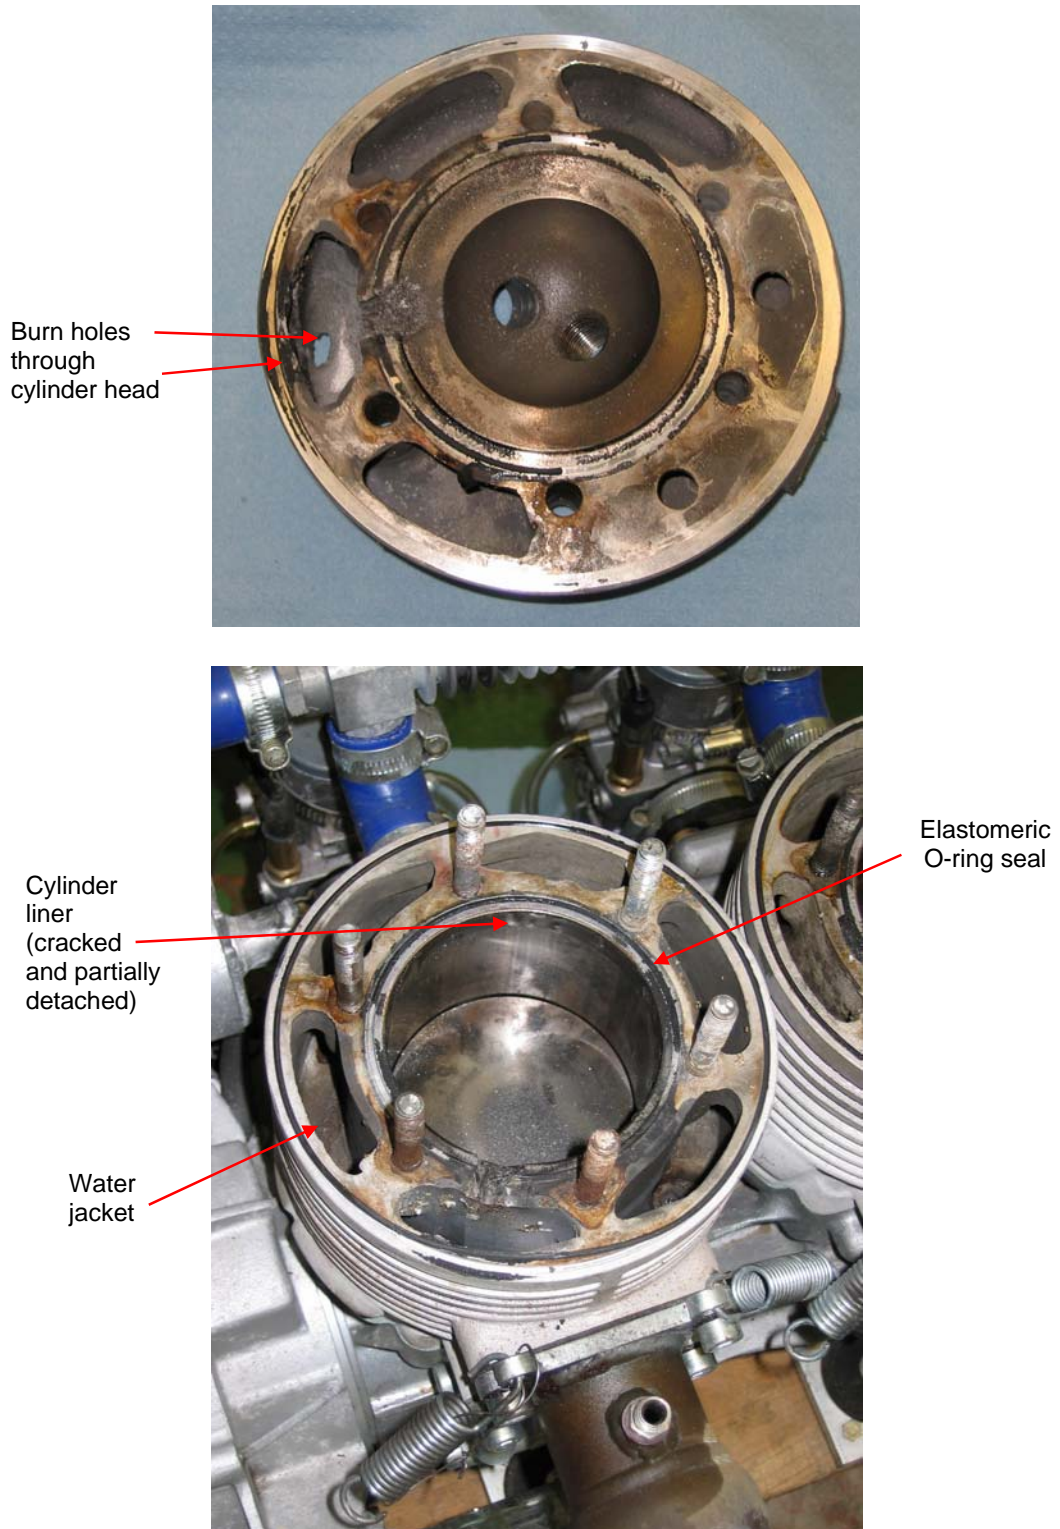
It was considered that the engine failure was caused by the loss of coolant allowing hot gases to burn through the cylinder casing. The evidence of corrosion in the bearings indicated that liquid had been present in the crankcase for some time. The accumulation of liquid in the crankcase probably resulted from a leak past one or both of the cylinder head elastomeric seals.

Figure 1 Rear cylinder with cylinder head removed (shown above)

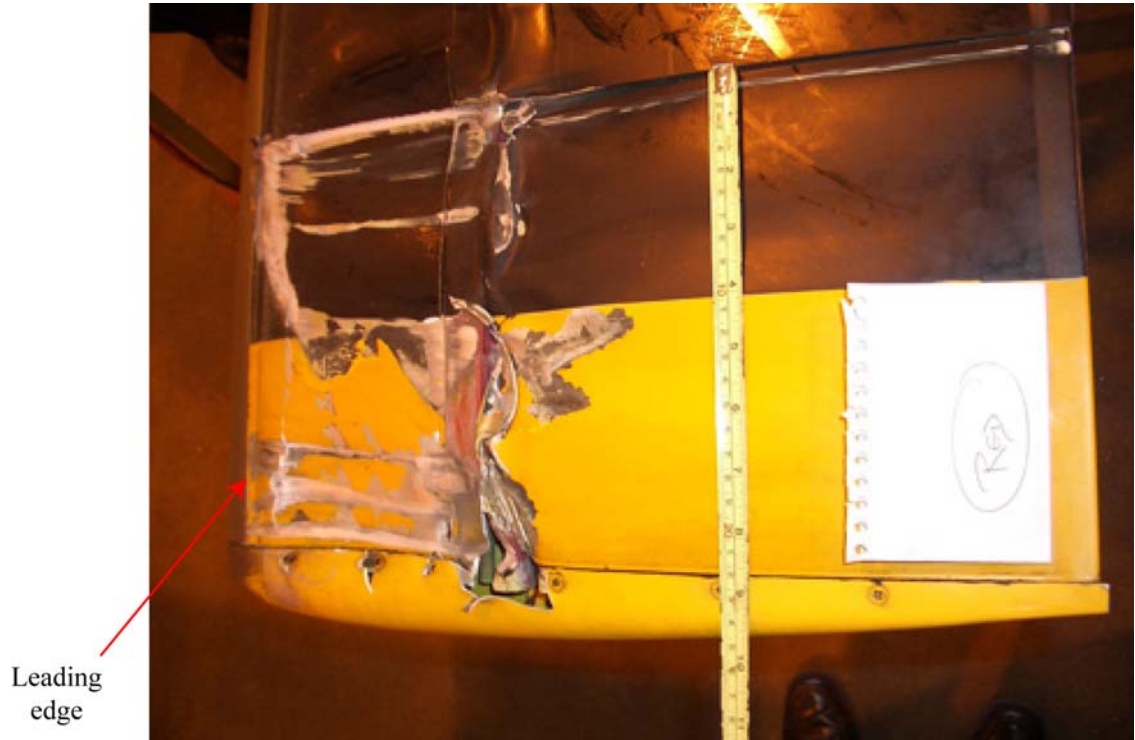
Figure 2

Red blade - lower surface

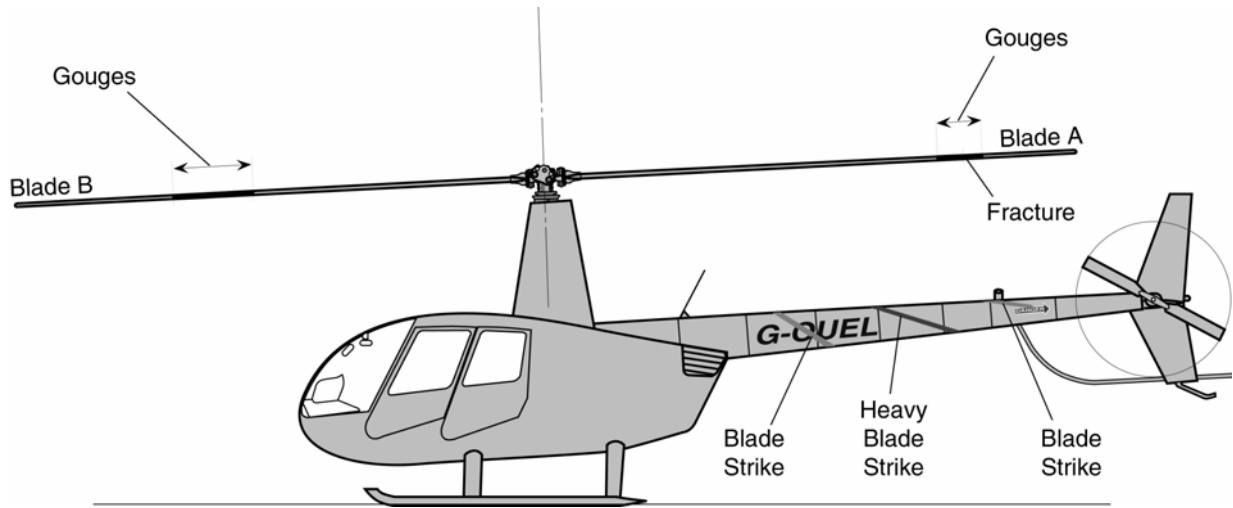
Figure 5

G-OUEL - Main rotor blade and tailboom marks
