## CONTENTS

### COMMERCIAL AIR TRANSPORT

<b>Aircraft Type and Registration:</b>	Boeing 737-800, EI-DHD	
<b>No &amp; Type of Engines:</b>	2 CFM 56-7B26 turbofan engines	
<b>Year of Manufacture:</b>	2005	
<b>Date &amp; Time (UTC):</b>	23 December 2009 at 0847 hrs	
<b>Location:</b>	Glasgow Prestwick Airport	
<b>Type of Flight:</b>	Commercial Air Transport (Passenger)	
<b>Persons on Board:</b>	Crew - 6	Passengers - 129
<b>Injuries:</b>	Crew - None	Passengers - None
<b>Nature of Damage:</b>	None	
<b>Commander's Licence:</b>	Airline Transport Pilot's Licence	
<b>Commander's Age:</b>	33 years	
<b>Commander's Flying Experience:</b>	5,557 hours (of which 1,832 were on type) Last 90 days - 113 hours Last 28 days - 78 hours	
<b>Information Source:</b>	Airfield operator's investigation report and further enquiries by the AAIB

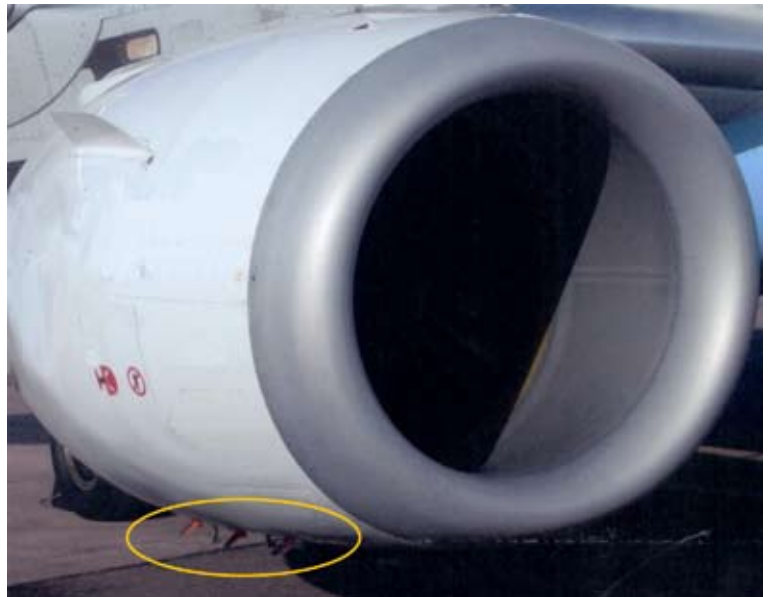
**Figure 1**

The fan cowls of the Embraer 195 aircraft comprise two ‘clamshell’ doors of composite material, hinged at their top edge. When closed and fastened, three over-centre clamps on the outboard cowl engage with hooks on the inboard cowl and, when locked, the clamps are flush with the surface. When unlocked, the clamp levers protrude and their edges are painted ‘dayglo’ red to make them more conspicuous (Figure 1).

Upon inspection, it was found that the fan cowls of the right engine had torn away from their hinges, leaving only a small portion of the upper structure still attached. Examination of the debris recovered from the runway showed that it comprised a substantial piece of each cowl door and numerous smaller pieces. The lack of any damage to the clamps and hooks indicated that they had not been engaged and that this was the most likely

reason for the detachment of the cowls. Damage to the airframe was limited to scuffing and denting of the leading edge slats and two punctures of the slat skin.

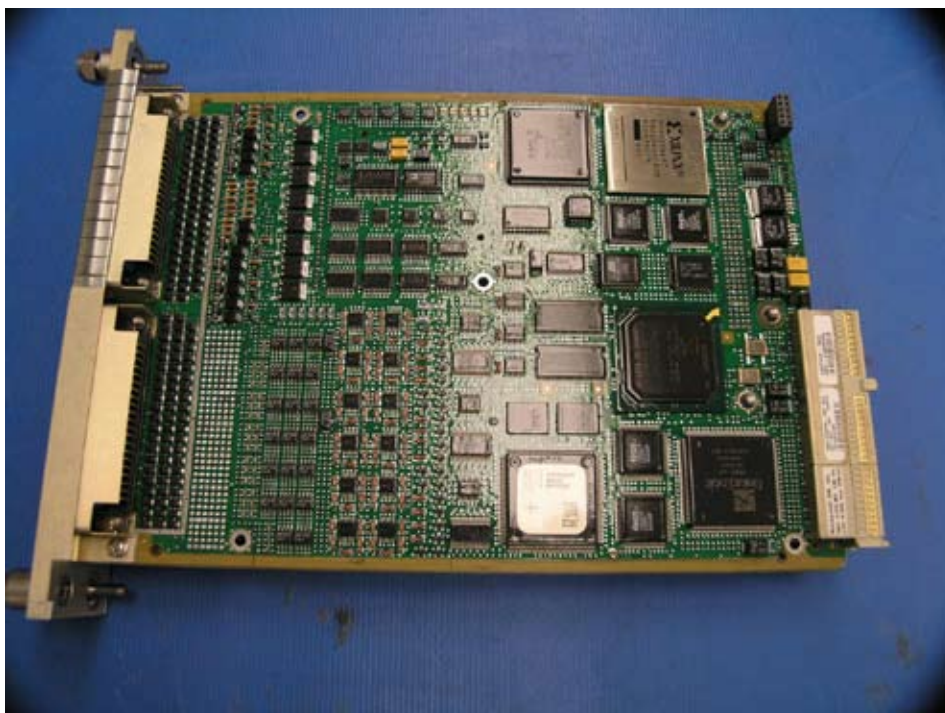
**Figure 5a**  
A CSIO2 module

The presence of contamination and corrosion on the CSIO2 card strongly suggested that moisture had been present on the board during service and, thus, may have been responsible for the incident to G-CHCV, although no indications of water were apparent on the MAU modules after the event. However, during the investigations of the Australian incidents, water was found to be present in and around the MAU cabinets. Accordingly, it was decided to examine the behaviour of the CSIO2 card under damp conditions by subjecting it to a water spray during operation.

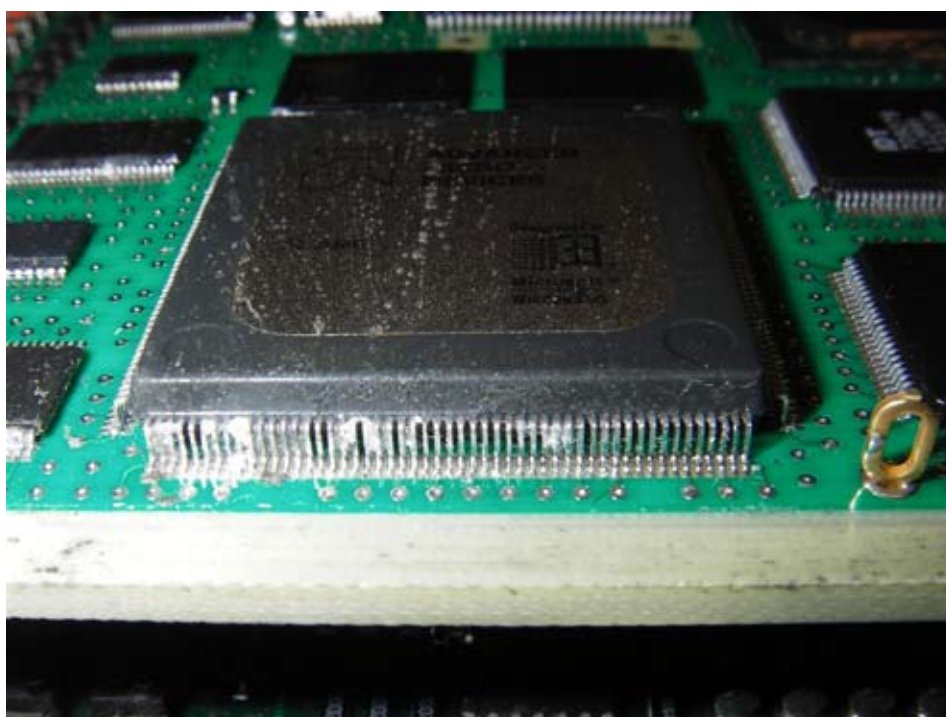
The spurious warnings and the loss of indications were found to be due to corrosion in an avionic module. The corrosion had occurred due to the module cabinet being cooled by unfiltered, non-conditioned air drawn from intakes on the fuselage underside. The situation was exacerbated by the helicopter being operated in a maritime environment.

**Figure 5b**  
Example of corrosion on another CSIO2 processor

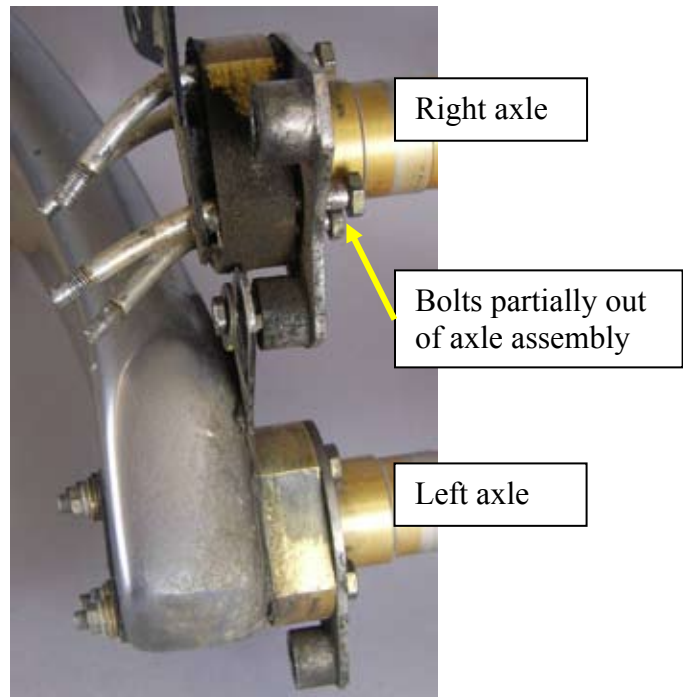
**Figure 1**

Following the accident, the four bolts, which had secured the right axle to the landing gear, were found to be bent and the threads were severely damaged; the nuts were not recovered. The bend in the bolts was consistent with a side load having been applied to the outside of the bottom of the tyre after the bolts had withdrawn out of the axle by around 10 mm to 15 mm. Figure 1 shows the damaged bolts on the right axle next

Right and left axles and securing bolts

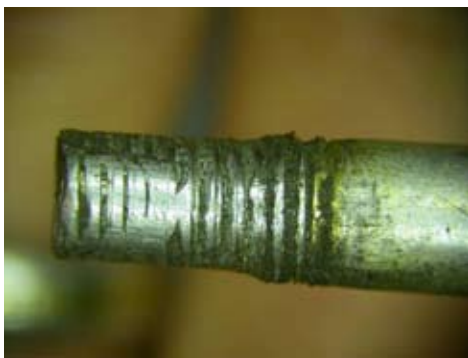
**Figure 2**

The threads on all four securing bolts, Figure 2, were extensively damaged and scored as a result of having been pulled through the locating holes in the landing gear leg; this action had destroyed any evidence that might have indicated the nature of any pre-detachment thread failures. However, examination by scanning electron microscopy (SEM) did reveal that the damage to the threads on the bolts was consistent with overload failure in a ductile manner. This damage may have been as a result of the nut having been pulled from the bolt. There was no evidence that any of the nuts had unwound prior to the failure of the threads.

Damaged threads on bolt from right axle

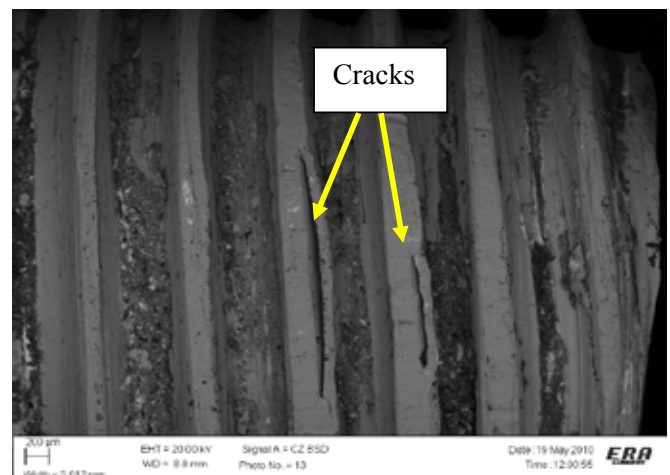
**Figure 3**

One of the bolts was examined by SEM, which revealed cracking and damage to the threads, Figure 3.

SEM image showing cracks in thread

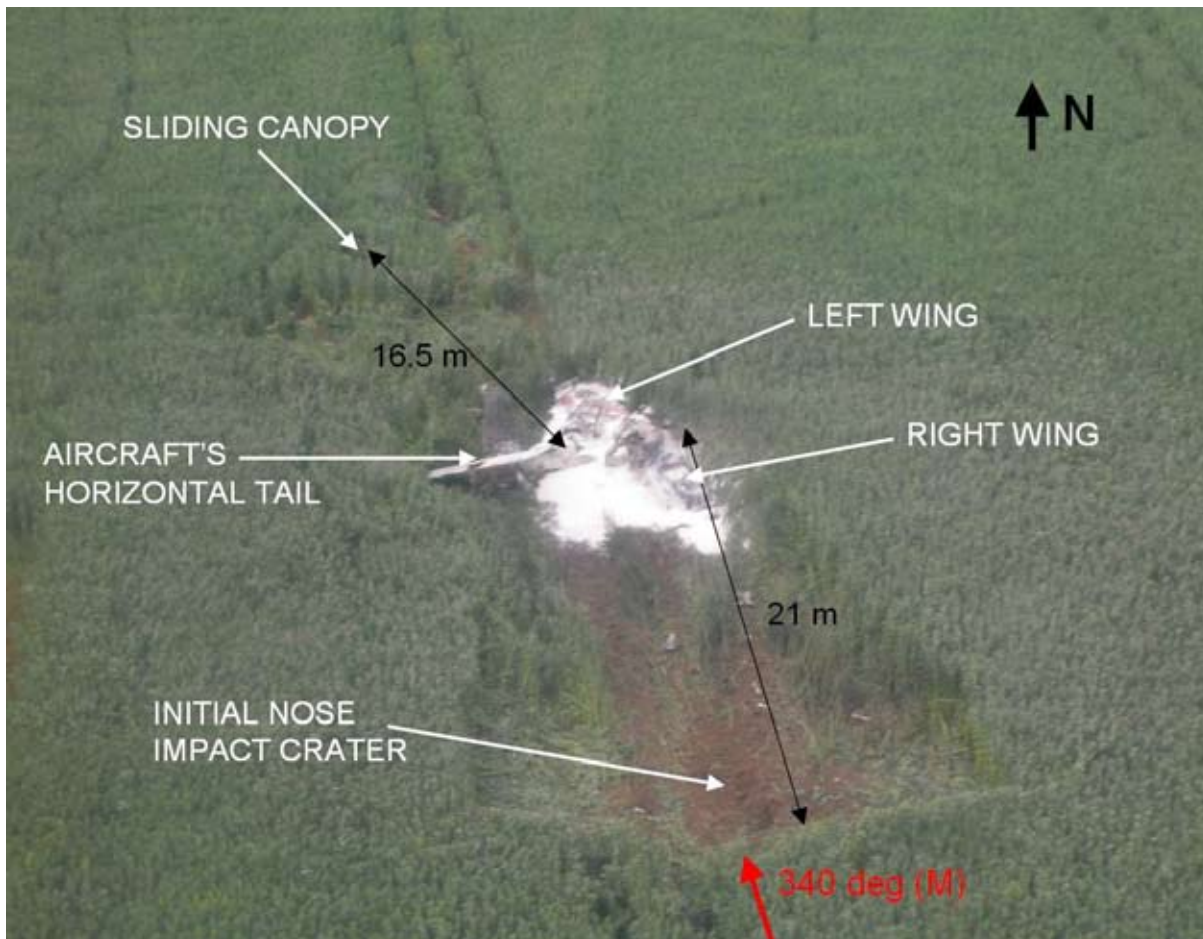
**Figure 5**

Both wing fuel tanks had ruptured, the separated engine was resting underneath the remains of the right wing fuel tank and the right side of the aircraft had

been exposed to more fire than the left side. The paint scheme on the left wing upper surface and left side of the vertical tail was mostly untarnished by fire or heat; these parts of the aircraft were facing into the prevailing wind at the time of the accident. The three-bladed propeller exhibited chordwise scratches and leading edge nicks consistent with rotation at impact, but not with high power. The engine had suffered significant fire damage and its three lower cylinders (No 5, 6 and 7) had detached. The No 5 and 6 cylinders were located within the initial wreckage trail, while the No 7 cylinder was located about 40 m north-east of the impact site<sup>1</sup>.

Accident site location – the main wreckage is surrounded by white fire-retardant foam that was applied by the fire service after the accident

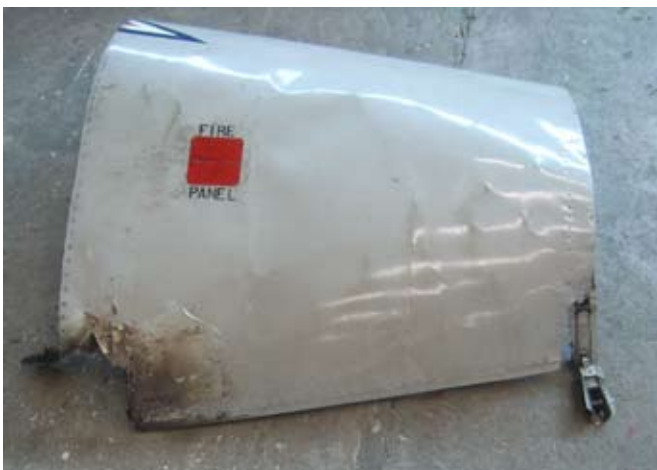
**Figure 6**

The latches securing the engine cowlings to the aircraft had failed in overload. The right engine cowling was missing a small portion of its rear lower corner and this area was surrounded by black burn marks and blistered paint (Figure 6). On the internal surface of the right engine cowling, in the lower forward section, there

Right engine cowling external surface – burnt area on lower aft corner

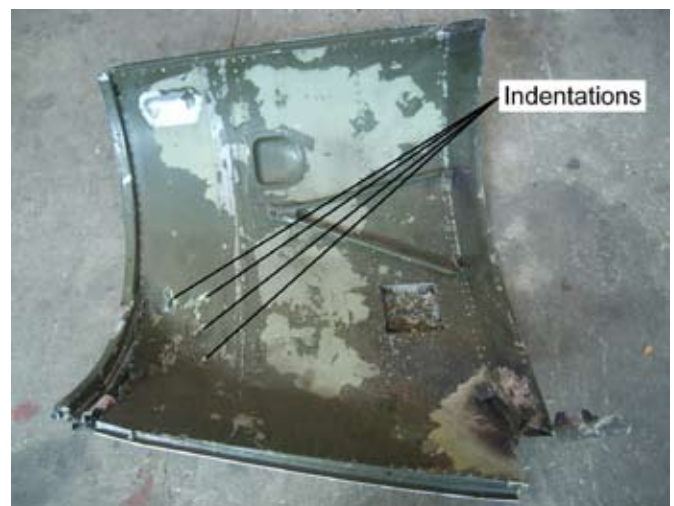
**Figure 7**

Right engine cowling inner surface – same burnt area visible on lower aft corner, and indentations near forward edge

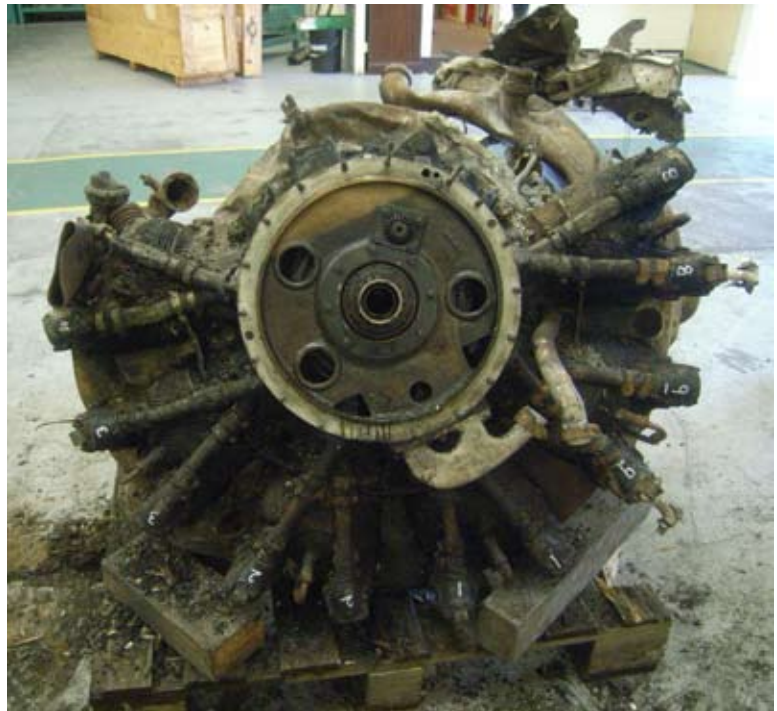
**Figure 10**

The engine had suffered from significant fire damage, and its No 5, 6 and 7 cylinders had detached (Figure 10). The cylinders had detached as a result of failure of some cylinder retaining bolts and the failure of engine casing material around the remaining cylinder retaining bolts. The master rod and all the articulating rods had failed near their roots. The section of master rod between the piston and root was missing. All the cylinders had damage of varying degrees to their skirt, consistent with impact from the connecting rods. The gudgeon pin from the No 6 piston, to which the master rod had been connected, had 'sheared' at its centre (Figure 11). The No 6 piston had suffered from multiple impact damage to its base and sidewalls, consistent with a flailing master rod. The No 5 and No 7 pistons were missing. Multiple sections of articulating rod material were also missing. The gudgeon pins from the remaining pistons (No 1, 2, 3, 4, 8, 9) were intact and still connected to sections of articulating

Front face of engine, positioned upside down, showing missing No 5, 6 and 7 cylinders (when the engine is installed, the No 1 cylinder sits at the '12 o'clock' position)

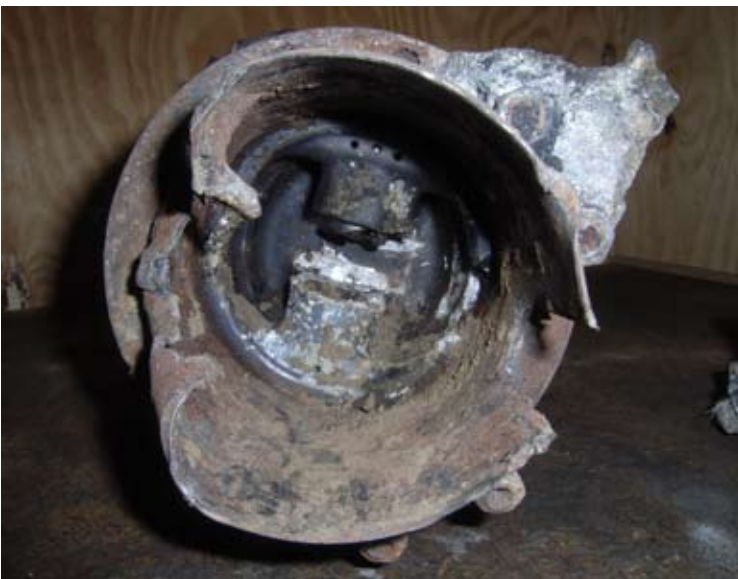
**Figure 11**

View inside No 6 cylinder showing damaged cylinder skirt, damaged piston and 'sheared' gudgeon pin

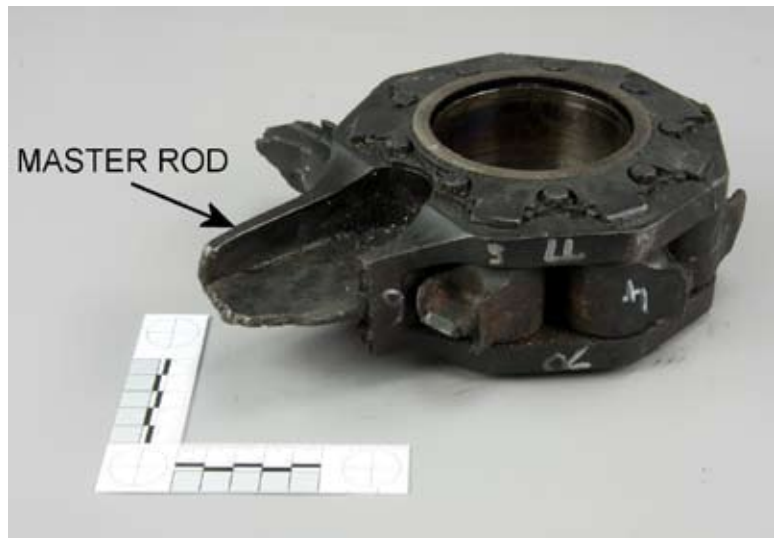
**Figure 12**

Remains of master rod and articulating rod ends

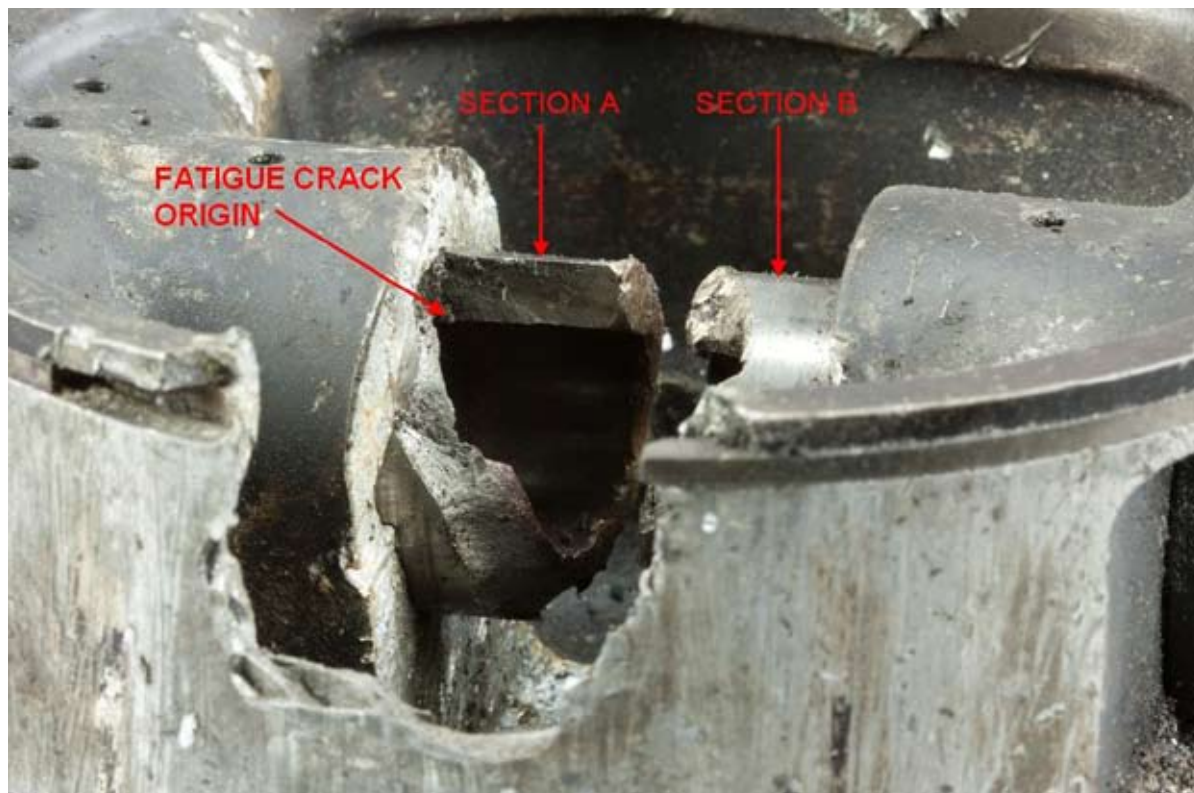
**Figure 13**

No 6 piston. Both portions of the failed gudgeon pin have been pushed back into their original seating position (compare to Figure 11 for their post-failure position)

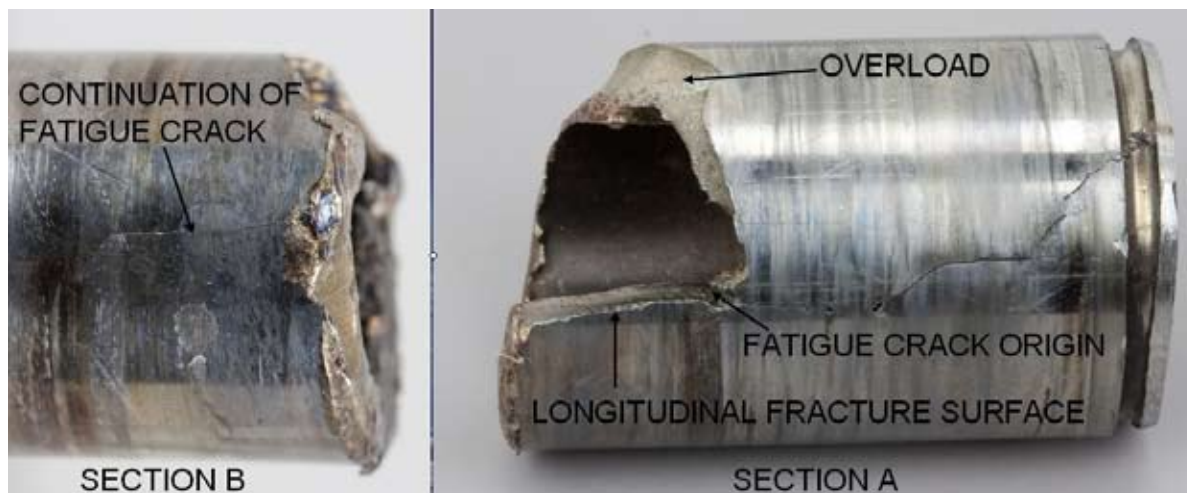
**Figure 14**

Both portions of No 6 gudgeon pin, showing fatigue crack origin

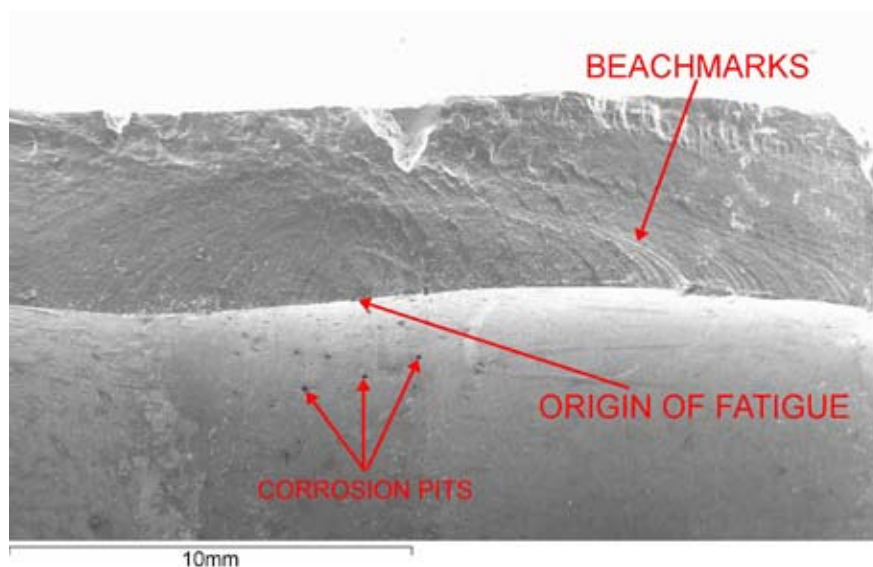
**Figure 15**

The two sections of pin were opened along the crack line to permit examination with a Scanning Electron Microscope (SEM) and Figure 15 shows an SEM image of the longitudinal fracture surface of section A. There was clear evidence of beachmarks, which are associated with metal fatigue, and these indicated the origin of the fatigue crack. A higher magnification image of this area revealed striations, which are another characteristic of metal fatigue. SEM examination of the crack in section B also revealed beachmarks and striations. The beachmarks on the longitudinal fracture surface of section A were counted several times, on

Scanning Electron Microscope (SEM) image of longitudinal fracture surface from section A, showing fatigue crack origin, beachmarks and corrosion pits

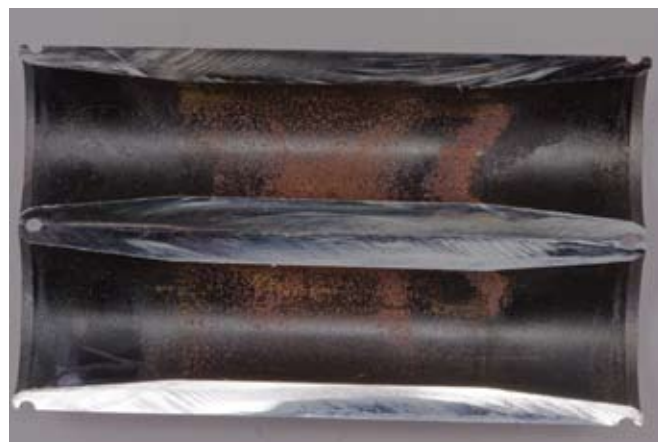
**Figure 16**

pin and the piston bores. The manufacturer's tolerance for this clearance was between 0 and 0.015 mm for a new installation and up to 0.05 mm for a worn installation. Measuring this clearance did not prove possible due to the build-up of sludge, oil and debris – most of which would have been as a consequence of the post-impact fire and break-up. Some of the gudgeon pins were free to rotate within the piston bores but others were

No 8 gudgeon pin sectioned, showing corrosion on internal surface

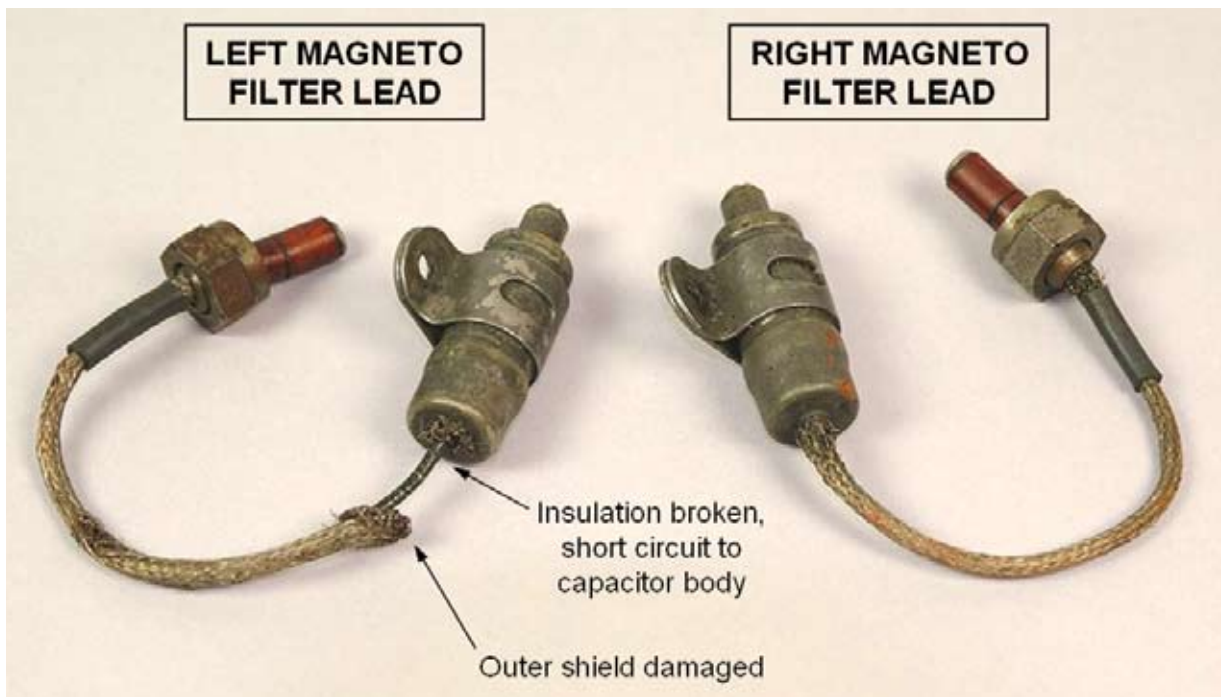
**Figure 1**

The left magneto filter lead (Figure 1) was in poor condition, exhibiting fraying of the outer shield material. The lead's insulation had failed at the exit of the filter capacitor body, and thus was electrically short-circuited to earth via the capacitor outer body.

Left and right magneto filter leads

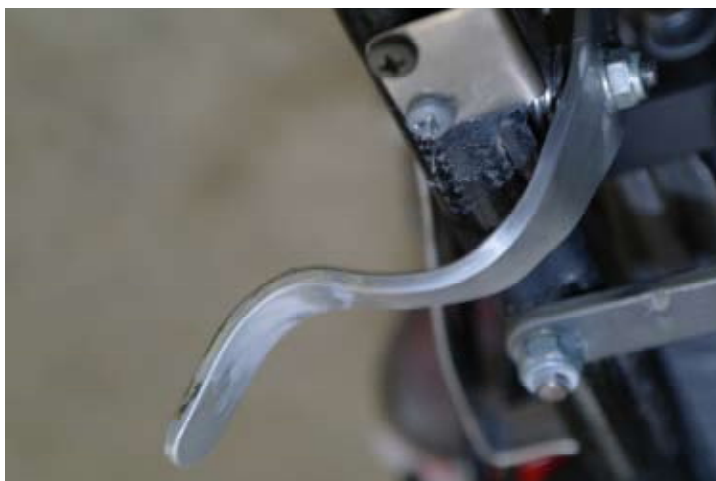
**Figure 1**

The condition of the fracture surface of the propeller shaft indicated that it had failed some time prior to the release of the propeller, possibly prior to the change of ownership. Given the operational history of the glider it is probable that the propeller shaft failed as a result of one of the two previous propeller strike events. Failure of the shaft would have increased the likelihood of the propeller moving 'out of plane' when rotating, but was

Damaged propeller lock

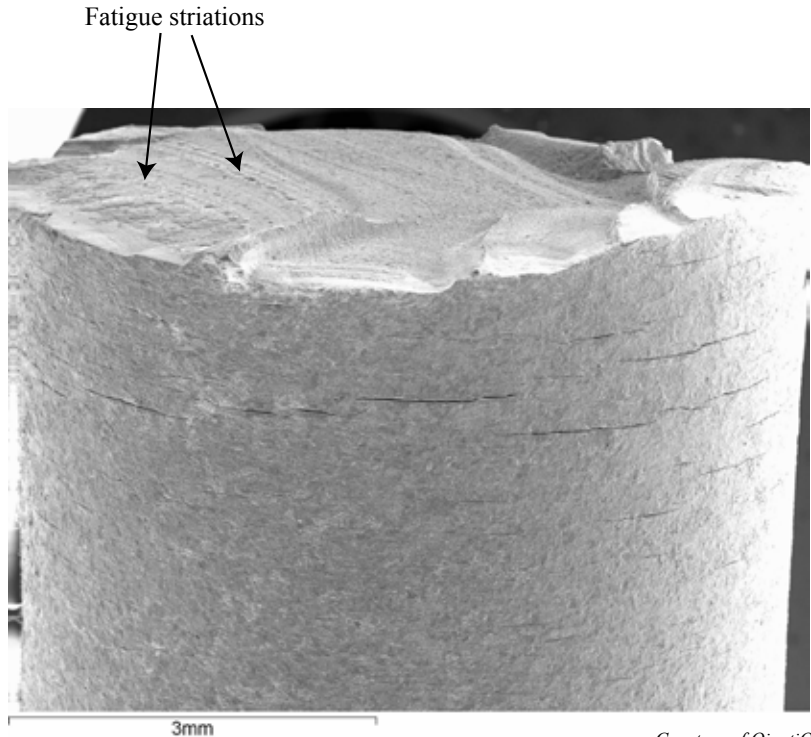
**Figure 1**

Failed exhaust valve stem showing secondary fatigue cracks

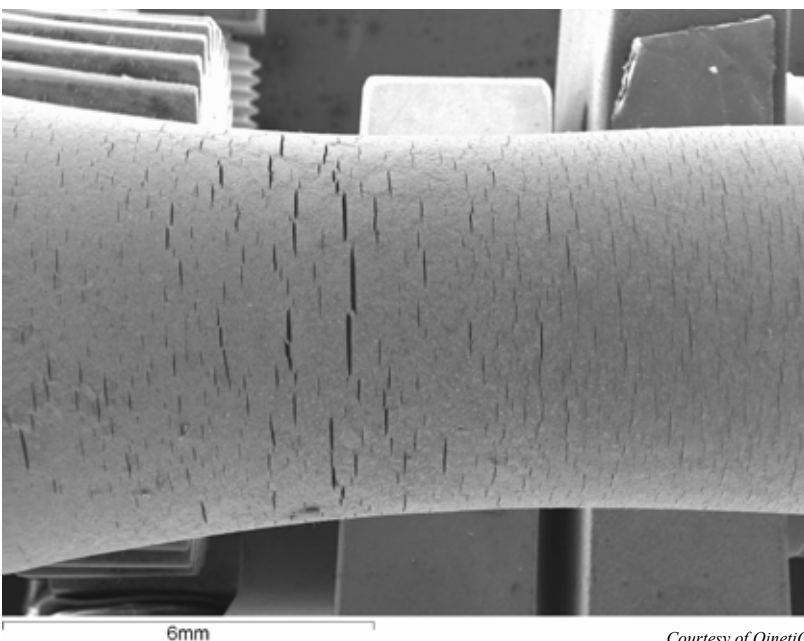
**Figure 2**

The exhaust valve that had not failed was also examined; numerous cracks were observed in the surface (Figure 2). These also appeared to be fatigue cracks and this valve, if allowed to continue in service, would have failed in the same manner as the fractured valve.

Surface cracking on stem of non-failed exhaust valve
