CONTENTS

COMMERCIAL AIR TRANSPORT

List of recent aircraft accident reports issued by the AAIB

(ALL TIMES IN THIS BULLETIN ARE UTC)

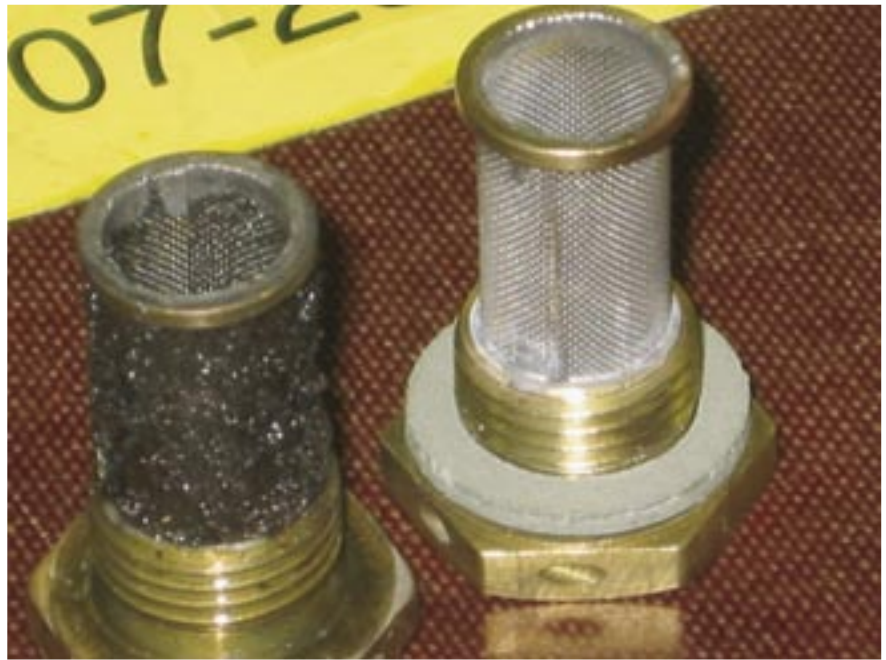
Figure 3

The fuel metering unit filter was removed and was found to be 80% to 85% blocked with debris, as indicated in Figure 3.

Contaminated filter removed from G-GBED (left) and identical clean filter (right)

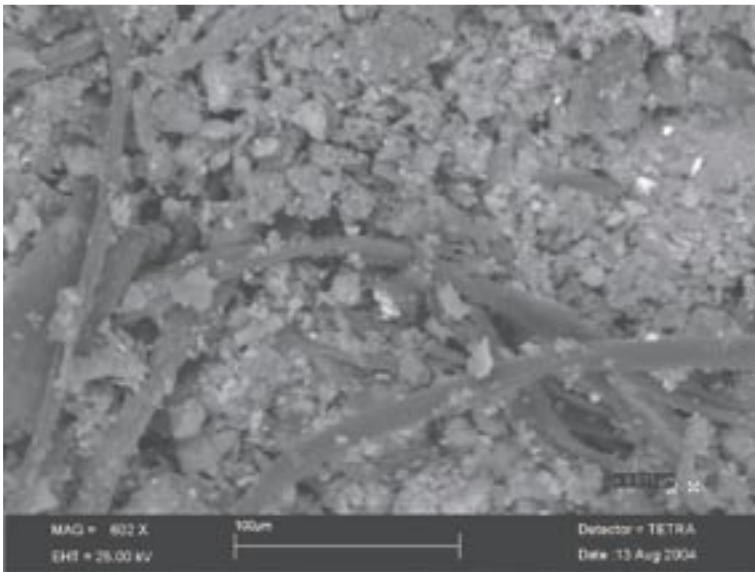
Figure 4

The fuel metering unit filter was removed from the parachute club's other similar aircraft and debris was also found, but the level of contamination was much less than that seen on G-BGED. Analysis by QinetiQ again showed that the debris consisted predominantly of fibres, with flakes and particulate matter also present. EDX analysis indicated a predominantly carbon based composition to the fibres and flakes although a few paint flakes and a single

Magnified image of the fibres and debris removed from the filter

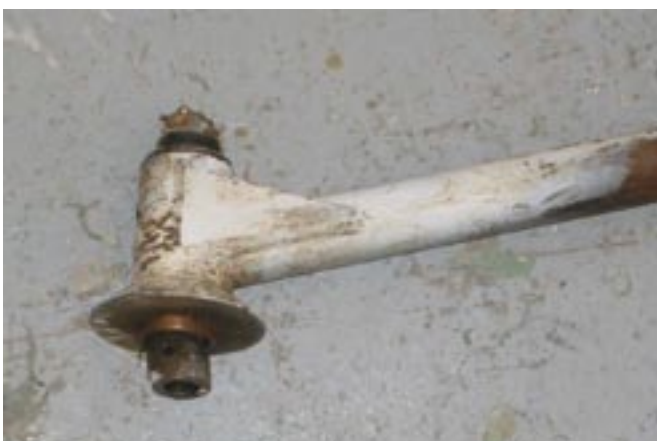
Figure 2a

View of nose leg, showing distortion of lower end of attachment shaft

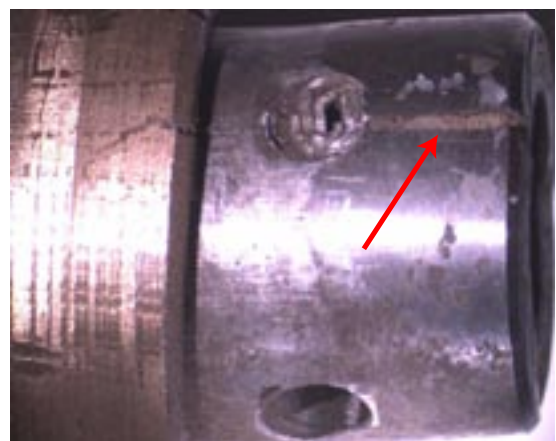
Figure 2b

Close-up view of shaft, showing additional drilling, remains of rolled steel pin and crack (arrowed)

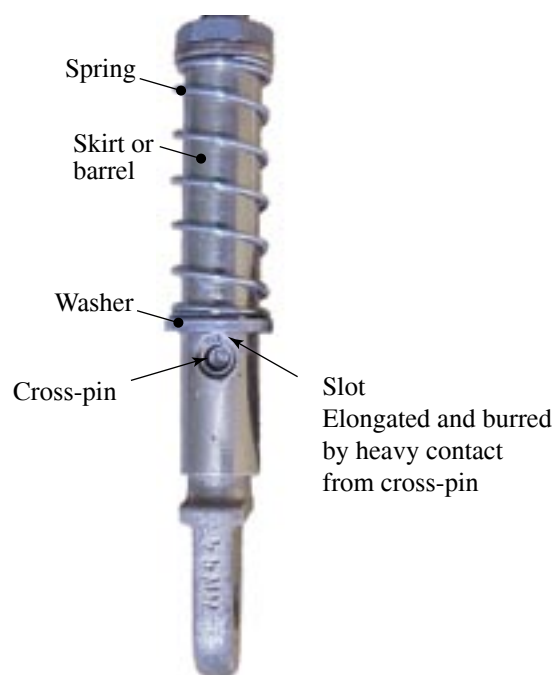
Figure 3

Damaged Downlock link showing distortion of slot and washer jammed on burr

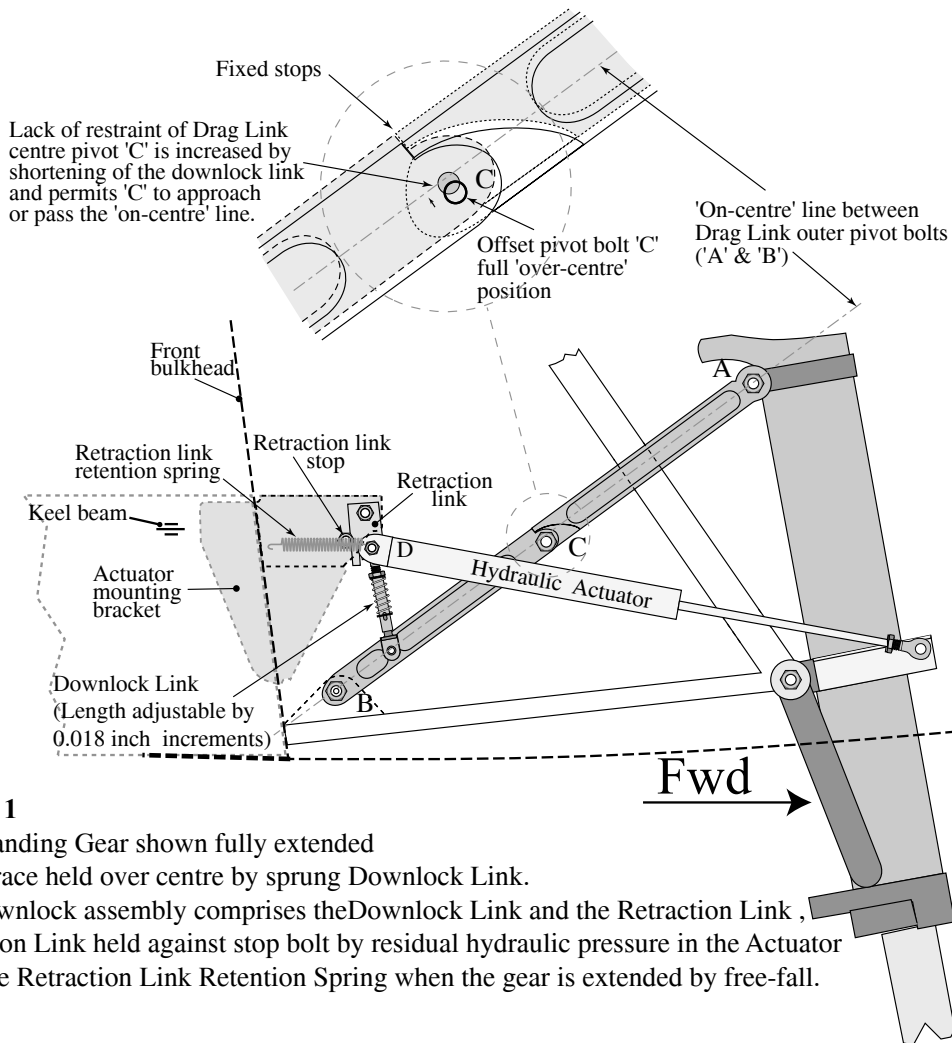
Figure 1

Inspection of the drag link after its removal from the aircraft showed that there was considerable wear in the upper and centre pivot joints ('A' & 'C' on Figure 1, next page) but the lower joint ('B' on Figure 1) of the lower link exhibited very little wear. Before dismantling the assembly, the 'over-centre' dimension of the drag link assembly was measured to be 0.310 inch which was greater than the specified minimum.

The upper joint, attaching the link to the landing gear leg, was the most severely worn. Measurement of the individual components showed that the bolt itself was unworn and dimensionally correct. The steel sleeve (Part No 9061-29) which runs in the upper link bush was found to have no significant wear on its outer surface. However, the bore of this sleeve, for which wear limits are given in the Aircraft Maintenance Manual (AMM), had been worn bell-mouthed at both ends. Although at its mid-point the bush bore was measured as 0.001 inch smaller than the lower limit given, resulting in a bolt clearance of only 0.003 inch on the measured bolt diameter, at the ends the clearance was 0.006 to 0.007 inch; the greatest wear being 0.001 inch above the maximum limit. The inside diameter of the bronze bush at the upper end of the upper drag link, within which the steel sleeve worked was also measured and also found to be bell-mouthed. There were no established wear limits for this bronze bush at the time of this accident. In the bore of this bush it was found that the wear was oval and more severe along the axis of the link. Similarly to the steel sleeve, the bore of the bronze bush also was very little worn near the middle of the bush and most worn on the left side which had been adjacent to the landing

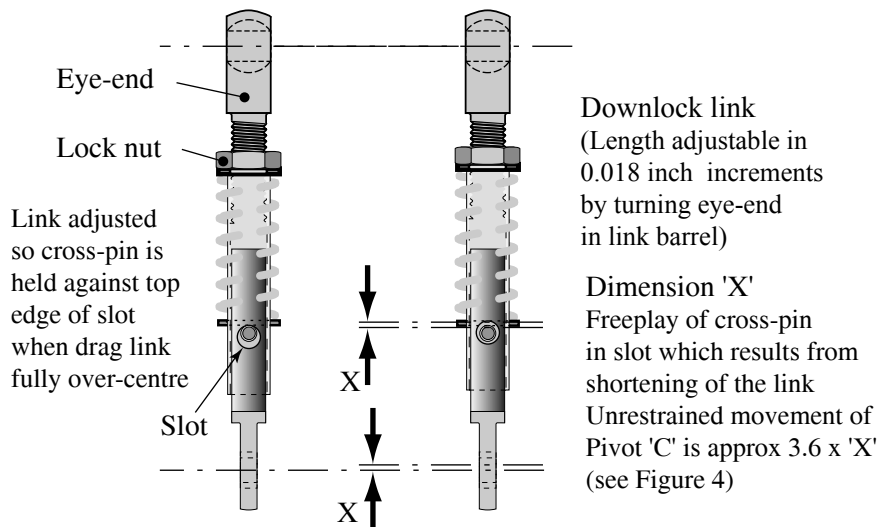
Figure 3

At the 50 hour check the fault in the emergency lowering of the nose landing gear was confirmed. It appeared that the downlock link was slightly too long to allow the retraction spring to pull the retraction link onto the downlock stop (see Figures 1 & 3). After lubrication of the downlock mechanism, the link was shortened by a small amount

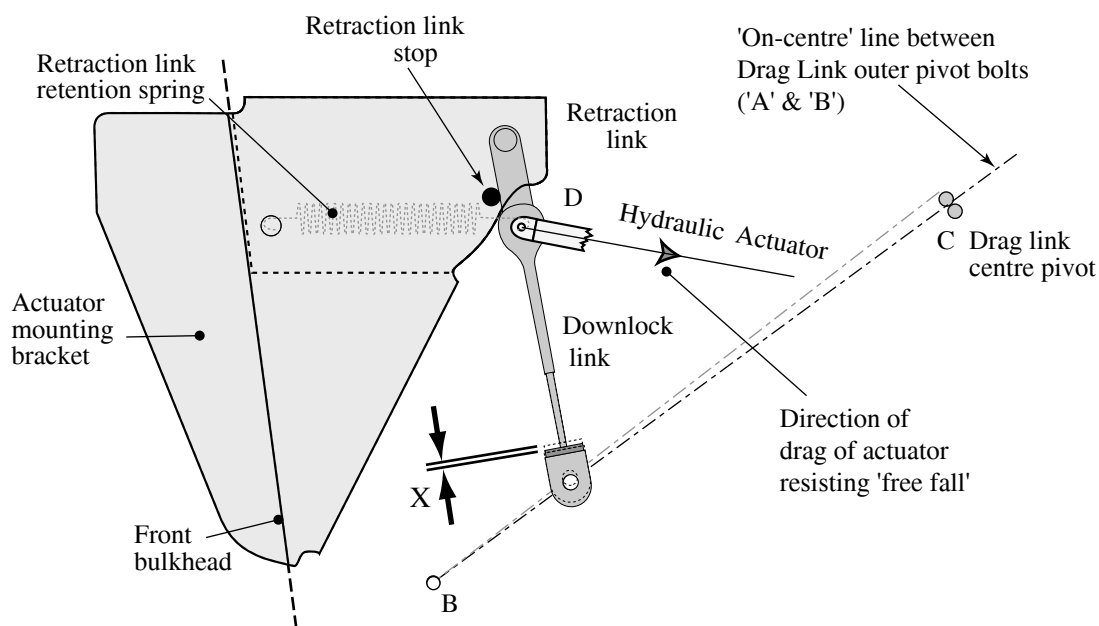
Figure 4

Consideration of the way in which the lock mechanism works during 'free-fall' extensions indicates that the hydraulic actuator acts, to some extent, as a damper against violent deployment and that the downlock spring draws the retraction link fully up to its stop. When the nose landing gear is extended but the aircraft's weight is not on the wheel, the weight of the forward raked strut tends to pull the drag link straight (ie off its full overcentre stop), against the gravitational pull on the drag link assembly itself which is tending to drive it

Schematic diagram of locking linkage showing effect of free play in Downlock Link on restraint at pivot 'C'

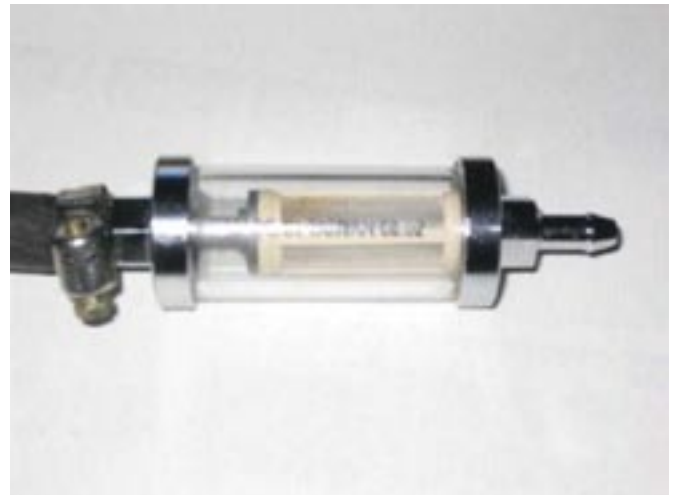
Figure 1

The pilot suspected fuel starvation and later removed the two carburettor float bowls, both of which contained sediment. He considered that there was a sufficient amount of sediment in the bowls to have restricted the supply of fuel (which was automotive MOGAS) into the engine. The larger items of sediment appeared to be small flakes of red paint, which matched the fuel cans from which he habitually filled the aircraft. It was not apparent how the sediment had reached the float bowls but further inspection showed that the replaceable element in the Purolator fuel filter assembly (Figures 1 and 2) had not been fully screwed home and could therefore 'rock' in place, allowing the flow of dirty fuel past the filter element.

G-CCBZ - fuel filter assembly

The pilot also considered that, in retrospect, he should have refuelled through a proper external strainer to filter the fuel into the tank, rather than using a simple 'jerry can' and siphon-tube arrangement. He also noted that the filter assembly did not indicate that the replaceable element should be screwed fully home and that, in this aircraft, the fuel supply to the engine primer is drawn from the fuel tank 'sight glass', which is not filtered.
