## ACCIDENT

<b>Aircraft Type and Registration:</b>	Bombardier BD700 Global Express, VP-CRC	
<b>No &amp; Type of Engines:</b>	2 Rolls Royce BR 710 series turbofans	
<b>Year of Manufacture:</b>	2007	
<b>Date &amp; Time (UTC):</b>	29 January 2008 at 0808 hrs	
<b>Location:</b>	London Luton Airport	
<b>Type of Flight:</b>	Private	
<b>Persons on Board:</b>	Crew - 3	Passengers - 1
<b>Injuries:</b>	Crew - None	Passengers - None
<b>Nature of Damage:</b>	Left inboard main landing gear tyre burst, flap drive shaft and two hydraulic pipes fractured, wiring loom damaged and localised wing structural damage	
<b>Commander's Licence:</b>	Airline Transport Pilot's Licence	
<b>Commander's Age:</b>	36 years	
<b>Commander's Flying Experience:</b>	3,759 hours (of which 92 hrs were on type) Last 90 days - 78 hours Last 28 days - 38 hours	
<b>Information Source:</b>	AAIB Field Investigation

## Synopsis

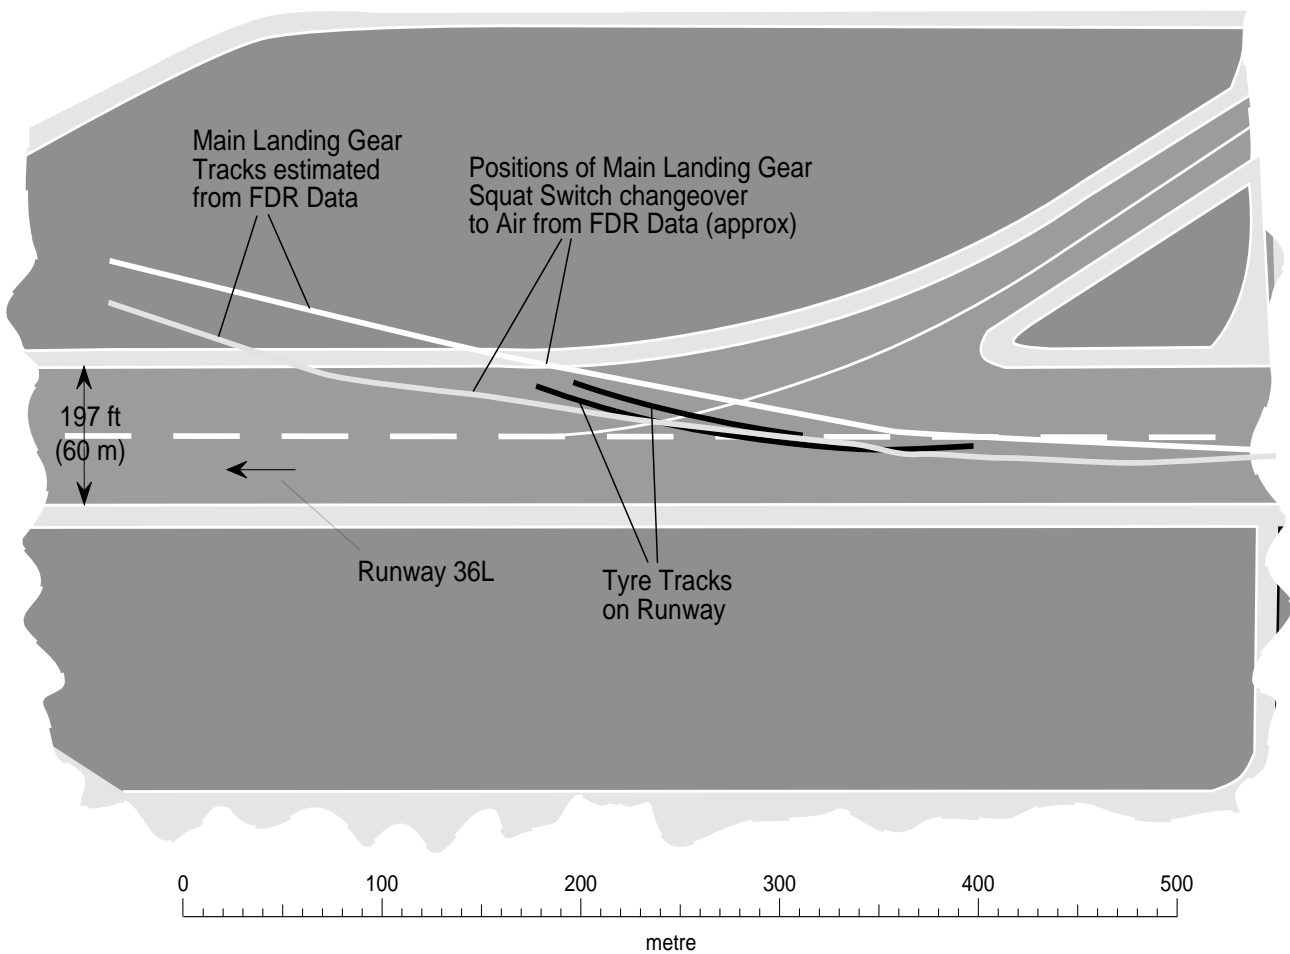
**Figure 3**

Plan View of Runway Tyre Marks and Main Landing Gear Tracks estimated from FDR Data
