CONTENTS

SPECIAL BULLETINS

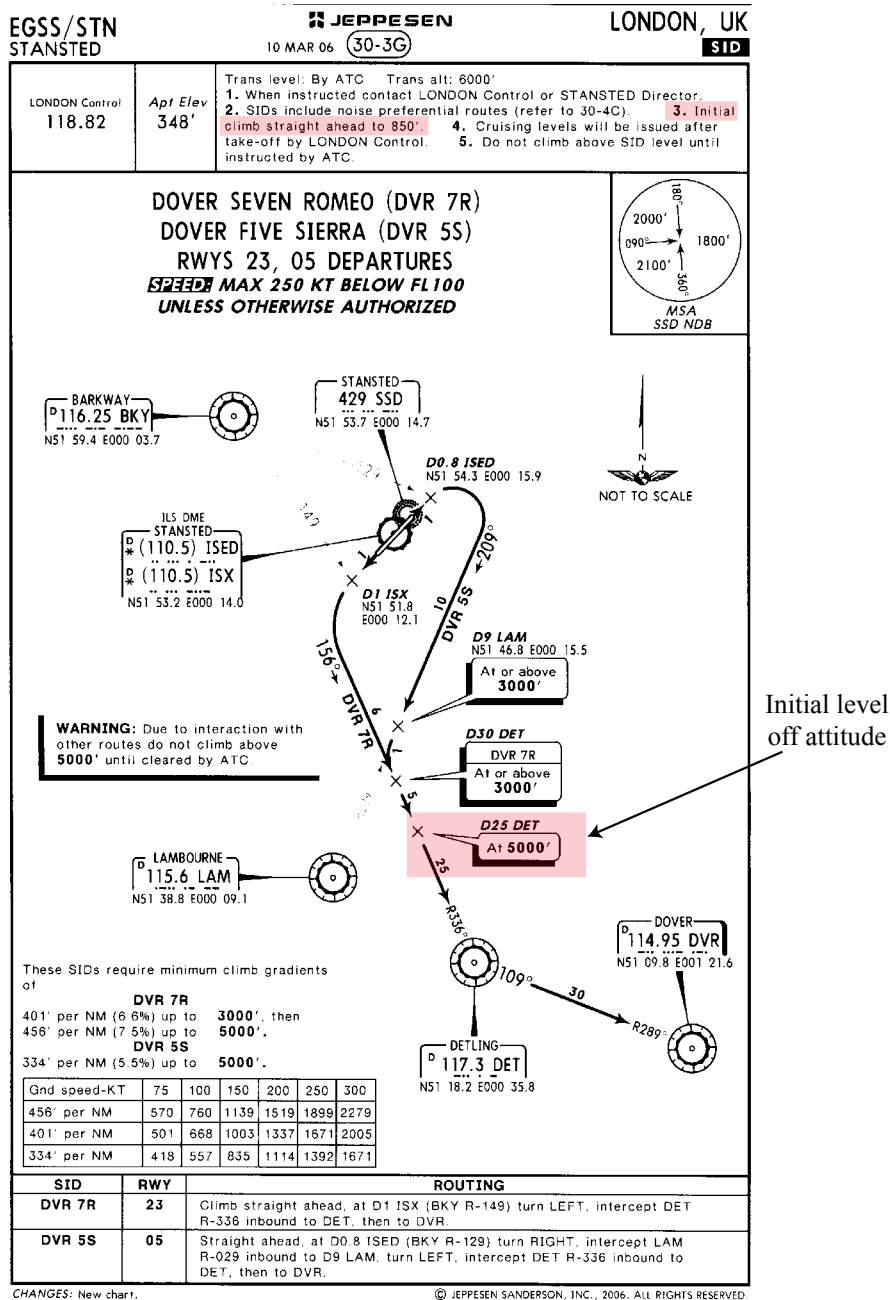
Figure 1

DVR 5S SID plate used by the crew

The commander commented that there might be a language issue with the 'Initial climb' note on the plate. His initial doubt, during the co-pilot's brief, should have alerted him to seek clarification from ATC before takeoff. As he had operated out of other major UK airports before on "numerous occasions", he either interpreted the meaning of the note correctly or failed to notice it on the previous departures.

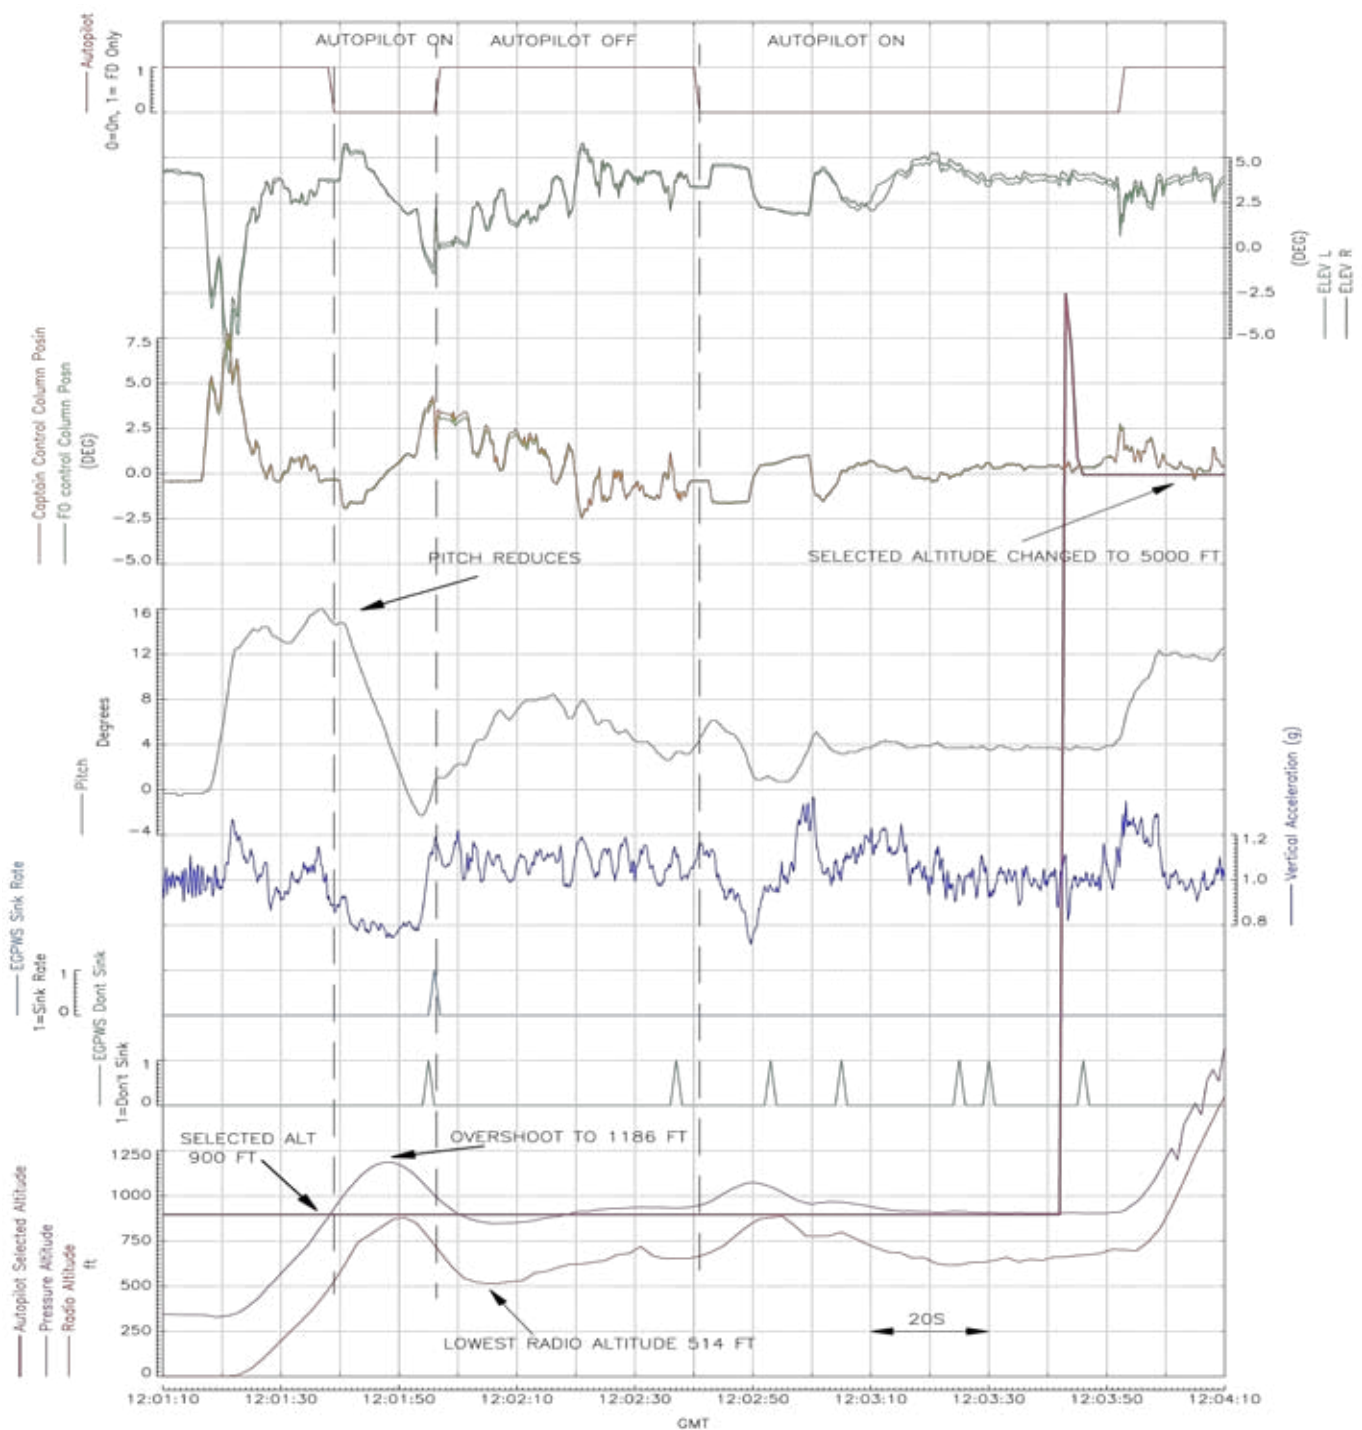
Figure 3

One second after the "DON'T SINK" alert, an EGPWS "SINK RATE" alert was triggered. Unlike "DON'T SINK", this alert monitors for excessive descent rates with respect to radio altitude, in all phases of flight. At the time of the alert, the EGPWS recorded a descent rate of 2,029 ft/min at an altitude of 694 ft agl.

Flight data recorder (FDR) - TC-JGR

of 514 ft agl. A steady increase in altitude to 719 ft agl (938 ft pressure altitude) ensued, followed by an additional altitude decay, triggering a second “DON’T

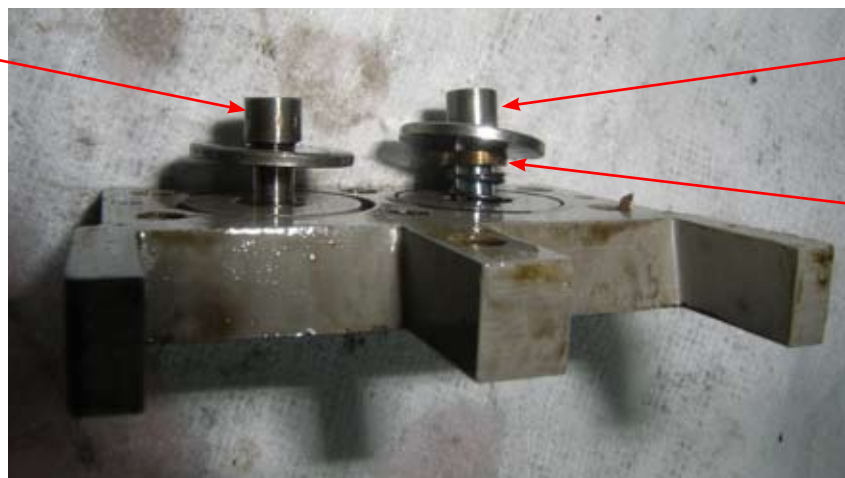
Brake valve plungers showing loose support sleeve on the right valve

for the left brake valve was secure within its housing, while the right valve sleeve sprang from the unit during disassembly. The right brake valve plunger exhibited witness marks on its shaft, and these appeared to have been caused by contact with the sleeve during operation; the left valve plunger was undamaged. Measurement of the right valve sleeve showed that a clearance of 0.06 mm existed between the outer diameter of the sleeve and the hole in the housing in which it had been mounted. This clearance would have allowed a small degree of 'rocking' movement of the sleeve which, over time, produced the witness marks on the plunger shaft and, on this occasion led to it becoming jammed.

a degree of pressure being continually applied to the right wheel brake. Given that the pilot did not have any directional control issues until the nosewheel left the ground, the level of braking to the right main wheel must have been low. As the aircraft accelerated down the runway, the heat build-up within the right brake unit would have been rapid and it is likely that it was sufficient to cause the brake unit to 'seize', just as the nosewheel lifted from the ground.

The brake selector unit is not subject to a fixed life and it was not determined when this unit had been fitted to the aircraft. As a result of this event, the maintenance organisation has introduced routine spectrographic oil analysis of the hydraulic fluid within the brake system to allow early identification of component deterioration.

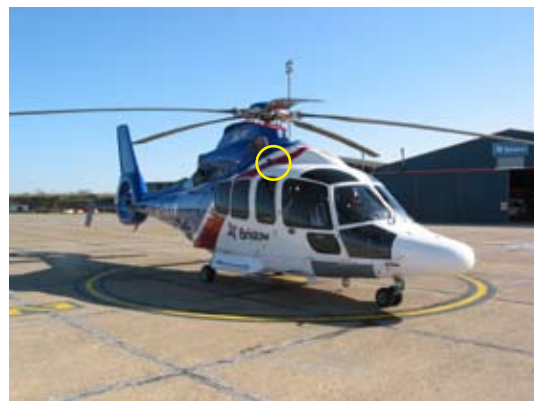
Figure 1

Location of EC155 Hoist Fixed Connector (circled)

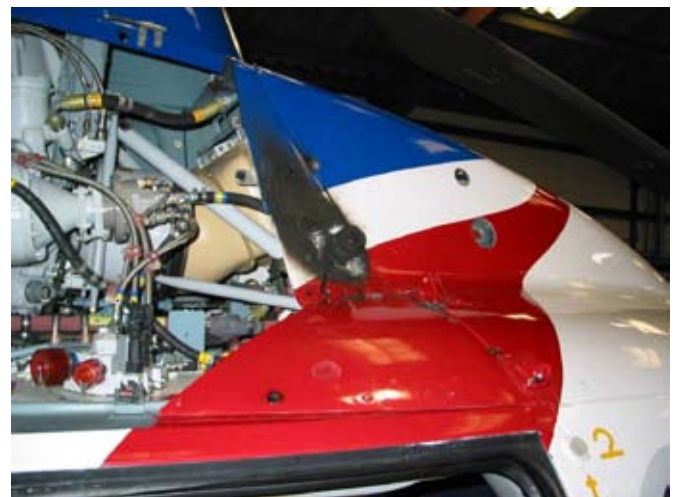
Figure 2

The aircraft was examined in the operator's maintenance hangar at Norwich Airport. The hoist connector was fire damaged and the right side of the oil cooler support fairing was badly charred in the vicinity of the connector (Figure 2). Localised charring was also visible at three fastener locations around the edges of the fairing, where it attached to the aluminium framework of the fuselage. The fire damage was more evident on the external side of the connector and the fairing.

Fire damage to hoist fixed connector and oil cooler support fairing

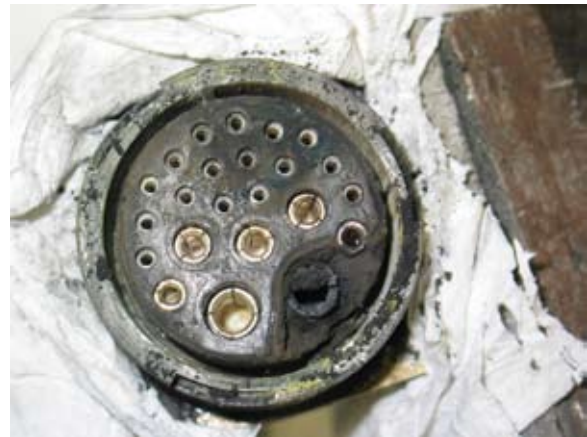
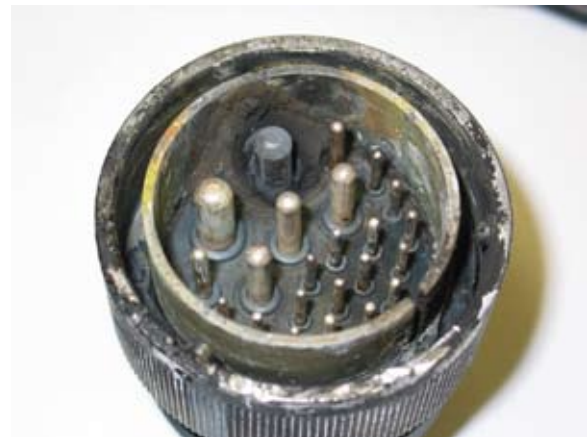
Figure 3

disassembly, evidence was found of arcing between the power contact ('W') and the body of the connector (Figure 3). The burning damage to the inner surface of the body was in the plane of the interface between the fixed connector and the shunt plug. The elastomeric insulator material in the vicinity of the power contact was heavily charred and partly burnt away. The heat damage was greatest in the vicinity of the power contact and the area of shorting on the connector body. The other contacts were free from significant heat damage.

Evidence of arcing between power contacts and body of connector

The strip examination of the fixed connector and shunt plug showed that arcing had occurred between the positive contact 'W' for the hoist motor and the body of the connector. The fire damage to the panel and the charring around the three fastener holes is indicative

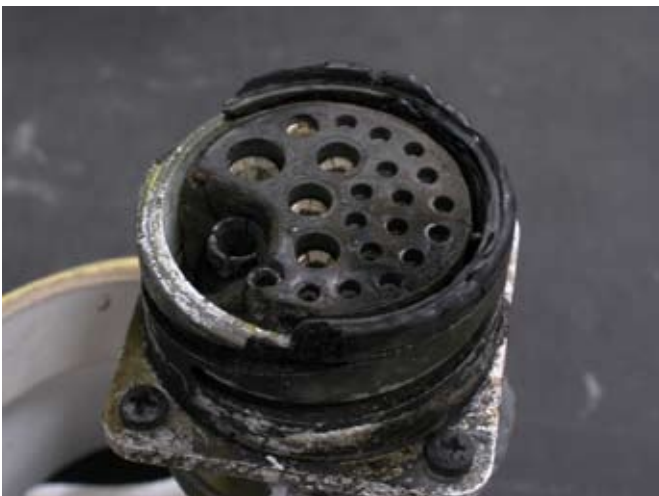
Figure 4

The environmental seal between the two parts of the connector was destroyed in the region closest to the power and earth pins. The remaining 60% of the seal was heat affected, but intact. Examination showed that it was deeply indented around the circumference due to being crushed against the sharp edge of the O-ring groove (Figure 4). Several deep circumferential cuts were also visible on one part of the seal circumference.

Damage to hoist connector environmental seal

have been resistant to the ingress of moisture, given that it was equipped with an environmental seal and the quality of the potting of the shunt plug was acceptable, the cuts in the seal could have provided a path for moisture from rain or aircraft washing, to enter the connector over a period of time. Once inside, it could have accumulated in the small gap at the interface of the fixed connector and shunt plug, until sufficient moisture was present to cause a short circuit.

The use of a square-section seal, whilst retaining the groove for an O-ring on the seal land, provides the potential for the seal to be damaged by being compressed against the sharp edge of the O-ring groove when the connector halves are assembled. To address this issue, the following Safety Recommendation is made:

Safety Recommendation 2007-072

It is recommended that Eurocopter modify the method of sealing the hoist connector '24 DELTA' on EC155 aircraft, to ensure that it is effective in preventing moisture ingress into the connector.

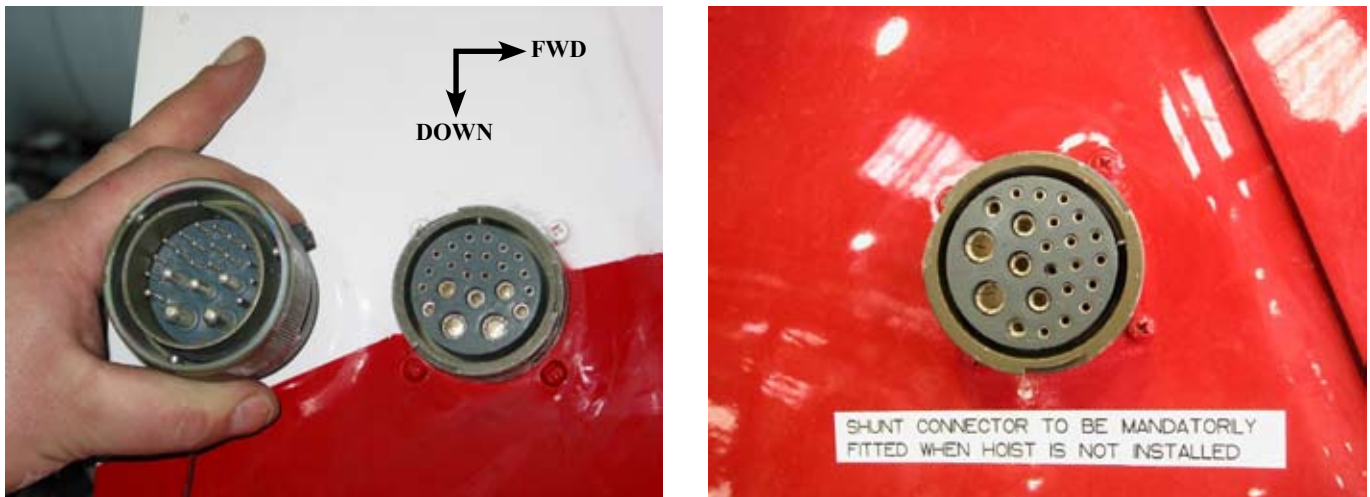
**Figure 5**

It was noted that the fixed connector on G-ISSV was installed with the power and earth contacts lowermost. The connector on another of the operator's recently-delivered EC155 helicopters was similarly oriented. However, inspection of another new EC155 at the aircraft manufacturer's facility showed that the fixed connector on this aircraft was installed with the power and earth contacts facing aft (Figure 5).

Differing orientations of hoist fixed connector

In this and the previous hoist fire incident, the fixed connector was installed with the power and earth contacts facing downwards. This orientation of the contacts could increase the likelihood of an electrical short if moisture is present within the connector. To reduce the likelihood of shorting, the following Safety Recommendation is made:

Safety Recommendation 2007-073

It is recommended that Eurocopter determine the most appropriate orientation for mounting the EC155 hoist fixed connector to minimise its susceptibility to shorting from moisture ingress.

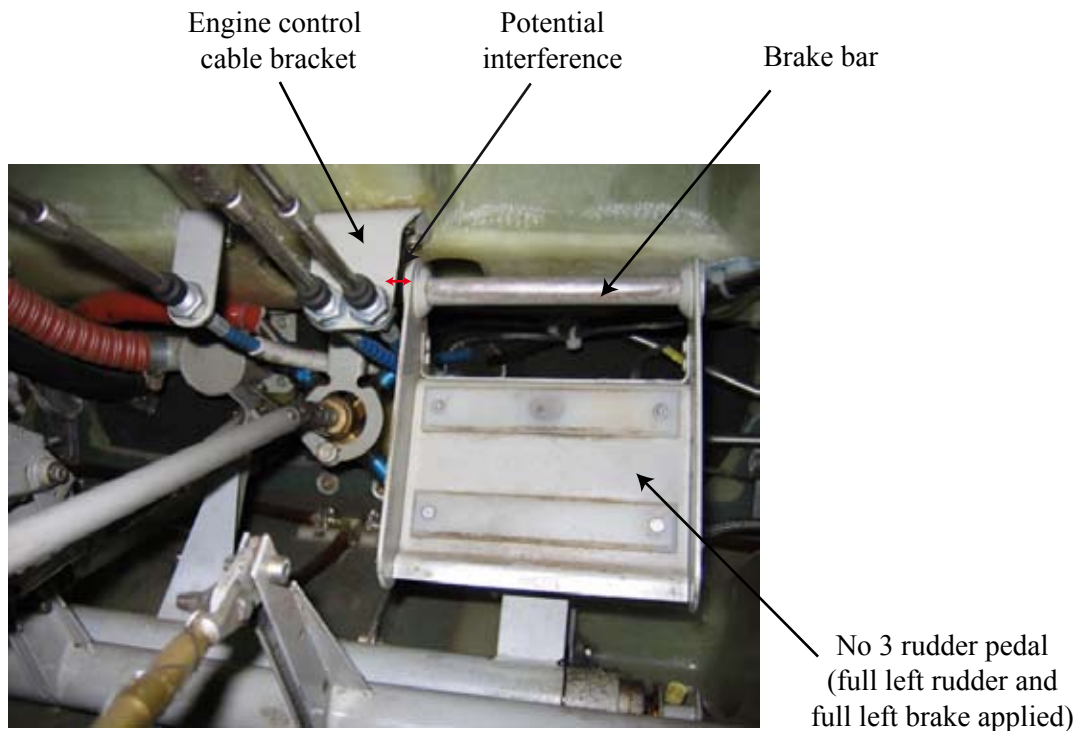
Figure 3

The maintenance organisation reported that, after prolonged attempts, it was found possible to produce interference between the No 3 pedal and a fixed bracket supporting engine control cables. With the No 3 pedal adjusted fully forward, pushing the brake bar of this pedal fully forward (thus applying full left rudder and full left wheel brake) positioned the top part of the pedal close to the bracket. If a left side force was simultaneously applied to the No 3 pedal, its edge could contact the bracket (Figure 3). It appeared that the pedal could possibly get caught behind the bracket and that a significant force on the right pedal could be required to clear the foul.

No 3 pedal clearance (similar aircraft)

The available evidence indicated that G-EFSM's rudder restriction had resulted from interference of the engine control cable bracket with the No 3 pedal. This would have required the pedal to have been adjusted fully forward and pushed and rotated fully forward. It appeared that it would be relatively easy to apply wheel brake inadvertently in this way when applying full rudder; this would not normally be of any relevance while airborne. While it appeared that a sufficiently high force applied to the No 2 pedal would be expected to free the mechanism, this could not be positively confirmed and involved the risk of damaging the rudder pedal mechanism or its mountings. The restriction was clearly a highly undesirable occurrence and in this case caused a significant delay in recovery from the spin.

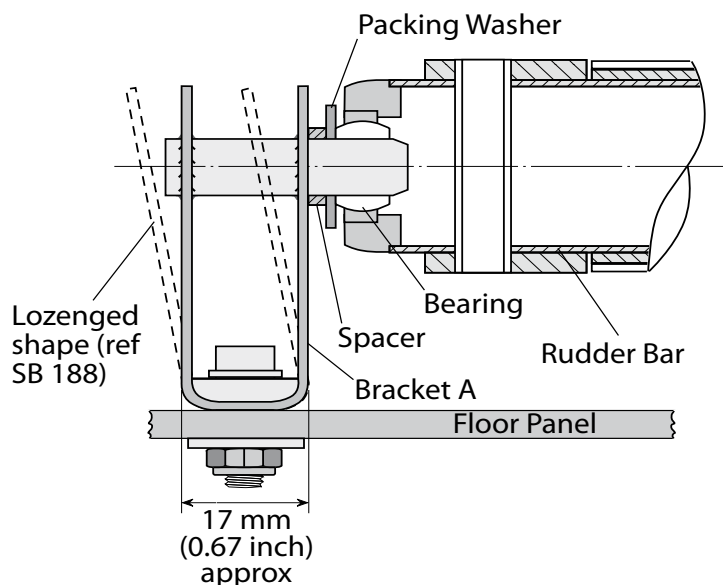
Figure 4

The control restriction apparently resulted from excessive lateral displacement of the No 3 pedal. Such

Rudder bar support bracket
