**(ALL TIMES IN THIS BULLETIN ARE UTC)**

**ACCIDENT**

<b>Aircraft Type and Registration:</b>	Boeing 777-222, N786UA	
<b>No &amp; Type of Engines:</b>	2 Pratt & Whitney PW4090 series turbofan engines	
<b>Year of Manufacture:</b>	1997	
<b>Date &amp; Time (UTC):</b>	26 February 2007 at 1000 hrs	
<b>Location:</b>	London (Heathrow) Airport	
<b>Type of Flight:</b>	Commercial Air Transport (Passenger)	
<b>Persons on Board:</b>	Crew - 20	Passengers - 185
<b>Injuries:</b>	Crew - None	Passengers - None
<b>Nature of Damage:</b>	Heat and fire damage to the right main power distribution panel, surrounding structure and components inside the Main Equipment Centre	
<b>Commander's Licence:</b>	Airline Transport Pilot's Licence	
<b>Commander's Age:</b>	52 years	
<b>Commander's Flying Experience:</b> (Hours all approximate)	18,000 hours (of which 2,800 hours were on type) Last 90 days - 215 hours Last 28 days - 65 hours	
<b>Information Source:</b>	AAIB Field Investigation

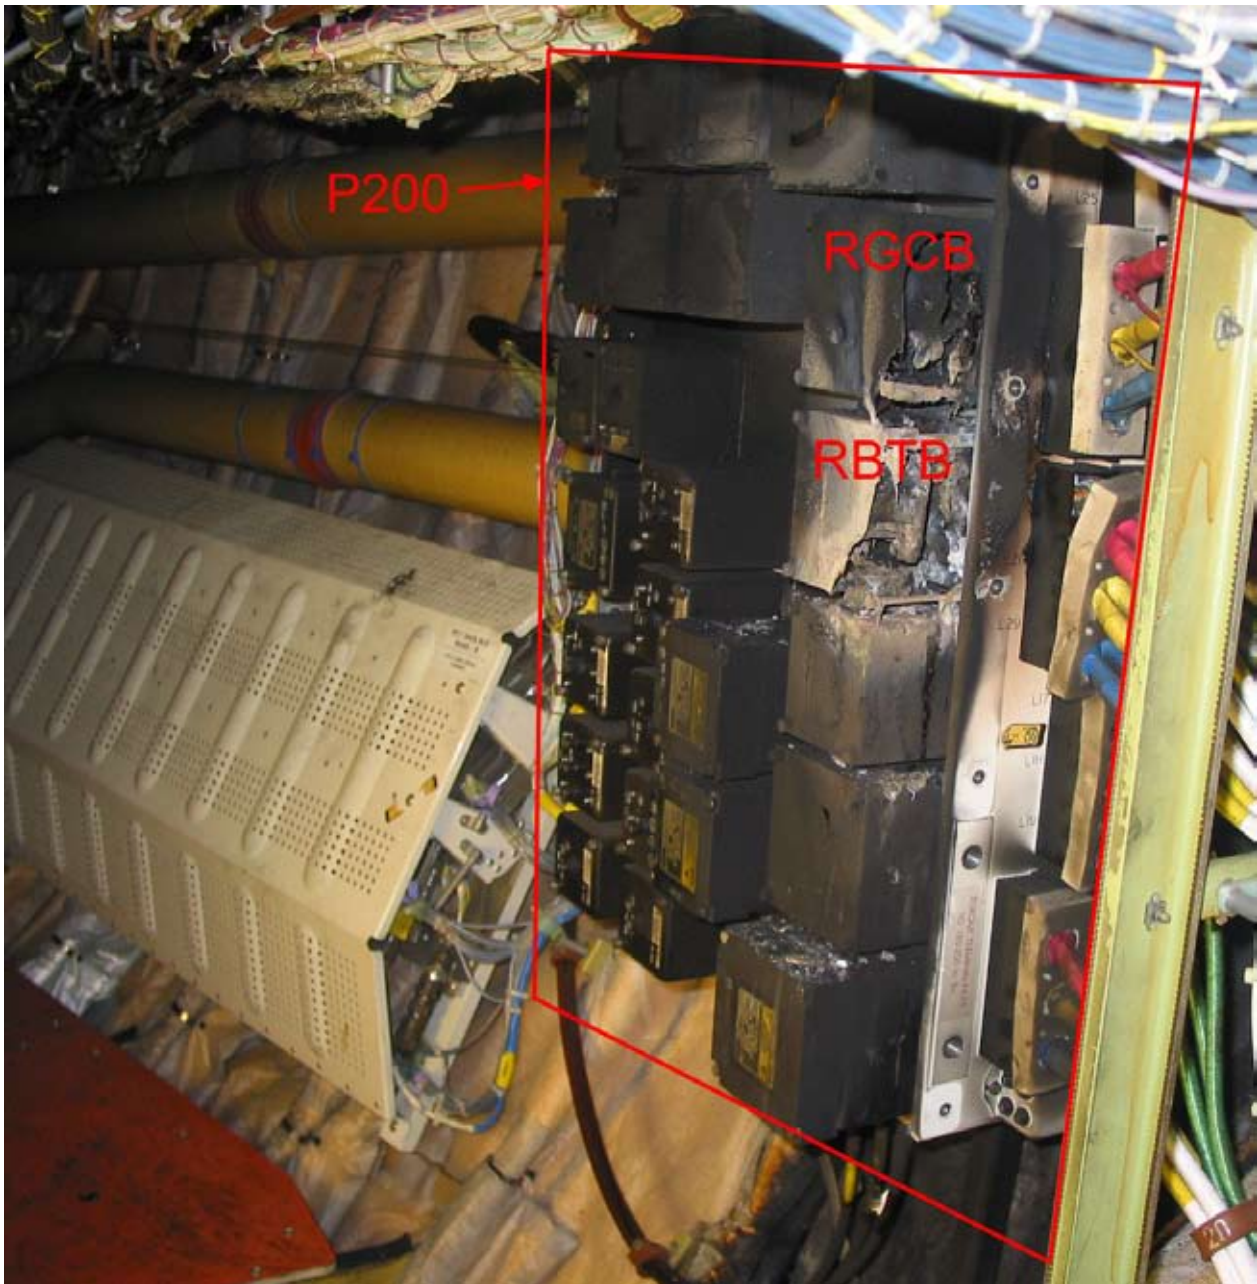
**Figure 2**

An inspection inside the MEC after the accident revealed extensive heat and fire damage to the P200 power panel as shown in Figure 2. The worst affected components of the power panel were the RGCB and RBTB contactors, parts of which had melted and vaporised. There was evidence that molten metal had dripped down onto the insulation blankets beneath this panel. Extensive fire damage to the fire-retardant insulation blankets located behind and beneath the power panel under the floor, had occurred as shown in Figure 3. Nearby components including a floor panel, equipment cooling system ducting, other wire bundles and some structural frames and stringers in the vicinity were later determined to have suffered sufficient heat damage to require replacement.

revealed that both the RBTB and RGCB had suffered from extreme heating and electrical arcing. The main moveable contacts within both contactors were destroyed. There was some insulation damage to the bus bars within the panel in the vicinity of the RBTB. The damage to the surrounding components of the power panel appeared to be a consequence of a failure within either the RBTB or RGCB.

Fire damage to P200 panel, showing burnt-out RGCB and RBTB contactors  
(panel cover has been removed in this photograph)

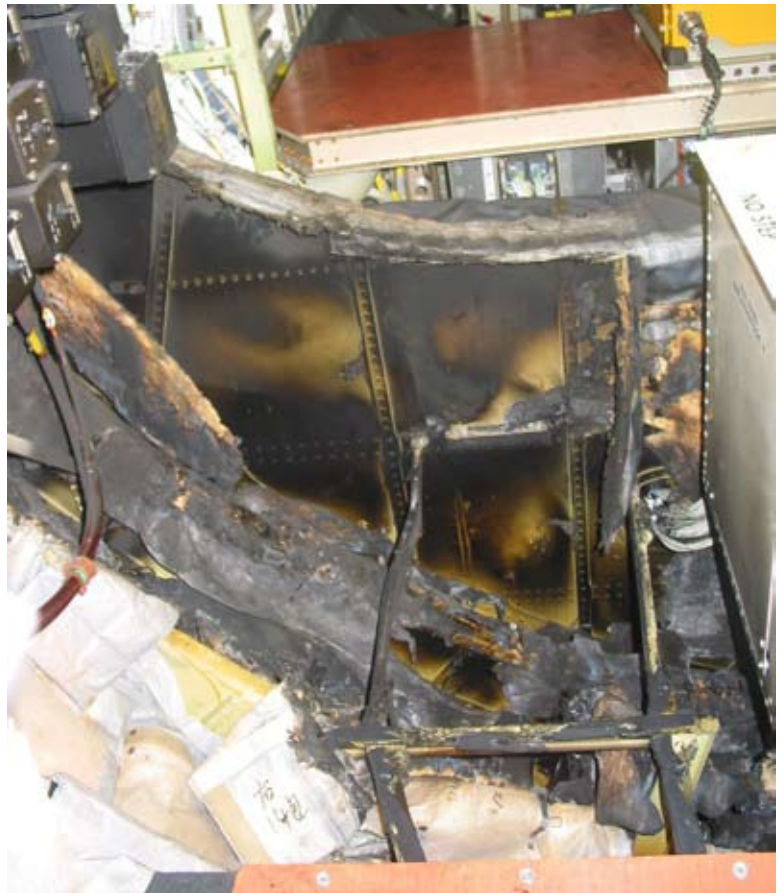
**Figure 3**

Burnt aircraft structure and insulation blankets  
located directly below P200 panel  
(viewed looking aft with floor panel removed)

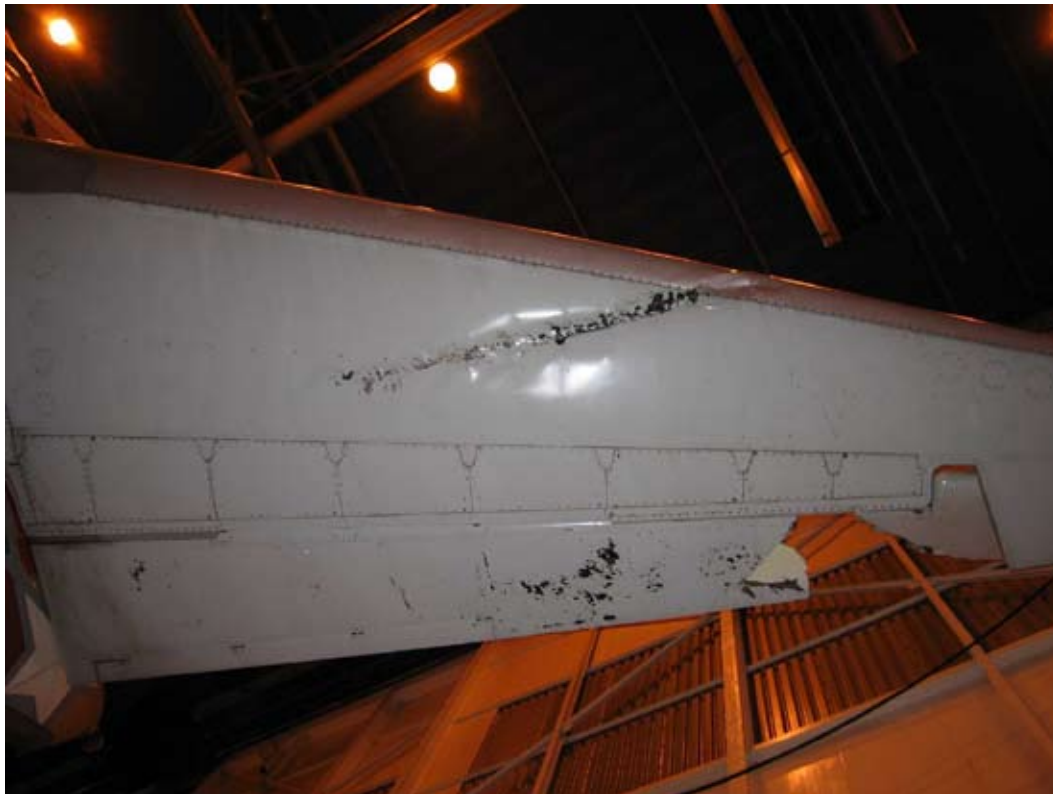
**Figure 2**

Damage to left tailplane and left elevator on G-DOCT

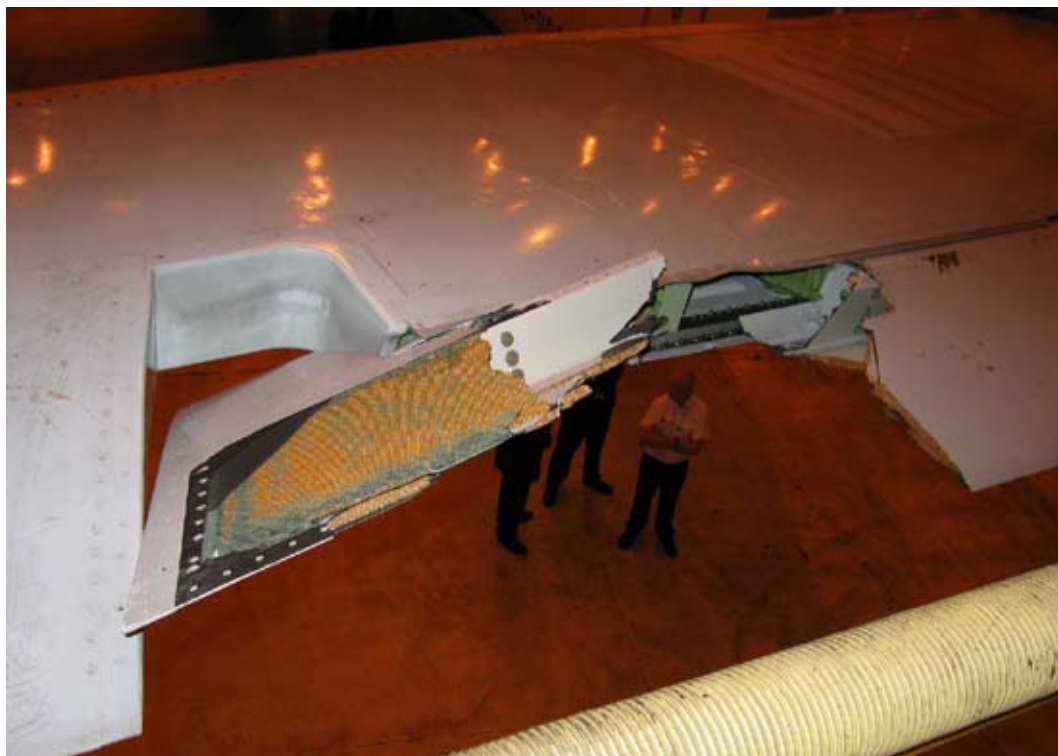
**Figure 3**

Damage to left elevator of G-DOCT, showing separation of outboard section

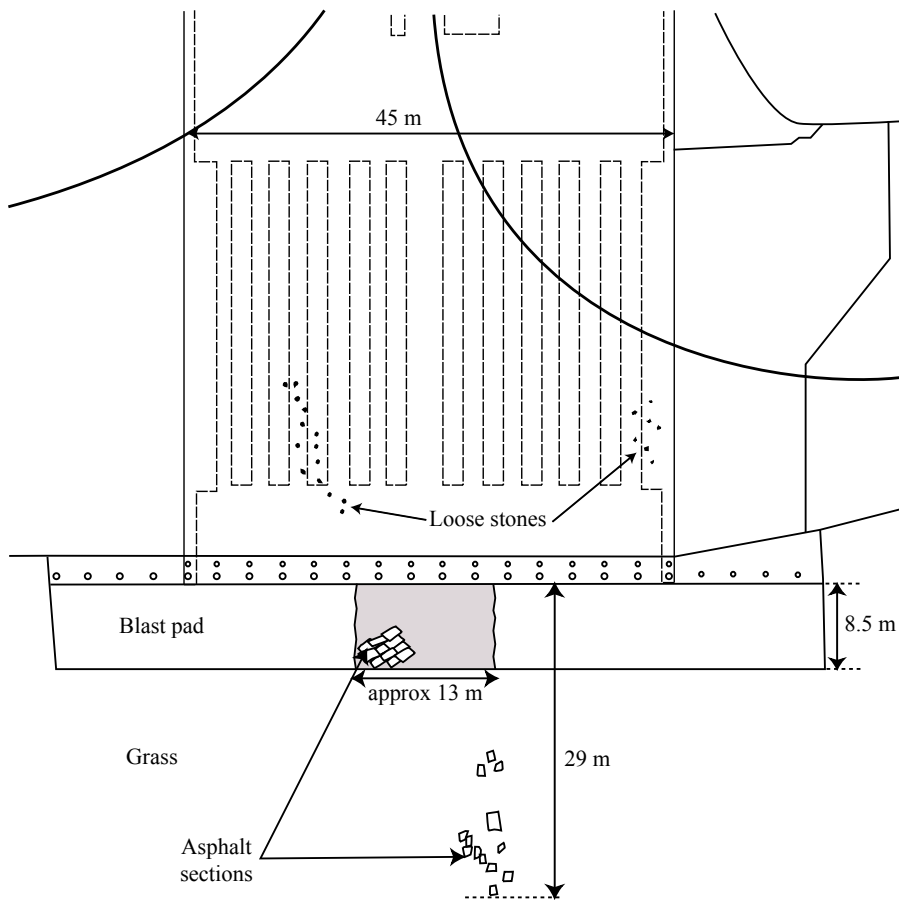
**Figure 5**

The blast pad (also known as an erosion strip) at the Runway 16 threshold at Aberdeen Airport was a paved area 8.4 m long and 72 m wide, extending beyond both sides of the 45 metre-wide runway (area shown in yellow in Figure 4). The asphalt surface of the central section of this blast pad, approximately 6.5 m either side of the runway centreline, had completely detached. Most sections of asphalt had been blown aft into a grass area – some were found 20 metres behind the end of the blast pad. The remainder of the asphalt sections were piled up in the damaged area of the blast pad (see Figure 5), the largest of which was approximately 1.8 m by 1.5 m and 6 cm thick, weighing approximately 340 kg. The exposed surface below the removed asphalt consisted of stones and dirt with almost no bitumen residue. Some of the stones from this surface were found on the runway. The majority of the bitumen overband sealing (designed to create a flush surface, without cracks, between the runway and blast pad) had detached with the asphalt.

Blast pad debris following accident to G-DOCT.  
Grey area denotes delaminated portion of blast pad

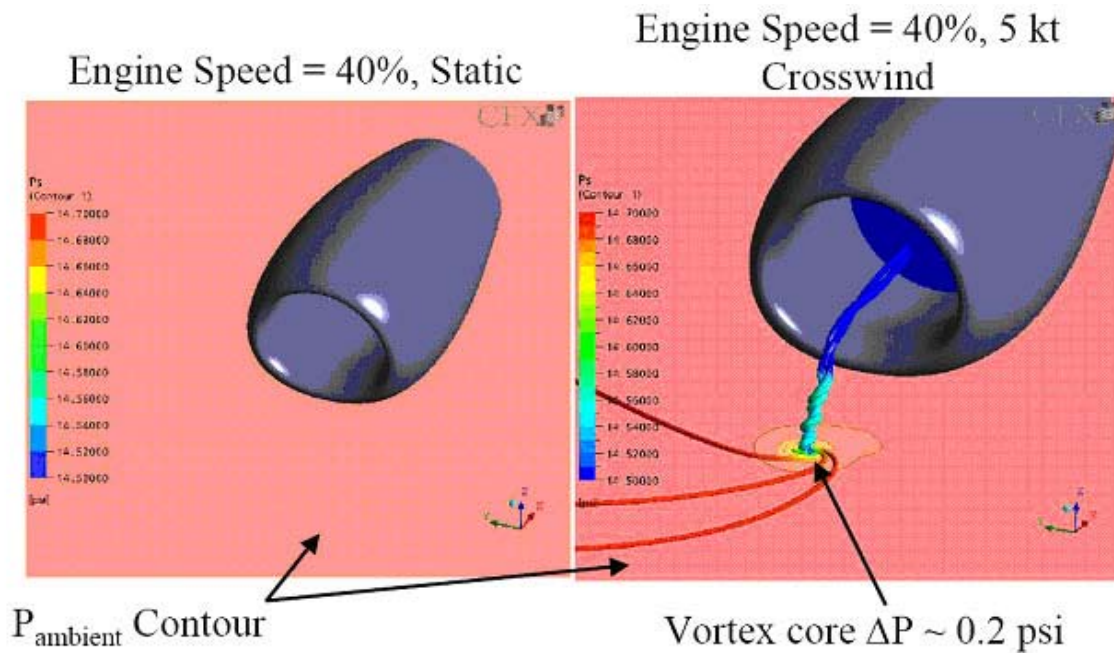
**Figure 9**

A further study was then conducted to examine the suction effects from the engine inlet. As G-DOCT made its tight final right turn, to line up with the runway, its left engine was spooled up to 40%  $N_1$  and the path of the left engine probably passed over the blast pad surface. The study was therefore carried out at 40%  $N_1$ . The results indicated that in 'nil wind' conditions the static pressure on the ground, in front of the engine inlet, was equal to ambient pressure. However, when a 5 kt cross-wind was introduced into the model, a vortex was generated in front of the engine inlet which applied a suction force of 0.2 psi to the ground. The cross-wind induced flow asymmetry and this triggered the vortex formation. Figure 9 shows the vortex and the pressure contours for a power setting of 40%  $N_1$ .

Results from the engine manufacturer's engine inlet study which revealed a 0.2 psi suction force at ground level with a power setting of 40%  $N_1$  and a 5 kt cross-wind

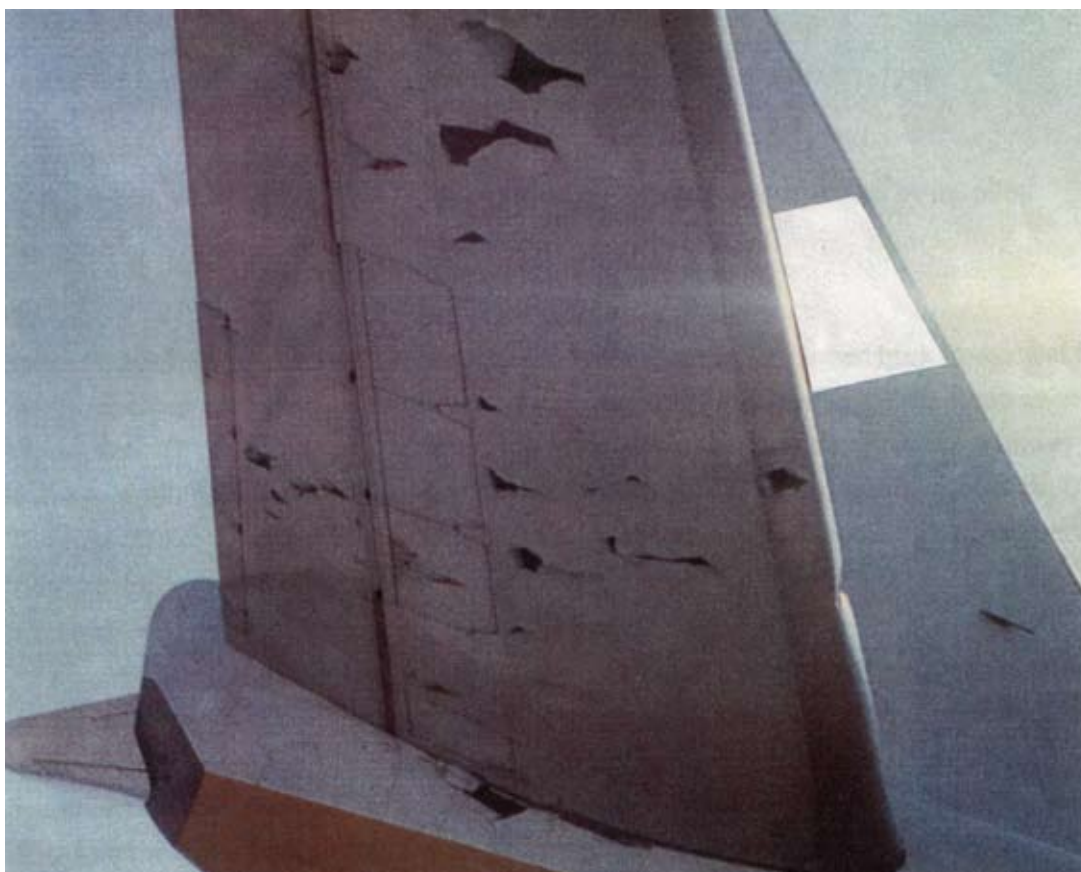
**Figure 10**

Damage to right tailplane underside of Boeing 737, G-MONM,  
at Luton Airport on 22 September 1992,  
following strikes by paving blocks from the turnpad area

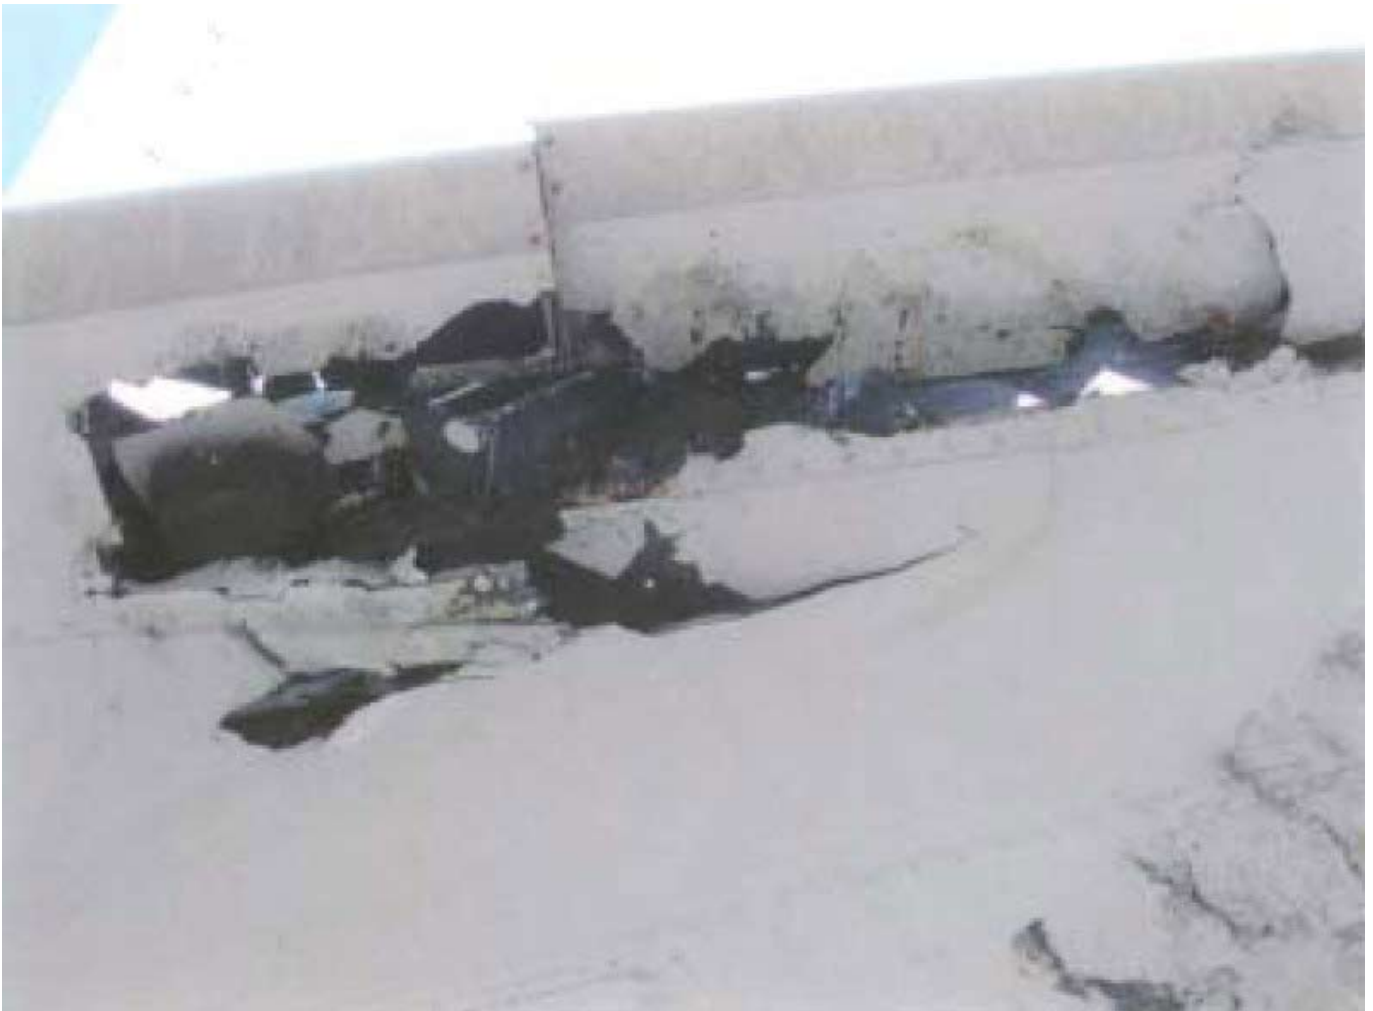
**Figure 11**

Damage to left tailplane leading edge of Airbus A320 at Treviso S. Angelo airport in Italy on 6 August 2002, following a strike by a large section of asphalt from the stopway

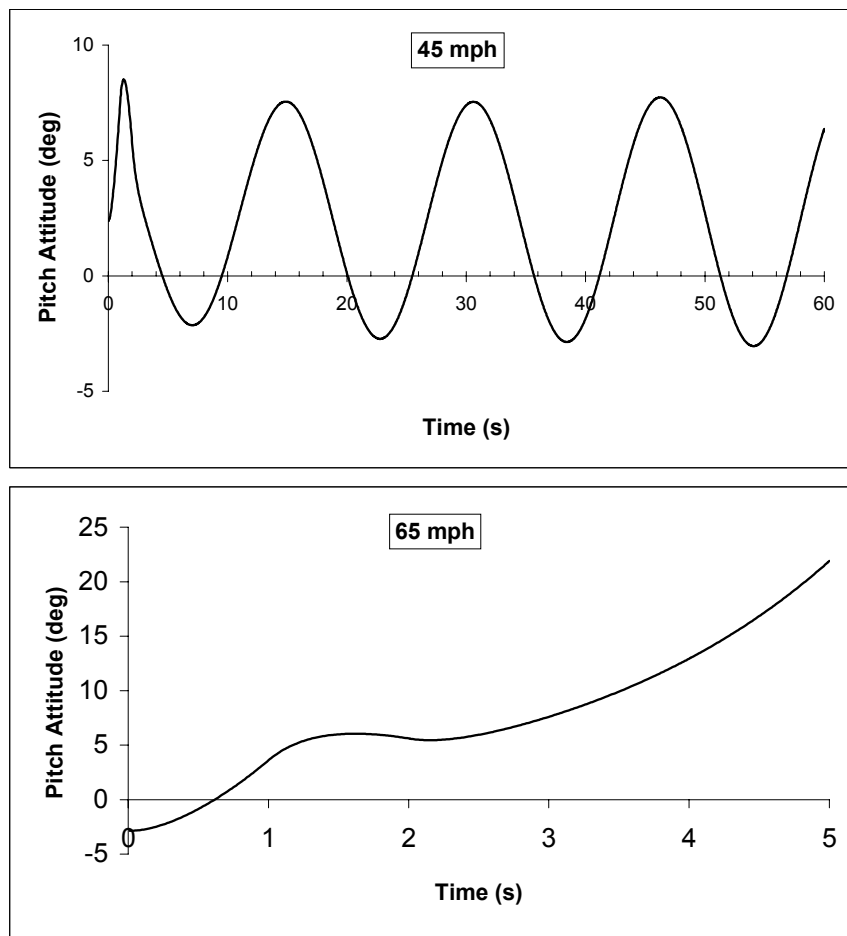
Figure 3

The University of Glasgow was asked to model the stability of G-BIGU using their RASCAL simulator that had been developed to model gyroplanes. The pod, tailplane and vertical tail aerodynamics were those estimated from a similar looking single-seat Air Command gyroplane. The mass properties, CG, thrust line and geometric data used were those specific to G-BIGU with the 23 ft diameter rotor fitted. The results showed that when the aircraft was excited by a fore and aft stick input, the response was a stable and lightly damped pitch oscillation (see Figure 3) at 45 mph. However, when the speed was increased to 65 mph the model predicted that G-BIGU would have an unstable rapidly divergent pitch response shown by the rapidly increasing pitch angle in Figure 3. The control stick was assumed to be held fixed following

Modelled pitch response of accident aircraft at 45 mph and 65 mph following a fore and aft stick input
