MARINE ACCIDENT INVESTIGATION BRANCH

FISHING ACCIDENT REPORT

The Loss of *Solway Harvester*

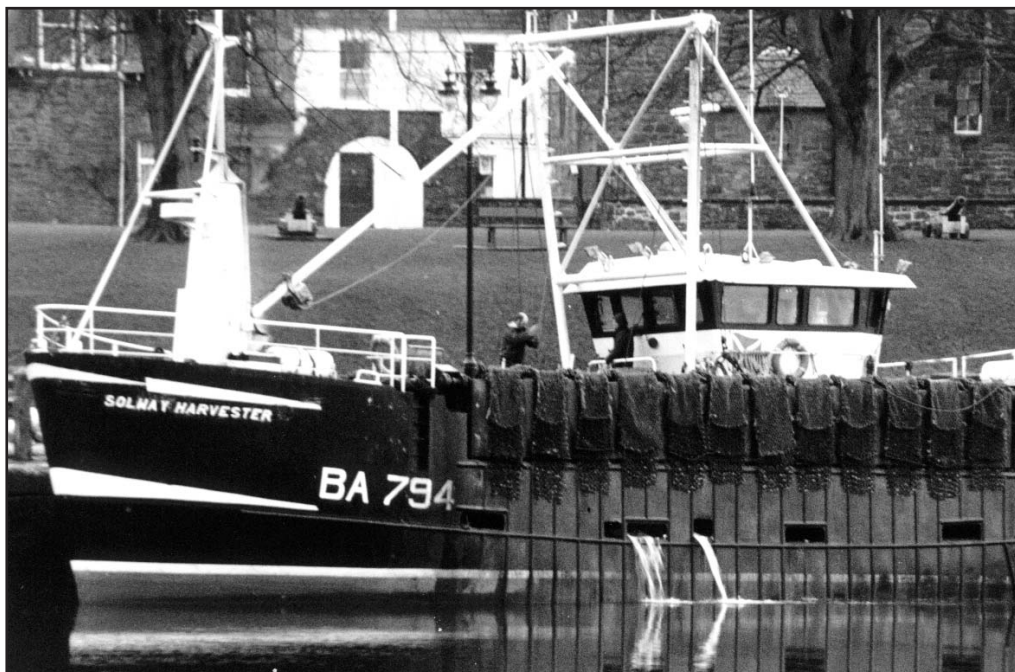
On the evening of 11 January 2000 the 19.43m Scottish scallop dredger *Solway Harvester* was reported as missing. The weather was very bad at the time.

Following an extensive search, the wreck of *Solway Harvester* was found in a depth of 35 metres, 11 miles south-east of the Isle of Man. All of her seven crew had drowned.

All the evidence indicates *Solway Harvester* began to take water into her fish hold through open ice scuttles while she was making way during the late afternoon of 11 January 2000. She was, at that time, heading for shelter in the lee of the Isle of Man. It was a foul night, and a strong south-westerly wind was blowing. She stopped and, with the way off her, came beam to sea and started to roll heavily. The floodwater in the fish hold reduced her stability to such an extent that she became vulnerable to a capsize. The heavy rolling in large waves caused her cargo of bagged scallops and loose gear to shift and this, together with the reduced stability, caused her to capsize at about 1745.

The investigation found that her bilge alarm was not functioning before the accident. Without this, it is probable that those on board were unaware she was taking water into the fish hold until, probably, a few minutes before the accident. It also found that the bilge pumping arrangements were not working as intended.

With about 6 to 9 tonnes of water in her fish room, evidence of a shift in weight on board, the failure of her watertight integrity and the effects of heavy rolling meant she lost her stability. A capsize was inevitable.
