Asbestos Survey for

Fleet Support Limited

HMS Cardiff
HM Naval Base
Portsmouth
Hampshire
PO1 3NJ

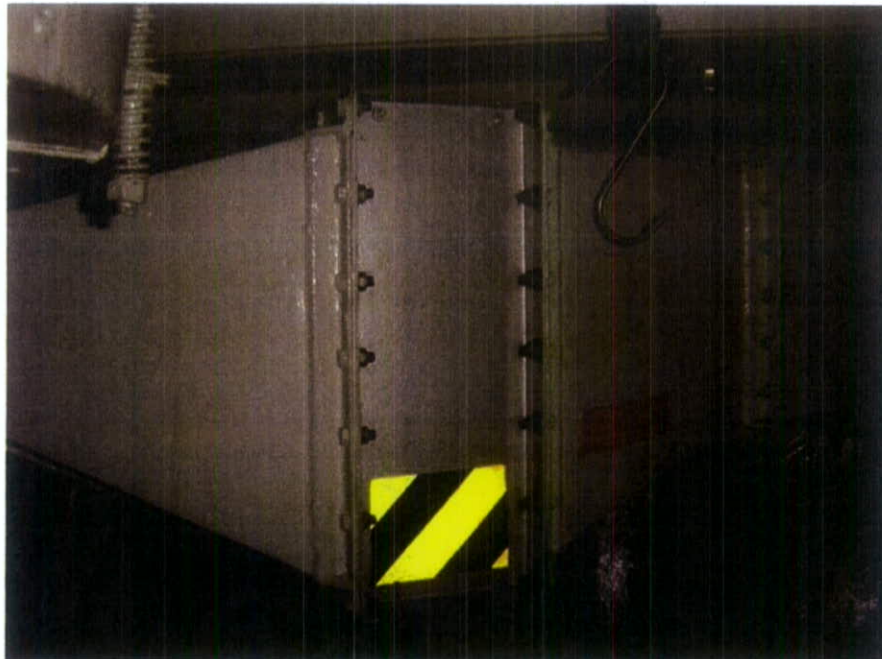
Location Ref:	003	Survey Type:	T 2
Product:	Gasket	Product Type:	Gaskets
Area:	B	Damage:	Low damage: Scratches or marks
Floor:	2 deck	Treatment:	Composite asbestos materials
Room:	Bosuns store	Asbestos Type:	Chrysotile
Surveyor Name:		Identification:	Identified
Drawing Ref:	D01	Quantity:	To ducting
Asbestos ?	Yes	Accessibility:	Medium Accessibility
Date:	14 January 2008	Material Risk Score:	4
Next Inspection:	13 January 2009	Material Risk Band:	Very Low Risk
Analysis:	Dominant	Priority Risk Score:	N/A
Action:	Inspect periodically & manage as required

Material Comments:	Metal floor and walls, with textile and MMMF cover to sections, woven textile over foam and MMMF lagging to pipework. Asbestos containing gasket sampled from metal ducting to ceiling on port side.
--------------------	--

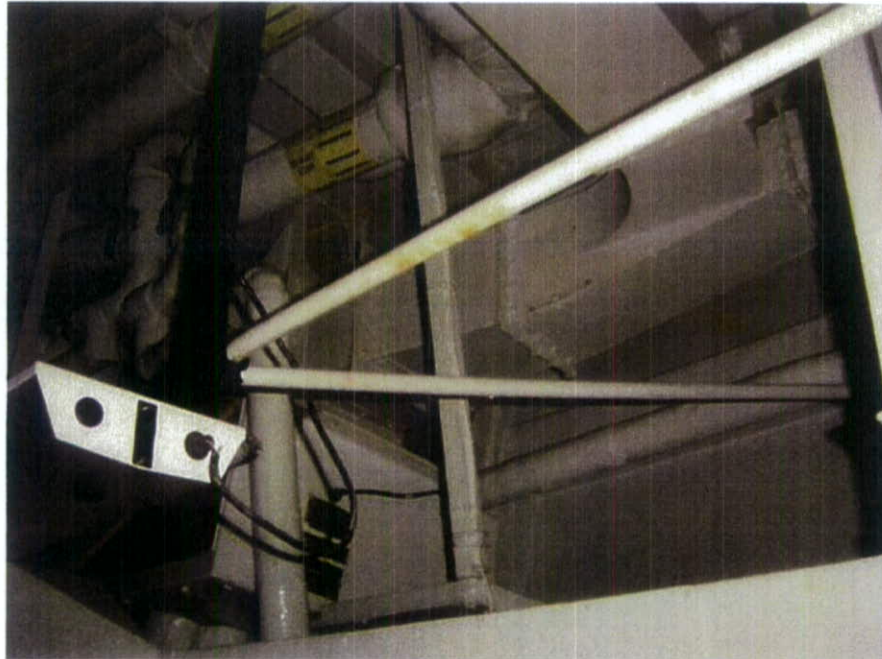
Location Ref:	009	Survey Type:	T 2
Product:	Gasket	Product Type:	Gaskets
Area:	C	Damage:	Low damage
Floor:	2 deck	Treatment:	Composite asbestos materials
Room:	Laundry	Asbestos Type:	Chrysotile
Surveyor Name:		Identification:	Strongly Presumed as previous sample
Drawing Ref:	D01	Quantity:	To ducting
Asbestos ?	Yes	Accessibility:	Medium Accessibility
Date:	14 January 2008	Material Risk Score:	4
Next Inspection:	13 January 2009	Material Risk Band:	Very Low Risk
Analysis:	Dominant	Priority Risk Score:	N/A
Action:	Inspect periodically & manage as required

Material Comments:	metal ducting present throughout room. Low level found to have rubber gaskets where accessed with high level ducting found to have asbestos containing gaskets, as Loc Ref: 003.
--------------------	--

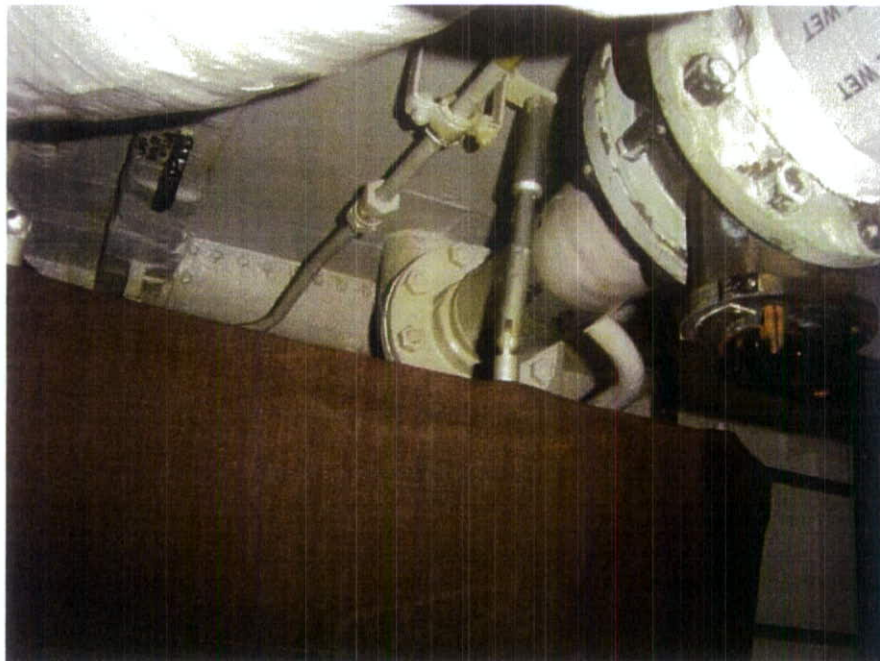
Location Ref:	010	Survey Type:	T 2
Product:	Gasket	Product Type:	Gaskets
Area:	C	Damage:	Good condition
Floor:	2 deck	Treatment:	Composite asbestos materials
Room:	Corridor	Asbestos Type:	Chrysotile
Surveyor Name:		Identification:	Identified
Drawing Ref:	D01	Quantity:	To pipework
Asbestos ?	Yes	Accessibility:	Medium Accessibility
Date:	14 January 2008	Material Risk Score:	3
Next Inspection:	13 January 2009	Material Risk Band:	Very Low Risk
Analysis:	Dominant	Priority Risk Score:	N/A
Action:	Inspect periodically & manage as required

Non asbestos lino to floor, metal walls, metal ceiling with metal panels, foam lagged pipework. Asbestos containing gasket sampled to pipe by door to section B. Suspect other gaskets remain hidden in this area

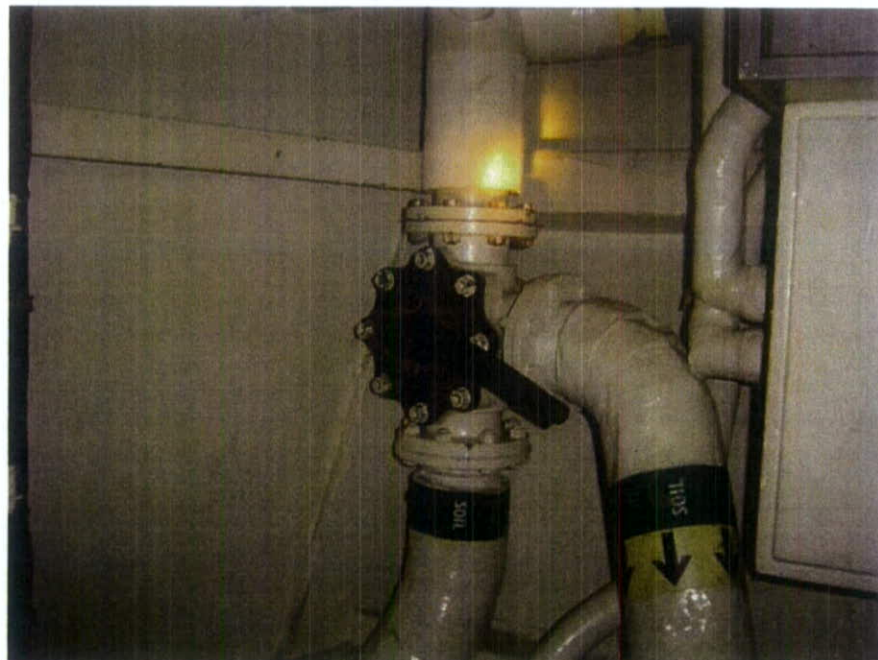
Location Ref:	013	Survey Type:	T 2
Product:	Gasket	Product Type:	Gaskets
Area:	C	Damage:	Good condition
Floor:	3 deck	Treatment:	Composite asbestos materials
Room:	Lobby	Asbestos Type:	Chrysotile
Surveyor Name:		Identification:	Identified
Drawing Ref:	D01	Quantity:	To pipework
Asbestos ?	Yes	Accessibility:	Medium Accessibility
Date:	14 January 2008	Material Risk Score:	3
Next Inspection:	13 January 2009	Material Risk Band:	Very Low Risk
Analysis:	Dominant	Priority Risk Score:	N/A
Action:	Inspect periodically & manage as required

Metal floor, metal walls with MMMF cover, rubber gaskets to metal ducting. Asbestos containing gaskets to pipework. cork gaskets also observed to pipework in this area.

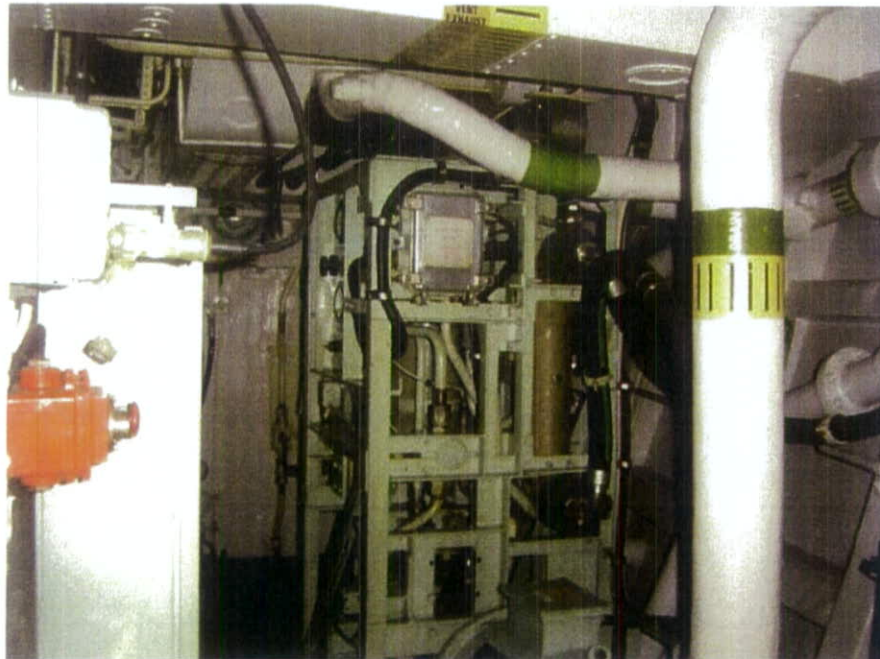
Location Ref:	015	Survey Type:	T 2
Product:	Gasket	Product Type:	Gaskets
Area:	C	Damage:	Good condition
Floor:	3 deck	Treatment:	Composite asbestos materials
Room:	Hvdraulics compartment	Asbestos Type:	Chrysotile
Surveyor Name:		Identification:	Strongly Presumed as previous sample
Drawing Ref:	D01	Quantity:	To pipework
Asbestos ?	Yes	Accessibility:	Medium Accessibility
Date:	14 January 2008	Material Risk Score:	3
Next Inspection:	13 January 2009	Material Risk Band:	Very Low Risk
Analysis:	Dominant	Priority Risk Score:	N/A
Action:	Inspect periodically & manage as required

Metal floor and ceiling, textile and MMMF cover to walls, foam lagged pipework, metal ducting with cork insulation Suspect asbestos containing gaskets, as Loc Ref: 013, to pipework.

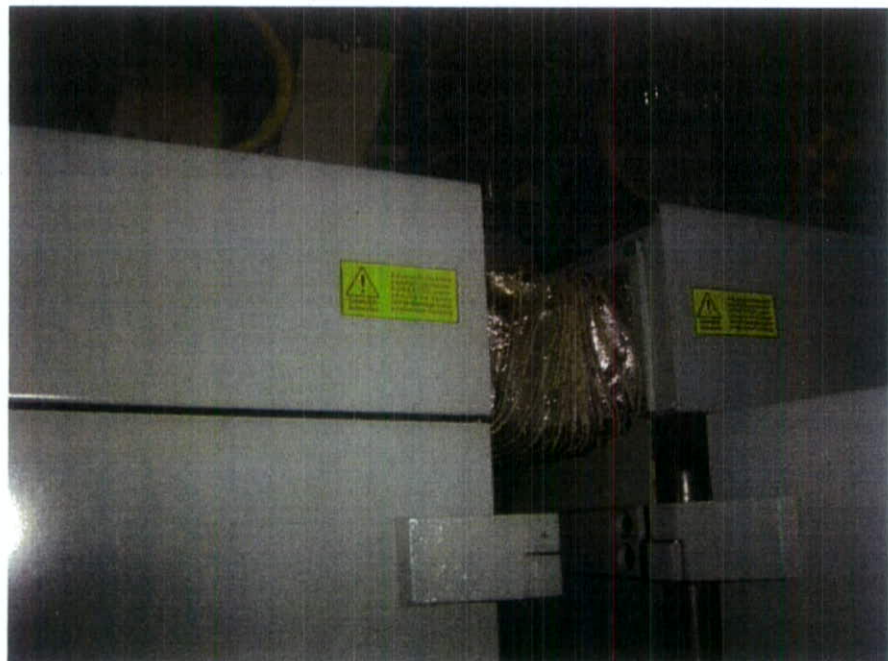
Location Ref:	078	Survey Type:	T 2
Product:	Woven textile	Product Type:	Ropes and woven textiles
Area:	G	Damage:	Low damage
Floor:	02 deck	Treatment:	Composite asbestos materials
Room:	909 office	Asbestos Type:	Chrysotile
Surveyor Name:		Identification:	Identified
Drawing Ref:	D01	Quantity:	14 No. sections
Asbestos ?	Yes	Accessibility:	Easy Accessibility
Date:	14 January 2008	Material Risk Score:	4
Next Inspection:	13 January 2009	Material Risk Band:	Very Low Risk
Analysis:	Dominant	Priority Risk Score:	N/A
Action:	Inspect periodically & manage as required

Material Comments: Asbestos containing flexible conduits between numerous electrical/control cabinets and walls. Conduits present at high and low level. Warning labels applied to equipment.

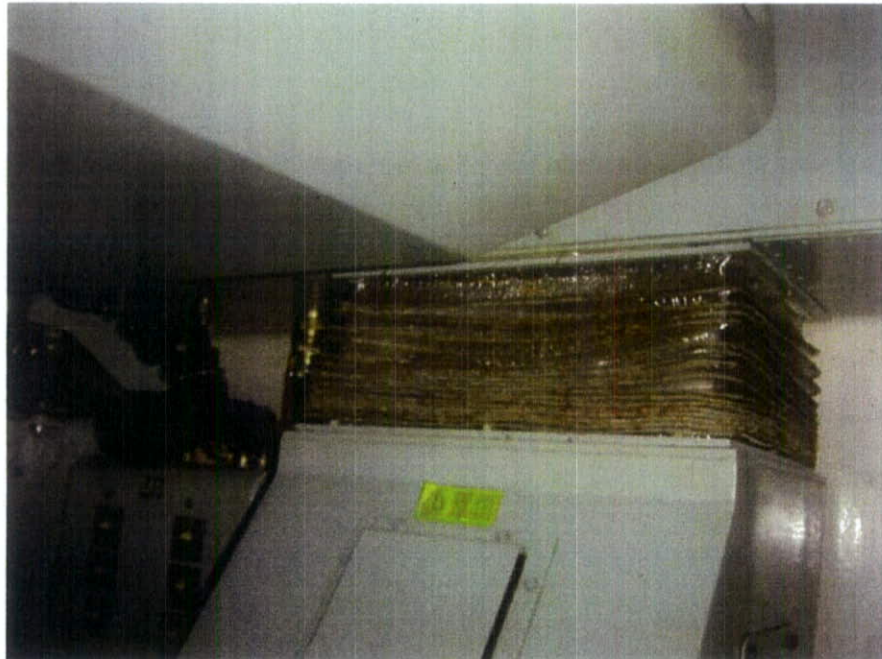
Location Ref:	079	Survey Type:	T 2
Product:	Woven textile	Product Type:	Ropes and woven textiles
Area:	H	Damage:	Low damage
Floor:	02 deck	Treatment:	Composite asbestos materials
Room:	909 annexe	Asbestos Type:	Chrysotile
Surveyor Name:		Identification:	Strongly Presumed as previous sample
Drawing Ref:	D01	Quantity:	3 No. sections
Asbestos ?	Yes	Accessibility:	Easy Accessibility
Date:	14 January 2008	Material Risk Score:	4
Next Inspection:	13 January 2009	Material Risk Band:	Very Low Risk
Analysis:	Dominant	Priority Risk Score:	N/A
Action:	Inspect periodically & manage as required

Asbestos containing flexible conduits, as Loc Ref: 078, between numerous electrical/control cabinets. Warning labels applied to equipment.

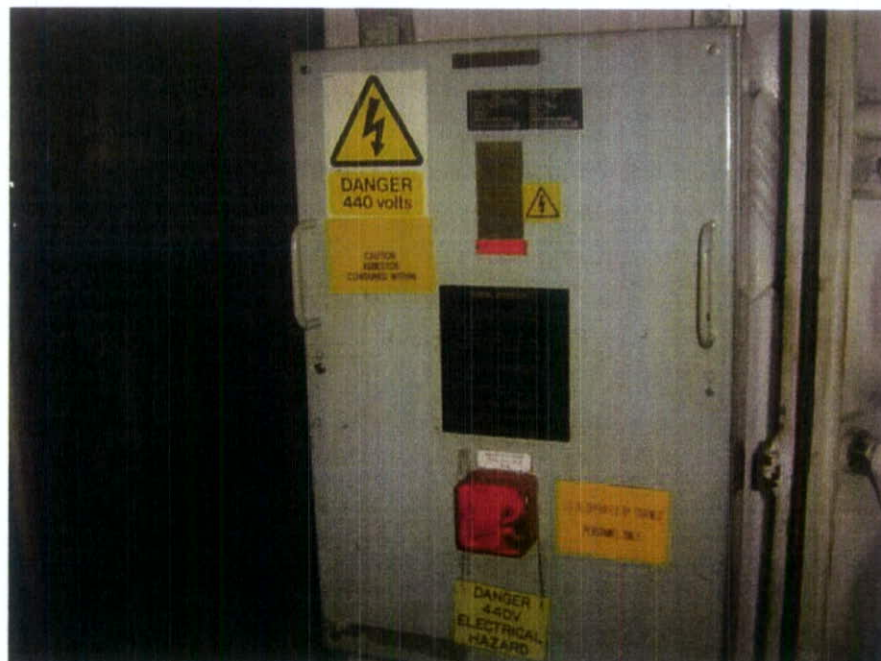
Location Ref:	116	Survey Type:	T 2
Product:	Fuse guard	Product Type:	Asbestos cement
Area:	H	Damage:	No visible damage
Floor:	3 deck	Treatment:	Asbestos cement sheets etc
Room:	Lobby	Asbestos Type:	Chrysotile
Surveyor Name:		Identification:	Strongly Presumed
Drawing Ref:	D01	Quantity:	To fuse boxes
Asbestos ?	Yes	Accessibility:	Difficult Accessibility
Date:	14 January 2008	Material Risk Score:	3
Next Inspection:	13 January 2009	Material Risk Band:	Very Low Risk
Analysis:	Presumed Significant	Priority Risk Score:	N/A
Action:	Inspect periodically & manage as required

Material Comments: Fuse box with asbestos warning sticker affixed. Not opened but presume asbestos cement flash guards or asbestos fuse tape within. Presume same materials present within fuse boxes of same construction throughout ship

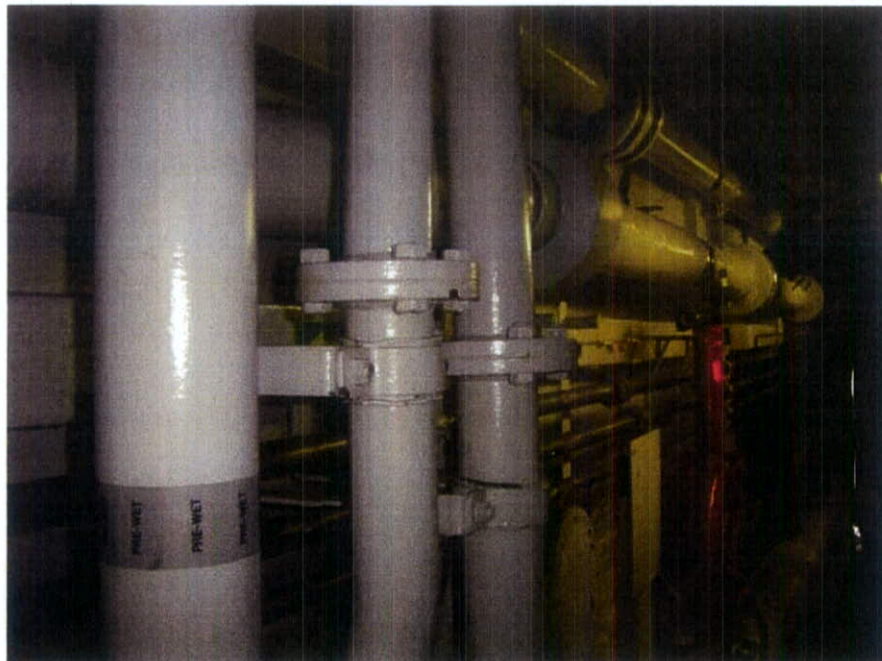
Location Ref:	138	Survey Type:	T 2
Product:	Gasket	Product Type:	Gaskets
Area:	J	Damage:	Low damage
Floor:	2 deck	Treatment:	Composite asbestos materials
Room:	Perimeter offices	Asbestos Type:	Chrysotile
Surveyor Name:		Identification:	Identified
Drawing Ref:	D01	Quantity:	To pipework
Asbestos ?	Yes	Accessibility:	Medium Accessibility
Date:	14 January 2008	Material Risk Score:	4
Next Inspection:	13 January 2009	Material Risk Band:	Very Low Risk
Analysis:	Dominant	Priority Risk Score:	N/A
Action:	Inspect periodically & manage as required

Asbestos containing gasket to unlagged metal pipework opposite server. Further gaskets may remain concealed to flanges

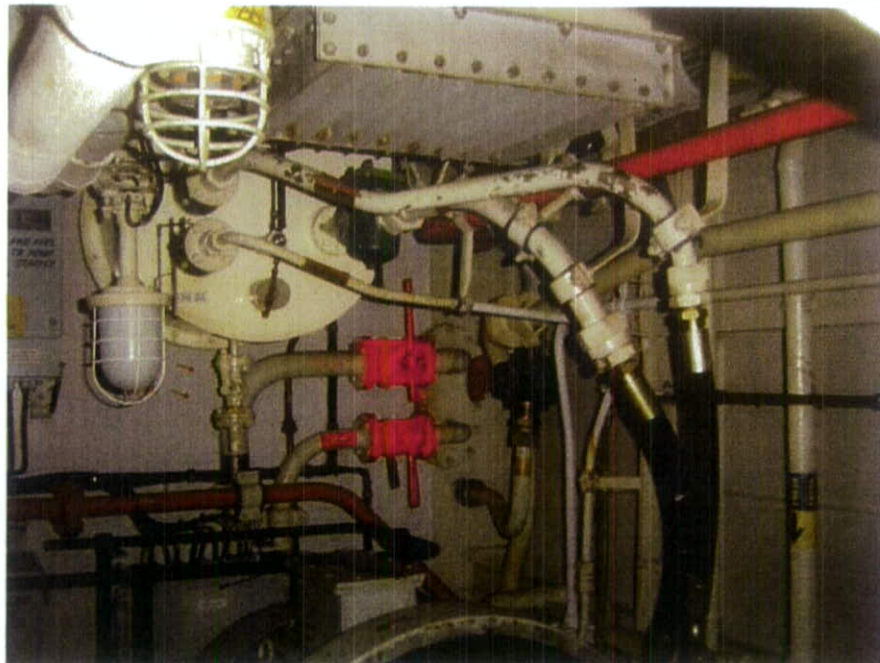
Location Ref:	146	Survey Type:	T 2
Product:	Gasket	Product Type:	Gaskets
Area:	K	Damage:	Good condition
Floor:	4 deck	Treatment:	Composite asbestos materials
Room:	Forward engine room	Asbestos Type:	Chrysotile
Surveyor Name:		Identification:	Identified
Drawing Ref:	D01	Quantity:	To pipework
Asbestos ?	Yes	Accessibility:	Medium Accessibility
Date:	14 January 2008	Material Risk Score:	3
Next Inspection:	13 January 2009	Material Risk Band:	Very Low Risk
Analysis:	Dominant	Priority Risk Score:	N/A
Action:	Inspect periodically & manage as required

Asbestos containing gasket to pipework. Suspect same gasket material used throughout room and mixed with cork rubber and plastic gaskets which were also observed.

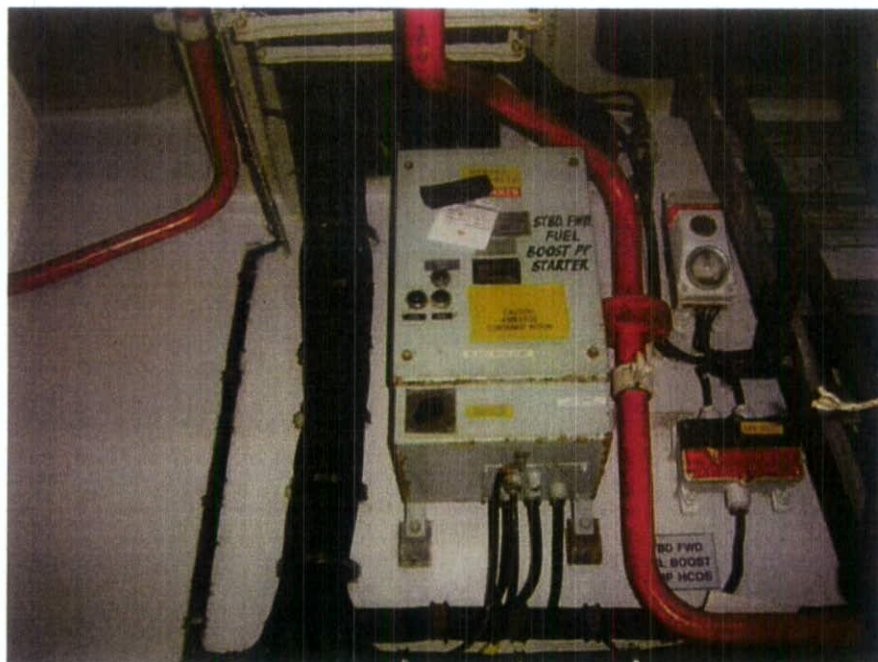
Location Ref:	150	Survey Type:	T 2
Product:	Cement	Product Type:	Asbestos cement
Area:	K	Damage:	No visible damage
Floor:	4 deck	Treatment:	Asbestos cement sheets etc
Room:	Forward engine room	Asbestos Type:	Chrysotile
Surveyor Name:		Identification:	Strongly Presumed
Drawing Ref:	D01	Quantity:	To fuse/control boxes
Asbestos ?	Yes	Accessibility:	Difficult Accessibility
Date:	14 January 2008	Material Risk Score:	3
Next Inspection:	13 January 2009	Material Risk Band:	Very Low Risk
Analysis:	Presumed Significant	Priority Risk Score:	N/A
Action:	Inspect periodically & manage as required

Material Comments: 2 No. fuse/control boxes labelled as asbestos containing. Presume asbestos fuse tape or asbestos cement within. Presume same materials present within boxes of same construction throughout ship

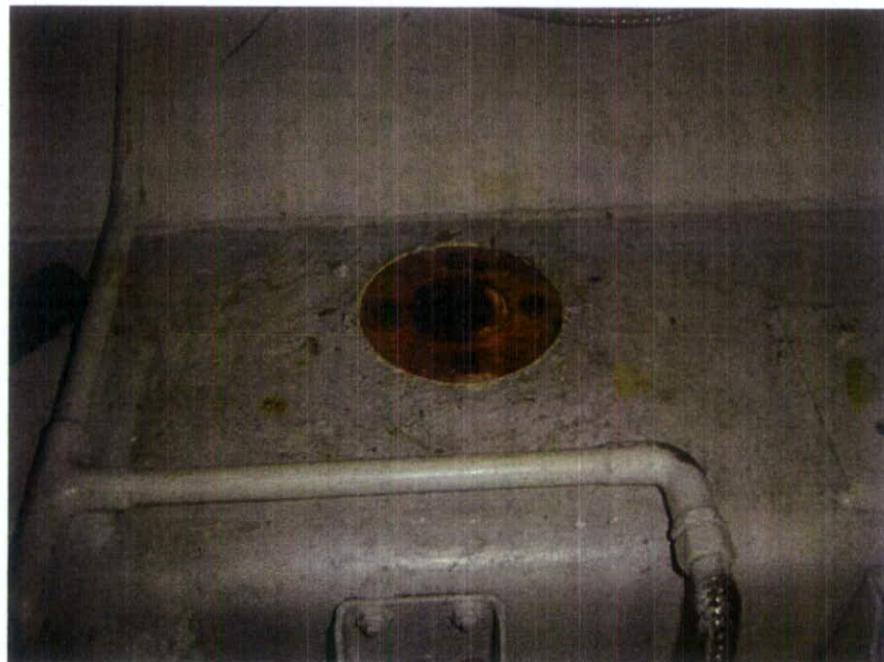
Location Ref:	153	Survey Type:	T 2
Product:	Gasket	Product Type:	Gaskets
Area:	K	Damage:	Low damage
Floor:	4 deck	Treatment:	Composite asbestos materials
Room:	Forward engine room	Asbestos Type:	Chrysotile
Surveyor Name:		Identification:	Identified
Drawing Ref:	D01	Quantity:	1 No. observed.
Asbestos ?	Yes	Accessibility:	Easy Accessibility
Date:	14 January 2008	Material Risk Score:	4
Next Inspection:	13 January 2009	Material Risk Band:	Very Low Risk
Analysis:	Dominant	Priority Risk Score:	N/A
Action:	Remove identified ACM

Exposed asbestos containing gasket to top of 1 No. Olympus engine. Suspect gaskets of same material remain concealed to engines. Gaskets to ducts above engine found to be cork where accessible.

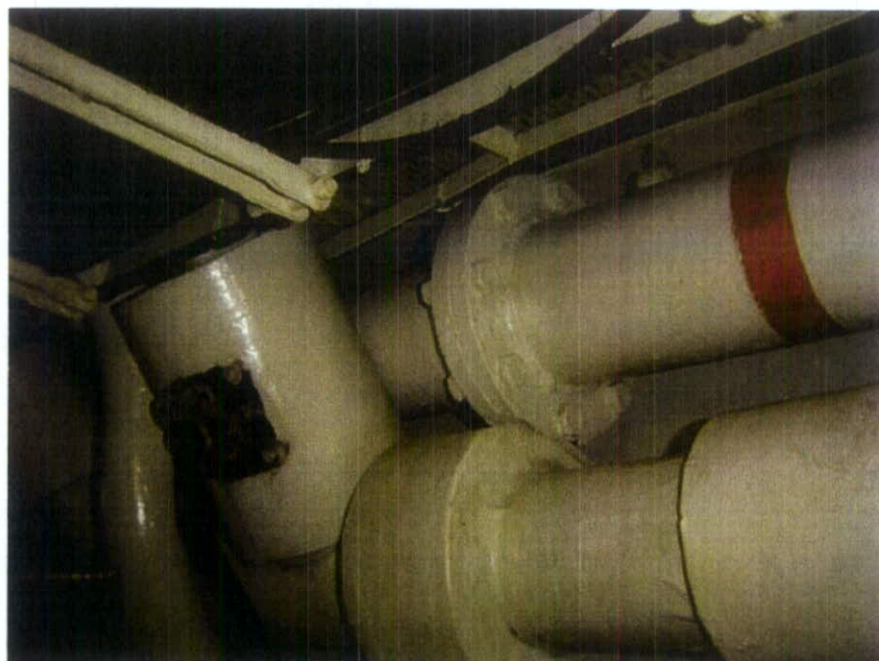
Location Ref:	169	Survey Type:	T 2
Product:	Gasket	Product Type:	Gaskets
Area:	L	Damage:	Good condition
Floor:	2 deck	Treatment:	Composite asbestos materials
Room:	Perimeter corridors	Asbestos Type:	Chrysotile
Surveyor Name:		Identification:	Identified
Drawing Ref:	D01	Quantity:	To pipework.
Asbestos ?	Yes	Accessibility:	Medium Accessibility
Date:	14 January 2008	Material Risk Score:	3
Next Inspection:	13 January 2009	Material Risk Band:	Very Low Risk
Analysis:	Dominant	Priority Risk Score:	N/A
Action:	Inspect periodically & manage as required

Material Comments: Exposed asbestos containing gasket sampled from pipework on starboard side. Suspect further gaskets of same material remain concealed to pipework.

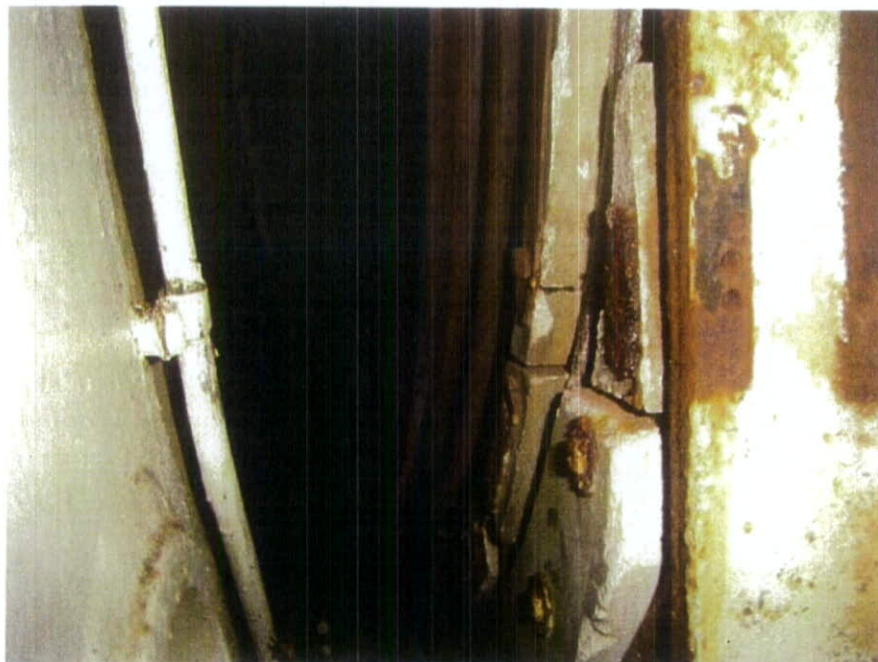
14/01/08	179	D01	L	4 deck	After engine room	Insulation	10	High Risk	N/A	Asbestos containing insulation material adjacent to sample identified in Loc Ref: 178, on 2 No. engines, some minor debris observed. It is suspected that further instances of samples 178 & 179 are likely to be concealed within engines.	Removed By Licenced Contractor	T 2
14/01/08	180	D01	L	4 deck	After engine room	Gasket	4	Very Low Risk	N/A	Asbestos containing gasket exposed to side of 1 No. engine. Suspect same gasket material is concealed within both engines.	Inspect periodically & manage as required	T 2

Location Ref:	179	Survey Type:	T 2
Product:	Insulation	Product Type:	Thermal Insulation
Area:	L	Damage:	High damage: Visible debris
Floor:	4 deck	Treatment:	Unsealed laggings and sprays
Room:	After engine room	Asbestos Type:	Chrysotile
Surveyor Name:		Identification:	Identified
Drawing Ref:	D01	Quantity:	<1 sqm visible
Asbestos ?	Yes	Accessibility:	Medium Accessibility
Date:	14 January 2008	Material Risk Score:	10
Next Inspection:	13 February 2008	Material Risk Band:	High Risk
Analysis:	Dominant	Priority Risk Score:	N/A
Action:	Removed By Licenced Contractor

Asbestos containing insulation material adjacent to sample identified in Loc Ref: 178, on 2 No. engines, some minor debris observed. It is suspected that further instances of samples 178 & 179 are likely to be concealed within engines.

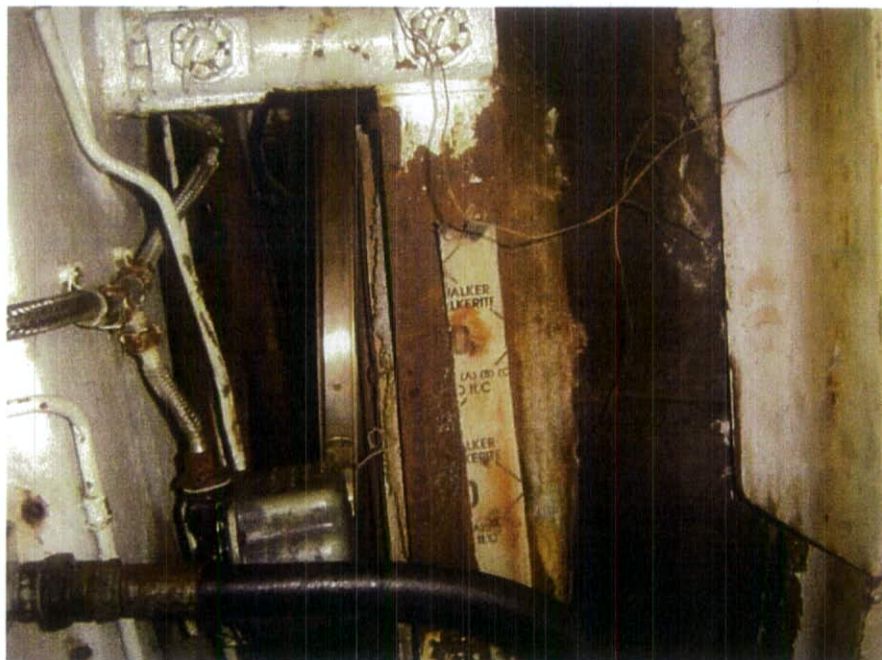
Location Ref:	180	Survey Type:	T 2
Product:	Gasket	Product Type:	Gaskets
Area:	L	Damage:	Low damage
Floor:	4 deck	Treatment:	Composite asbestos materials
Room:	After engine room	Asbestos Type:	Chrysotile
Surveyor Name:		Identification:	Identified
Drawing Ref:	D01	Quantity:	To engines
Asbestos ?	Yes	Accessibility:	Easy Accessibility
Date:	14 January 2008	Material Risk Score:	4
Next Inspection:	13 January 2009	Material Risk Band:	Very Low Risk
Analysis:	Dominant	Priority Risk Score:	N/A
Action:	Inspect periodically & manage as required

Material Comments:	Asbestos containing gasket exposed to side of 1 No. engine. Suspect same gasket material is concealed within both engines
--------------------	---

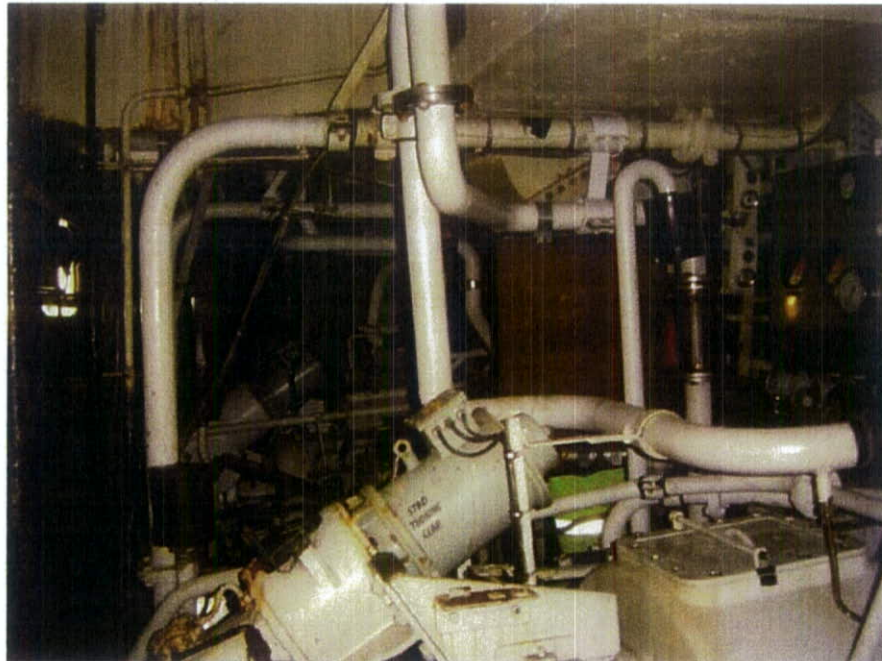
Location Ref:	181	Survey Type:	T 2
Product:	Gasket	Product Type:	Gaskets
Area:	L	Damage:	Low damage
Floor:	4 deck	Treatment:	Composite asbestos materials
Room:	After engine room	Asbestos Type:	Chrysotile
Surveyor Name:		Identification:	Identified
Drawing Ref:	D01	Quantity:	To pipework
Asbestos ?	Yes	Accessibility:	Medium Accessibility
Date:	14 January 2008	Material Risk Score:	4
Next Inspection:	13 January 2009	Material Risk Band:	Very Low Risk
Analysis:	Dominant	Priority Risk Score:	N/A
Action:	Inspect periodically & manage as required

Asbestos containing gasket material sampled from pipework. Due to the extent of pipework throughout this area it is likely that a mixture of gasket materials will be present to flanges

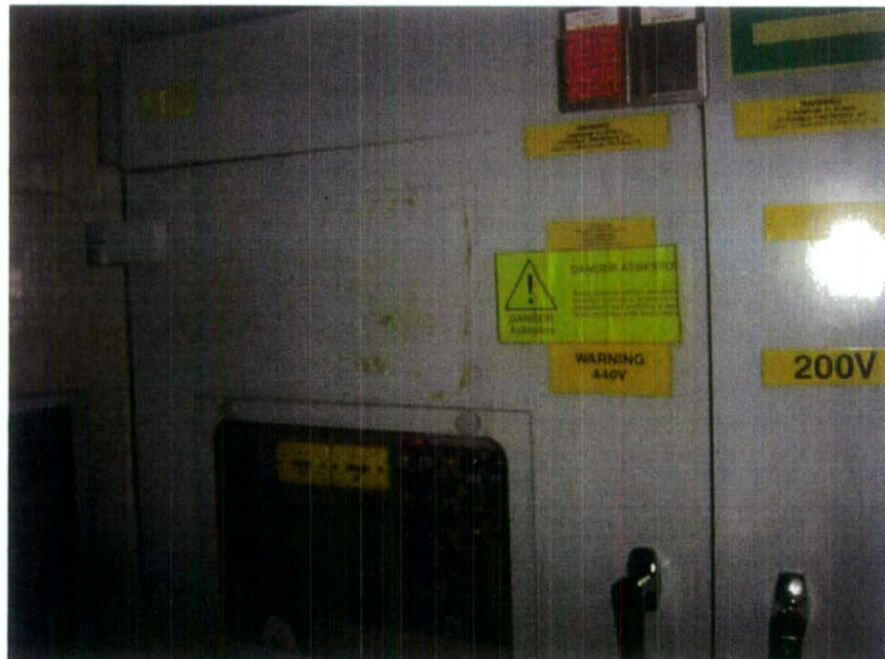
Location Ref:	<input type="text" value="201"/>	Survey Type:	<input type="text" value="T 2"/>
Product:	<input type="text" value="Cement"/>	Product Type:	<input type="text" value="Asbestos cement"/>
Area:	<input type="text" value="G"/>	Damage:	<input type="text" value="No visible damage"/>
Floor:	<input type="text" value="02 deck"/>	Treatment:	<input type="text" value="Asbestos cement sheets etc"/>
Room:	<input type="text" value="909 office"/>	Asbestos Type:	<input type="text" value="Chrysotile"/>
Surveyor Name:	<input type="text"/>	Identification:	<input type="text" value="Strongly Presumed as previous sample"/>

Drawing Ref:	<input type="text" value="D01"/>	Quantity:	<input type="text" value="To cabinet"/>
Asbestos ?	<input type="text" value="Yes"/>	Accessibility:	<input type="text" value="Medium Accessibility"/>
Date:	<input type="text" value="14 January 2008"/>	Material Risk Score:	<input type="text" value="3"/>
Next Inspection:	<input type="text" value="13 January 2009"/>	Material Risk Band:	<input type="text" value="Very Low Risk"/>
Analysis:	<input type="text" value="Dominant"/>	Priority Risk Score:	<input type="text" value="N/A"/>
Action:	<input type="text" value="Inspect periodically & manage as required"/>

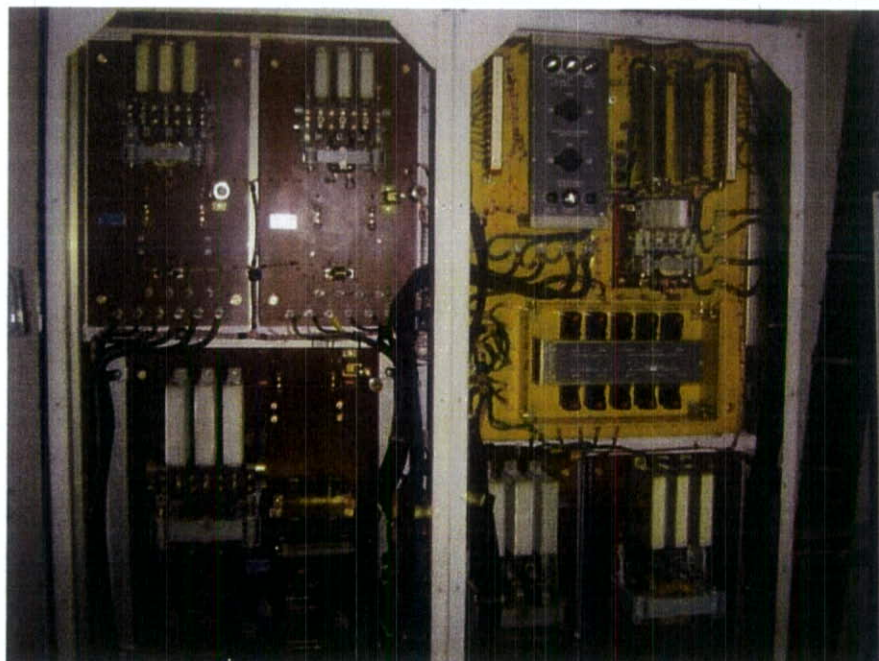
Location Ref:	227	Survey Type:	T 2
Product:	Cement	Product Type:	Asbestos cement
Area:	N	Damage:	Low damage
Floor:	3 deck	Treatment:	Asbestos cement sheets etc
Room:	909 power room	Asbestos Type:	Chrysotile
Surveyor Name:		Identification:	Identified
Drawing Ref:	D01	Quantity:	16 No. observed
Asbestos ?	Yes	Accessibility:	Easy Accessibility
Date:	14 January 2008	Material Risk Score:	4
Next Inspection:	13 January 2009	Material Risk Band:	Very Low Risk
Analysis:	Significant	Priority Risk Score:	N/A
Action:	Inspect periodically & manage as required

Material Comments:	Foam lagged pipes, MMMF cover to walls and ceiling. Asbestos cement relay shields observed within open control unit.
--------------------	--

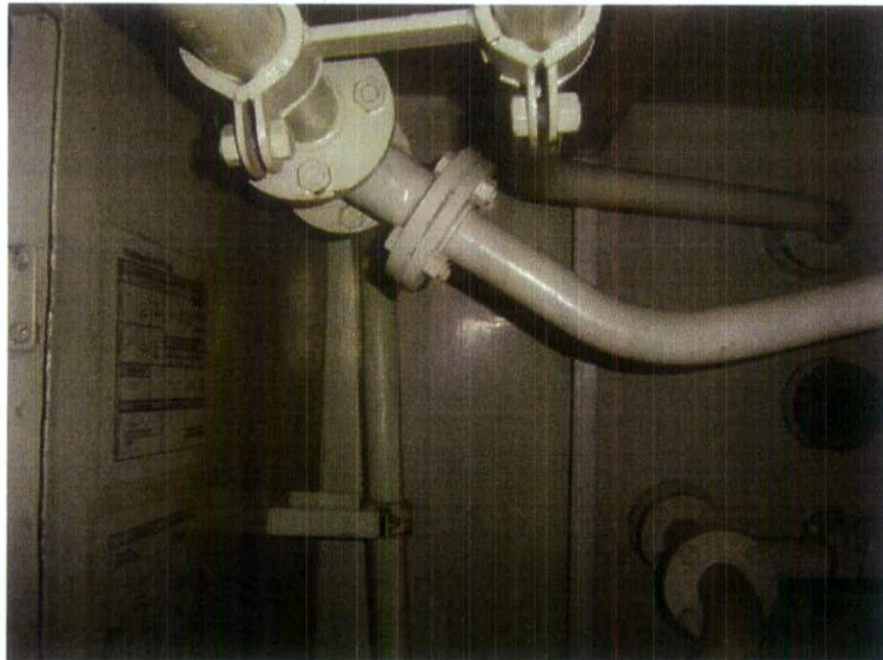
Location Ref:	231	Survey Type:	T 2
Product:	Gasket	Product Type:	Gaskets
Area:	N	Damage:	Good condition
Floor:	4 deck	Treatment:	Composite asbestos materials
Room:	Plummer block cmpt 1	Asbestos Type:	Chrysotile
Surveyor Name:		Identification:	Identified
Drawing Ref:	D01	Quantity:	To pipework
Asbestos ?	Yes	Accessibility:	Medium Accessibility
Date:	14 January 2008	Material Risk Score:	3
Next Inspection:	13 January 2009	Material Risk Band:	Very Low Risk
Analysis:	Dominant	Priority Risk Score:	N/A
Action:	Inspect periodically & manage as required

Material Comments:	Asbestos containing gaskets applied to pipework.
--------------------	--

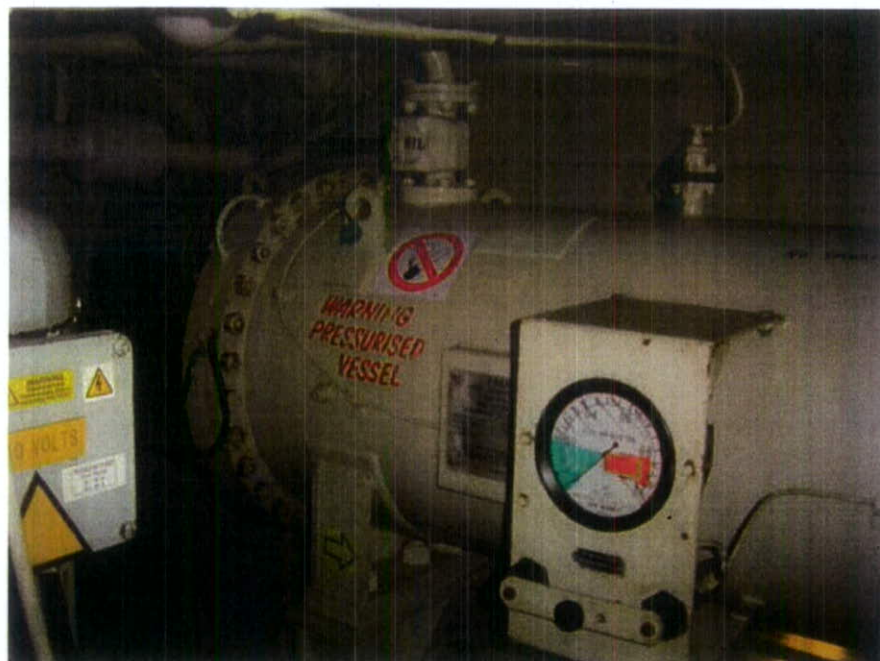
Location Ref:	239	Survey Type:	T 2
Product:	Gasket	Product Type:	Gaskets
Area:	N	Damage:	Good condition
Floor:	4 deck	Treatment:	Composite asbestos materials
Room:	Sewage treatment plant	Asbestos Type:	Chrysotile
Surveyor Name:		Identification:	Identified
Drawing Ref:	D01	Quantity:	To No. vessels.
Asbestos ?	Yes	Accessibility:	Medium Accessibility
Date:	14 January 2008	Material Risk Score:	3
Next Inspection:	13 January 2009	Material Risk Band:	Very Low Risk
Analysis:	Dominant	Priority Risk Score:	N/A
Action:	Inspect periodically & manage as required

Material Comments: Asbestos containing gaskets to pressurised filter vessels located to opposite sides of room

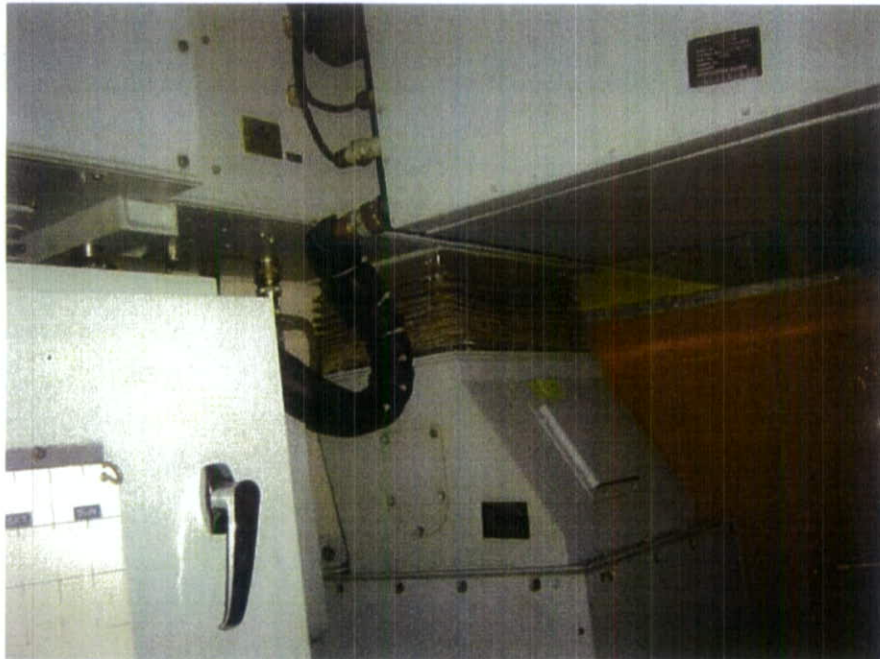
Location Ref:	245	Survey Type:	T 2
Product:	Woven textile	Product Type:	Ropes and woven textiles
Area:	N	Damage:	Low damage
Floor:	01 deck	Treatment:	Composite asbestos materials
Room:	909 annexe	Asbestos Type:	Chrysotile
Surveyor Name:		Identification:	Identified
Drawing Ref:	D01	Quantity:	3 No. sections
Asbestos ?	Yes	Accessibility:	Easy Accessibility
Date:	14 January 2008	Material Risk Score:	4
Next Inspection:	13 January 2009	Material Risk Band:	Very Low Risk
Analysis:	Dominant	Priority Risk Score:	N/A
Action:	Inspect periodically & manage as required

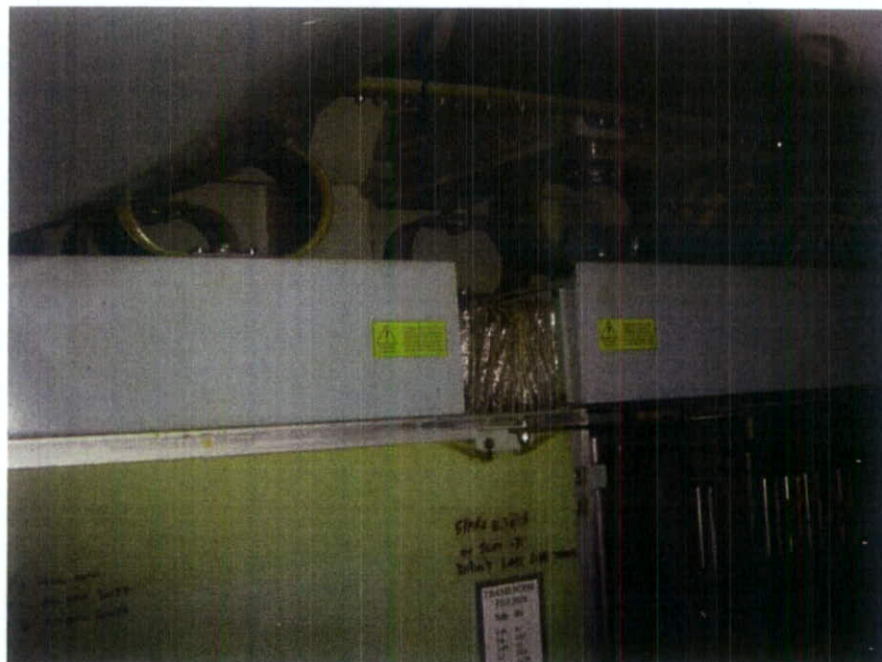
Location Ref:	246	Survey Type:	T 2
Product:	Woven textile	Product Type:	Ropes and woven textiles
Area:	N	Damage:	Low damage
Floor:	01 deck	Treatment:	Composite asbestos materials
Room:	909 office	Asbestos Type:	Chrysotile
Surveyor Name:		Identification:	Strongly Presumed as previous sample
Drawing Ref:	D01	Quantity:	8 No. sections
Asbestos ?	Yes	Accessibility:	Easy Accessibility
Date:	14 January 2008	Material Risk Score:	4
Next Inspection:	13 January 2009	Material Risk Band:	Very Low Risk
Analysis:	Dominant	Priority Risk Score:	N/A
Action:	Inspect periodically & manage as required

Material Comments: Asbestos containing woven textile conduits, as Loc Ref: 245, at high level between cabinets and to wall adjoining 909 annexe.

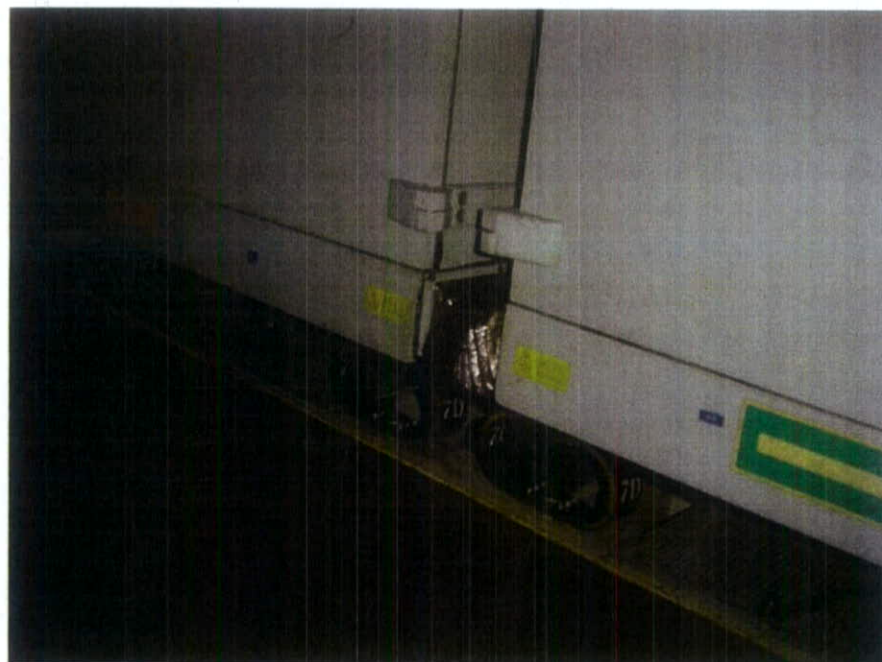
Location Ref:	247	Survey Type:	T 2
Product:	Woven textile	Product Type:	Ropes and woven textiles
Area:	N	Damage:	Low damage
Floor:	01 deck	Treatment:	Composite asbestos materials
Room:	909 office	Asbestos Type:	Chrysotile
Surveyor Name:	[REDACTED]	Identification:	Strongly Presumed as previous sample
Drawing Ref:	D01	Quantity:	8 No. sections
Asbestos ?	Yes	Accessibility:	Easy Accessibility
Date:	14 January 2008	Material Risk Score:	4
Next Inspection:	13 January 2009	Material Risk Band:	Very Low Risk
Analysis:	Dominant	Priority Risk Score:	N/A
Action:	Inspect periodically & manage as required

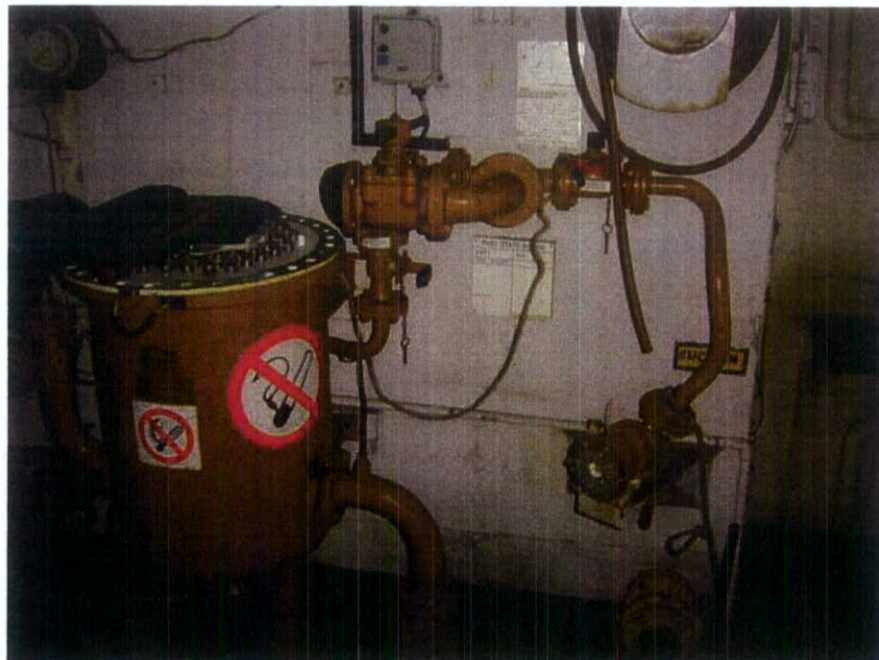
Location Ref:	<input type="text" value="253"/>	Survey Type:	<input type="text" value="T 2"/>						
Product:	<input type="text" value="Gasket"/>	Product Type:	<input type="text" value="Gaskets"/>						
Area:	<input type="text" value="P"/>	Damage:	<input type="text" value="Low damage"/>						
Floor:	<input type="text" value="1 deck"/>	Treatment:	<input type="text" value="Composite asbestos materials"/>						
Room:	<input type="text" value="Hangar"/>	Asbestos Type:	<input type="text" value="Chrysotile"/>						
Surveyor Name:	<input type="text"/>	Identification:	<input type="text" value="Identified"/>						
Drawing Ref:	<input type="text" value="D01"/>	Quantity:	<input type="text" value="To pipework"/>						
Asbestos ?	<input type="text" value="Yes"/>	Accessibility:	<input type="text" value="Medium Accessibility"/>						
Date:	<input type="text" value="14 January 2008"/>

Material Risk Score	<input type="text" value="4"/>	Material Risk Band:	<input type="text" value="Very Low Risk"/>	Priority Risk Score:	<input type="text" value="N/A"/>
Material Risk Score	<input type="text" value="4"/>								
Material Risk Band:	<input type="text" value="Very Low Risk"/>								
Priority Risk Score:	<input type="text" value="N/A"/>								
Next Inspection:	<input type="text" value="13 January 2009"/>								
Analysis:	<input type="text" value="Dominant"/>								
Action:	<input type="text" value="Inspect periodically & manage as required"/>

Material Comments: Asbestos containing gasket sampled on brown painted pipework to fuel filter. Other accessed gaskets to this section of pipework were found to be cork.

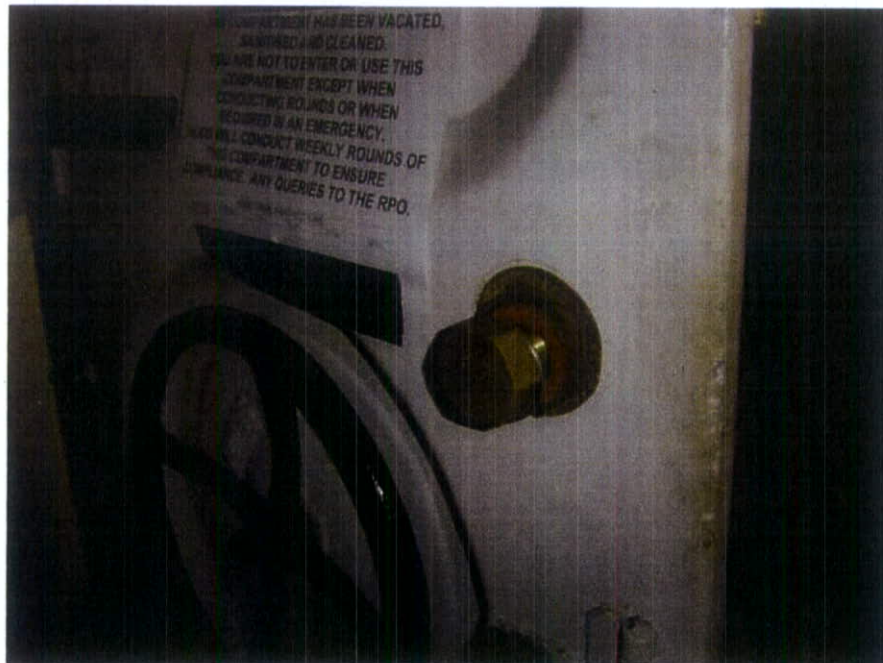
Drawing Ref:	<input type="text" value="D01"/>	Quantity:	<input type="text" value="1 No. to door"/>
Asbestos ?	<input type="text" value="Yes"/>	Accessibility:	<input type="text" value="Easy Accessibility"/>
Date:	<input type="text" value="14 January 2008"/>	Material Risk Score: <input type="text" value="3"/> Material Risk Band: <input type="text" value="Very Low Risk"/> Priority Risk Score: <input type="text" value="N/A"/>	
Next Inspection:	<input type="text" value="13 January 2009"/>		
Analysis:	<input type="text" value="Dominant"/>		
Action:	<input type="text" value="Inspect periodically & manage as required"/>

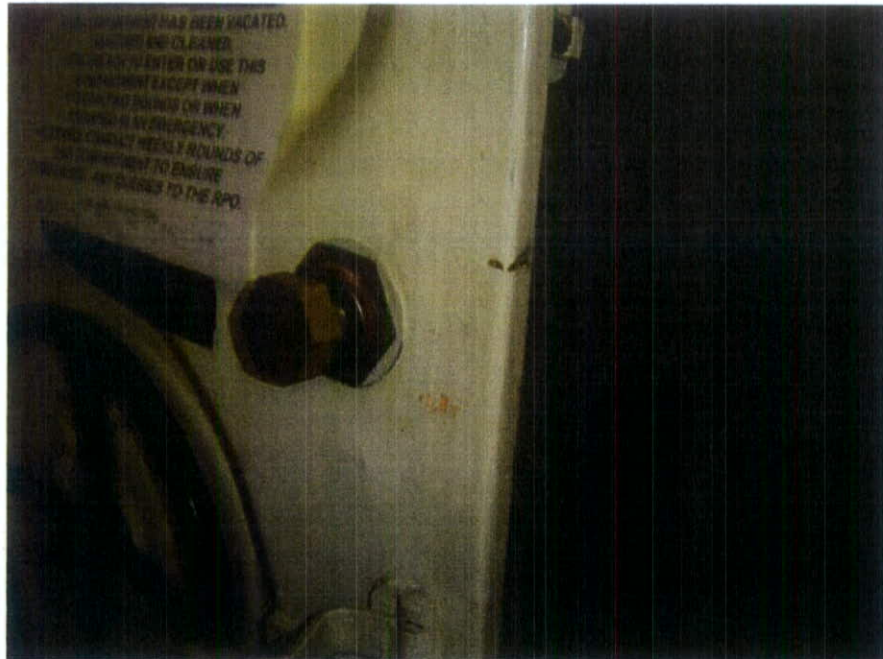
Location Ref:	258	Survey Type:	T 2
Product:	Gasket	Product Type:	Gaskets
Area:	P	Damage:	Low damage
Floor:	1 deck	Treatment:	Composite asbestos materials
Room:	Air weapon & maint compt	Asbestos Type:	Chrysotile
Surveyor Name:		Identification:	Strongly Presumed as previous sample
Drawing Ref:	D01	Quantity:	1 No.
Asbestos ?	Yes	Accessibility:	Easy Accessibility
Date:	14 January 2008	Material Risk Score:	4
Next Inspection:	13 January 2009	Material Risk Band:	Very Low Risk
Analysis:	Dominant	Priority Risk Score:	N/A
Action:	Inspect periodically & manage as required

Material Comments:	Asbestos containing gasket, as Loc Ref: 257, to door bolt on door leading to Air weapon magazine.
--------------------	---

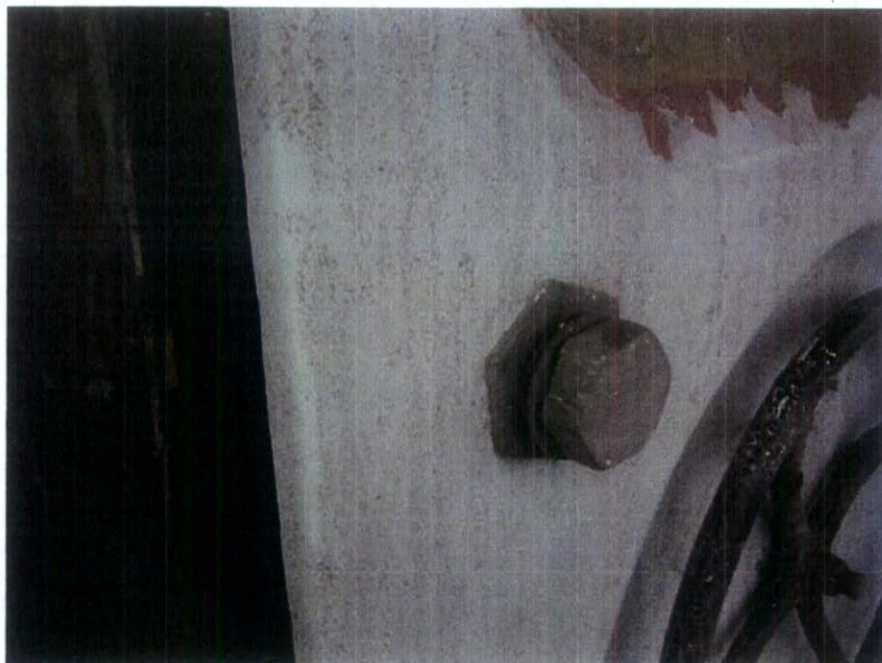
Location Ref:	261	Survey Type:	T 2
Product:	Gasket	Product Type:	Gaskets
Area:	P	Damage:	Low damage
Floor:	1 deck	Treatment:	Composite asbestos materials
Room:	Torpedo stowage cmpt	Asbestos Type:	Chrysotile
Surveyor Name:		Identification:	Strongly Presumed as previous sample
Drawing Ref:	D01	Quantity:	1 No.
Asbestos ?	Yes	Accessibility:	Easy Accessibility
Date:	14 January 2008	Material Risk Score:	4
Next Inspection:	13 January 2009	Material Risk Band:	Very Low Risk
Analysis:	Dominant	Priority Risk Score:	N/A
Action:	Inspect periodically & manage as required

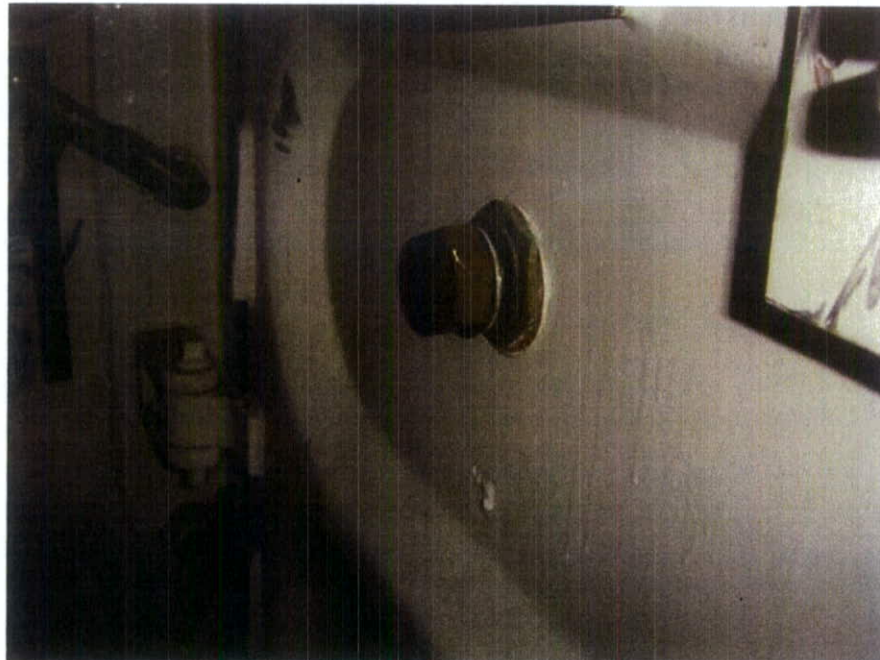
Location Ref:	279	Survey Type:	T 2
Product:	Gasket	Product Type:	Gaskets
Area:	P	Damage:	Good condition
Floor:	4 deck	Treatment:	Composite asbestos materials
Room:	Lobby	Asbestos Type:	Chrysotile
Surveyor Name:		Identification:	Strongly Presumed as previous sample
Drawing Ref:	D01	Quantity:	2 No.
Asbestos ?	Yes	Accessibility:	Easy Accessibility
Date:	14 January 2008	Material Risk Score:	3
Next Inspection:	13 January 2009	Material Risk Band:	Very Low Risk
Analysis:	Dominant	Priority Risk Score:	N/A
Action:	Inspect periodically & manage as required
