Asbestos Survey for

Fleet Support Limited

HMS Cardiff
HM Naval Base
Portsmouth
Hampshire
PO1 3NJ

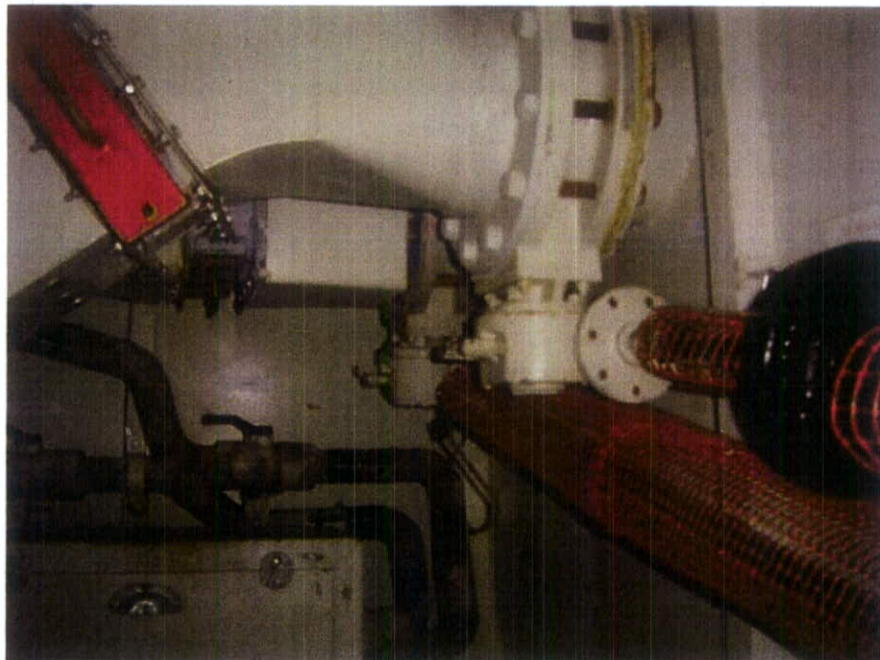
Location Ref:	287	Survey Type:	T 2
Product:	Gasket	Product Type:	Gaskets
Area:	P	Damage:	Good condition
Floor:	4 deck	Treatment:	Composite asbestos materials
Room:	New bulk store	Asbestos Type:	Chrysotile
Surveyor Name:		Identification:	Identified
Drawing Ref:	D01	Quantity:	To pipework
Asbestos ?	Yes	Accessibility:	Medium Accessibility
Date:	14 January 2008	Material Risk Score:	3
Next Inspection:	13 January 2009	Material Risk Band:	Very Low Risk
Analysis:	Dominant	Priority Risk Score:	N/A
Action:	Inspect periodically & manage as required

Material Comments:	Asbestos containing gaskets to 2 No. cylindrical sections of ducting, which exit through wall.
--------------------	--

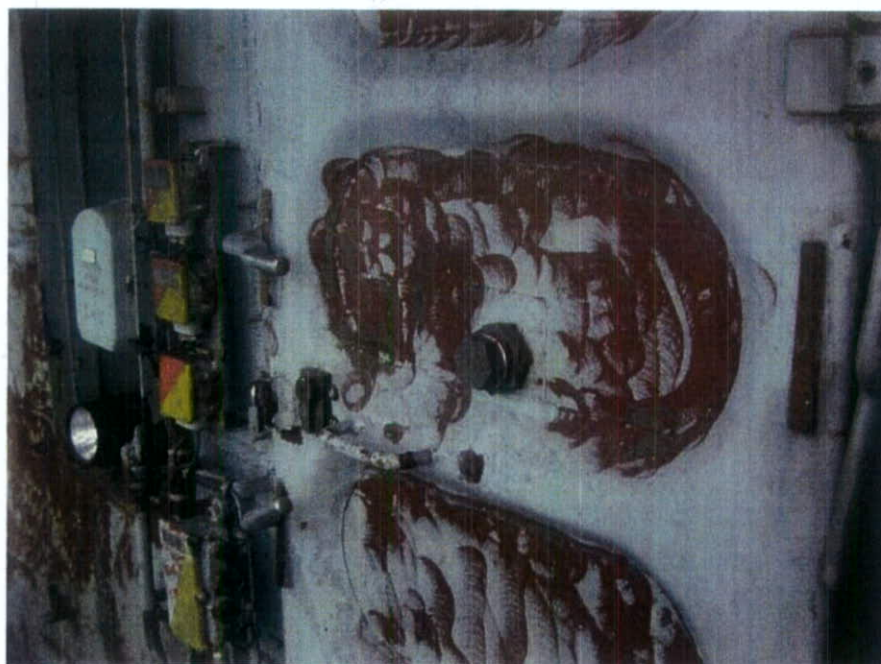
Location Ref:	335	Survey Type:	T 2
Product:	Gasket	Product Type:	Gaskets
Area:	N	Damage:	Low damage
Floor:	1 deck	Treatment:	Composite asbestos materials
Room:	Btry chrg room	Asbestos Type:	Chrysotile
Surveyor Name:		Identification:	Strongly Presumed as previous sample
Drawing Ref:	D01	Quantity:	1 No.
Asbestos ?	Yes	Accessibility:	Easy Accessibility
Date:	14 January 2008	Material Risk Score:	4
Next Inspection:	13 January 2009	Material Risk Band:	Very Low Risk
Analysis:	Dominant	Priority Risk Score:	N/A
Action:	Inspect periodically & manage as required

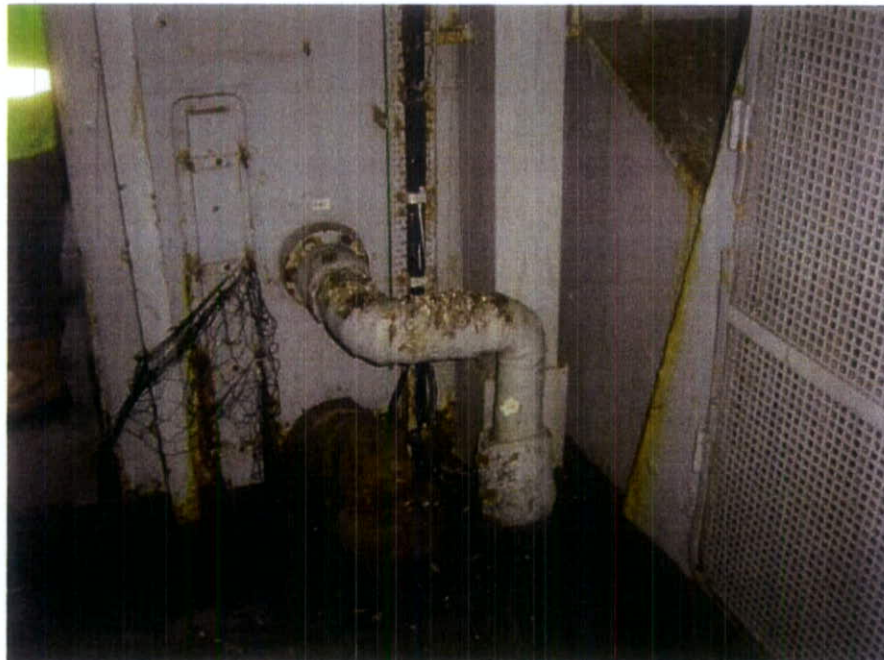
Location Ref:	336	Survey Type:	T 2
Product:	Debris	Product Type:	Loose asbestos
Area:	External	Damage:	High damage: Visible debris
Floor:	02 deck	Treatment:	Enclosed sprays and lagging
Room:	Area behind V/UHF office	Asbestos Type:	Chrysotile
Surveyor Name:		Identification:	Identified
Drawing Ref:	D01	Quantity:	1 No.
Asbestos ?	Yes	Accessibility:	Easy Accessibility
Date:	14 January 2008	Material Risk Score:	8
Next Inspection:	13 April 2008	Material Risk Band:	Medium Risk
Analysis:	Dominant	Priority Risk Score:	N/A
Action:	Limit access prior to environmental clean
