CONTENTS

SPECIAL BULLETINS / INTERIM REPORTS

SUMMARIES OF AIRCRAFT ACCIDENT ('FORMAL') REPORTS

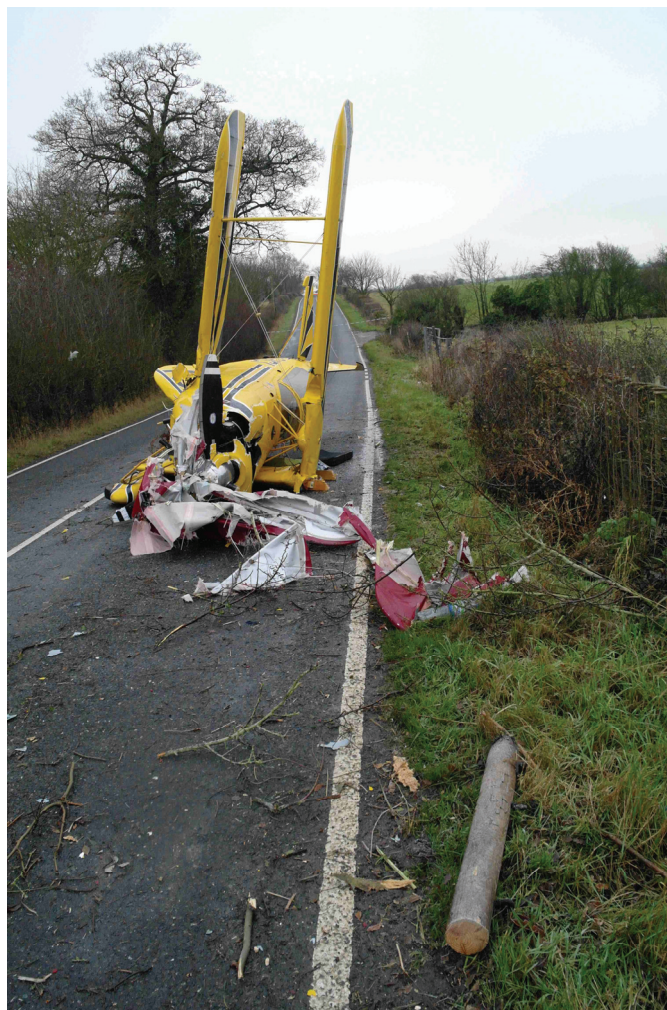
Figure 1

The wreckage of G-IICI was located on a road that borders the southern boundary of Leicester Airport. It was largely intact and was lying on the left side of its fuselage. Both left mainplanes were severely damaged. The cockpit area was intact and the occupants were able to vacate the aircraft using the hinged canopy.

Location of G-IICI - note some wreckage from G-BVXS (silver and red) attached to the propeller of G-IICI

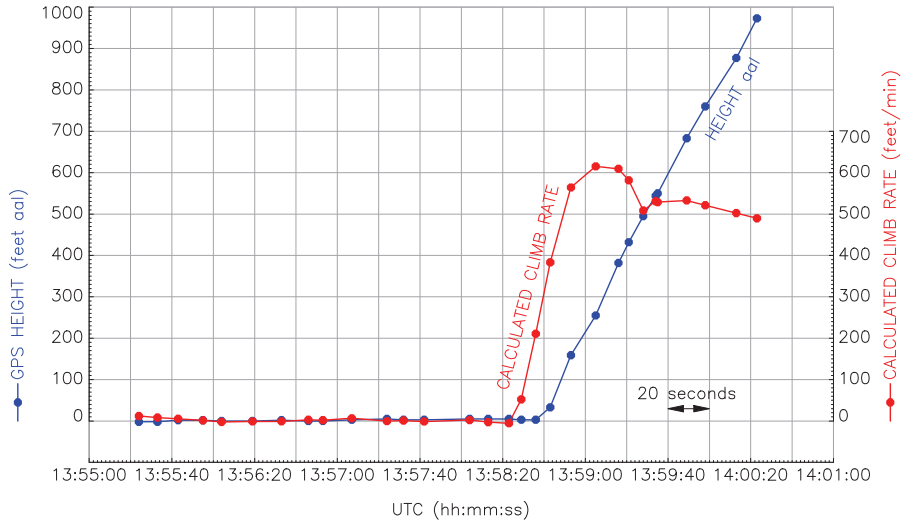
A Garmin GPSMAP 496 was recovered from the wreckage of G-BVXS. The GPS unit had sustained damage during the ground impact but data was recovered from its internal memory that included a log of the accident flight. The last recorded point positioned G-BVXS on the crosswind leg of the left-hand circuit to Runway 33,973 ft aal³ and about two seconds after the collision. The GPS altitude data together with a calculated climb rate (averaged over consecutive points⁴) is illustrated at Figure 2 and shows that G-BVXS was climbing at about 500 ft/min during the climb onto the crosswind leg. The calculated groundspeed, again between consecutive points, showed that G-BVXS's average speed over the last 10 seconds of the recorded log was 45 kt. Similarly, the groundspeed of G-IICI during this same period leading up to the collision was about 90 kt.

GPS derived height above airfield level for G-BVXS

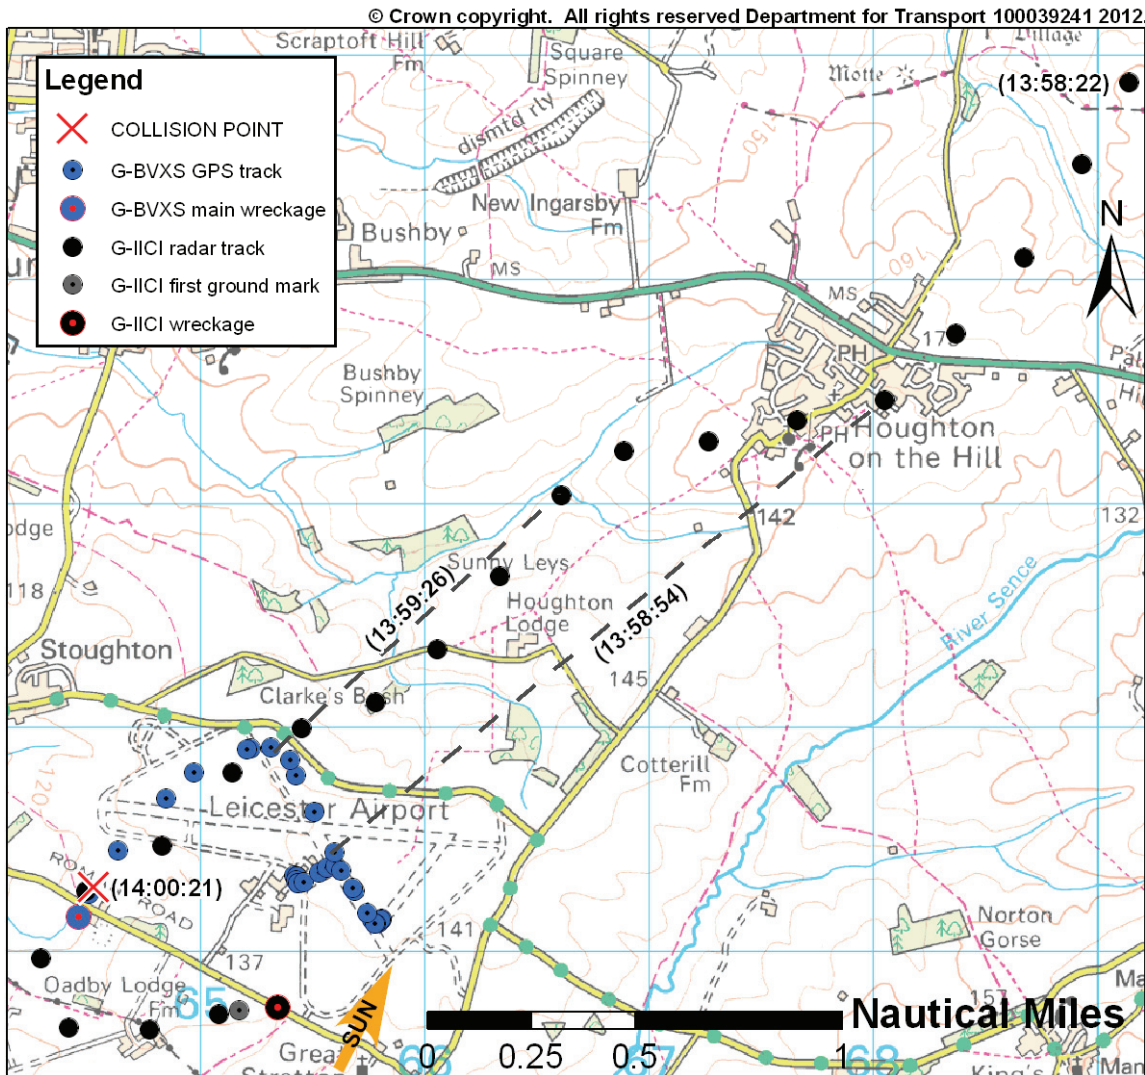
G-BVXS and G-IICI ground tracks from GPS and radar

locations of both aircraft. Also indicated are the relative positions of both aircraft to each other at a number of points leading up to the collision. They show that G-BVXS was either directly ahead, but under the nose (and in the general direction of the sun – also indicated), of G-IICI, or on a constant bearing from the time G-IICI turned onto the crosswind leg, until the collision.

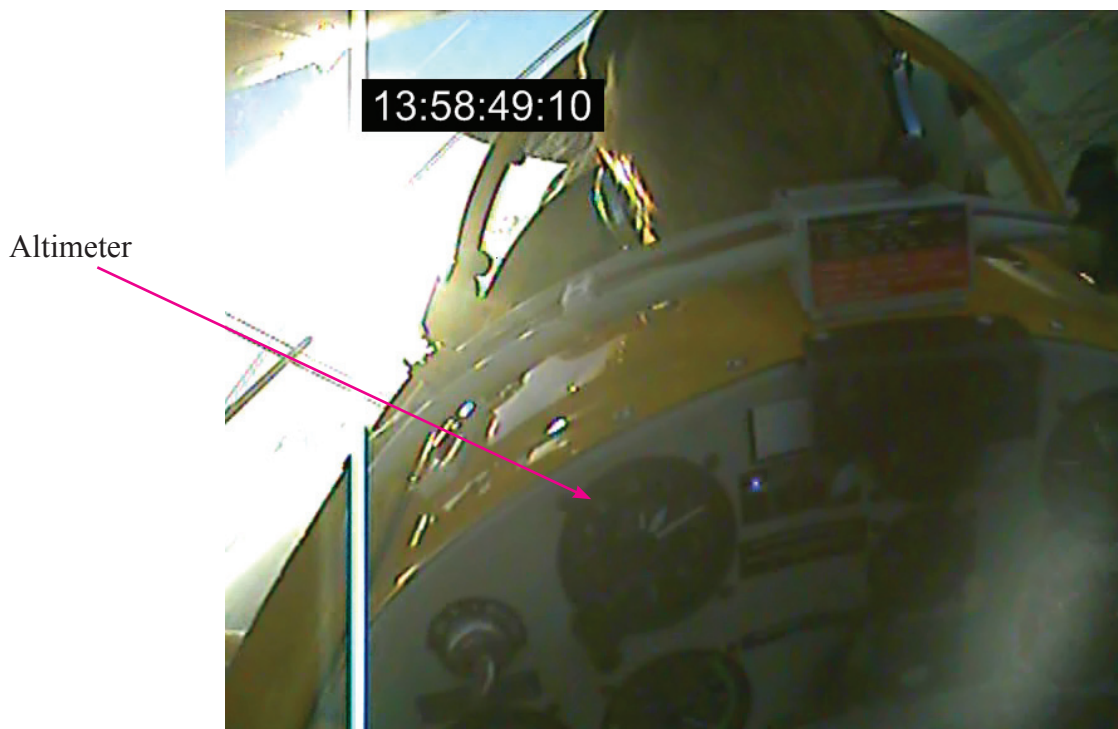
Figure 4

Head-down view from helmet-mounted camera video recording as the aircraft reaches Houghton-on-the-Hill with the altimeter visible and indicating 1,200 ft

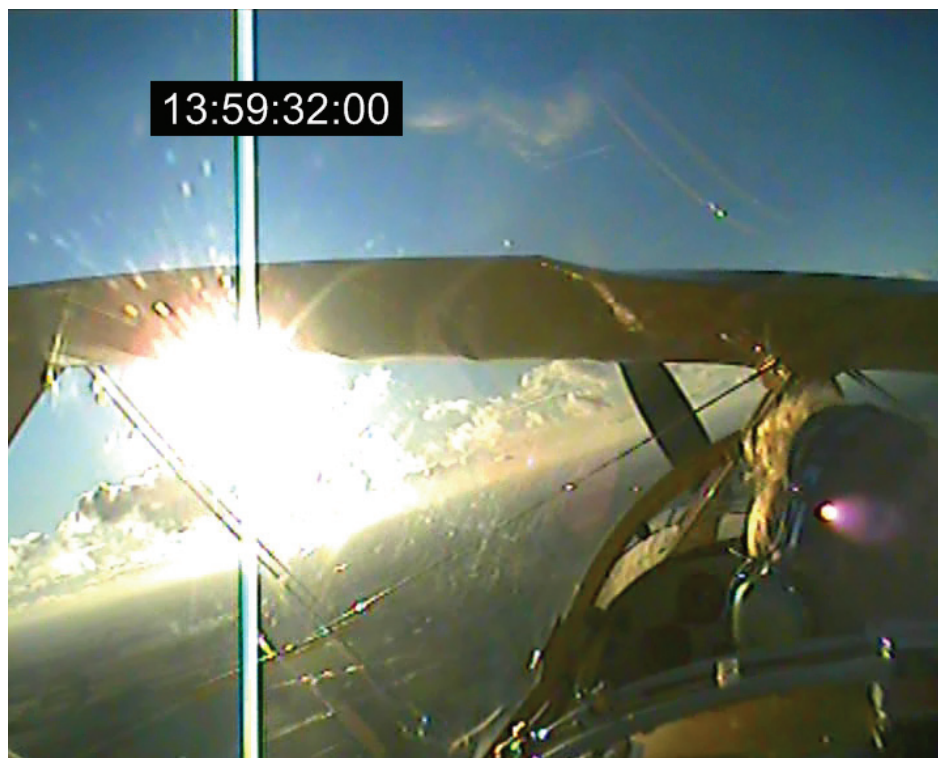
Figure 5

View from helmet-mounted camera with the airfield just in view

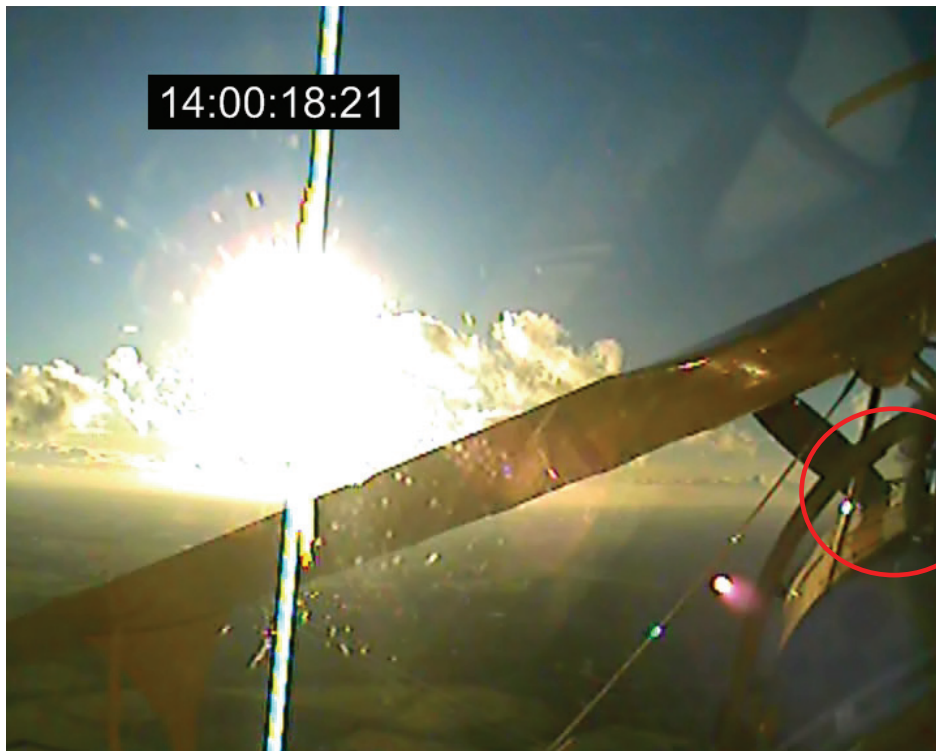
Figure 6

First recorded image with G-BVXS in view (a small portion of the left wing and strut is visible at the junction of G-IICI's propeller blade and upper nose cowling)

The video images from the helmet-mounted camera showed that G-BVXS was approximately wings level (wings parallel with the horizon) when the collision occurred. G-IICI was banked at approximately 30° to the left, almost on the same heading as G-BVXS, with the spinner of G-IICI approximately half a metre below and to the right of the tail wheel of G-BVXS. The witness mark located halfway along one of the propeller blades of G-IICI (which appeared to match the damaged tail wheel of G-BVXS) and the fact that the right main wheel of G-BVXS became detached but the left wheel remained attached, are all consistent with analysis of the flight paths using the video images.

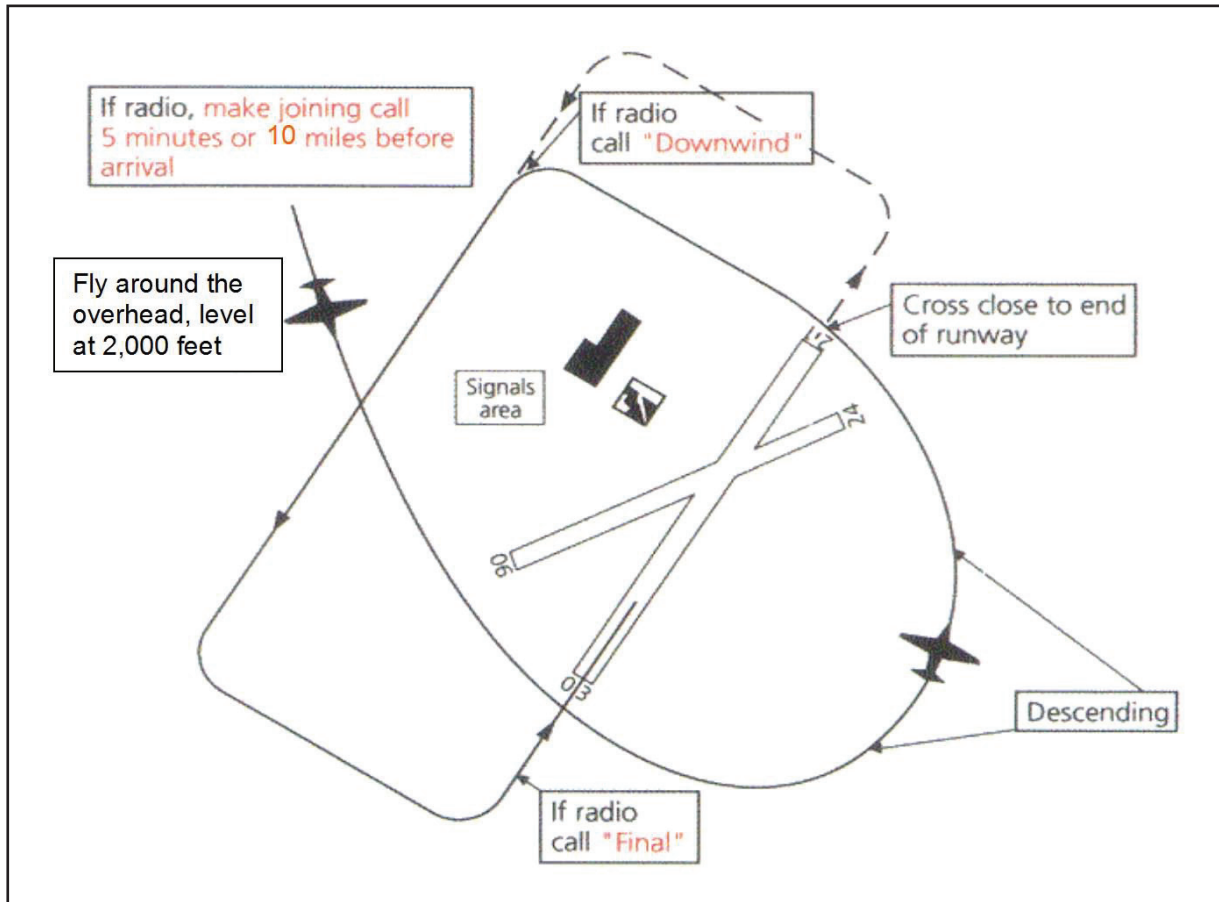
Figure 7

Diagram of the overhead join from CAA Safety Sense Leaflet 6

In appropriate conditions, a standard overhead join offers the opportunity for a pilot to gain improved situational awareness of other circuit traffic. The pilot of G-IICI had not carried out a standard overhead join due to his assessment of the cloud base to the north of

the airfield. In addition, situational awareness may have been improved by keeping the radio's volume to a level at which radio calls from other aircraft in the circuit can be heard and making joining radio transmissions 5 mins or 10 nm from the airport, as recommended in Safety Sense Leaflet 6.
