(ALL TIMES IN THIS BULLETIN ARE UTC)

INCIDENT

Aircraft Type and Registration:	Airbus A319-111, G-EZIU	
No & Type of Engines:	2 CFM56 turbofan engines	
Year of Manufacture:	2005	
Date & Time (UTC):	6 February 2007 at 1146 hrs	
Location:	En route to from Barcelona to Liverpool	
Type of Flight:	Commercial Air Transport	
Persons on Board:	Crew - 6	Passengers - 78
Injuries:	Crew - None	Passengers - None
Nature of Damage:	None	
Commander's Licence:	Airline Transport Pilot's Licence	
Commander's Age:	46 years	
Commander's Flying Experience:	Total 12,500 hours (of which 2,166 were on type) Last 90 days - 81 hours Last 28 days - 26 hours	
Information Source:	AAIB Field Investigation

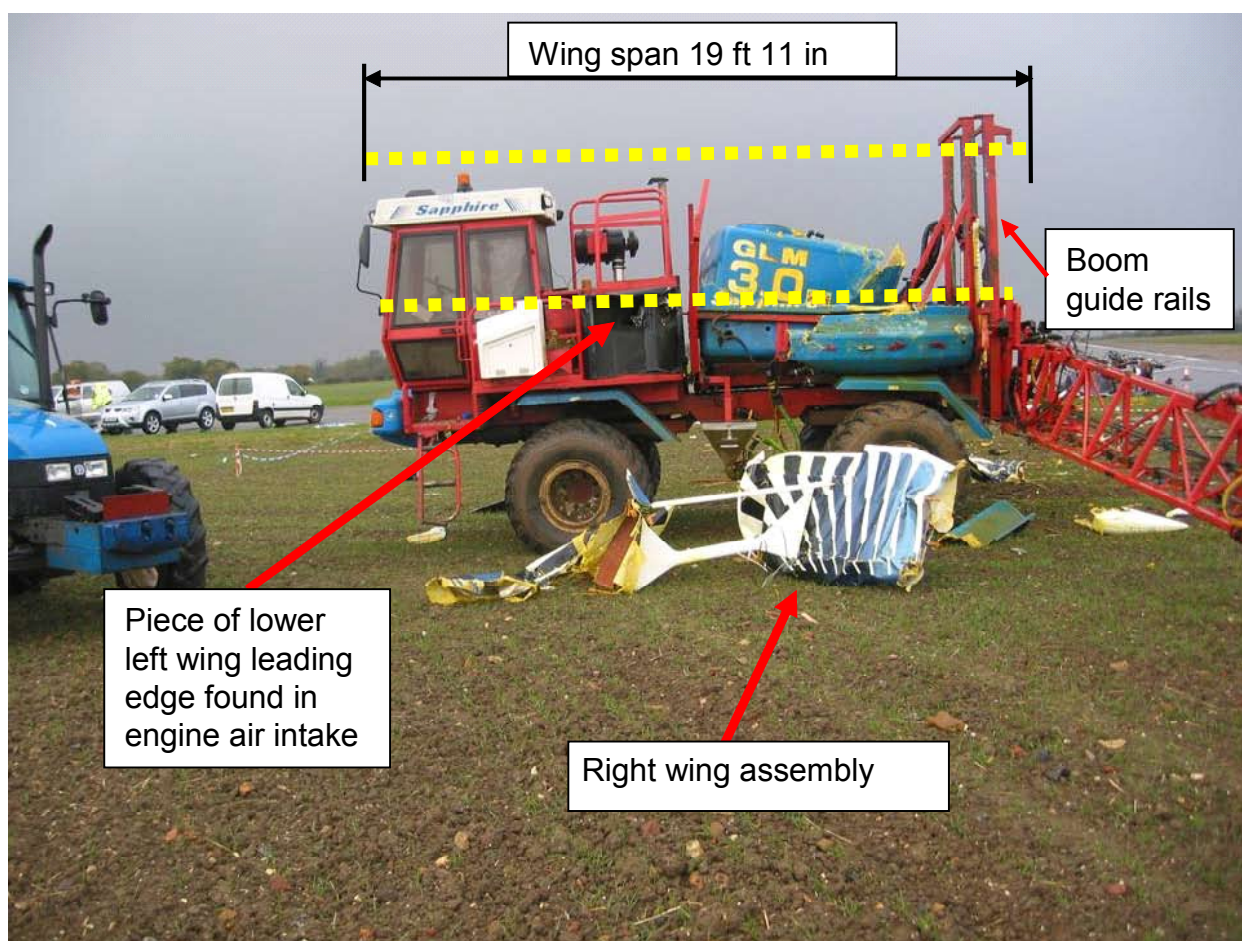
Figure 3 shows the vehicle with the likely impact positions of the wing leading edges. The right wings were torn off in the impact and came to rest by the side of the vehicle. The left wings mostly disintegrated, but the larger fragments remained attached to the bracing wires and were carried to the main impact area along with the fuselage.

The nose and engine of the aircraft passed through the vehicle, disrupting the relatively insubstantial tank structure, although, as can be seen from Figure 3, the landing gear would have impacted the vehicle chassis. It was clear that the main wheels had detached at this point, with the vehicle running over one of them during the estimated 4 to 5 metres it took to come to a halt. The fuselage had 'nosed over', striking the ground some

Probable wing impact positions on vehicle

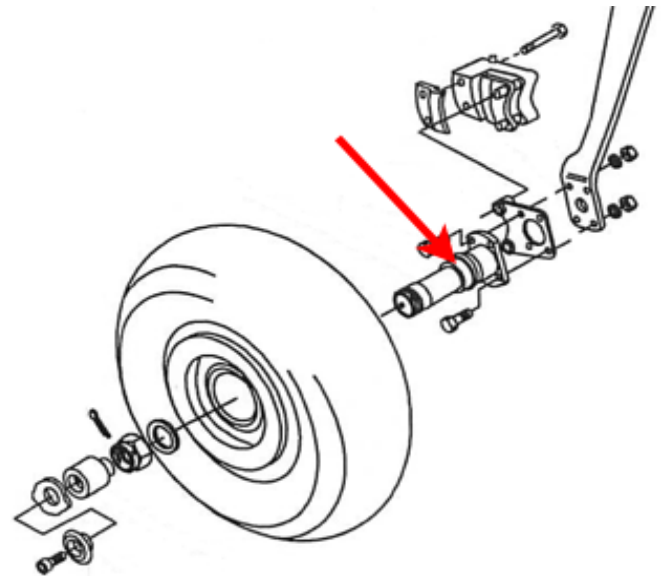
Figure 1

The fracture plane was normal to the axis of the axle, fractionally outboard from the corner formed by the reduced axle diameter at the shoulder. Optical microscopy revealed two separate and distinct regions of fatigue cracking on diametrically opposing sides of the fracture, both originating from multiple origins on the outer surface. The configuration of the axle's flanged attachment to the strut was symmetrical, which allows it to be installed onto the strut either way up. Given the stub axle's loading environment, it was evident that the two opposing zones of fatigue had propagated at separate times, the first crack having initiated and grown to a size insufficient to cause a complete rupture during some earlier period in service. At that time, the axle had been installed at 180° from its position at the time of final failure. The second region of fatigue cracking had so weakened the remaining material that it had ruptured in overload, allowing the wheel to separate.

Main landing gear stub axle arrangement, showing location of failure

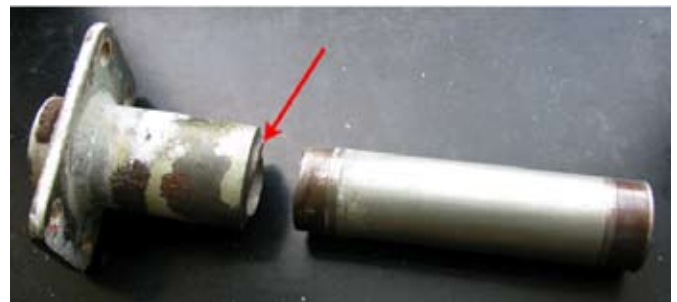
Figure 2

Stub axle fatigue cracking region

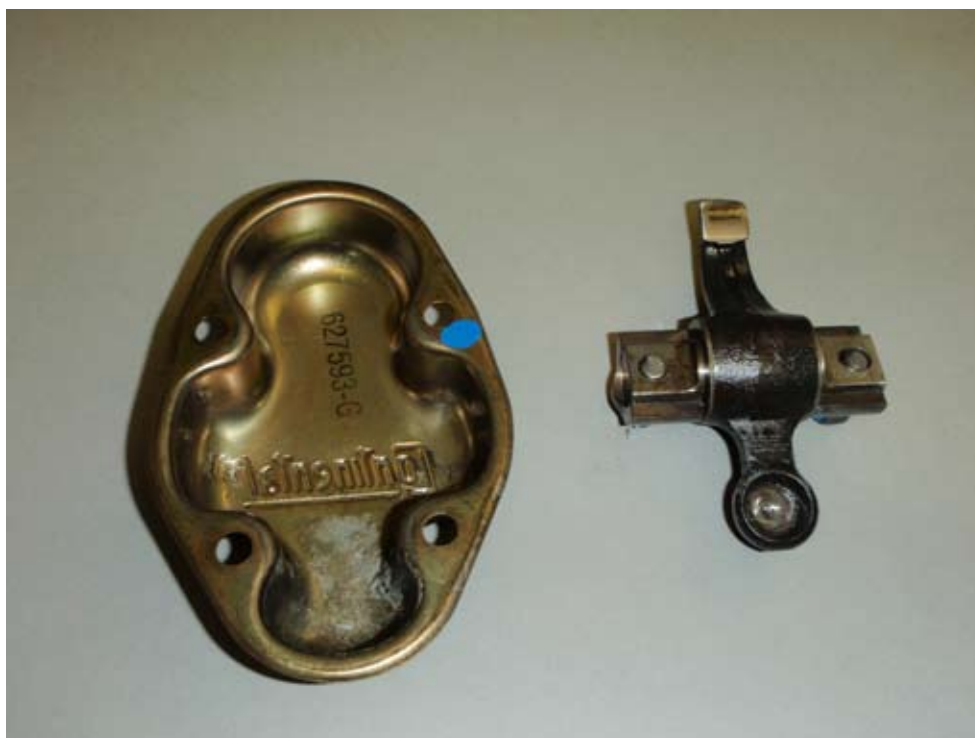
The engine was strip-examined with a representative from the manufacturer present. The two stud bolts that attached the inlet valve rocker assembly to the No 4 cylinder head were found to have failed (Figures 2 and 3), leaving the inlet valve closed. The valve opened satisfactorily when tested. Witness marks were present inside the rocker cover which appeared to have been made by the tie-down nuts from the failed stud bolts.

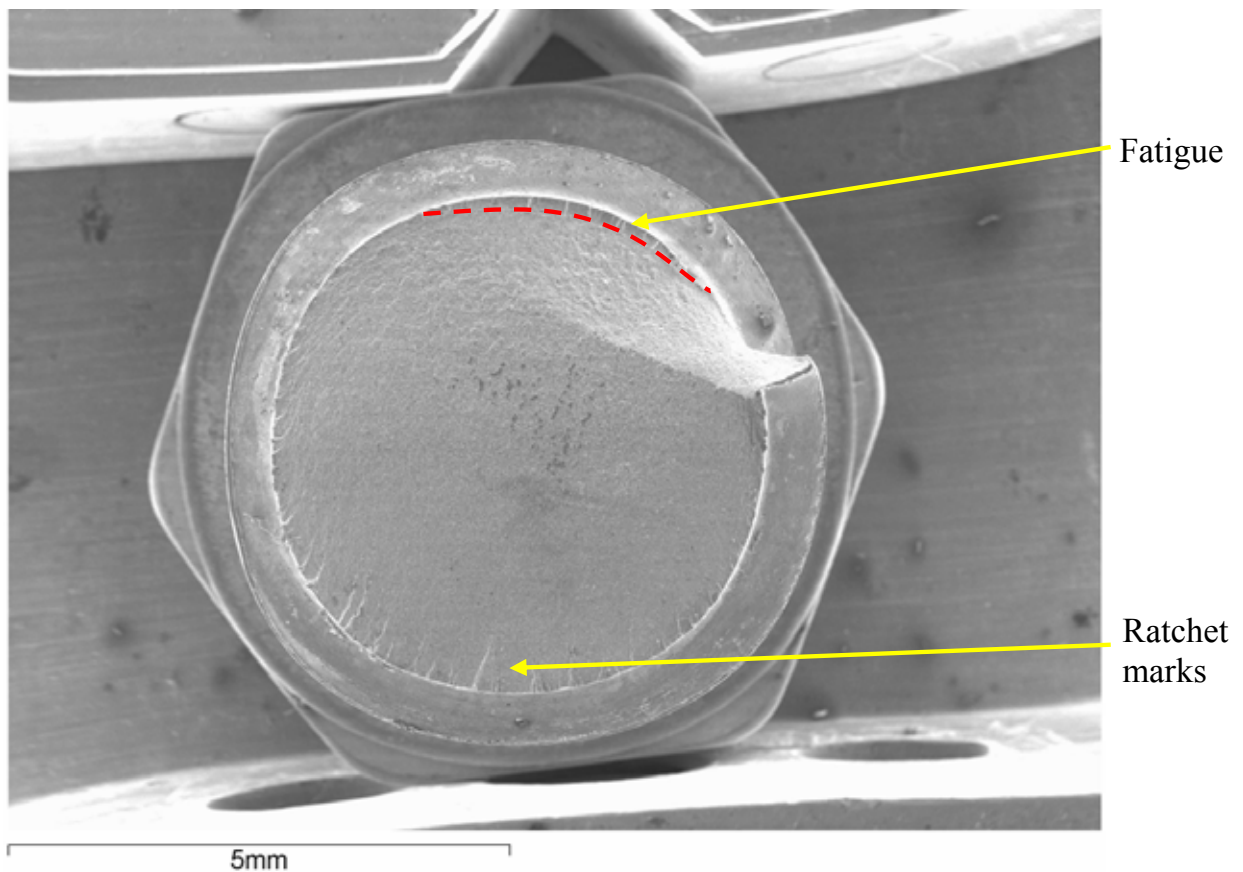
examination. Both showed evidence of fatigue, although no material defect that could have initiated the fatigue was found in either bolt. The hardness value of each bolt was checked; one was found to be 33 and the other 35 on the Rockwell 'C' hardness scale (HRC) the specified hardness range for this type of bolt being 28-32 HRC. The slightly high hardness values were not considered to be significant.

Figure 4
Fracture surface of bolt A

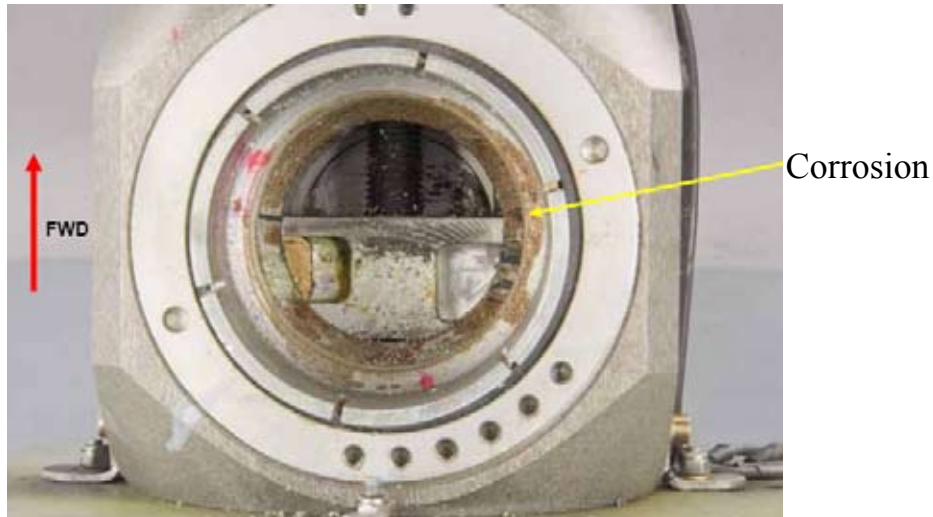
Figure 1 shows the hub in which the root portion of the failed blade, (Figure 2) had been located. Corrosion products were present on the threads in the hub and there was no evidence of a jointing compound having been used in the assembly. The fracture face had propagated around the circumference of the root of a thread and had continued into the adjacent root, causing a 50 mm overlap. A 'thumbnail' feature was visible on the fracture face together with two 'bright' areas; these are shown on the photographs and are designated 'Cracks 1, 2 and 3'. It was concluded that all the cracks were progressive in nature, although outside these areas it was apparent that the fracture was the result of overload. Additional examination of the cracks, using a scanning electron microscope at low power, revealed fracture surface delamination, which is characteristic of stress corrosion cracking (SCC). A section was taken through one of the cracks and it was found that smaller cracks branched off it; all the cracks were intergranular in nature. This, together with the branching feature, is also characteristic of SCC.

Figure 1
Hub after removal of the failed blade root portion

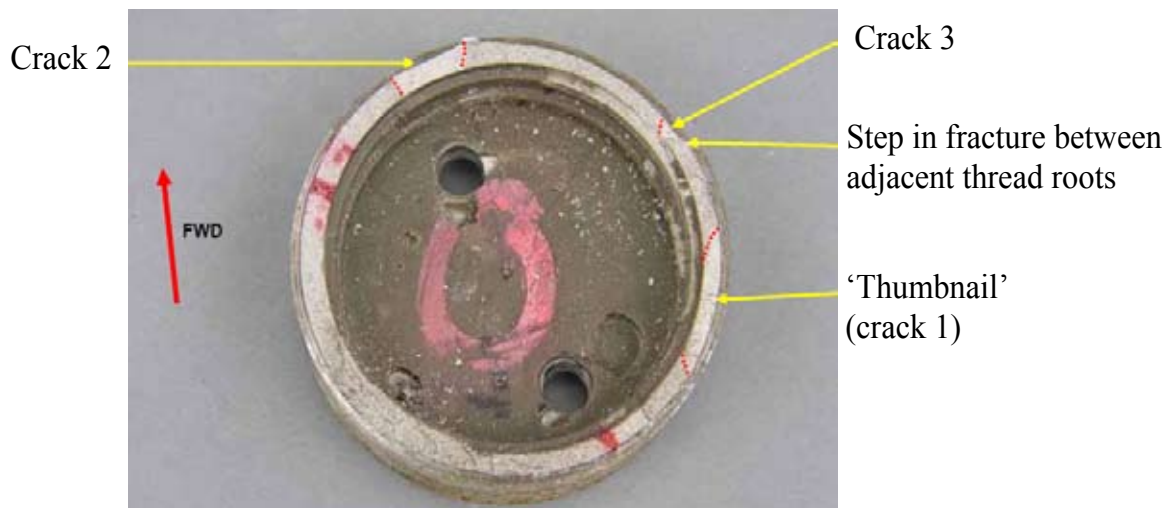
Figure 2
Failed blade root section showing cracked areas

For SCC to occur, a sustained tensile stress must be present in the material, in a corrosive environment. A microstructural examination indicated that the threads had been machined rather than rolled; this had exposed end grains at the thread roots, which would make them susceptible to SCC¹. Although a considerable

It was concluded that the right propeller blade failure was the result of stress corrosion cracking within the threads of its root section. This probably occurred due to a combination of residual stresses within the root arising from the thread machining process, and a corrosive environment arising from moisture ingress.

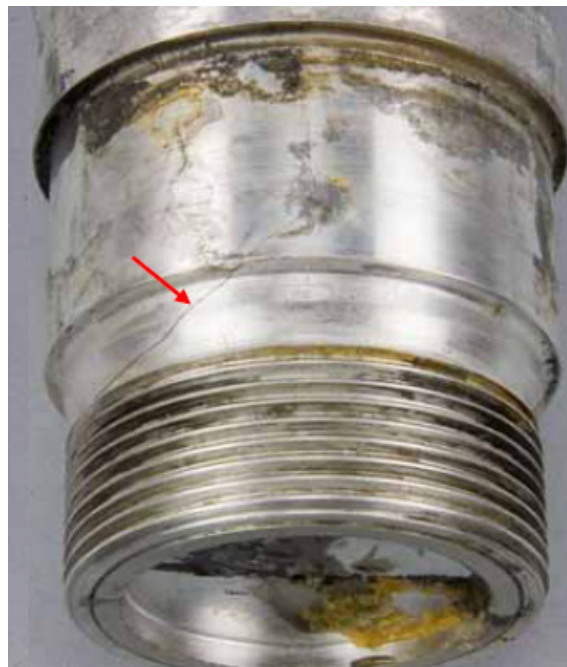
Figure 3

View showing crack in root of one blade from the left propeller
