G-REDL - INITIAL REPORTS

SPECIAL BULLETINS

(ALL TIMES IN THIS BULLETIN ARE UTC)

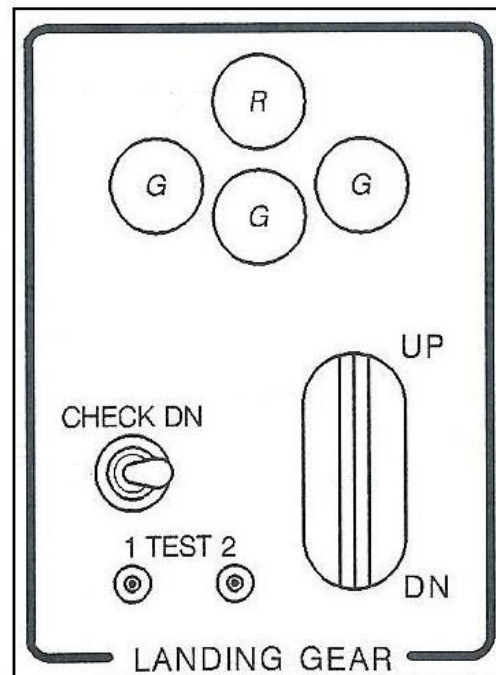
Figure 1

TBM 700 - Landing gear control and indication panel

When the actuator was functionally tested on a rig, an anomaly was found. It successfully retracted, giving the correct UP lock indications, but almost simultaneously, the switch indications for DOWN lock were detected. This meant that the actuator would have sent an indication to the landing gear control unit that the nose gear leg was locked both UP and DOWN. This anomaly could have produced the continuous red light reported by the pilot.

It is recommended that EADS Socata amends the TBM 700 Pilot's Operating Handbook, to clarify the need for manual extension of the landing gear if a continuous red light is showing, even if the green gear lights on the landing gear control and indication panel are lit.

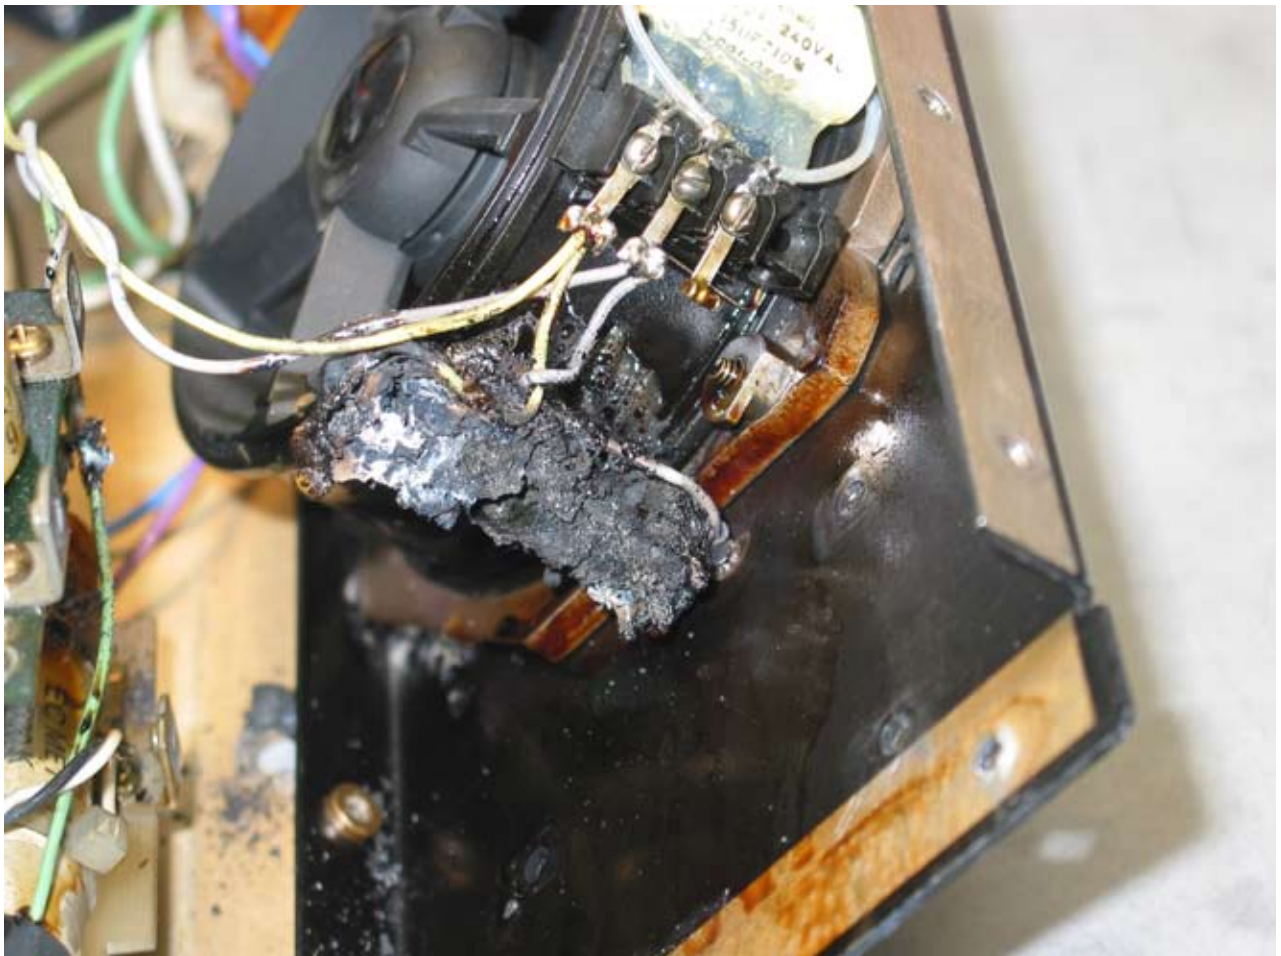
test bench power supply. As soon as electrical power was applied, smoke emanated from the area around the cooling fan. Further disassembly of the unit identified that a capacitor in the cooling fan power supply circuit was completely burnt out. (Figure 1) The capacitor was too badly damaged to allow any further analysis of why it had failed. The inverter was then repaired and tested, with no further anomalies identified.

Figure 1
Burnt out capacitor

It has not been possible to isolate the reason for the capacitor overheating due to the severity of the damage. Previous failures of this component are low in

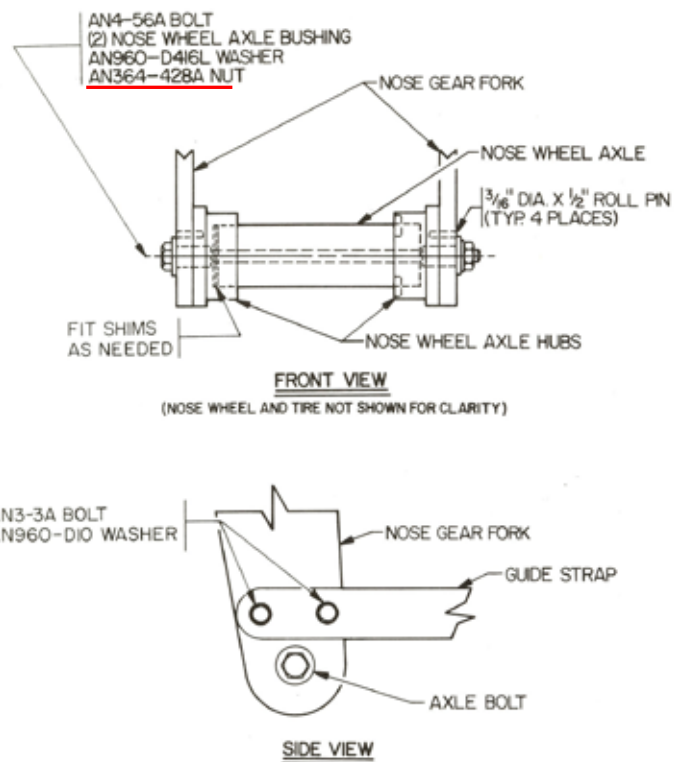
Figure 1

The owner/pilot was unsure as to why the nut had become detached. Thread debris was present on the end of the spindle bolt suggesting that the thread within the nut may have suffered an overload failure in tension.

The tension nut is deeper than the shear nut, which increases the overall width of the fork assembly, although in fact the SB does not specify a longer axle bolt. However it does advise that for retractable gear aircraft, such as G-KSIR, it may not be feasible to use the AN365 tension nut due to width constraints in the nosegear well. In such a case, it advises using a 'lower height' MS21042-4 steel self-locking nut, which offers high tensile strength.

Notwithstanding, because nose gear shimmy can cause fairly severe side loads to the axle and fork assembly, replacement of the AN364-428A (shear) nut with an A365-428A (tension¹) nut would be a prudent change.'

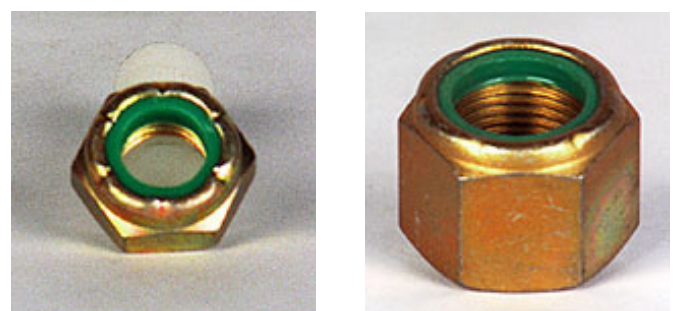
AN364-428A (shear)

AN365-428A (tension)
