CONTENTS

Summary of:	Aircraft Accident Report No: 7/2008	94
	Report on the accident to Aerospatiale SA365N, G-BLUN near the North Morecambe gas platform, Morecambe Bay on 27 December 2006

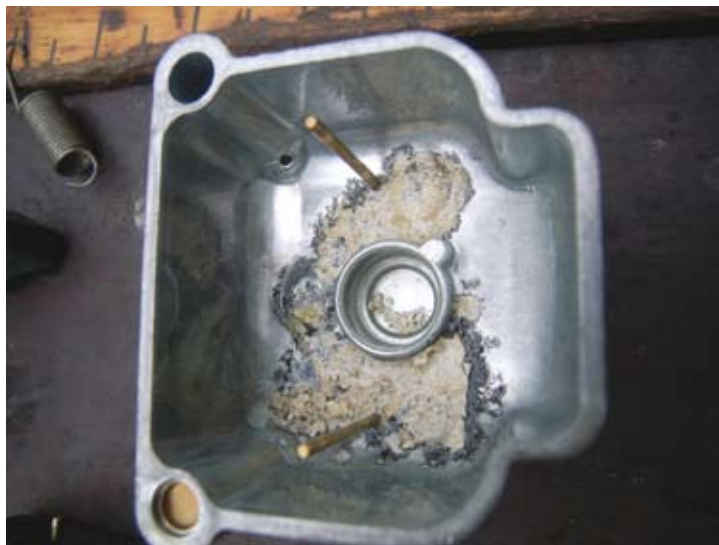
Figure 2

The right carburettor was removed and a well-defined area of exfoliating corrosion was found in the bottom of the carburettor bowl, a small piece of this material was also found in the main fuel jet, see Figures 2 and 3. There was no evidence of corrosion on the left carburettor bowl. The position and clearly defined nature of this material suggested the presence of water in the carburettor bowl. It was noted that the inclusion of a drip tray under the carburettor prevented removal of the carburettor bowl without first removing the carburettor from the intake manifold and there was no requirement to carry out an inspection of the bowls during routine maintenance. Burring found on screw heads around the carburettor did indicate that it had been disassembled at some point prior to the accident.

The right carburettor bowl was examined under a scanning electron microscope, which confirmed that the material in the bowl was a corrosion product of the zinc alloy bowl. Swabs taken for analysis confirmed the presence of chloride, bromide and acetate ions on the inner surface of the bowl. The concentration of these ions within the corroded area was found to be significantly higher than the surrounding material and sufficiently high to have initiated corrosion in the zinc

Corrosion in right carburettor bowl

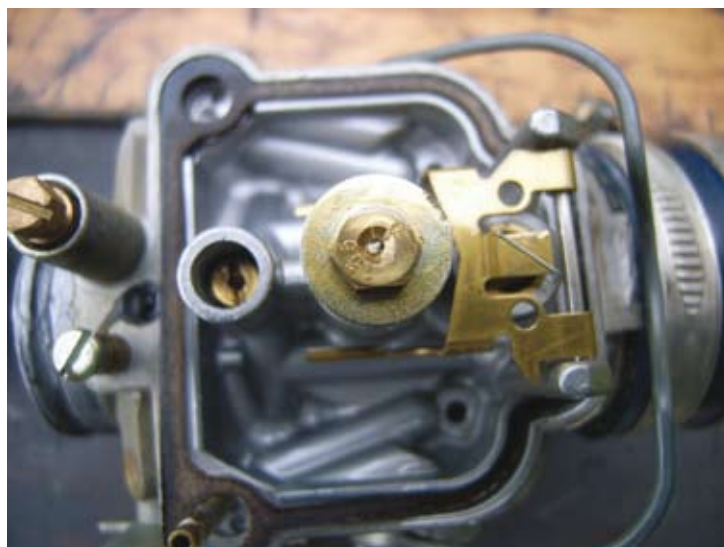
Figure 3

Blocked fuel jet

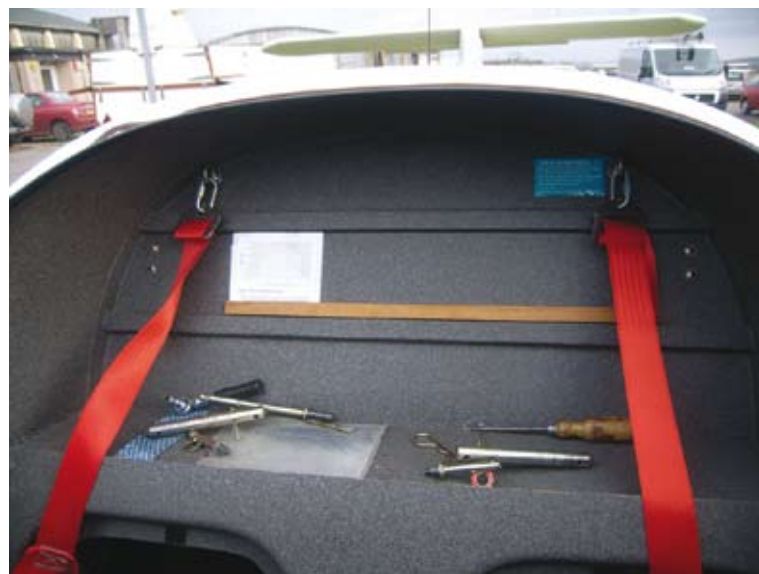
Figure 4
Shoulder harness installation

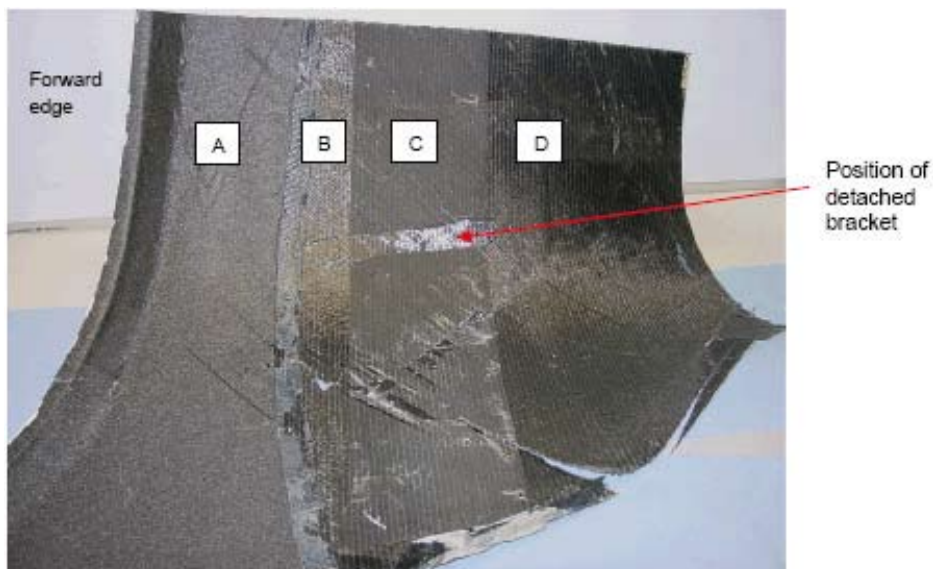
Figure 5

The inner face of the fuselage showed four areas of differing surface finish, see Figure 5. Area A was an area where no bonding had taken place and had been painted for aesthetic reasons, Areas B and D were shiny in appearance and had a smooth surface finish. Area C had a rough finish, normally associated with the

removal of a 'peel ply' from the composite structure¹. The manufacturer's documentation confirmed that the harness fittings were to have been bonded in Area C and, in the event that the bond extended beyond the 'peel ply' area, the surface finish in those areas was to have been abraded to improve the bond strength. The remains of the bond for the passenger harness fitting extended 45 mm forward and 18 mm aft of the peel ply area, whereas the pilot's fitting had, with the exception of the rearmost 25 mm, been bonded to area C. The positioning of area C across the fuselage was not uniform: the area was narrower and its forward edge was displaced aft on the right (passenger) side of the fuselage. Adhesive paste had extruded from both harness fitting joints which indicated that there was adequate adhesive present during the bonding process. However, the depth of adhesive varied across

the cross section of the fitting, possibly in an attempt to maintain the vertical alignment of the fitting when bonded to the curved cross section of the fuselage.

A detailed examination of the area where the passenger attachment had been bonded revealed that in area B the surface of the carbon fibre remained highly reflective and the bond failure appeared to be 'adhesive' (the bond having failed at the interface between the adhesive and the composite surface). This was clear evidence of a relatively poor bond. There was evidence of light abrasion to the surface in areas B and D but this had not improved adhesion in those areas. In area C, the prepared area, the bond line had a dull appearance and was characteristic of 'cohesive' failure of the bond, with the surface of the composite structure being pulled away together with some of the underlying fibres.

Interior fuselage surface finish
