CONTENTS

SPECIAL BULLETINS

Airbus A319-111	G-EZAC	15-Sep-06	1
-----------------	--------	-----------	---

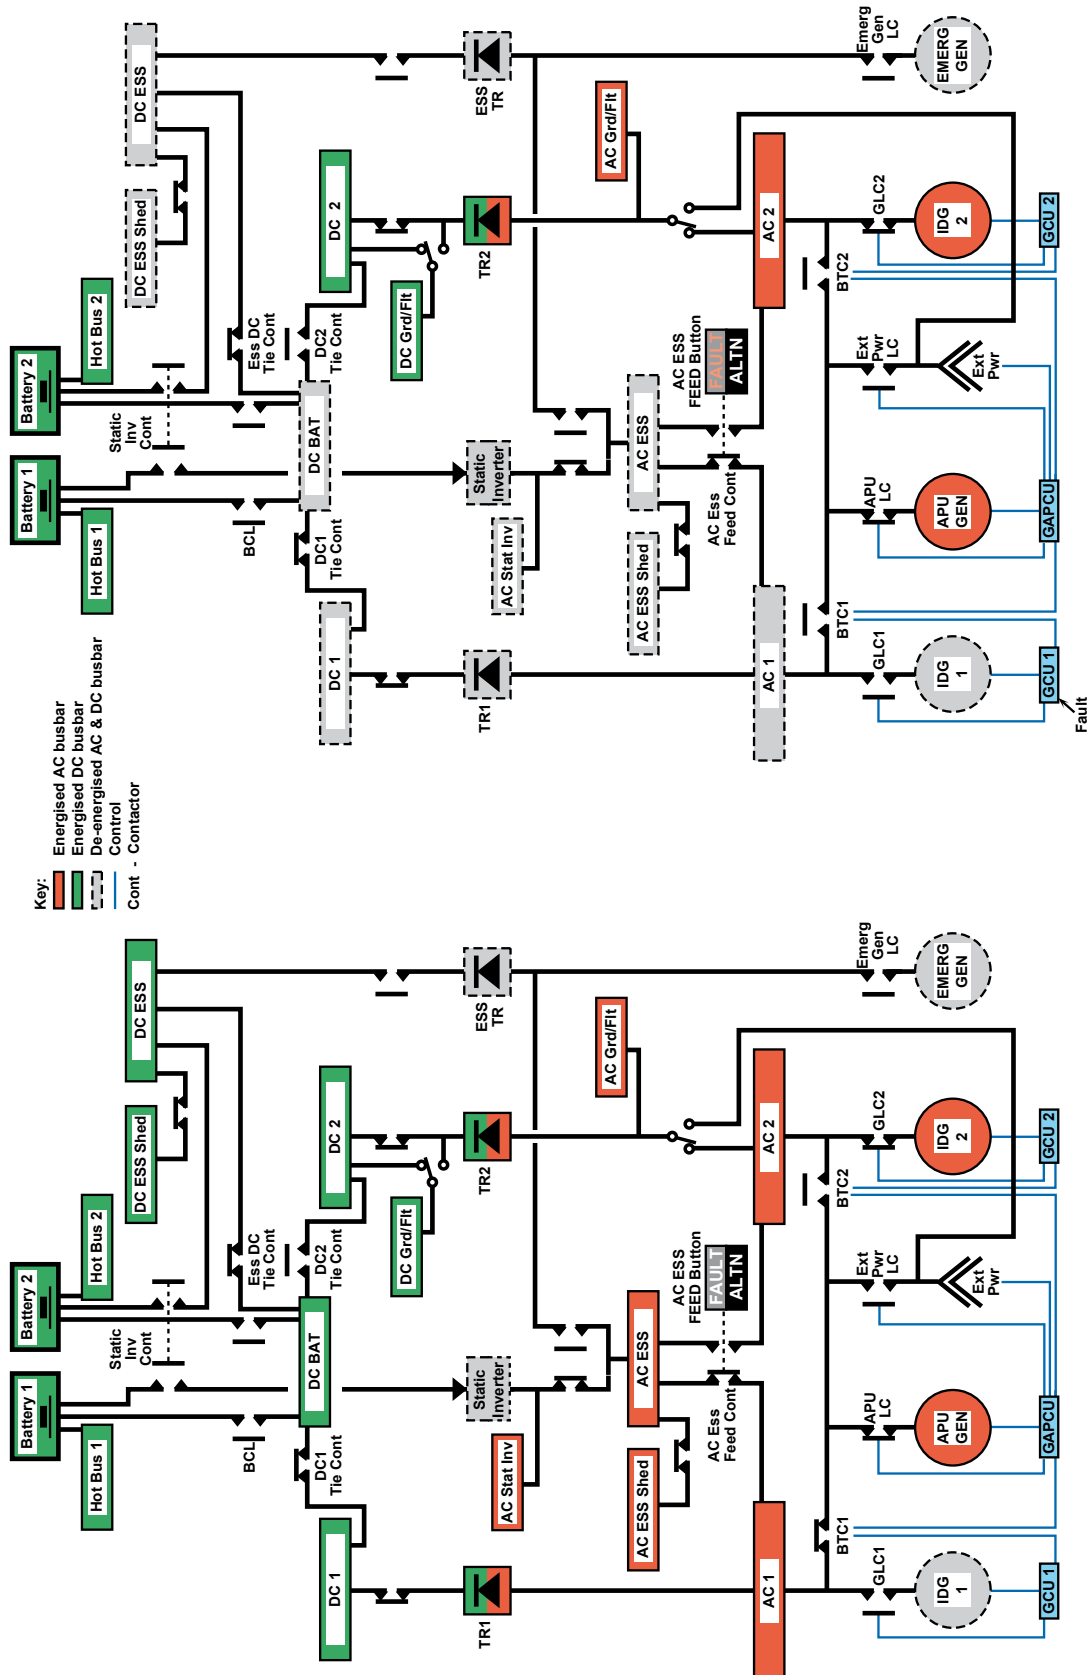
Figure 1.1 Configuration On Dispatch

Two engine-driven IDGs normally power the aircraft's electrical services (Figure 1.1). Each IDG provides 3-phase Alternating Current (AC) power to an AC main busbar (AC1 or AC2) via a Generator Line Contactor (GLC). The IDG outputs are isolated from each other by two Bus Transfer Contactors (BTC). A Generator Control Unit (GCU) monitors the IDG output and opens the GLC if it detects an out-of-limits condition. The BTCs then close, to supply both AC main busbars from one generator. Selecting an IDG off also opens the respective GLC. In the event of loss of output from

The evidence indicated that a monitoring system had incorrectly interpreted a fault in GCU1 as a GLC1 fault and opened BTC1 as a result. This had disconnected the APU generator from the AC1 busbar, leading to the loss of AC1 and a number of other busbars, including the AC ESS and DC ESS busbars. It was undesirable that the incorrect interpretation of a single fault should cause the loss of a main busbar. At this time the inappropriate action by the GCU appears to have been due to inadequate logic in the monitoring system. Therefore:

It is recommended that Airbus should revise, for the A320 aircraft series, the fault monitoring logic of the Generator Control Unit to prevent the monitoring system from incorrectly interpreting a fault within the GCU as an external system fault.

It is recommended that Airbus should introduce, for Airbus A320 series aircraft, a modification to automatically transfer the electrical feed to the AC Essential busbar in the event of the loss of the No 1 Main AC busbar.

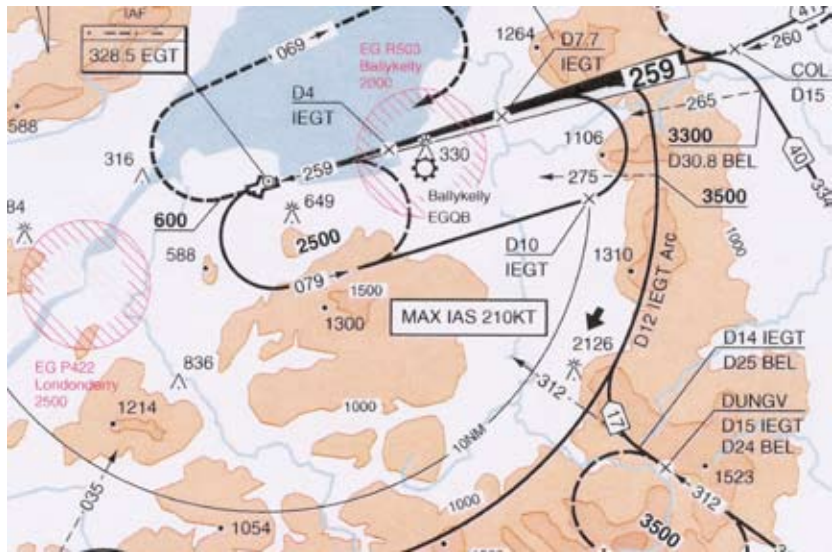
Figure 4

The operating company had provided the operating crew with airfield charts for LDY that had been published by a commercial provider, Figure 4. For three days prior to the incident flight, the commander tried in vain to obtain a copy of the LDY airfield charts, through the LPL operations office and another commercial provider. This was to be fully prepared for the flight into this limiting airfield. However, he did obtain a copy of these charts the day after the incident and stated that, had he seen these previously, he would have been fully aware of the existence of BKY and would not have landed there. This was due to the different presentation of the data, in particular, the manner in which BKL was

Section of approach chart used by the crew of EI-DIJ

Throughout flying training, pilots are taught to believe their flight instruments unless they have good reason to doubt the information being presented. Once visual with BKL, the crew of the A320 were convinced that this was their destination airfield. Distracted by what they perceived was a problem with the ILS glideslope and DME, and the perceived slight sense of urgency from the ATCO, they became focused on landing at the only airfield they could see. Whilst BKL was marked on their approach plates, they failed to recognise the depiction as an airfield.

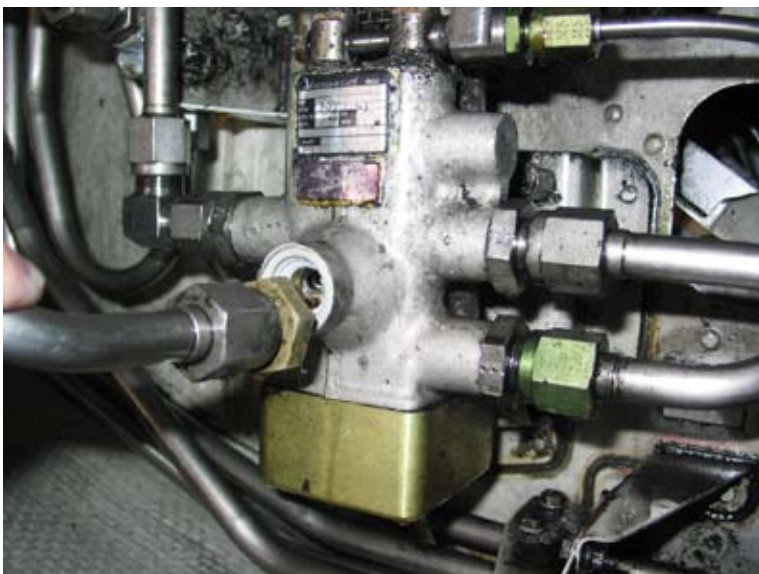
Figure 1

Fractured hydraulic union on the BDDV

Inspection of the aircraft revealed that a hydraulic reducer union on the brake dual distribution valve (BDDV) had fractured, Figure 1, allowing fluid to leak from the Yellow hydraulic system.

The hydraulic union had fractured in the region of the last full thread before the run-out, on the threaded end to which the hydraulic pipe attaches. The fracture was the result of a fatigue crack initiation at the thread root, which propagated to a relatively small crack under low magnitude cyclic stress. Given the small crack advance, the large area of overload was possibly due to the presence of a high static load on the fitting, over which the cyclic loading was superimposed. This was possibly due to separate periods of vibration, or other excitation, as indicated by the presence of wider beach marks between the closely spaced striations. Crack initiation had occurred at multiple sites around the thread root, precluding a defect induced failure. There was no evidence of corrosion on the fitting. The final separation was essentially axial, and therefore unlikely to have been due to an attempt to over-tighten the fitting, which might be expected to produce a torsional separation. The results of the metallographic examination, hardness determinations and chemical analysis, indicated that the fitting had been correctly manufactured from an Al 2024 alloy in the fully heat treated condition.

The cause of the fatigue cracking in the failed hydraulic union was not established; however, no evidence was found of pre-existing defects, corrosion, or of an incorrect material specification.

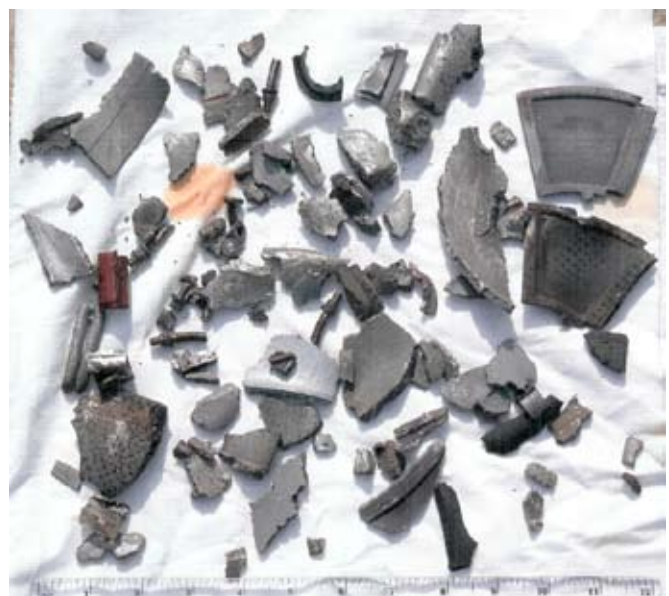
Figure 2

No airframe damage had occurred but on opening the APU access door, it could be seen that an internal failure had bulged and partly split the external casing of the unit. One of the two side-mounts had separated from the unit as a result of the deformation of the casing. Looking down the jet-pipe it could be seen that the turbine was damaged and displaced from its axis, whilst the exhaust duct within the APU had been seriously deformed by contact with high energy rotating turbo-machinery.

APU fragments

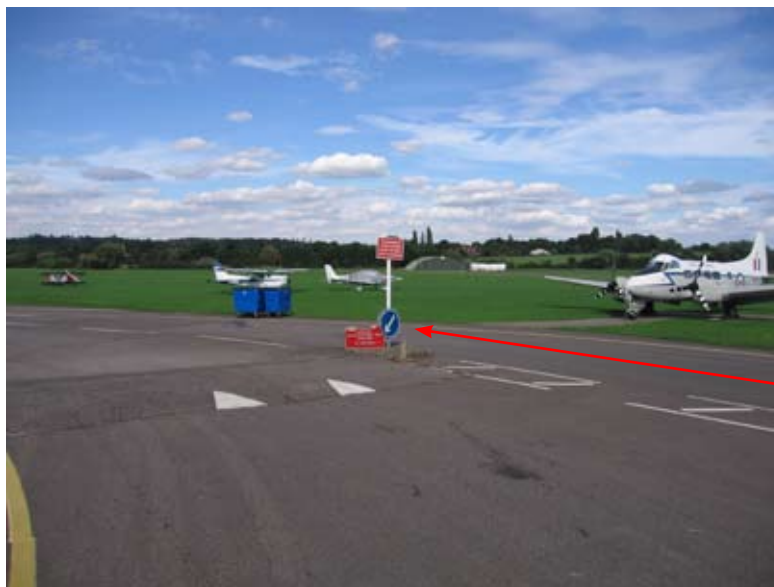
Figure 2

When in the ground attitude, the pilot’s field of vision ahead in a tail wheeled aircraft such as the Stampe, is extremely limited. When taxiing, a pilot must frequently look out of both sides of the cockpit, weaving from side to side, to ensure that the aircraft’s path is free from obstructions.

Accident
