CONTENTS

Summary of: Aircraft Accident Report No: 1/2011 136
Eurocopter EC225 LP Super Puma, G-REDU
Near the Eastern Trough Area Project Central Production Facility Platform
in the North Sea on 18 February 2009

INCIDENT

Aircraft Type and Registration:	Airbus A321-231, G-MEDJ
No & Type of Engines:	2 International Aero Engines V2533-A5 turbofan engines
Year of Manufacture & Serial No:	2004, MSN 2190
Date & Time (UTC):	24 August 2010 at 0225 hrs
Location:	At FL360 over northern Sudan
Type of Flight:	Commercial Air Transport (Passenger)
Persons on Board:	Crew - 7 Passengers - 42
Injuries:	Crew - None Passengers - None
Nature of Damage:	None
Commander's Licence:	Airline Transport Pilot's Licence
Commander's Age:	34 years
Commander's Flying Experience:	Approximately 7,500 hours (of which approximately 1,400 were on type) Last 90 days - 165 hours Last 28 days - 61 hours
Information Source:	AAIB Field Investigation

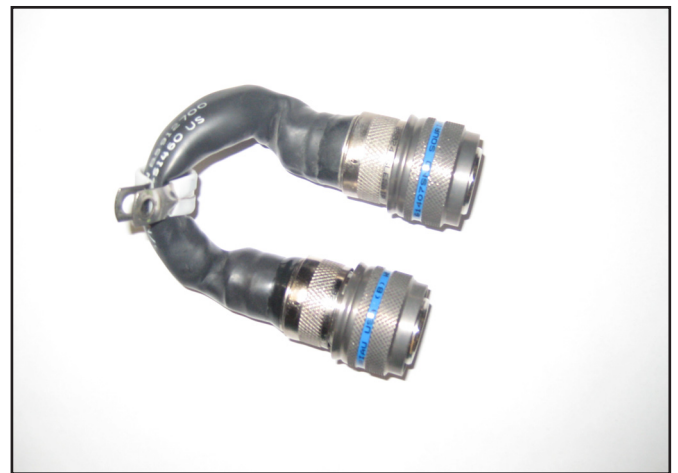
Figure 2

IDG1 and GCU1 were then taken to their manufacturer for further inspection. The IDG was subjected to a detailed strip examination under AAIB supervision with experienced overhaul and design specialists from the manufacturer present. The jumper lead appeared distorted (Figure 2) and when the outer cover was removed significant material damage to the wire braid was found at both ends, near the connectors (Figure 3).

Jumper lead as removed

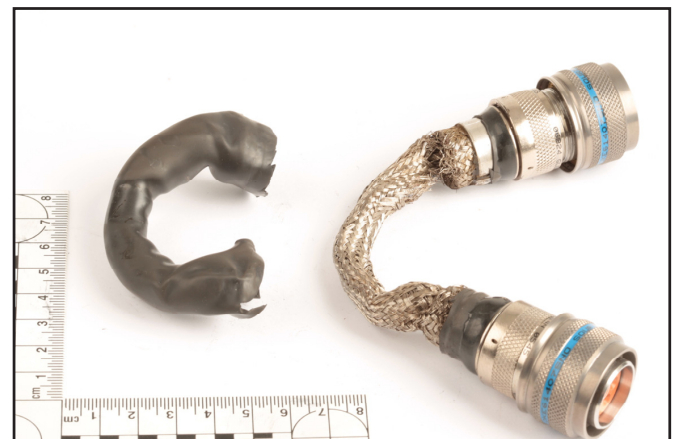
Figure 3

Jumper lead with outer cover removed

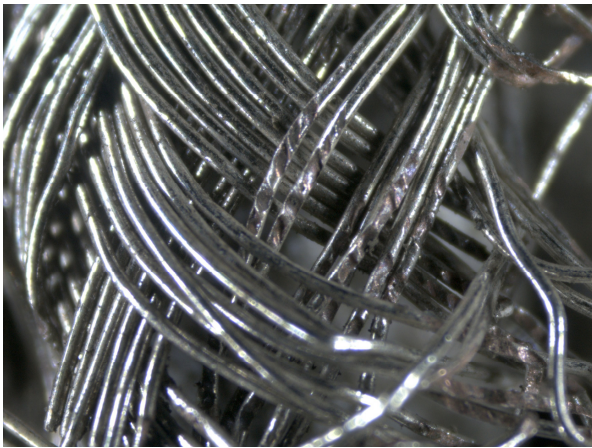
Figure 4

The jumper lead was taken to a forensic laboratory for examination. Evidence that the strands of wire braid had been chafing against each other was found (Figure 4). It was confirmed that wear marks made by the braid were present on the insulation of the seven wires inside

Close up of wire braid on jumper lead showing evidence of chafing

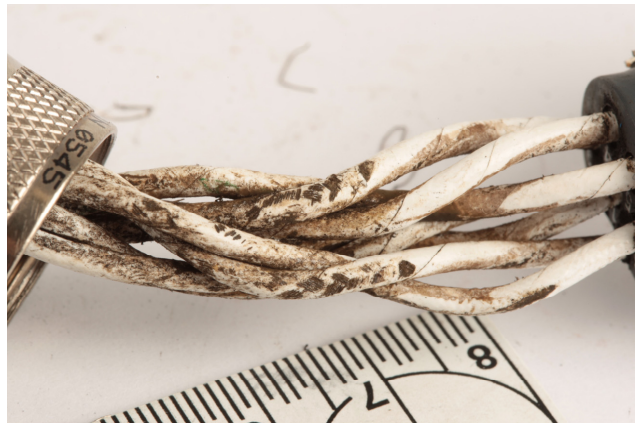
Figure 5

the braided outer sheath (Figure 5). The insulation was worn down on some of the cables, exposing the central conductor inside. Some cables exhibited holes in the insulation containing debris that was confirmed by an EDAX⁶ technique as being of the same composition as the wire braid. Using a Scanning Electron Microscope (SEM), evidence of arcing was found on wire No 5 (Figure 6). Despite extensive efforts, it was not possible to positively identify arcing or a short on any of the other wires. It was concluded that the failure mechanism of

Close up of wire in jumper lead showing wear marks

the jumper lead was the wire braid rubbing against the seven wires, with the vibration of the engine and the tight bend in the routing of the jumper lead providing the conditions conducive to wear. It was not clear if the ‘P’ clip, mid-way along the jumper lead, was a factor in the failure mechanism.

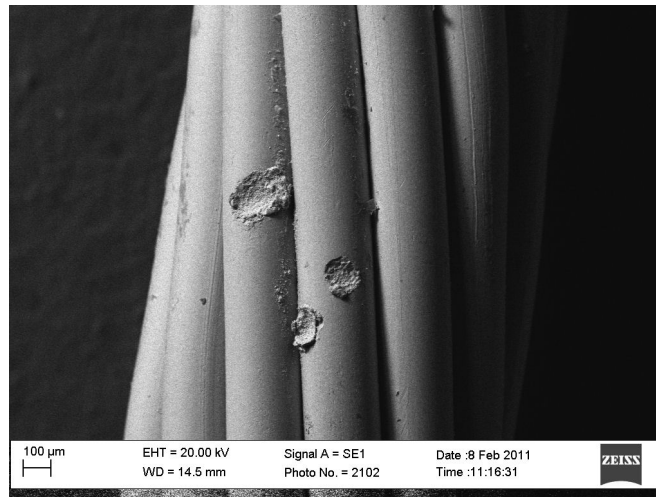
Figure 6

SEM image showing arcing damage on surface of strands in wire No 5

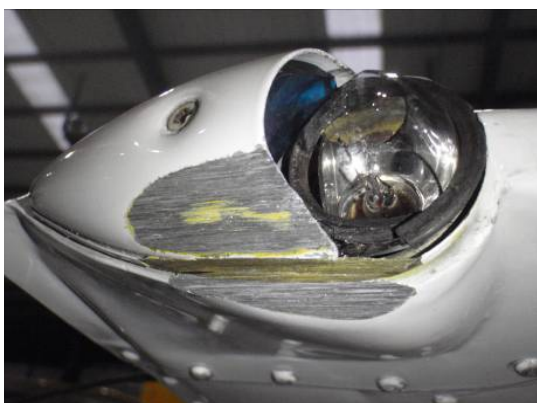
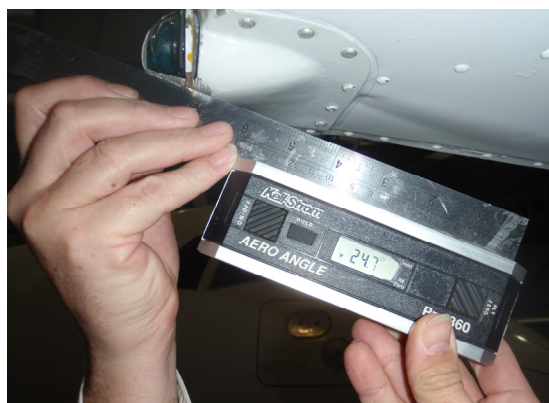
Figure 4

Aircraft damage

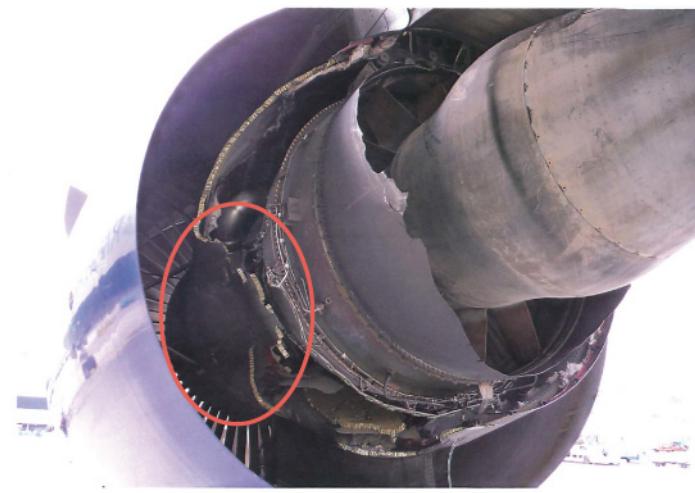
Figure 1

Thrust reverser buckled inner wall and missing nozzle

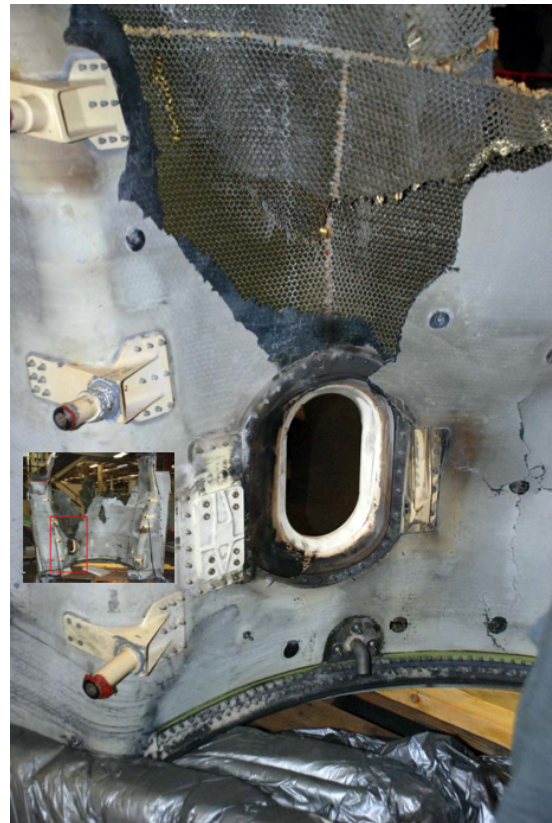
Figure 6

HP3 duct disbond location

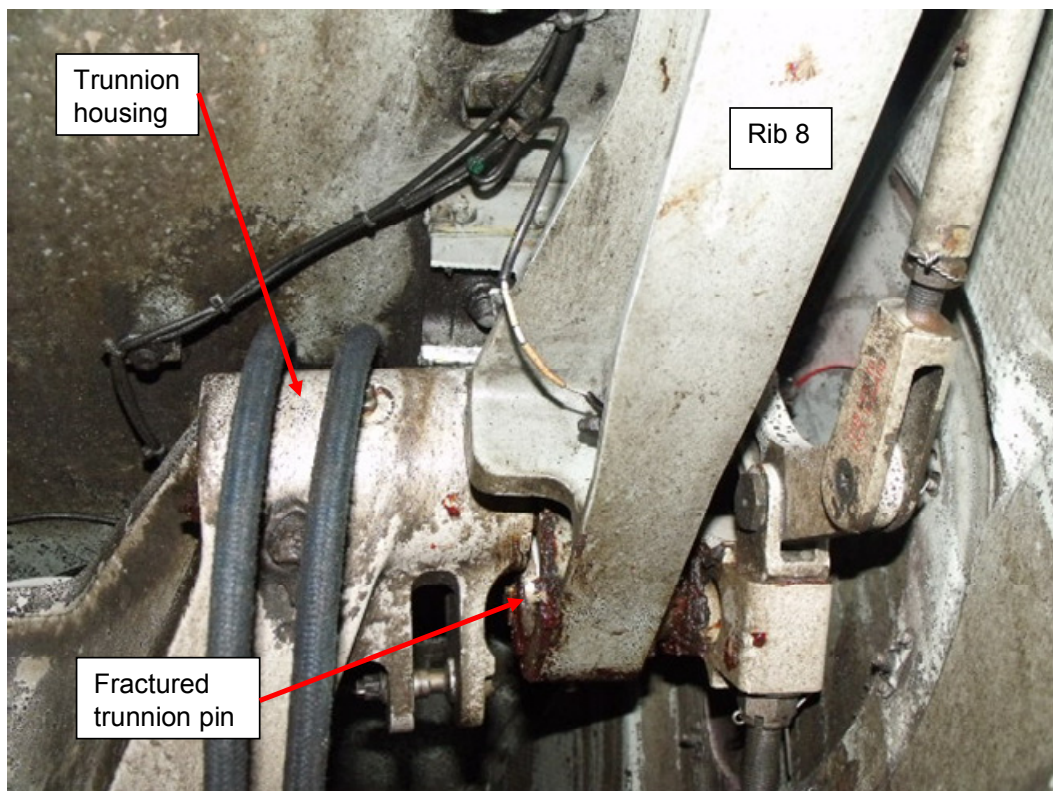
Figure 3

The AAIB examination of G-MAJD took place on the night of the accident. The aircraft was parked on the apron and was supported on jacks. It could clearly be seen that the left Main Landing Gear (MLG) was leaning outwards and, when looking into the left MLG bay, it was found that the outboard trunnion pin had broken. The trunnion pin is a fusible link and is designed to fail at a descent rate at touch down of approximately 10 ft/s. The trunnion housing was resting against the outboard rib (Rib 8), which had been damaged but was supporting the MLG leg albeit at a splayed angle (Figure 3). Also apparent was that the MLG doors were open, because the trunnion pin, which is attached to a bellcrank, is part of the door actuating mechanism; with the pin failed, the doors were able to drop down under gravity.

Photograph of left MLG showing fractured trunnion pin and trunnion housing forced up against Rib 8

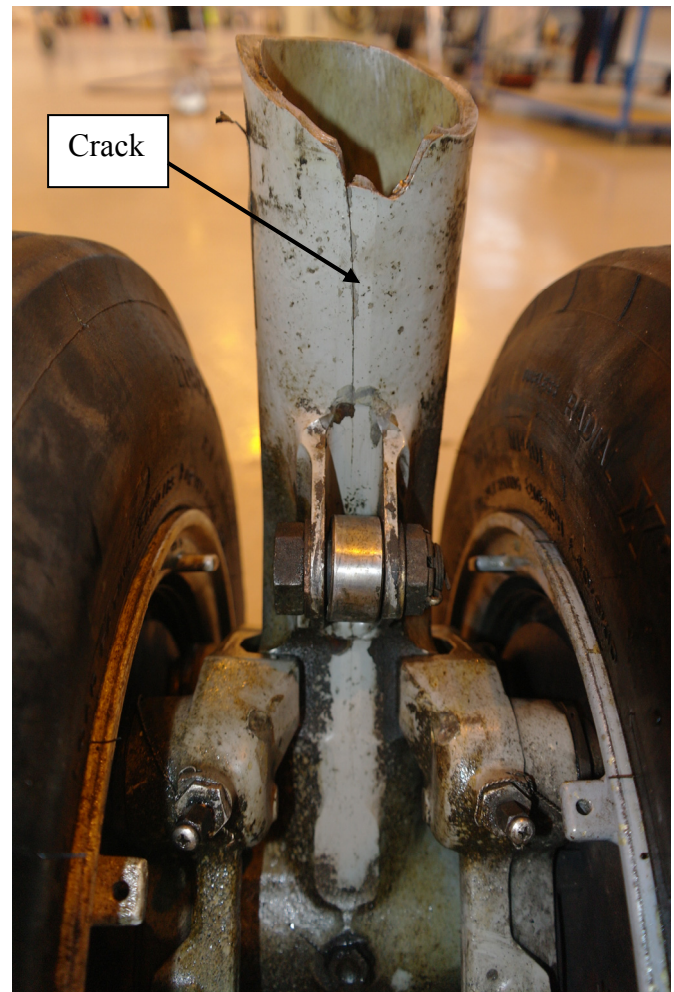
Figure 3

A few centimetres of uncracked material held the two halves of the upper segment together, so this had to be sawn and then broken apart in order to examine the crack faces. As can be seen in Figure 5, the faces were heavily corroded and it was not possible to identify

Broken trailing link showing circumferential fracture and longitudinal crack on upper face

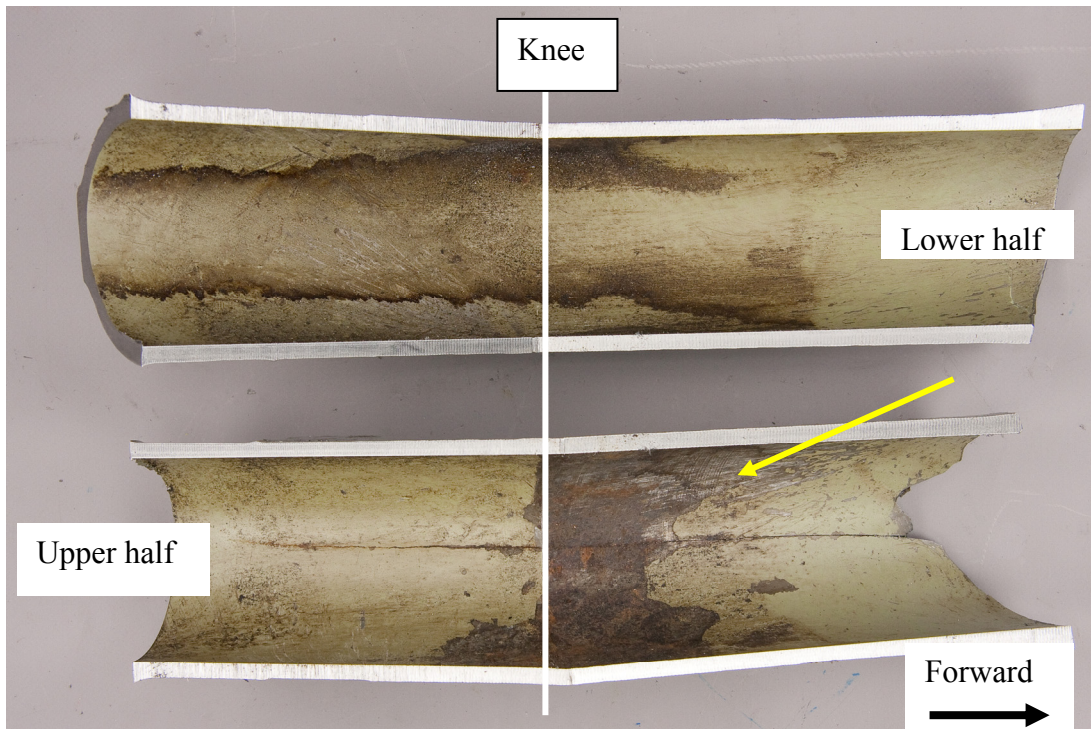
Figure 4

Longitudinal section through failed link showing extent of crack and corrosion on upper half and staining on lower half. Note scratches (arrowed)

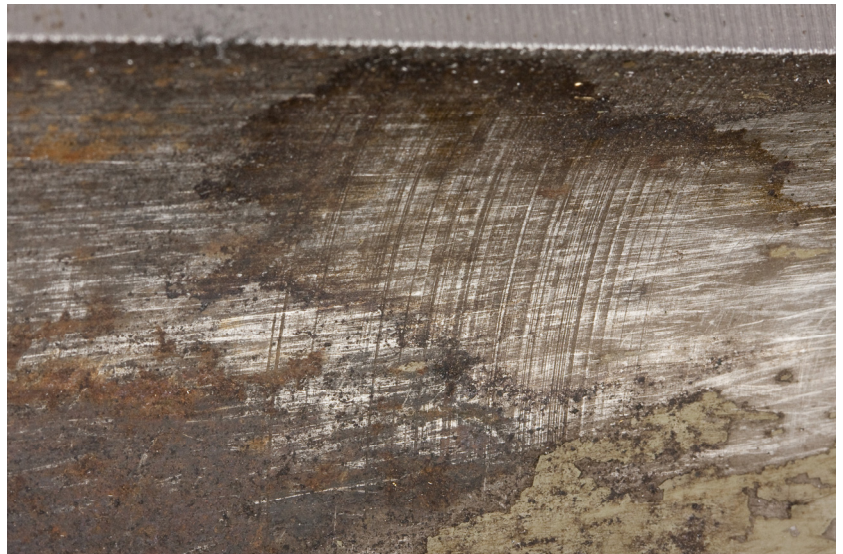
Figure 6

complete loss of the cadmium plating and deep pitting of the base metal. Also noted was a series of roughly longitudinal scratches in the paint (Figure 6), which appeared relatively fresh and were thought to have been caused post-failure of the link, possibly by scooping-up runway debris. However, microscopic examination showed that similar marks appeared in the heavily corroded region in a similar orientation, manifesting themselves as linear regions of deeper corrosion. Furthermore, the ‘fresh’ scratching appeared to run under a region of black staining, similar to that which was noted on the lower half of the link.

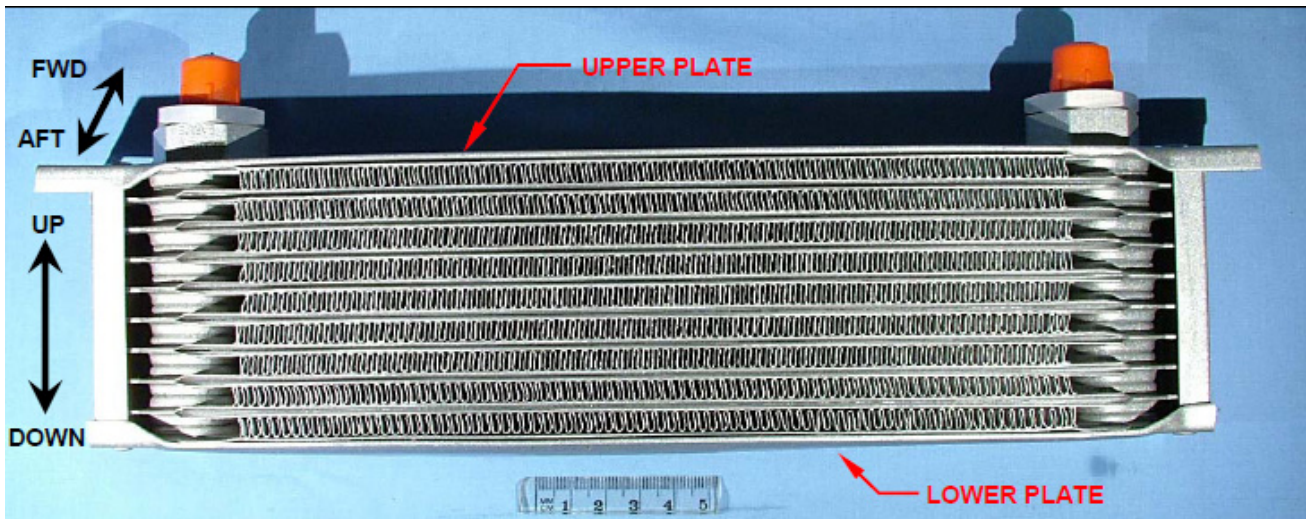
Figure 1
View of the incident oil cooler, as received

Both the incident oil cooler (see Figure 1) and the previously fitted component were examined by a metallurgist. After cleaning, an air pressure test revealed that there was a leak along an approximate 40 mm length of the lower plate, on the aft side as fitted to the aircraft. Both coolers were sectioned, (Figure 2) and the bulging in the lower plate of the incident unit could be seen. The cooling channels in the lower chamber were formed from corrugated sheet metal sandwiched between horizontal plates. However, it was apparent that there was an absence of solder between the lower plate and the corrugated channels, meaning that the plate had remained attached only around the periphery. As a result, the oil pressure within the chamber had caused the lower plate to bulge and had overloaded the sheet metal sidewalls of the chamber. The leak was due to a longitudinal fracture of the sheet metal sidewall, immediately adjacent to the soldered joint between it and the lower plate; this can be seen in Figure 3.

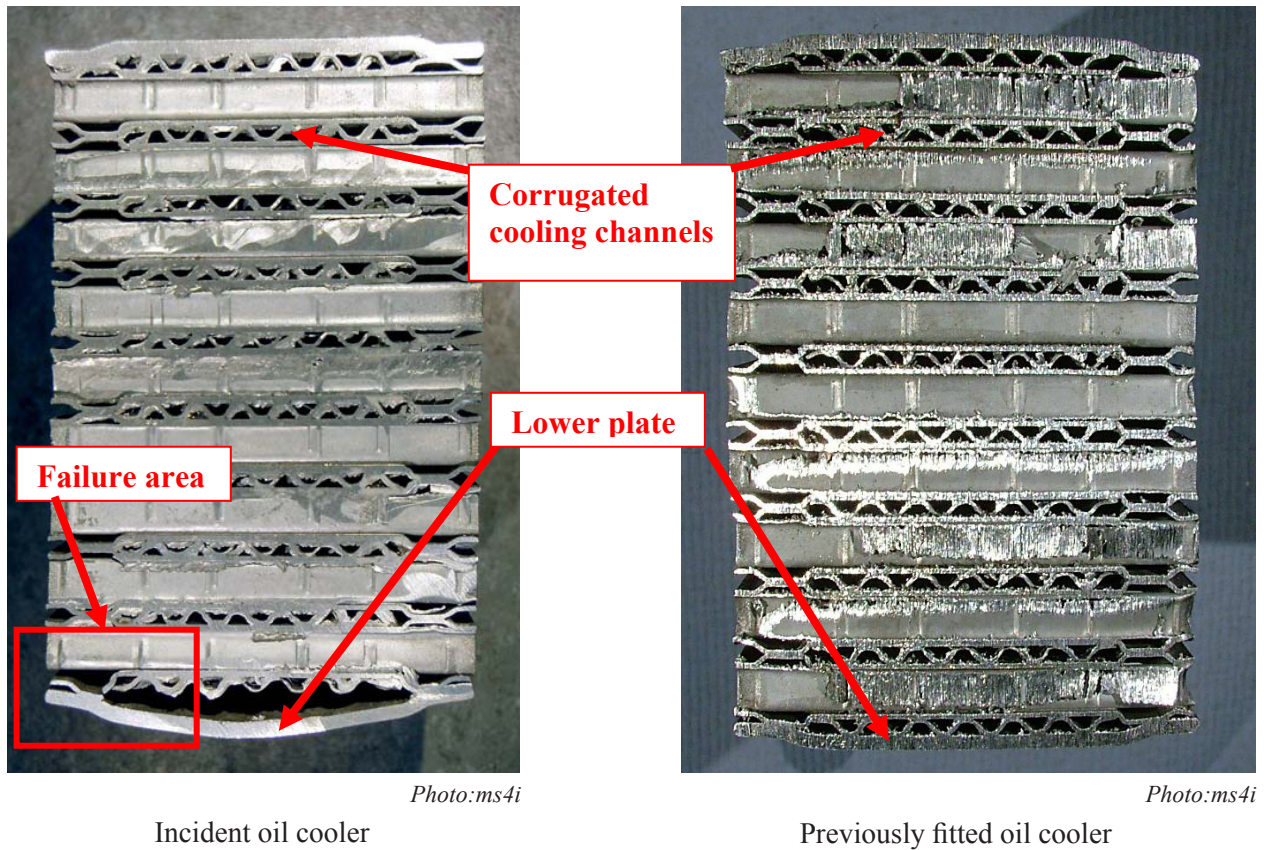
Figure 2

Oil coolers after being sectioned. Bulge in lower plate of incident unit is clearly visible

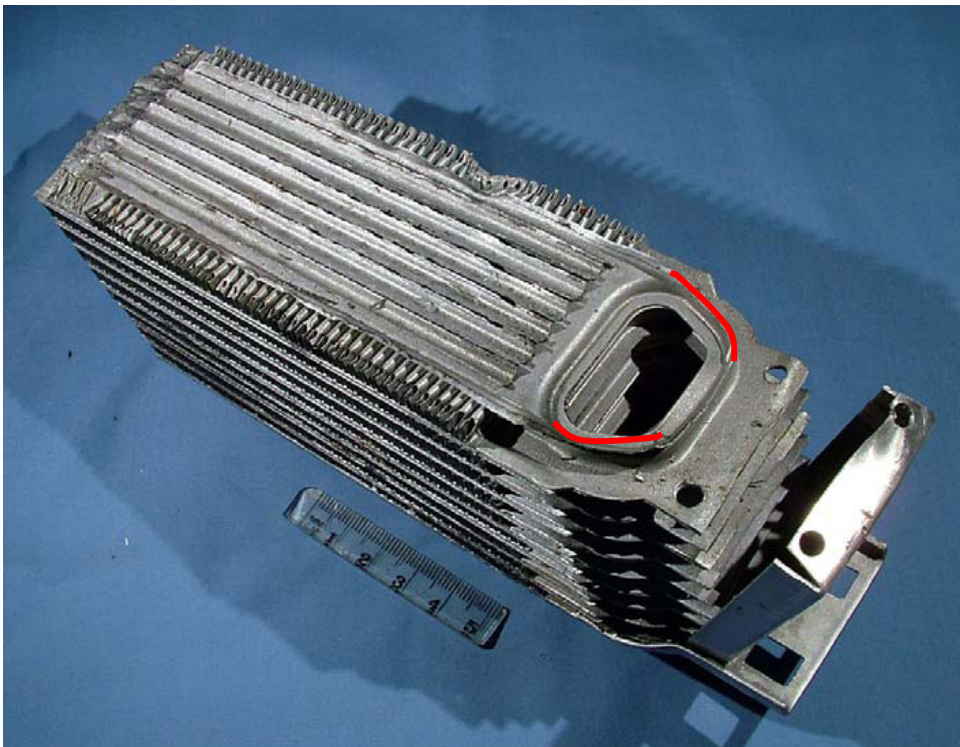
Both the fatigue cracks were approximately 25 mm in length and had penetrated through the full thickness of the chamber sidewall. These are shown on a photograph of the lower plate at Figure 5. The fatigue cracks were visually distinguishable from the deliberate

View of underside of previously fitted oil cooler, with lower plate torn off. Remains of channels can be seen; fatigue crack regions are highlighted

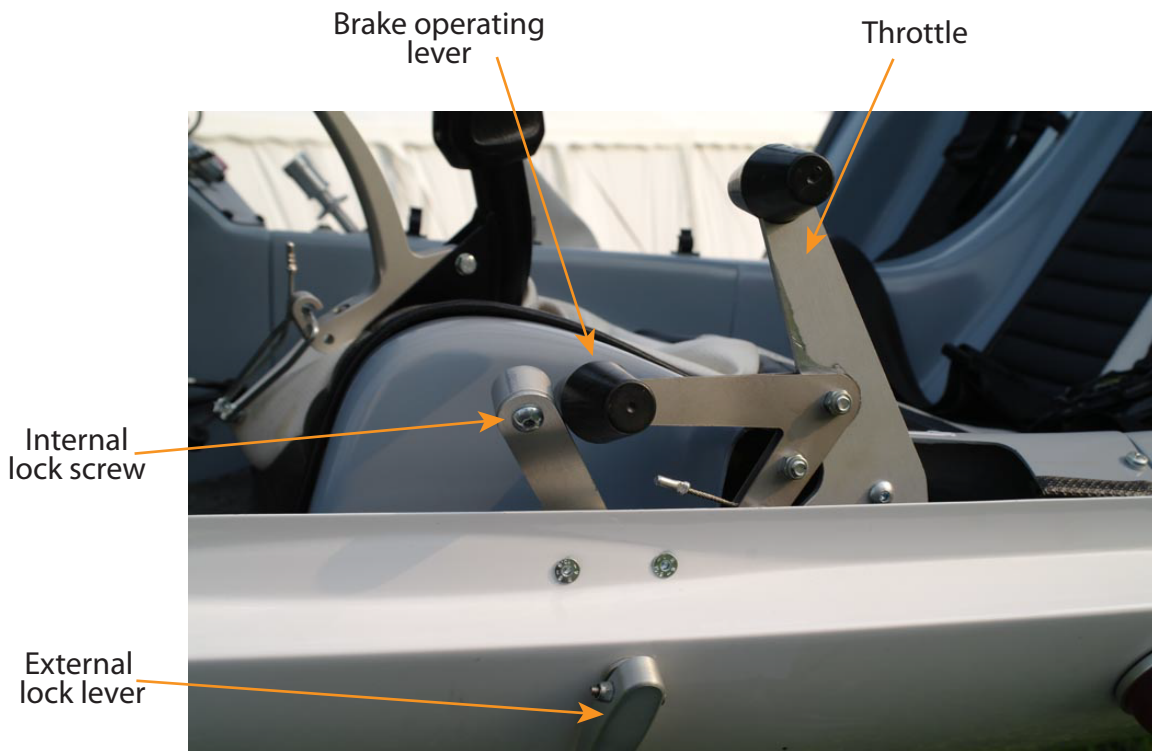
Figure 5
Throttle restricted by internal lock lever.
