## CONTENTS

### SPECIAL BULLETINS / INTERIM REPORTS

S7/2012 EC225 LP Super Puma	G-CHCN	22-Oct-12	3
-----------------------------	--------	-----------	---

<b>Aircraft Type and Registration:</b>	EC225 LP Super Puma, G-CHCN
<b>No &amp; Type of Engines:</b>	2 Turbomeca Makila 2A1 turboshaft engines
<b>Year of Manufacture:</b>	2007 (Serial no: 2679)
<b>Date &amp; Time (UTC):</b>	22 October 2012 at 1418 hrs
<b>Location:</b>	In the North Sea, approximately 32 nm southwest of Sumburgh, Shetland Islands
<b>Type of Flight:</b>	Commercial Air Transport (Passenger)
<b>Persons on Board:</b>	Crew - 2                      Passengers - 17
<b>Injuries:</b>	Crew - None                      Passengers - None
<b>Nature of Damage:</b>	Fracture of the Main Gear Box bevel gear vertical shaft
<b>Commander's Licence:</b>	Airline Transport Pilot's Licence
<b>Commander's Age:</b>	46 years
<b>Commander's Flying Experience:</b>	Approximately 12,000 hrs (approx 1,000 hrs on type)
<b>Information Source:</b>	AAIB Field Investigation

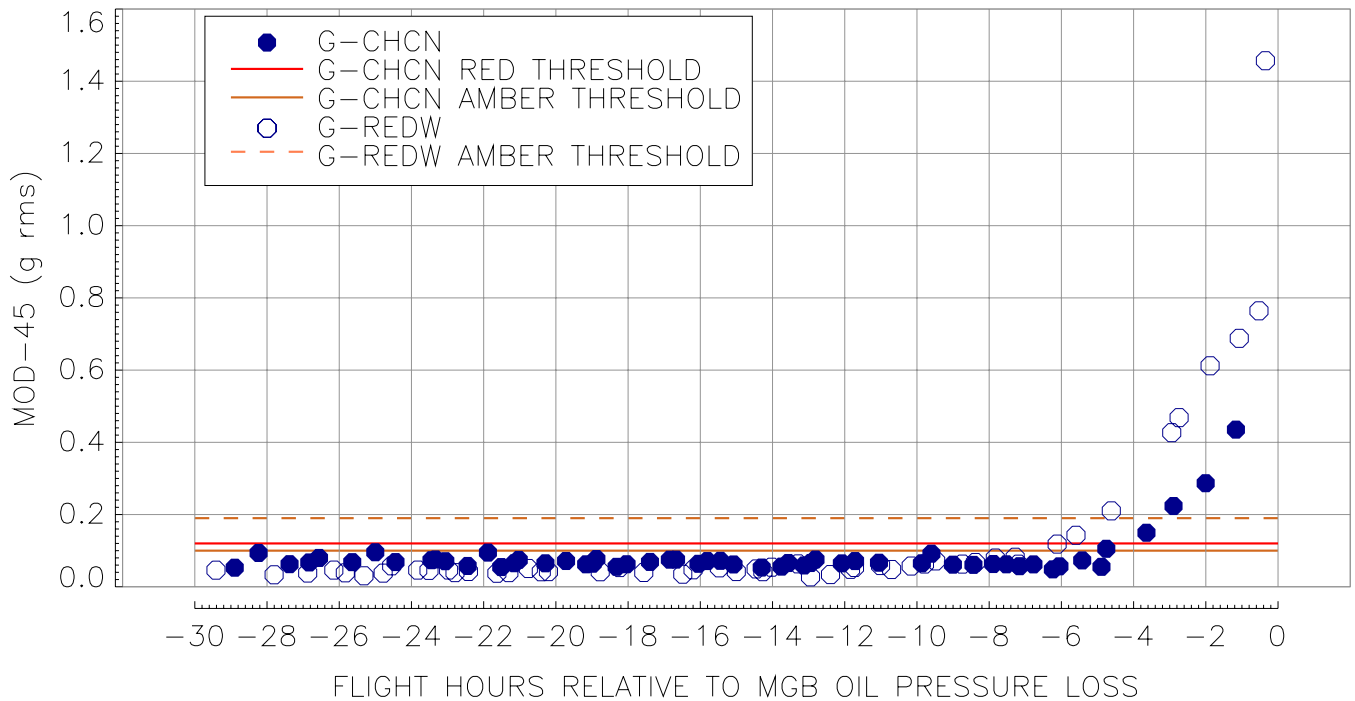
**Figure 1**

Comparison MOD-45 trend indications between G-CHCN and G-REDW

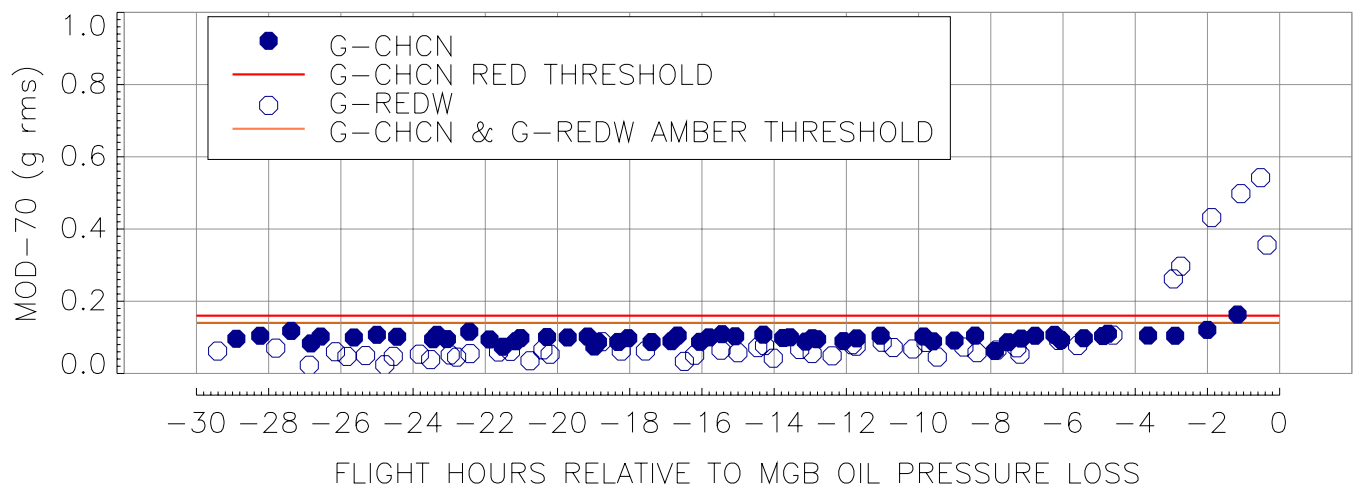
**Figure 2**

Comparison MOD-70 trend indications between G-CHCN and G-REDW

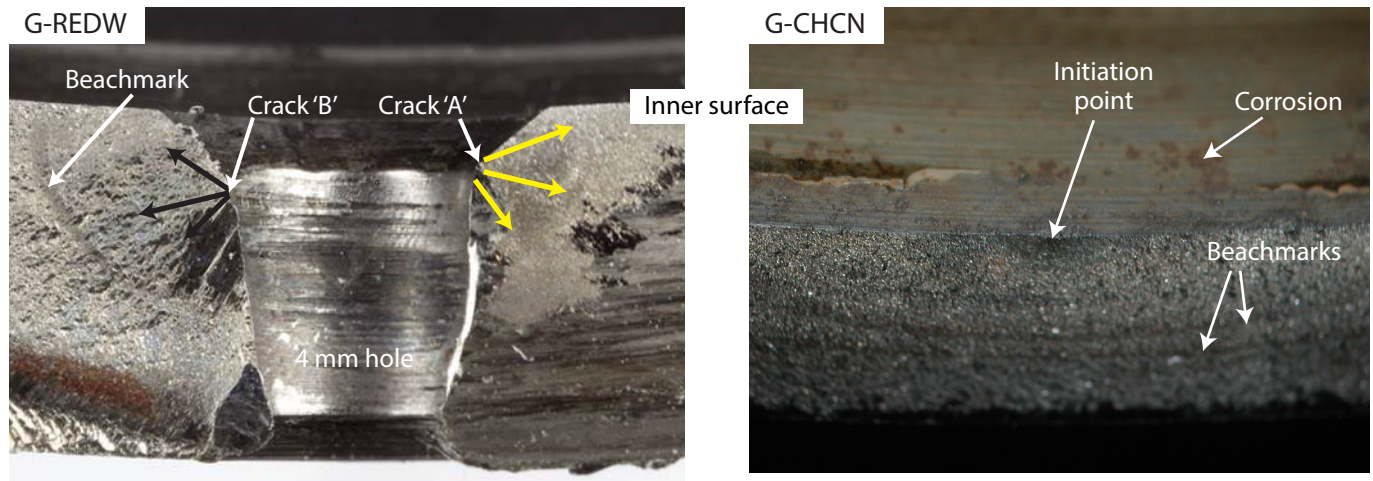
**Figure 3**

On G-REDW, the first crack to develop was identified as Crack 'A', which initiated at a corrosion pit approximately 0.06 mm deep located in the inner countersink of the Ø 4 mm hole (Figure 3). The crack then propagated along the fusion line between the area of the weld which had been previously melted, and the heat affected zone in the parent material in the vertical shaft. A second crack, Crack 'B', initiated after Crack 'A' at a small

Location of crack initiation on G-REDW and G-CHCN

scratch in the internal surface of the hole. Numerous corrosion pits that could only initially be detected by a scanning electron microscope were also present around the circumference of the inner countersink. Crack 'B' ran into a third crack identified as Crack 'C' (Figure 4).

On G-CHCN the fatigue crack initiated at an area of corrosion on the inner surface of the shaft (Figure 3), approximately 47° around the circumference from the Ø 4 mm hole (Figure 4). It has not yet been determined where the crack initiated in relation to the heat affected zone. Away from the initiation point, the crack propagated in both directions in the parent material in the vertical shaft. Small areas of corrosion were also visible in the machining marks around the inner flange that had been machined during manufacture to remove the root of the weld. The initial examination has not

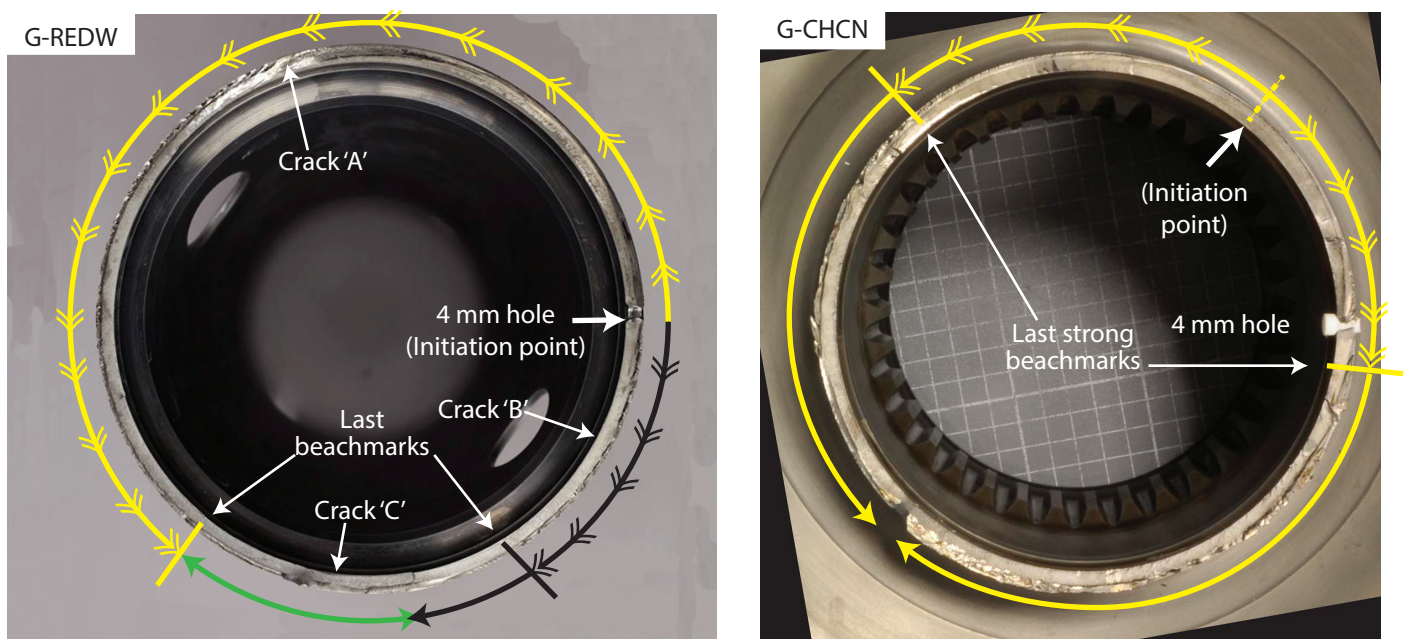
**Figure 4**

The fracture surfaces of the shafts on G-REDW and G-CHCN both displayed characteristic fatigue beachmarks, which can be formed when an event such as an engine start or significant change in torque has taken place (Figure 4). Beachmarks can be difficult to identify and can be interpreted in a number of ways.

For G-REDW the first beachmark was identified at 4 mm from the initiation point. Crack growth estimates are complicated by variations in engine torque and the changing stiffness of the shaft as the crack grows to failure. A number of different models are being considered, one of which suggests that the time for the crack to grow from the first beachmark to failure could be

Location of beachmarks on G-REDW and G-CHCN

as low as 20 engine<sup>4</sup> hours. From the recorded data this corresponds to approximately 15 flying<sup>5</sup> hours. Another model has shown that the crack growth time could be as high as 31 flying hours. Detailed analysis of the beachmarks continues.

For G-CHCN, work continues to identify all the beachmarks on the fracture surface. The provisional examination and analysis indicates that the first beachmark was identified at 2 mm either side of the initiation point (giving a crack length of 4 mm). Early analysis shows that there is a possible close correlation in the crack propagation time in the shafts fitted to G-CHCN and G-REDW.

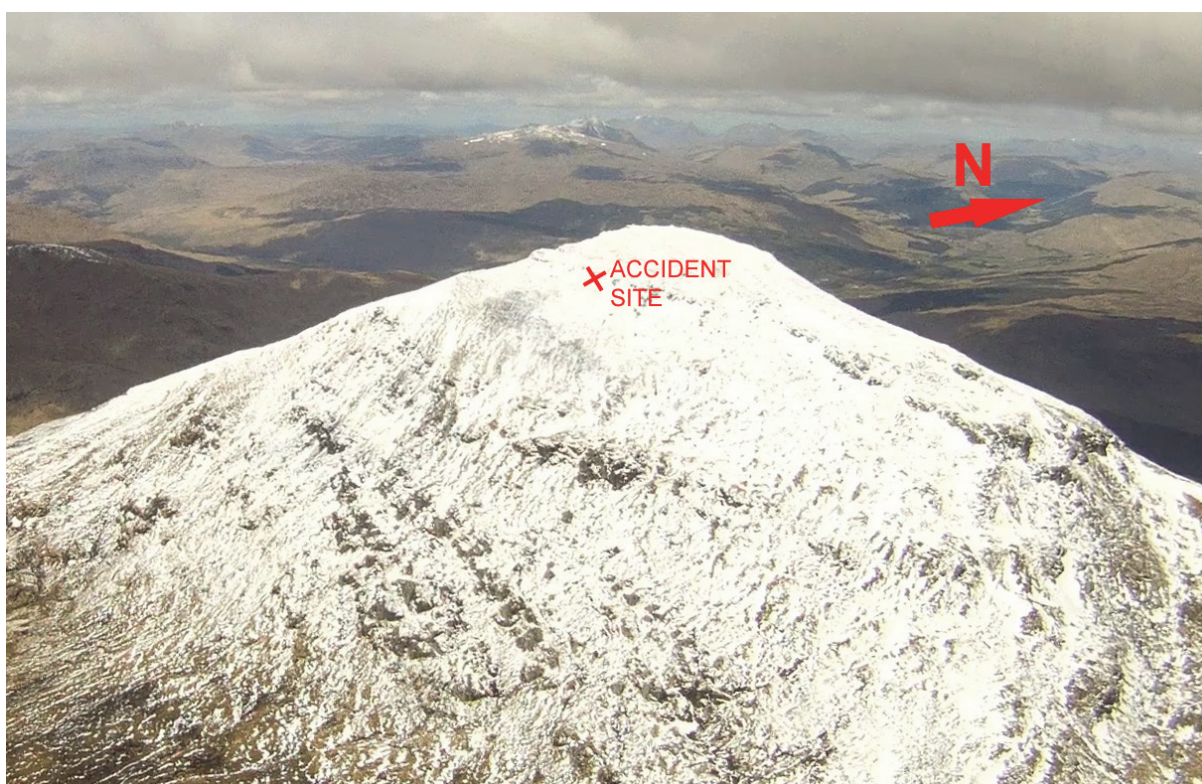
**Figure 2**

Accident site location, 100 ft below summit of Ben More (image extracted from video camera fitted to G-CWIK)

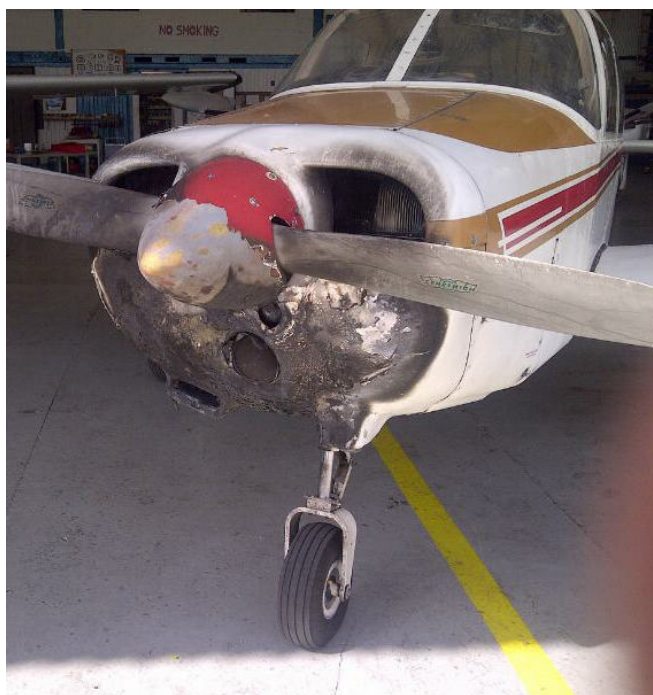
**Figure 1**

The source of fuel for the fire was likely to have been fuel pumped into the carburettor venturi by the carburettor accelerator pump, which operates when the throttle lever is advanced swiftly forwards. The induction of the fuel into the engine relies on airflow to move the fuel upwards into the engine inlet manifold. However, if the engine is stopped when the throttle lever is advanced, excess fuel will drip downwards from the carburettor and pool in the carburettor heat box. The heat radiated by the hot exhaust system can then cause the pooled fuel to vaporise and can also act as an ignition source for the fuel vapour.

Fire damage to the forward lower section of the engine bay

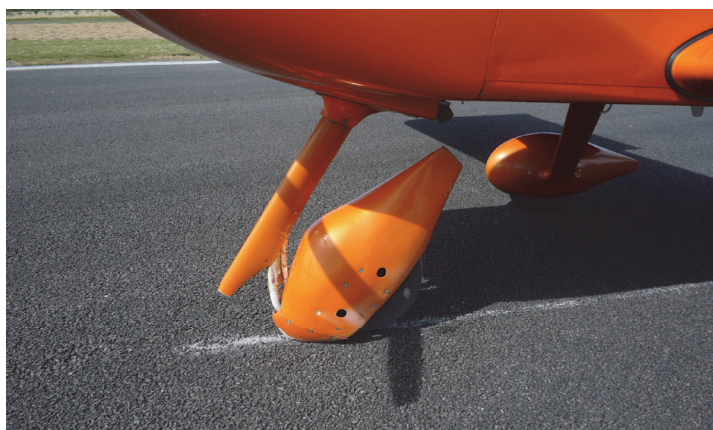
**Figure 1**

first. This caused the nosewheel leg to bend backwards until it was in contact with the runway, and the aircraft stopped on the paved surface after a short ground run. The pilot vacated the aircraft uninjured. Figure 1 shows the damage to the nose landing gear.

Damage to nose landing gear
