## CONTENTS

### AAIB FIELD INVESTIGATIONS

| Robinson R22 Beta | G-CHZN | 06-Jan-12 | 3 |

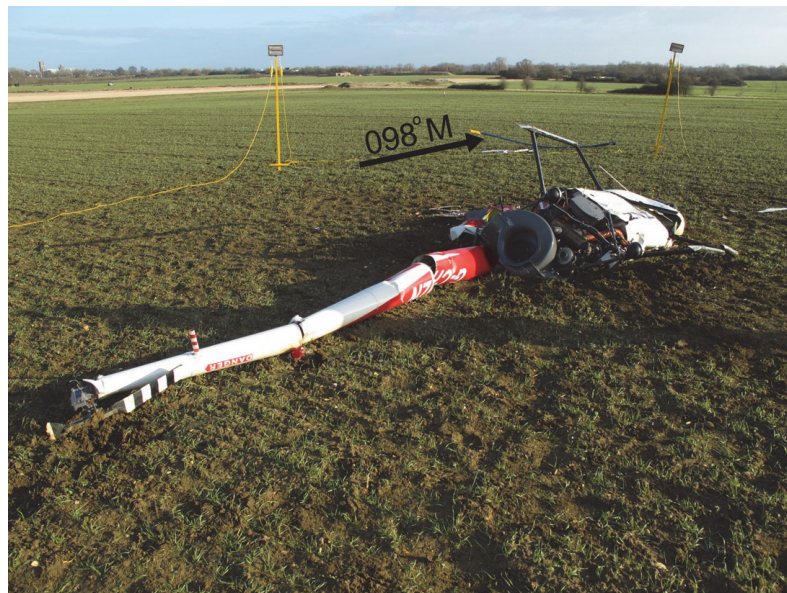
**Figure 7**  
Main wreckage

The main wreckage was found lying inverted in a field 2 miles south-west of Ely with its main rotor shaft buried in the ground (Figure 7). The lack of ground marks surrounding the wreckage indicated that the helicopter had struck the ground in an inverted attitude with very little horizontal speed. The main rotor (MR) blades were missing and one blade was found 315 m south-east of the main wreckage, in a hedge with its root embedded in the ground and its tip in the air (this will be referred to as MR blade No 1). The other MR blade was found 450 m east of the main wreckage lying flat in a field (this will be referred to as MR blade No 2). Both blades had separated from the main rotor hub at the coning hinge. Scattered along the length of a 500 m wreckage trail (Figure 8) orientated to the south-east of the main wreckage were multiple pieces

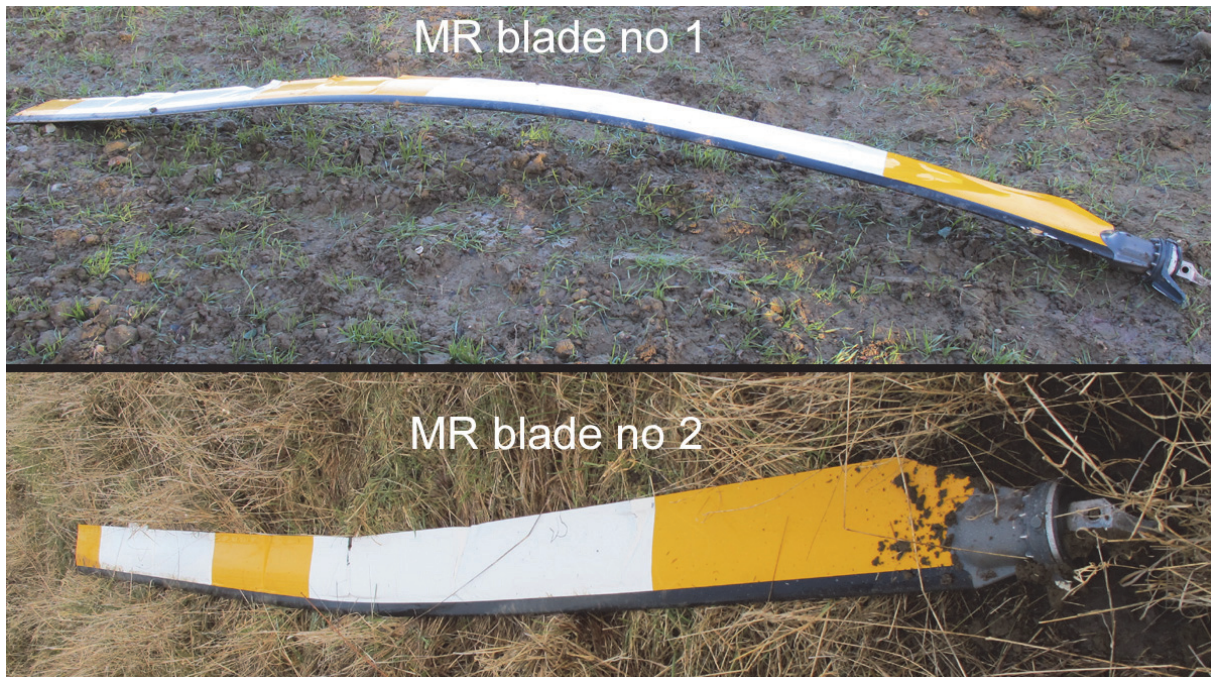
**Figure 9**

MR blade No 1 was bent downwards in a curve (Figure 9) and its lower skin was crinkled along the full span while the upper skin was crinkled from mid-span outwards. The blade also had a slight aft bend near the tip. The leading edge of the blade was undamaged, but it had a few black and red smears. At about 2.36 m span there was light scuffing on the leading edge which could have been caused by contact with the left skid. At

Main rotor blades No 1 and No 2 as recovered from the accident site

the blade's root the spindle tusk was bent 'aft' by about 10° (aft meaning opposite to the direction of rotation). The pitch horn was intact, but slightly bent, and there were witness marks at the edges of the hole that had secured the missing pitch link bolt – this indicated that a force was applied to the bolt before it separated. The spindle bearings were free to rotate with no 'ratchety' feel.

MR blade No 2 was bent aft at about mid-span and had a crinkled upper and lower skin (Figure 9). There was no leading edge or tip damage, but there were a few red and white smears on the leading edge. The spindle tusk was bent aft by about 40°. The pitch horn had failed near the blade root and metallurgical examination of the fracture surface revealed that this was an overload failure. The separated pitch horn was still attached to the pitch link which was still attached to the rotating swashplate. The spindle bearings were free to rotate with no 'ratchety' feel.

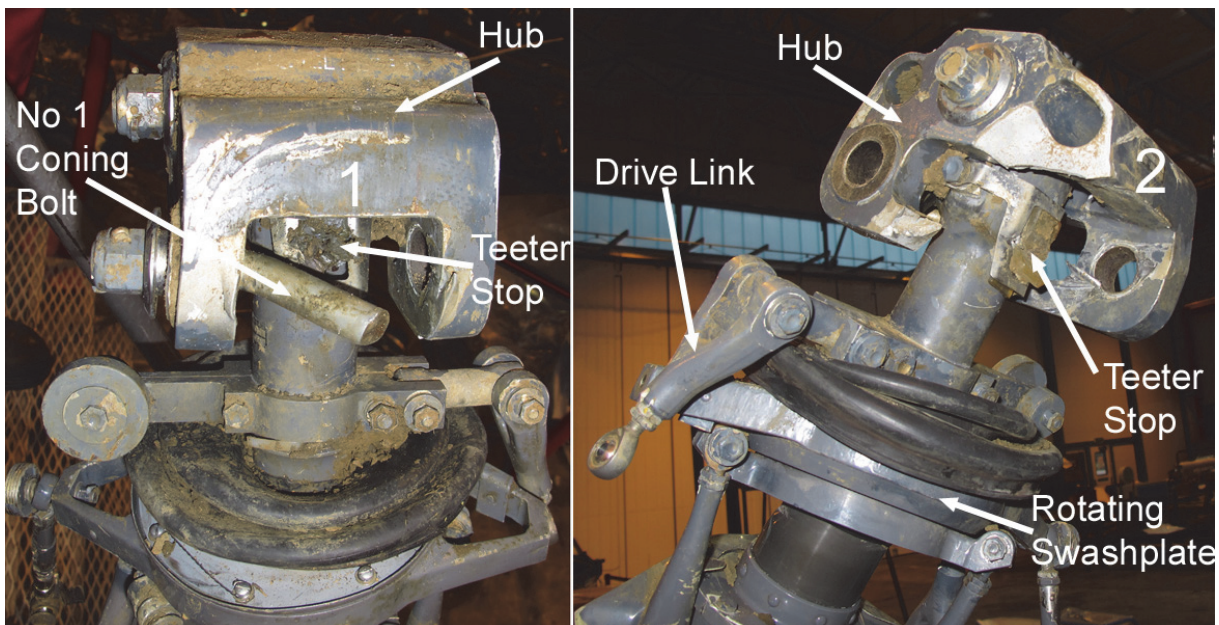
**Figure 10**

The main rotor hub was damaged as a result of the in-flight main rotor blade separations (Figure 10). The No 1 coning bolt had failed and was bent aft and the aft lug was also bent outwards. Metallurgical examination of the coning bolt fracture surface revealed that it had failed in overload with no evidence of fatigue. This evidence indicated that MR blade No 1 had separated following a radial and aft loading at the coning bolt that was in excess of design loads. MR blade No 2 had separated in a similar manner, failing the No 2 coning bolt in overload, and tearing the aft lug rearwards (Figure 10 – right image) – metallurgical examination of the hub fracture surfaces did not reveal any evidence of fatigue.

Both elastomeric teeter stops (Figure 10) were damaged and had split in the middle. This occurs when the blades flap downwards to an extreme angle and strike the mast and is known as 'mast bumping'. Witness marks on

Main rotor head as recovered from accident site, showing damaged teeter stops and drive link disconnected from rotating swashplate

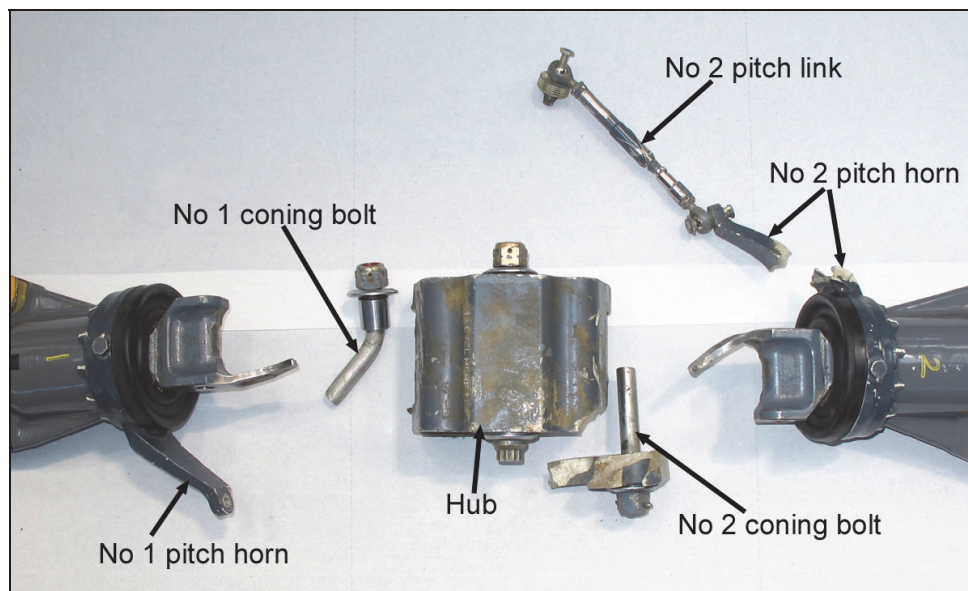
**Figure 11**

The No 1 pitch link had separated and the bolts at both the swashplate end and pitch horn end were missing. The pitch link bolt at the swashplate end secures the drive link to the swashplate through an eye end, so when this bolt separated the drive link detached from the swashplate as shown in Figure 10 (the drive link attaches on the inside of the swashplate, shown in Figure 6). Witness marks in the eye end of the drive link indicated that the bolt had been forced sideways and this lined up with a witness mark on the inside of the swashplate attachment hole. Such witness marks would not have been made if the nut had simply come off the bolt, or had broken, but the marks indicated that a high force was applied and therefore probably failed the bolt in overload. Similar witness marks at the pitch horn end of the pitch link indicated that this bolt probably also failed in overload, resulting in the separation of the No 1 pitch link. The

No 2 pitch link was found still secured at both ends but had separated from the blade where the pitch horn had failed (Figure 11).

Main rotor blade roots, coning bolts, hub and No 2 pitch link  
(No 1 coning bolt removed from hub, No 2 pitch link disconnected from rotating swashplate.  
No 1 pitch link and coning bolt heads were not found)

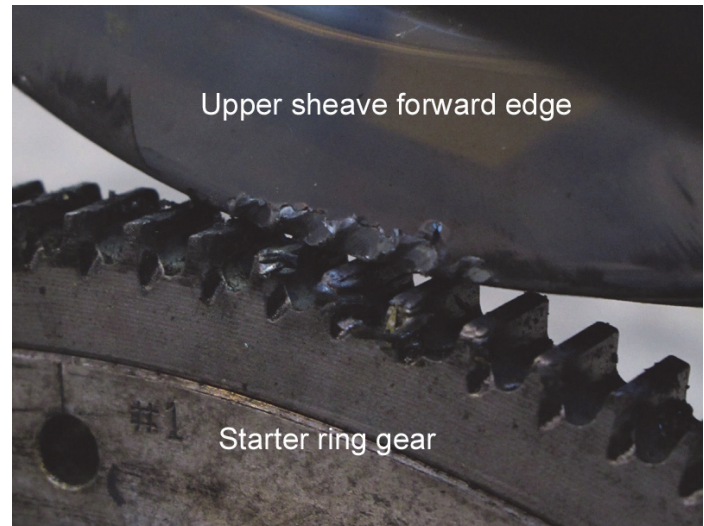
**Figure 12**

There was an impact imprint on the upper sheave from five teeth on the engine's starter ring gear (Figure 12) which probably occurred when the helicopter struck the ground inverted, causing the engine to strike the sheave. If the engine had been running at impact then multiple scores on the upper sheave would have been expected, therefore the engine was probably not rotating at impact. Fuel flow from the fuel tanks to the engine is by a gravity-feed system with no fuel pump, therefore the helicopter's inverted attitude prior to impact could have interrupted the fuel flow and caused engine stoppage prior to impact. To determine if engine stoppage had been an initiating event to the accident a strip examination was carried out.

Impact imprint on upper sheave from starter ring gear

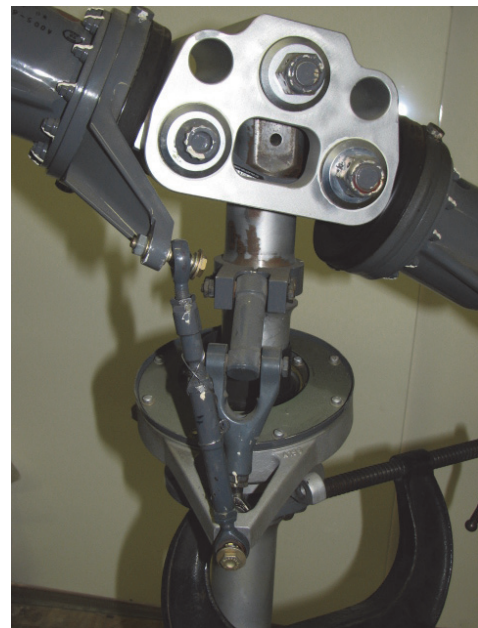
**Figure 13**

To explain the failure of the No 1 pitch link, the manufacturer set up a rig of an R22 main rotor head assembly (Figure 13), with the elastomeric teeter stops removed to simulate the geometric situation following mast bumping where the stops have been split and the blade root is striking the mast. Normally the pitch link is aligned vertically, perpendicular to the plane of rotation, and experiences pure tensile and compressive loads, but at extreme teetering angles the pitch link tilts aft. This allows bending loads to be applied to the pitch link and retaining bolts. The aerodynamic forces during rotor blade divergence could be sufficient to pitch the rotor blade further nose down than in Figure 13, which would force the pitch link down and fail the lower attachment bolt in a downwards and forward direction. This was consistent with the witness marks found in the swashplate attachment hole and the eye end of the drive link.

R22 rotor head with elastomeric teeter stops removed to simulate the static geometry when mast bumping occurs. The MR blade on the left has been pitched to the maximum nose-down position that could be attained with hand force – the pitch link is no longer ‘over-centre’

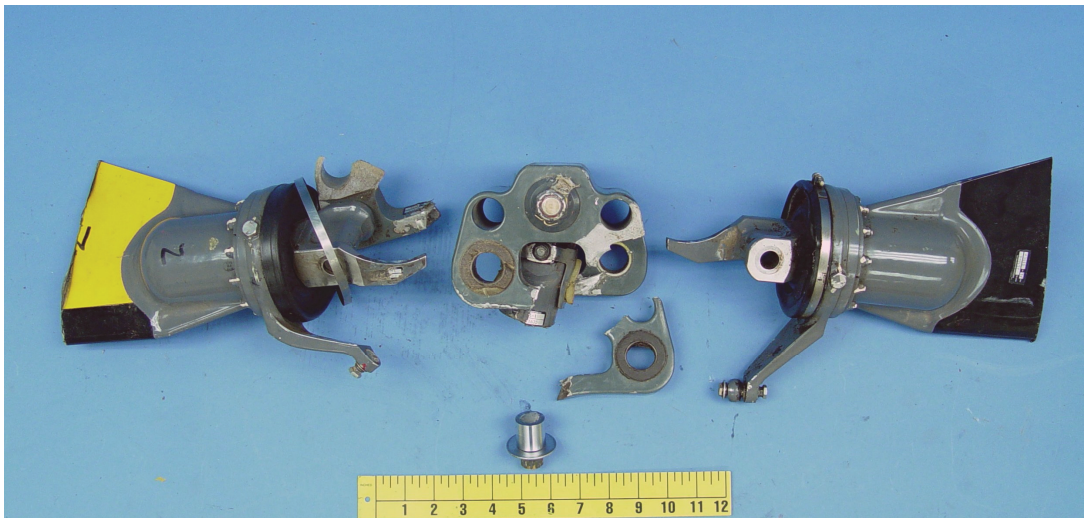
**Figure G1**

Rotor head components recovered from R22 accident (N7779M) near Del Valle, Texas  
– blade roots have been cut for examination

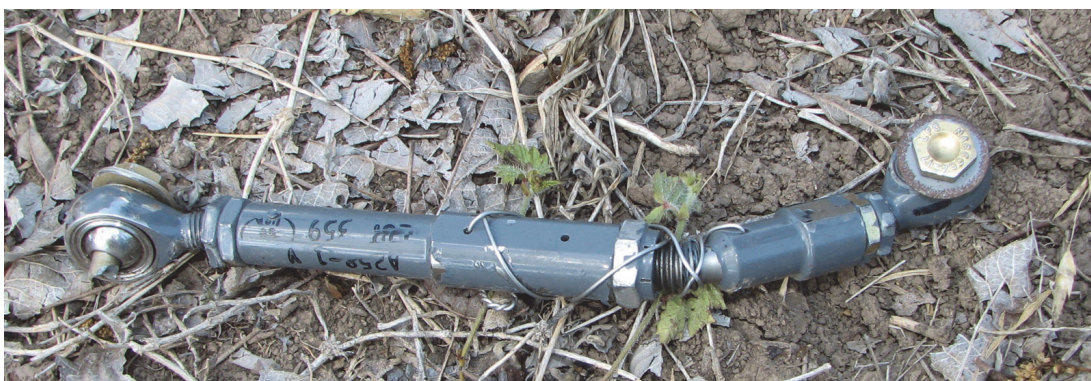
**Figure G2**

On 27 June 2011 an R22 (registration N7779M) suffered an in-flight breakup near Del Valle, Texas, USA. This accident is still under investigation but the NTSB provided the following information. The pilot had logged 220 flight hours, all of which were on the R22. Witnesses reported seeing it flying just above the trees and as it crossed the Colorado River they heard a loud ‘pop’ or ‘bang’ and saw something fall off the helicopter into the river. Both main rotor blades were found to have separated at the coning bolt and were located 265 m and 297 m respectively from the main wreckage. Both bolts were determined to have failed in overload and a corner of the hub had also failed, similar to the hub on G-CHZN (Figure G1). There was also clear evidence of mast bumping. One pitch link had failed at the upper thread and the other pitch link had separated following failure of both attachment bolts (Figure G2).

Separated pitch link from R22 accident (N7779M) near Del Valle, Texas  
– bolts at both ends have failed

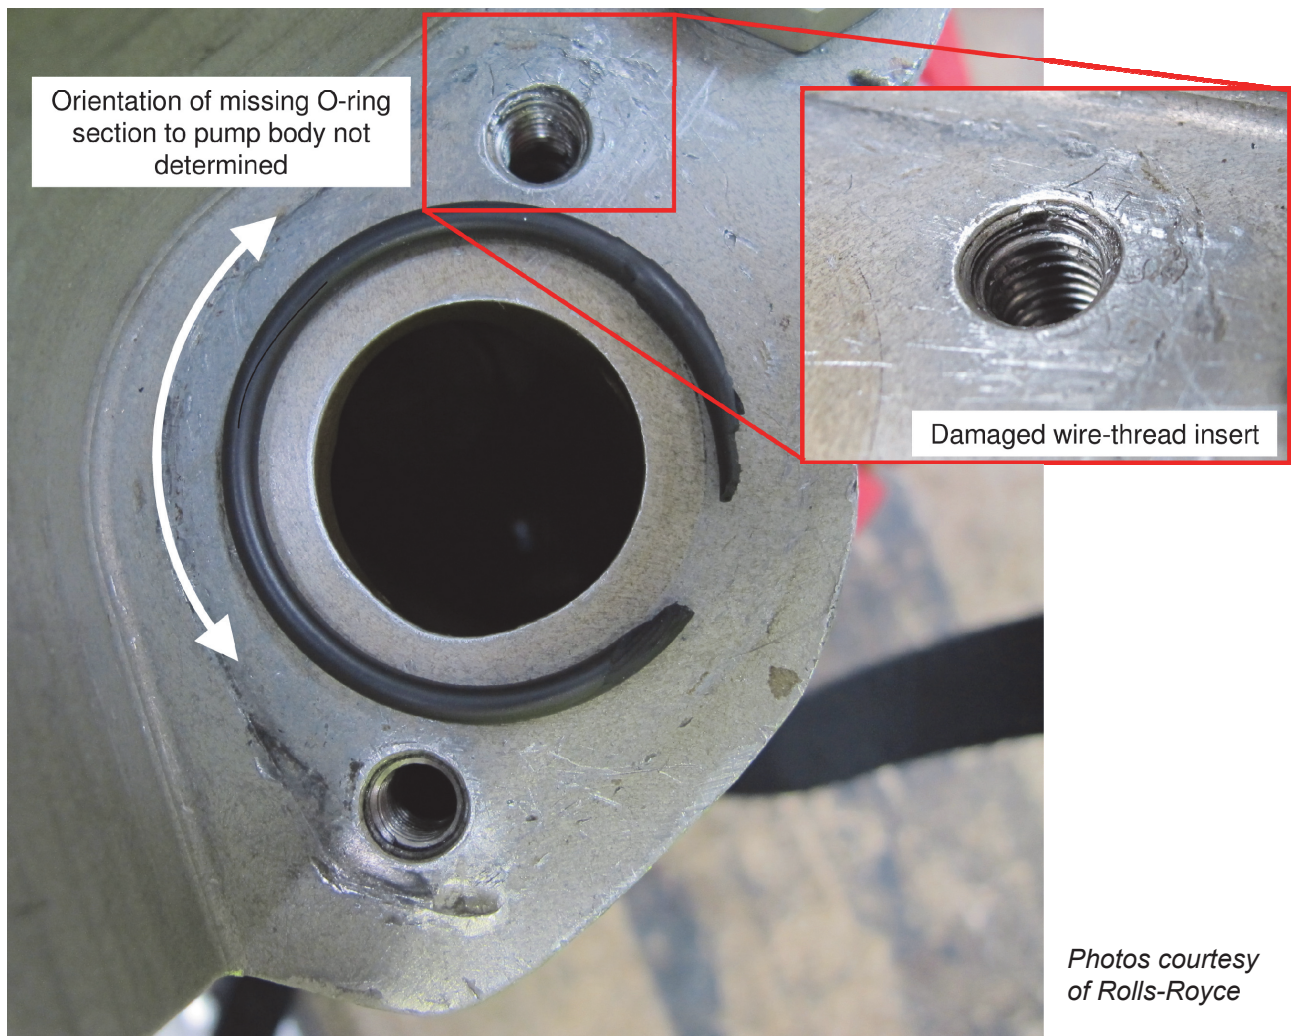
**Figure 2**

The threads on the lower bolt were found to be damaged, as was the start thread of the wire-thread insert in the pump body which had been displaced upwards slightly, and metallic debris was present on the insert's threads.

Examination of the damaged thread forms showed that the bolt had not been cross-threaded, rather that the start thread of the wire-thread insert had 'picked up' during insertion of the bolt, causing a progressive rounding-over of the bolt's threads as the bolt was tightened. A subsequent trial at the HP fuel pump manufacturer's overhaul facility, using a new bolt in the same hole, showed that whilst similar damage occurred to the bolt threads, the bolt torque specified in the Service Bulletin, 102 lbf-in, was only achieved when the flanged joint was fully fastened. It is therefore unlikely that the damaged wire-thread insert caused the lower bolt to remain only

Damaged O-ring seal, pump body and wire-thread insert

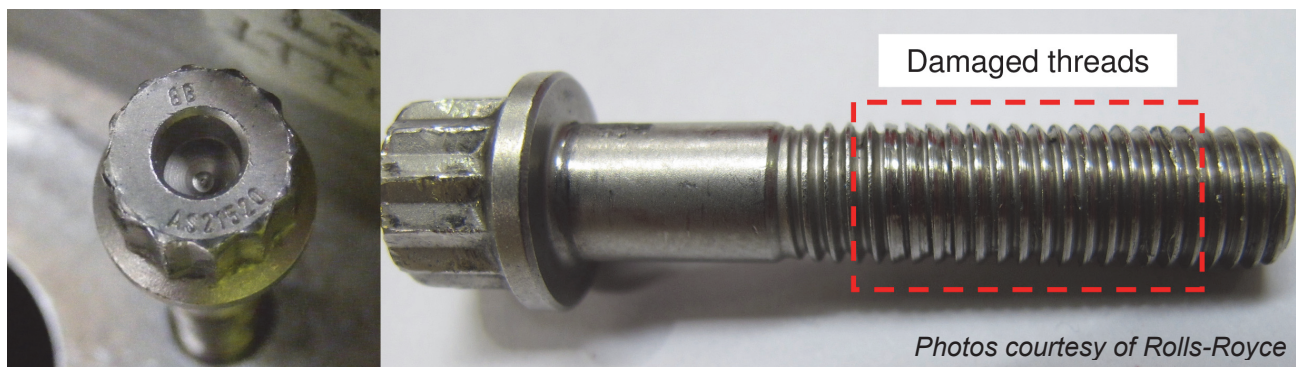
**Figure 3**

Lower bolt showing damaged threads and galling marks on head

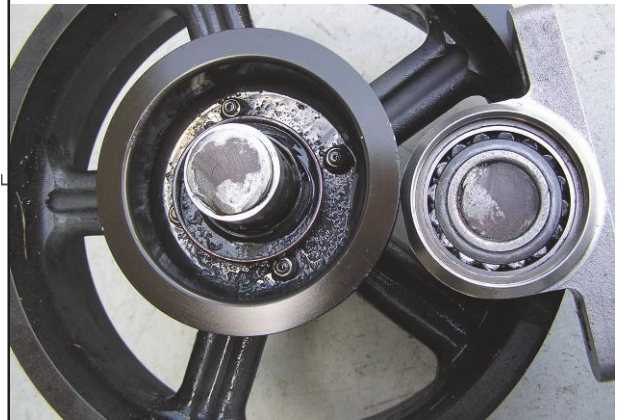
**Figure 3**  
Pulley and bearing, showing both fracture faces of the failed shaft

Figures 2 and 3 show a diagram of the secondary shaft assembly, together with a photograph of the failure. It can be seen that the failure occurred adjacent to the lower edge of the inner race of the upper bearing. The components were returned to the manufacturer in the USA, where the shaft, which is solid, was subjected to a metallurgical analysis. Figure 4 shows the two shaft halves following removal.

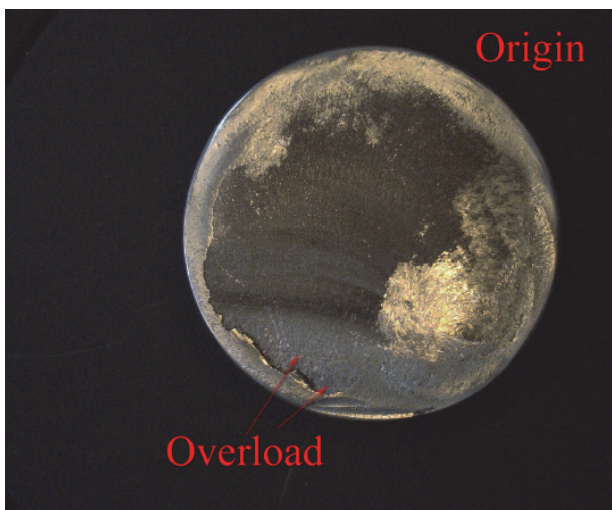
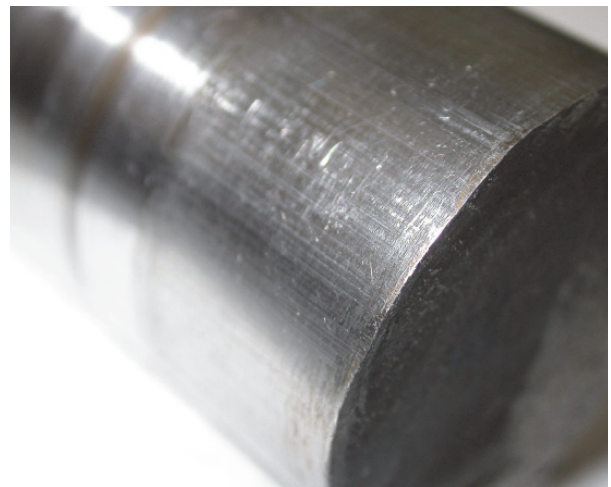
**Figure 5**  
Photographs of the fracture face and smeared surface close to the fracture origin

The examination indicated that the fracture occurred as a result of rotational bending fatigue, with area of the fracture origin and the final overload failure indicated in Figure 5. The surface of the shaft adjacent to the fracture showed evidence of mechanical wear in comparison to the surface finish elsewhere on the shaft; a photograph of this is also shown in Figure 5. It can be seen that the region was coincident with the location of the upper bearing, with the fracture occurring close to one end of it. The longitudinal scores were on top of the circumferential wear and are likely to have occurred during bearing removal.

The metallurgical report indicated that the area of wear was consistent with a fretting process which, in the region of the fracture origin, was associated with missing flakes of metal. The report additionally indicated that this may have induced a fatigue crack. No material defects were observed either in the origin or in the microstructure.
